RE: *Quarterly Status Report –April 2012 – June 2012*  
*Coldwater Road Landfill*  
*1245 East Coldwater Road, Flint, MI*  
*MID 005 356 860*  
FILE: 15388/47850/Docs

COLDWATER RD LANDFILL – ANIMAL BURROW PHOTO LOG

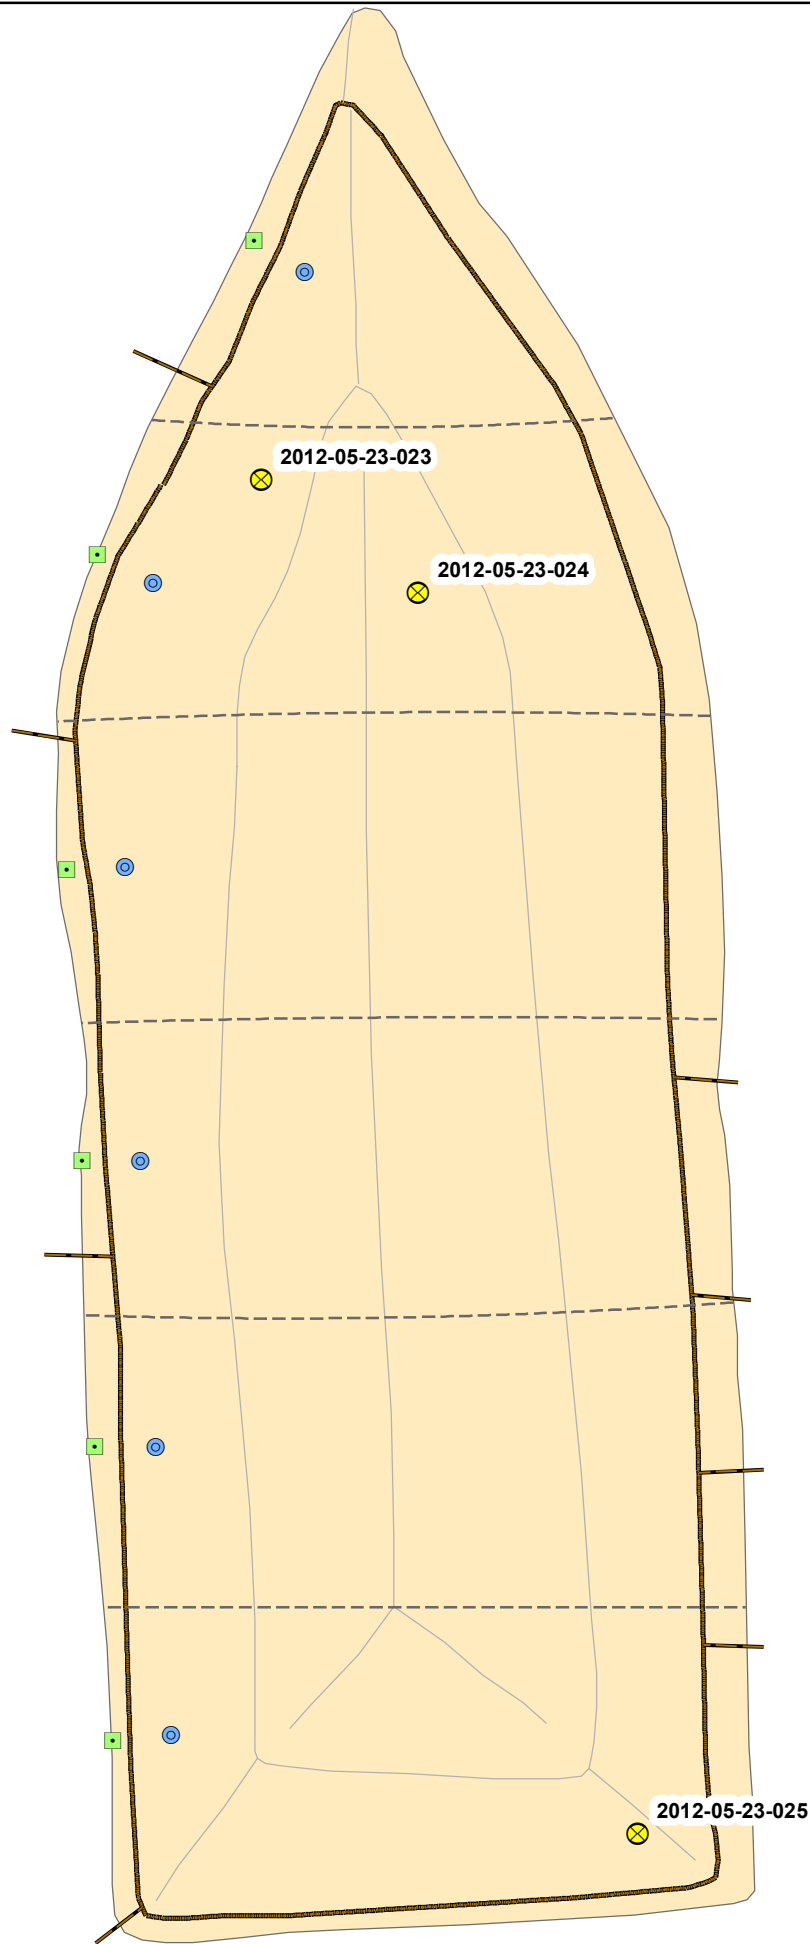
FIGURE 1

**2ND QUARTER 2012  
BURROW LOCATION  
MAP**

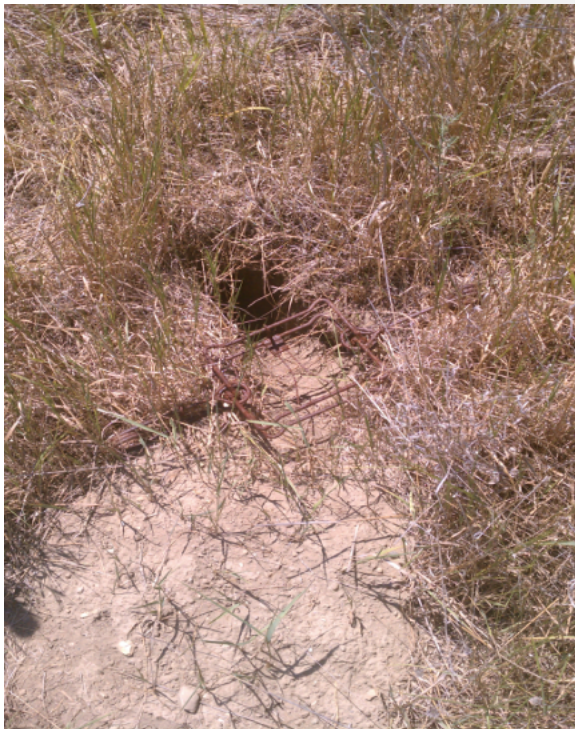
<b>NOTES:</b> <b>ID: 2012-05-23-024</b> PRE repair photo. Burrows appeared active. Trap set up for 4 weeks. No activity. No signs of liner damage.				
<b>LOCATION:</b> B3 - middle of slope		<b>APPROX. LENGTH:</b> 3 feet	<b>APPROX. DEPTH:</b> 1.5 feet	<b>APPROX. DIAMETER:</b> 8 inches
<b>DATE FOUND:</b> 5/23/12	<b>DATE CLOSED:</b> 6/27/12

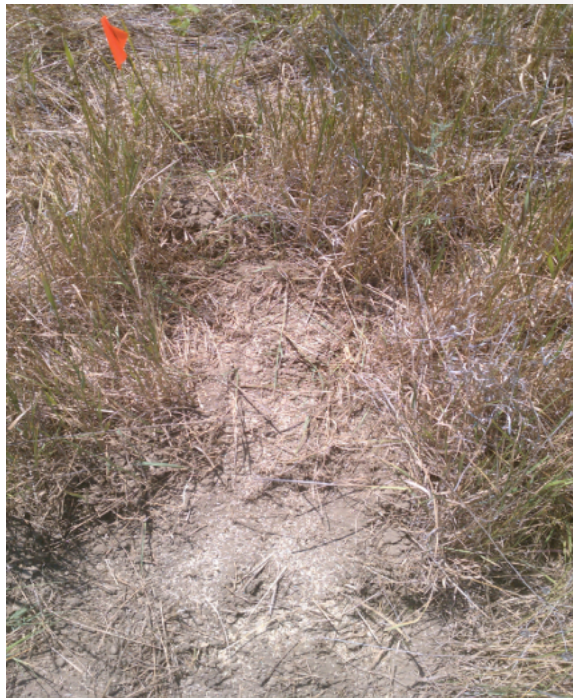
<b>NOTES:</b> POST repair photo. Filled in burrow.

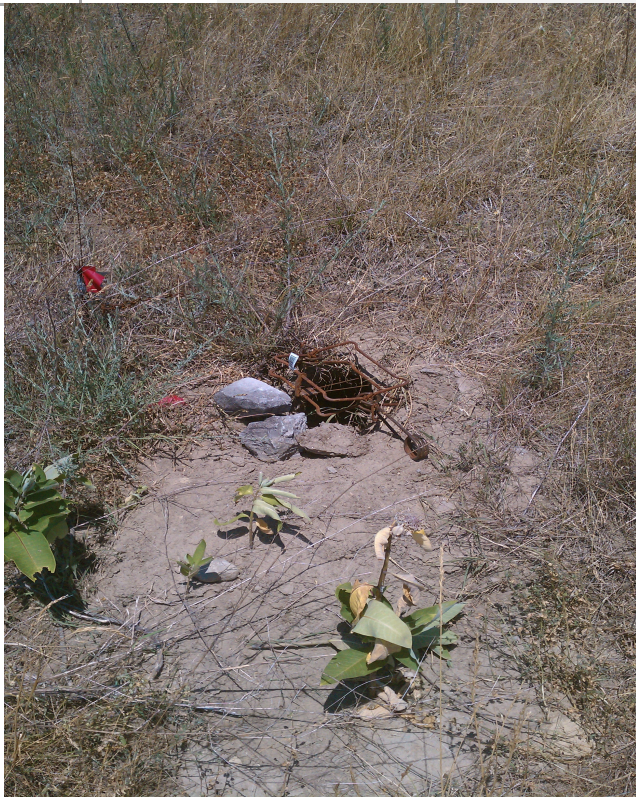
<b>NOTES:</b> <b>ID: 2012-05-23-025</b>  PRE repair photo.  Burrows appeared active.  Trap set up. Trap moved by animal but nothing caught.  Will continue to have trap set up until animal is caught or burrow appears inactive.					
<b>LOCATION:</b> F4 - middle of slope		<b>APPROX. LENGTH:</b> 3 feet	<b>APPROX. DEPTH:</b> 1 foot		<b>APPROX. DIAMETER:</b> 8 inches
<b>DATE FOUND:</b> 5/23/12	<b>DATE CLOSED:</b>				
<b>NOTES:</b>  POST repair photo will be provided once the burrow has been filled in.
