RE: Quarterly Status Report – July 2011 – September 2011
Coldwater Road Landfill
1245 East Coldwater Road, Flint, MI
MID 005 356 860 / Consent Order No. 64-05-92
FILE: 15388/47850/Docs

COLDWATER RD LANDFILL – ANIMAL BURROW PHOTO LOG

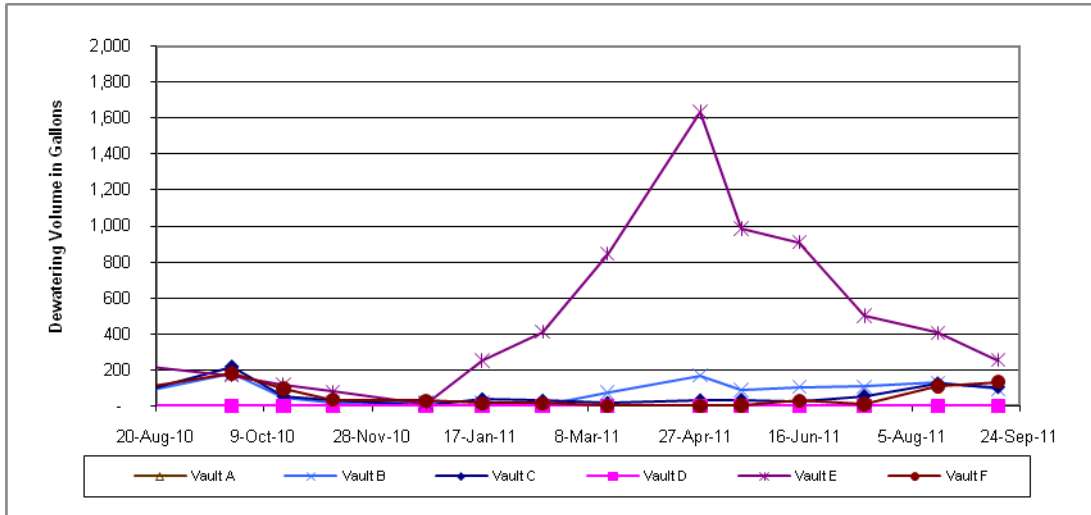
Total volume of water removed from the vaults during the third quarter was 2,023 gallons. According to the master flow meter, a total of 987 gallons were pumped from the sumps during the third quarter.

The following graph presents the vault dewatering data in graphical format for the past year:

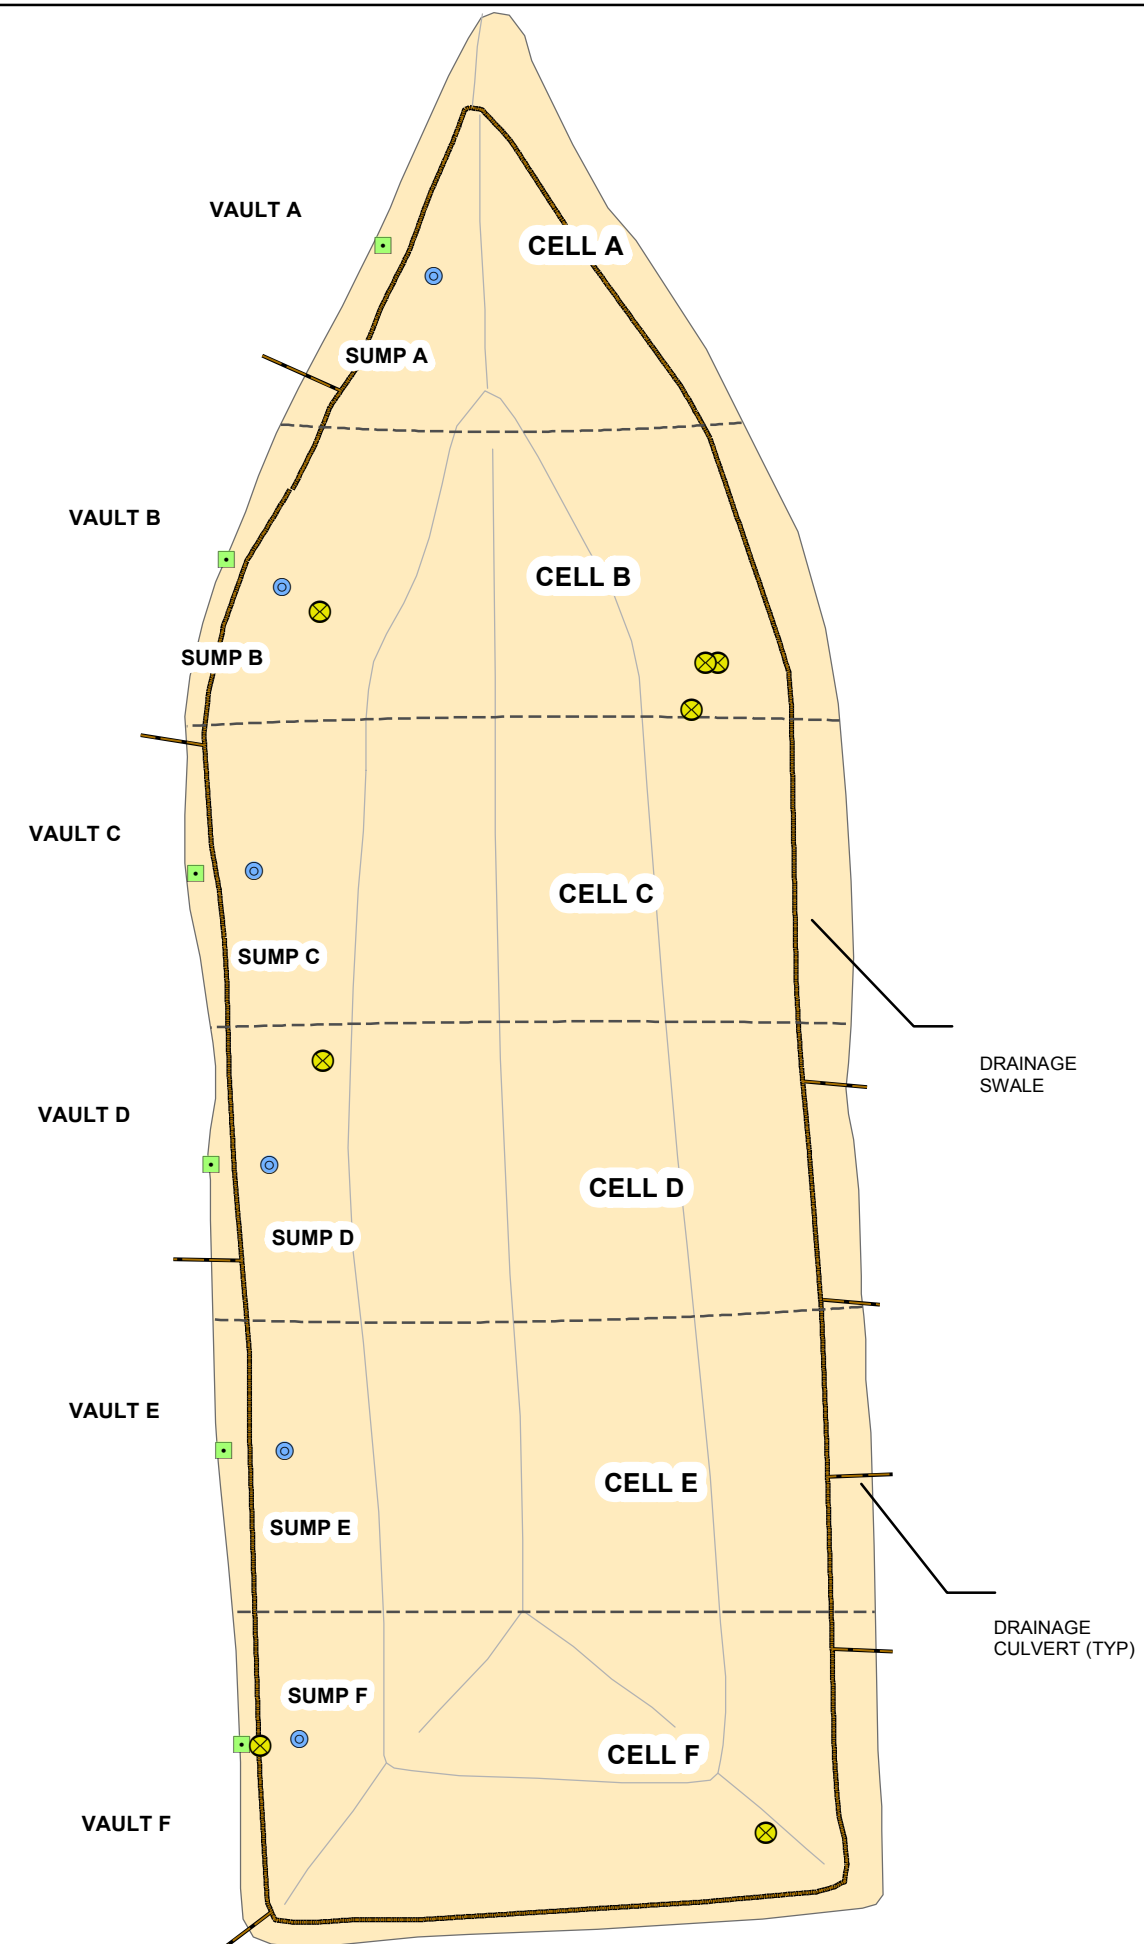
FIGURE 1

- » Filled in inactive animal burrows and set traps over active burrows; 1 animal trapped. See attached figure for animal burrow locations and photo log for detailed information concerning animal burrow activities for this quarter.
- » Perimeter fence repair occurred along the northwestern perimeter fence (1 repair).

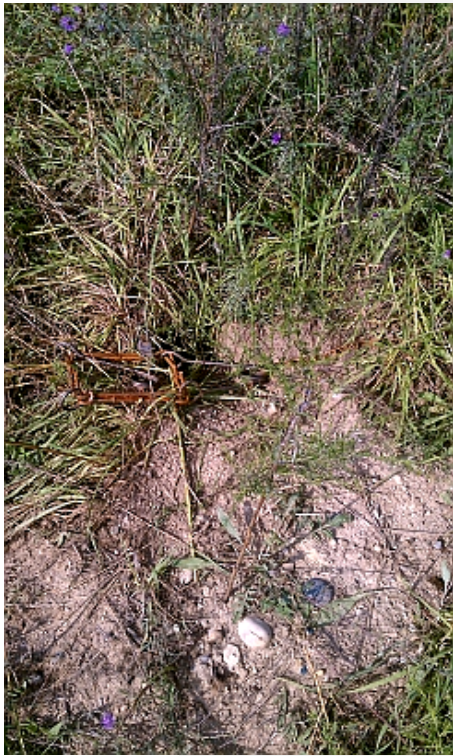
LOCATION: B3 - top of slope		APPROX. LENGTH: 3 feet	APPROX. DEPTH: 4 inches	APPROX. DIAMETER: 3 inches
DATE FOUND: 8/17/11	DATE CLOSED: 8/27/11

NOTES: PRE repair photo. Burrow appeared active. Set trap. Trap sprung. No signs of liner damage.				
LOCATION: B3 - top of slope		APPROX. LENGTH: 3 feet	APPROX. DEPTH: 4 inches	APPROX. DIAMETER: 3 inches
DATE FOUND: 8/17/11	DATE CLOSED: 8/27/11

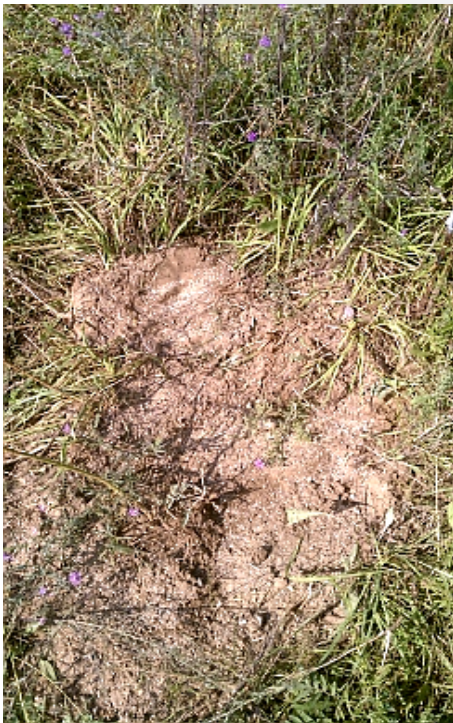
NOTES: POST repair photo. Filled in burrow and spread grass seed over area.

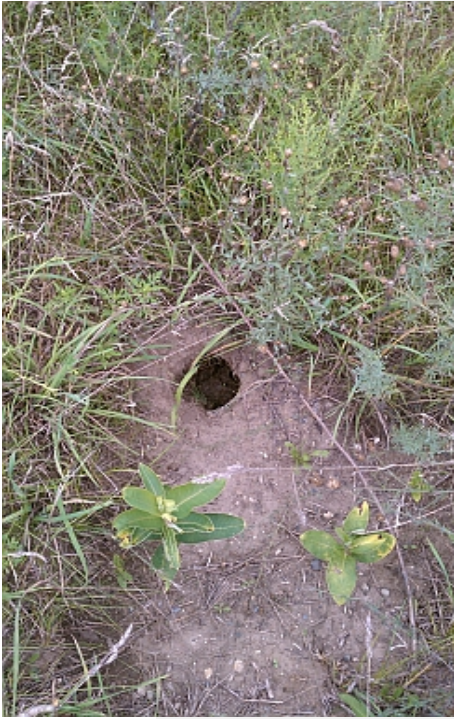
LOCATION: B3 – middle of slope		APPROX. LENGTH: 4 feet	APPROX. DEPTH: 1 foot	APPROX. DIAMETER: 4 inches
DATE FOUND: 8/17/11	DATE CLOSED: 9/13/11

NOTES: PRE repair photo. Burrow appeared active. Set trap. No signs of liner damage.				
LOCATION: B3 – middle of slope		APPROX. LENGTH: 4 feet	APPROX. DEPTH: 1 foot	APPROX. DIAMETER: 4 inches
DATE FOUND: 8/17/11	DATE CLOSED: 9/13/11

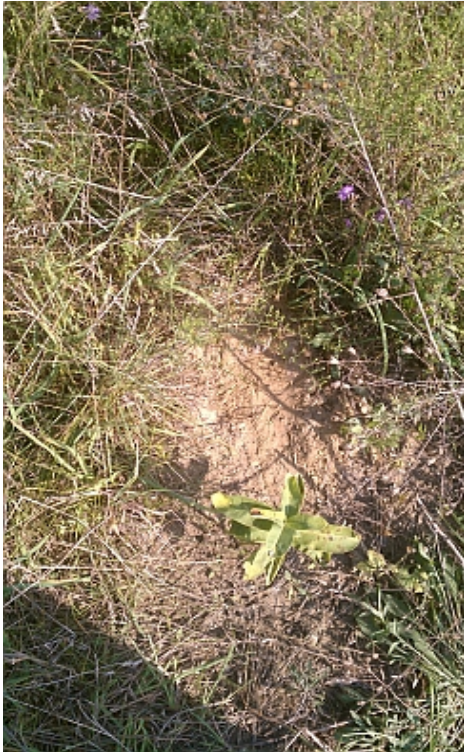
NOTES: POST repair photo. Had trap set for 4 weeks. No activity. Filled in burrow and spread grass seed over area.
