RE: Windiate Park/Dixieland Subdivision Landfill, Genesee County, Michigan (Site ID No. 25000689)  
FILE: 15388/68490 - Soil Cover Inspection Report

## WINDIATE PARK SOIL COVER MAINTENANCE CHECKLIST

# INSPECTION MAP

## WINDIATE PARK FLINT, MICHIGAN

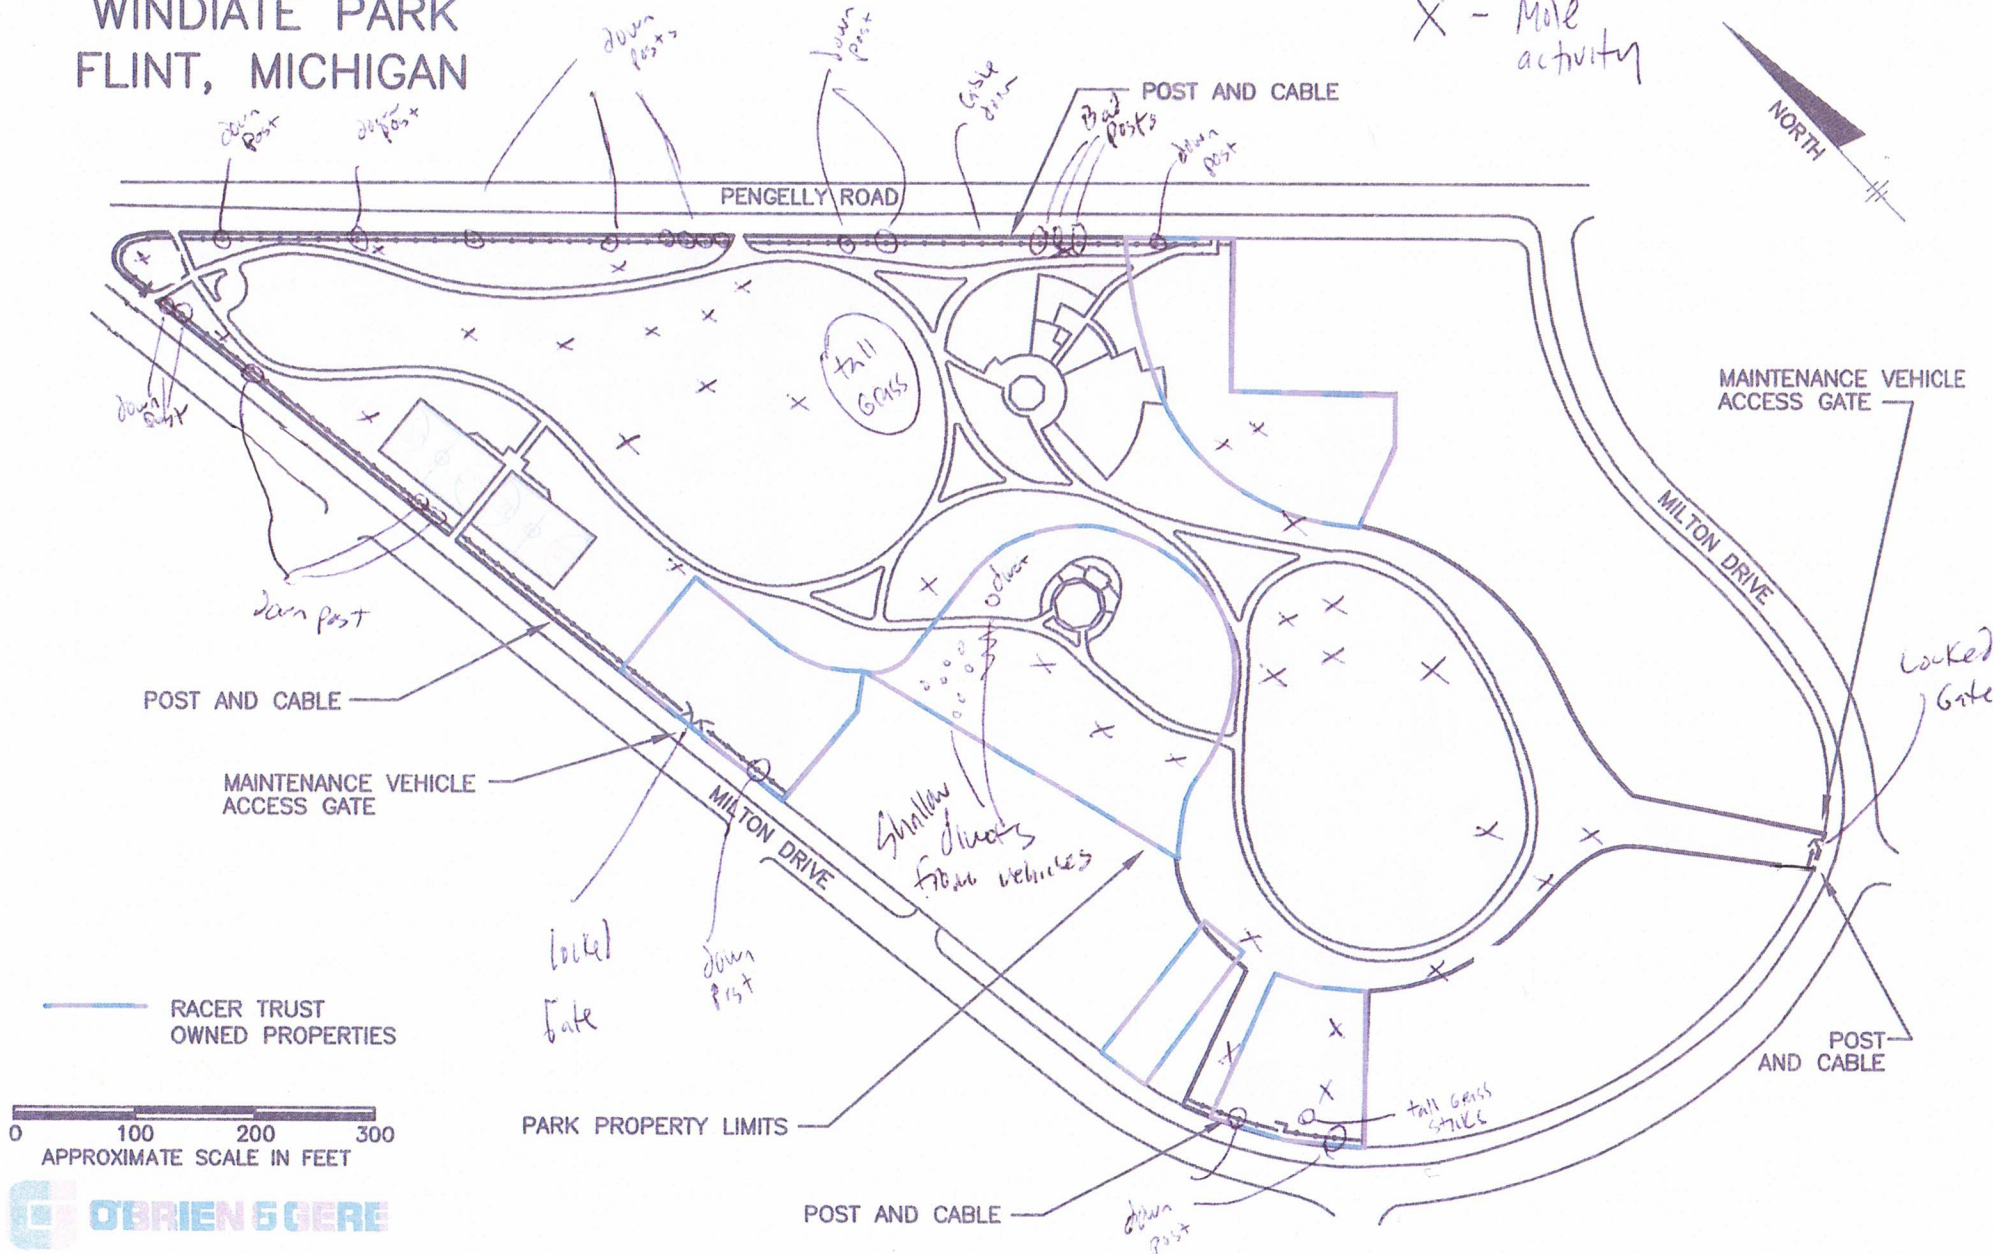
| Inspected Item: | Comments: |
|---|---|
| SOIL COVER | Acceptable. No maintenance required at this time. One area was observed with standing water, tall grass and tall woody plants. One area on the west side was observed with shallow divots due to a vehicle on grass. |
| GRASS/VEGETATIVE LAYER | Acceptable. No maintenance required at this time. One area was observed with standing water, tall grass and tall woody plants. |
| POST & CABLE / VEHICLE GATES | Acceptable. Twenty-three damaged posts were observed during the site inspection (either partially down or completely down). Two sections of down cable were observed. The south and west maintenance vehicle access gates were locked. |
| OTHER OBSERVATIONS | A number of mole mounds were observed. Unable to determine if the mounds are from recent activity or from older activity. |

X - Mole  
activity

Add additional soil to area where water has ponded.
