Arcadis Project No.:
30042872.03600

Subject:
Plant 3 Storm Sewer Outfall Modifications

PLANT 3 OUTFALL MAIN INSPECTION SUMMARY

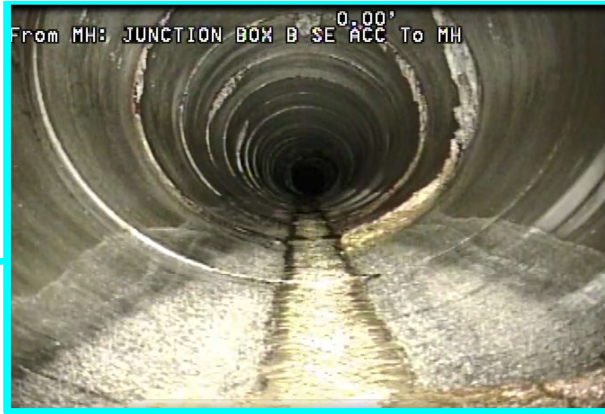
Minimal sediment, signs of minor infiltration, very little flow

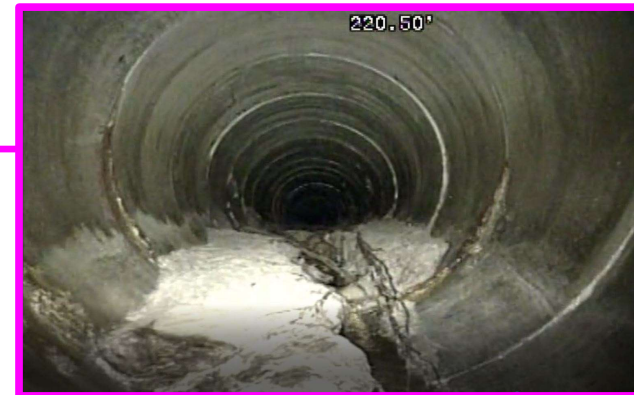
- The inspection ended at 220 feet where the camera was blocked by what appeared to be a pile of hardened concrete.
 - The vac truck could not access the manhole for cleaning due to the distance from the access road, soft grass, and a hill blocking the manhole.

Obstruction, end of May inspection

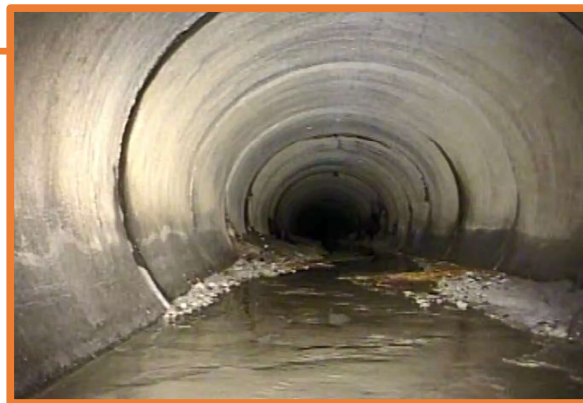
- December 2, 2019: Youngs conducted a sewer video inspection beginning at the Plant 3 outfall manhole and moving north towards the WWTP.
 - Groundwater infiltration (slow drips) were observed at several locations offsite.
 - A small diameter (2-3-inch diameter) pipe penetrated the main approximately 150 feet from the manhole and contributed a slow trickle, apparently groundwater infiltration. The pipe was located approximately below the parking lot in the Lansing Board of Water and Light (BWL) electrical substation parking lot and there is no visible inlet to the pipe at the ground surface.
 - Sediment accumulation was less than 1 inch deep near the outfall and increased to more than 8-11 inches deep farther north; the inspection ended at approximately 375 feet because the camera could not continue due to sediment approximately 10-11 inches deep.

Sediment accumulation, end of December inspection

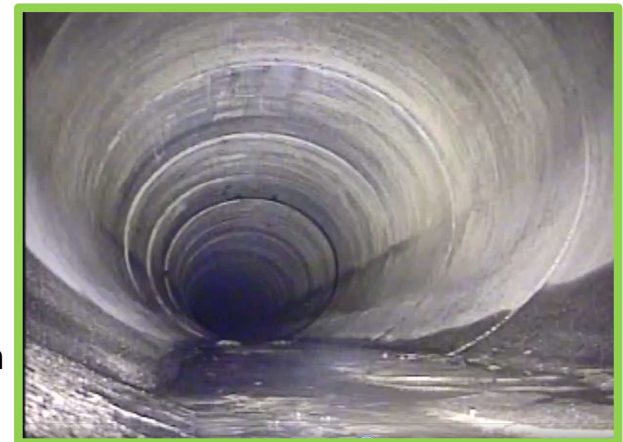
Sediment accumulation increases moving north

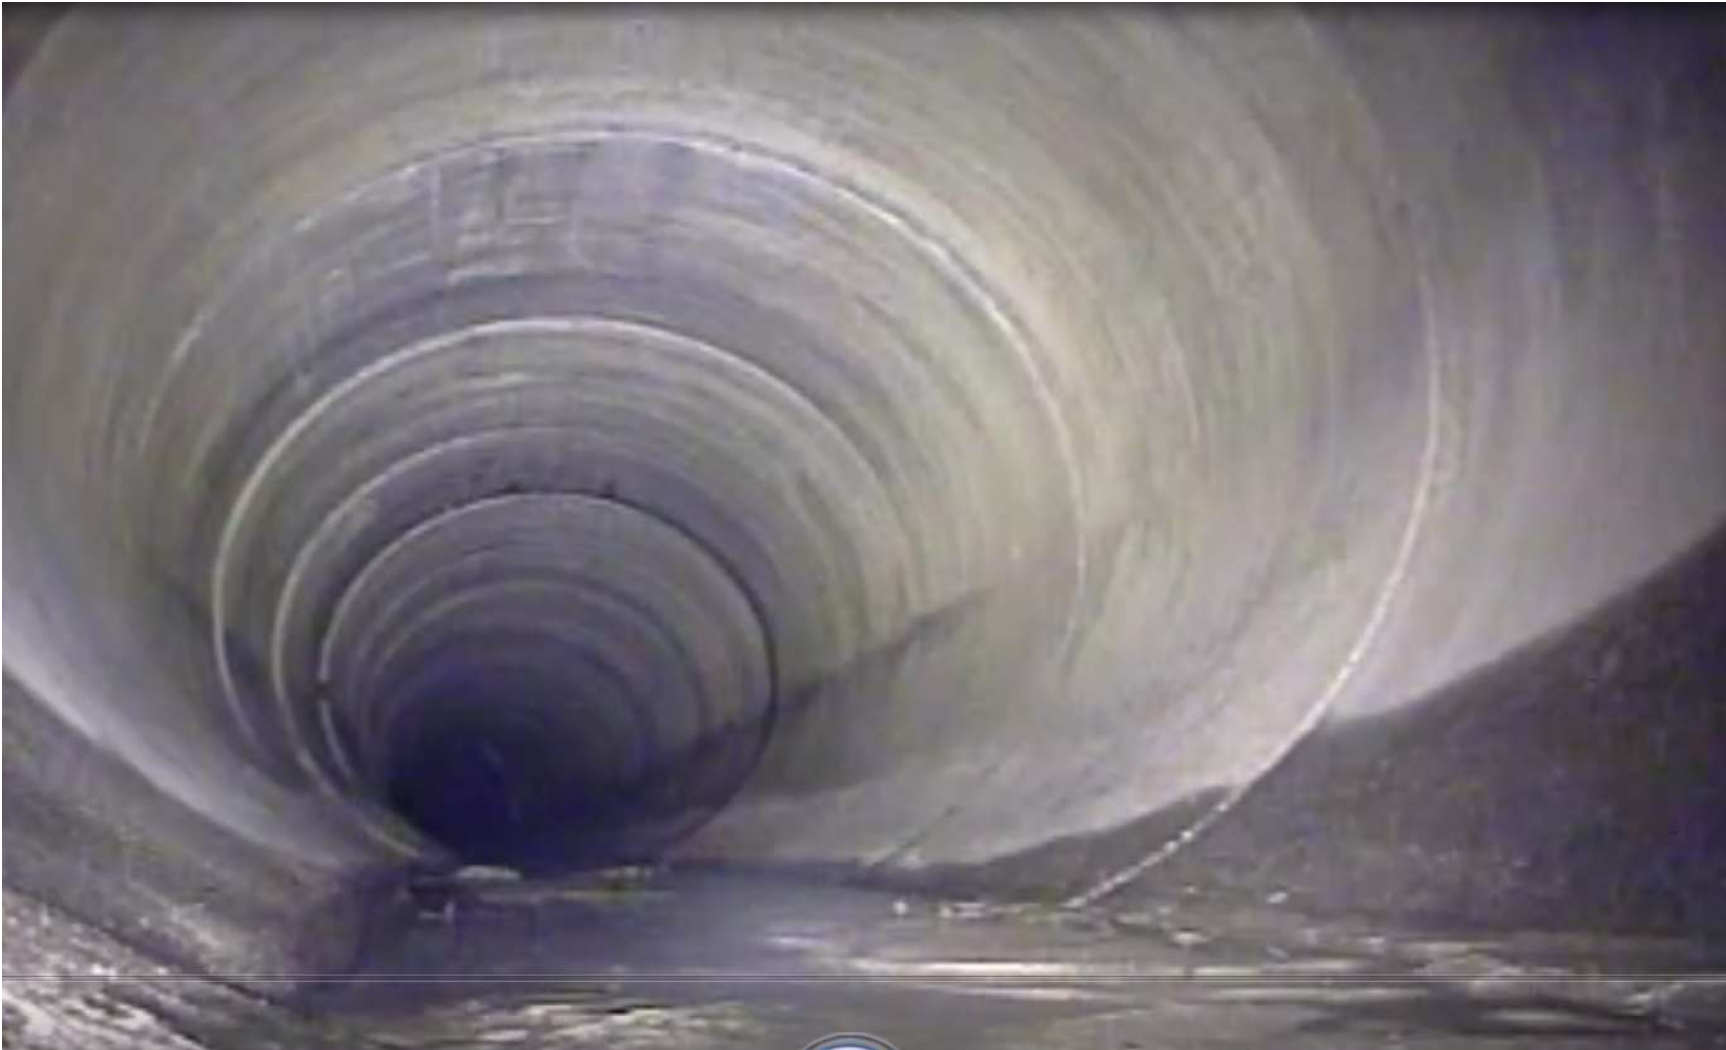
Start of inspection at entrance to 54" outfall main. Minor water flow (pre-outfall manhole fill), minor sediment

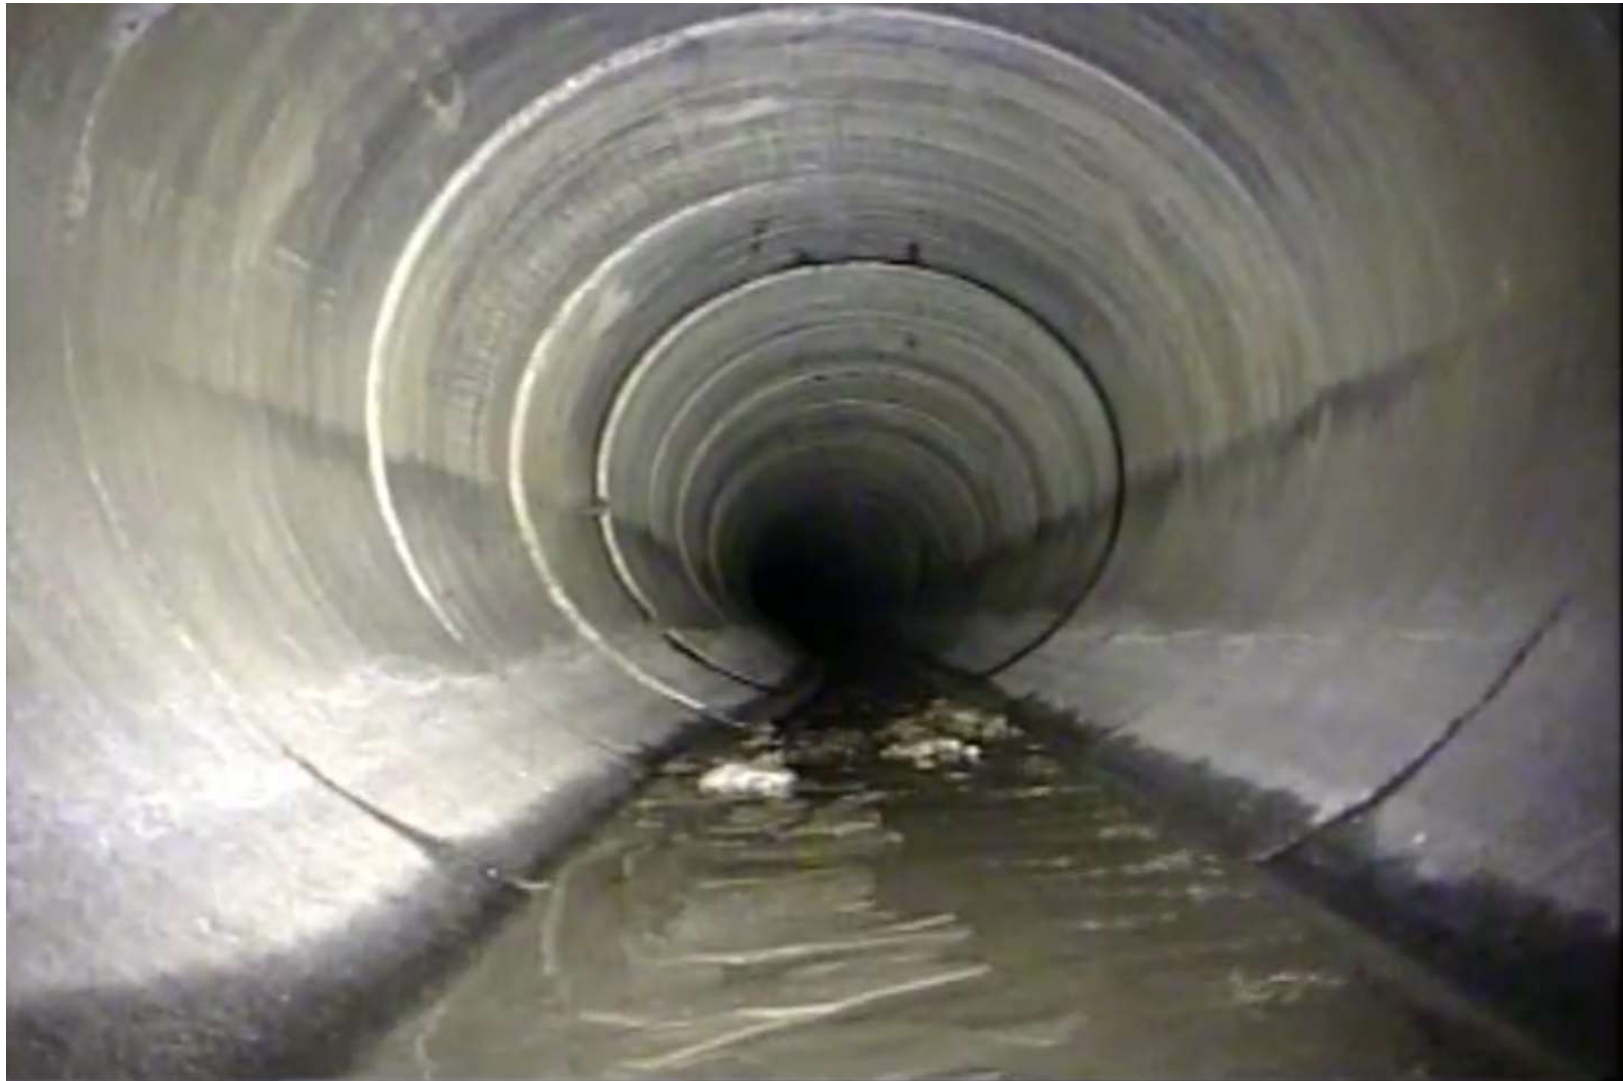
Minor sediment accumulation, evidence of infiltration through pipe joints at ~30 feet

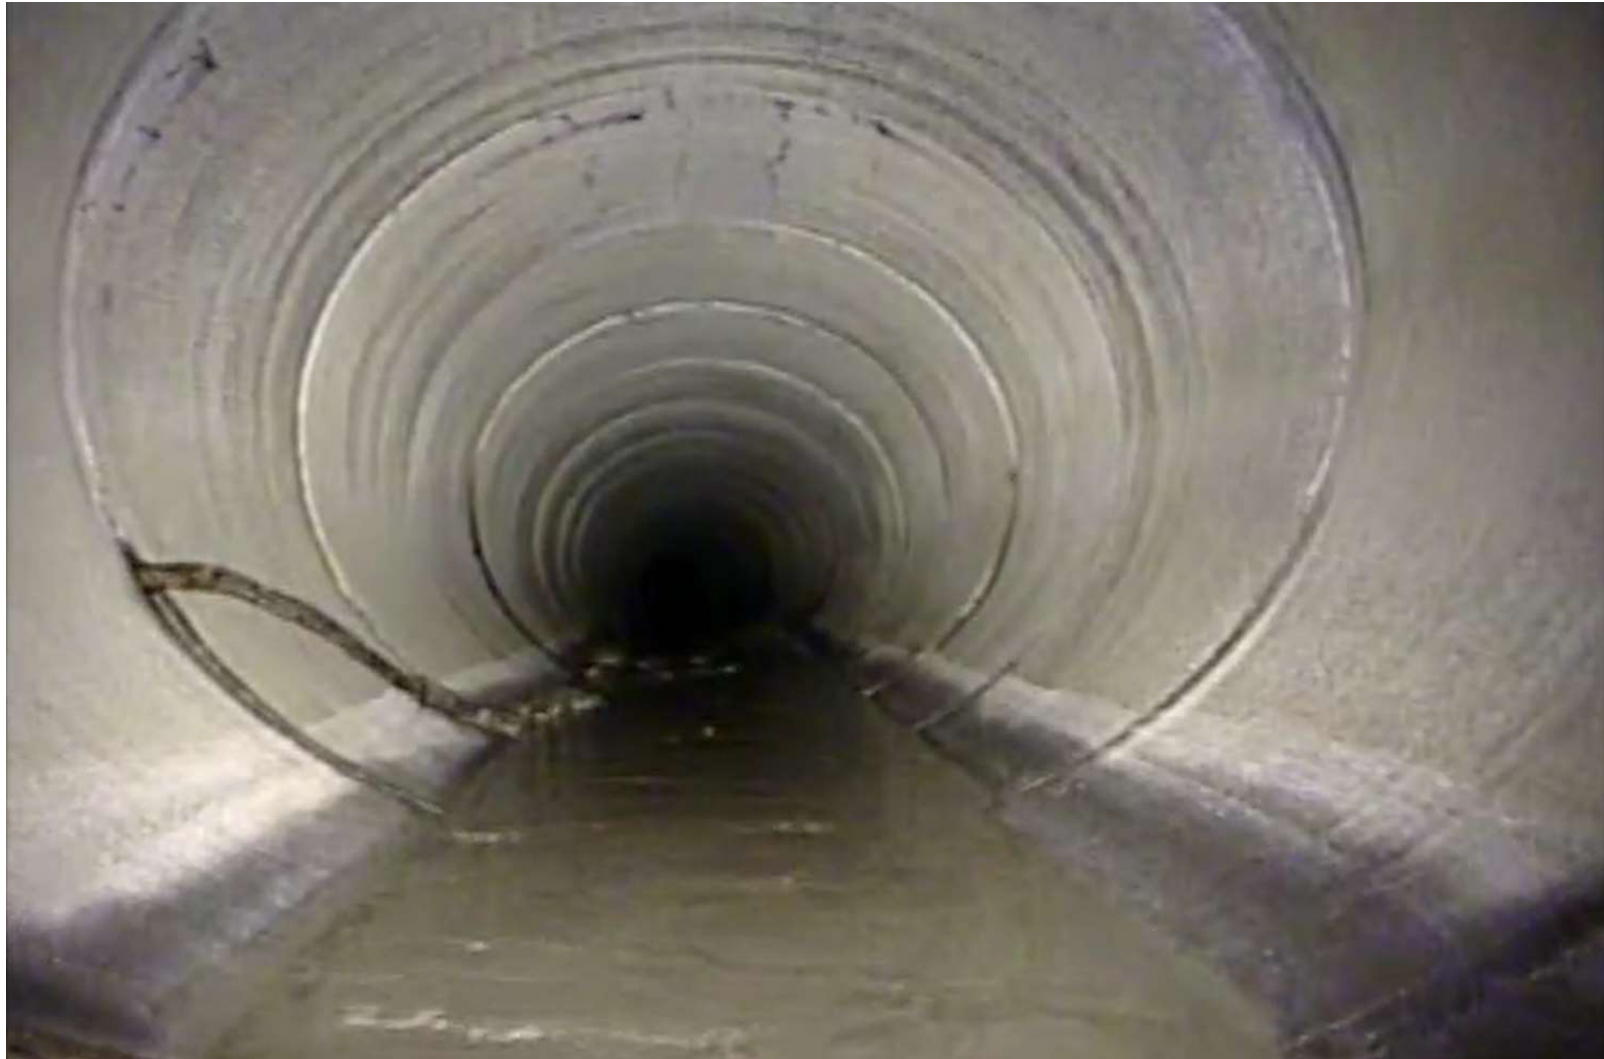
Tree root intrusion with groundwater infiltration, increased sediment accumulate ~80 feet north of outfall manhole

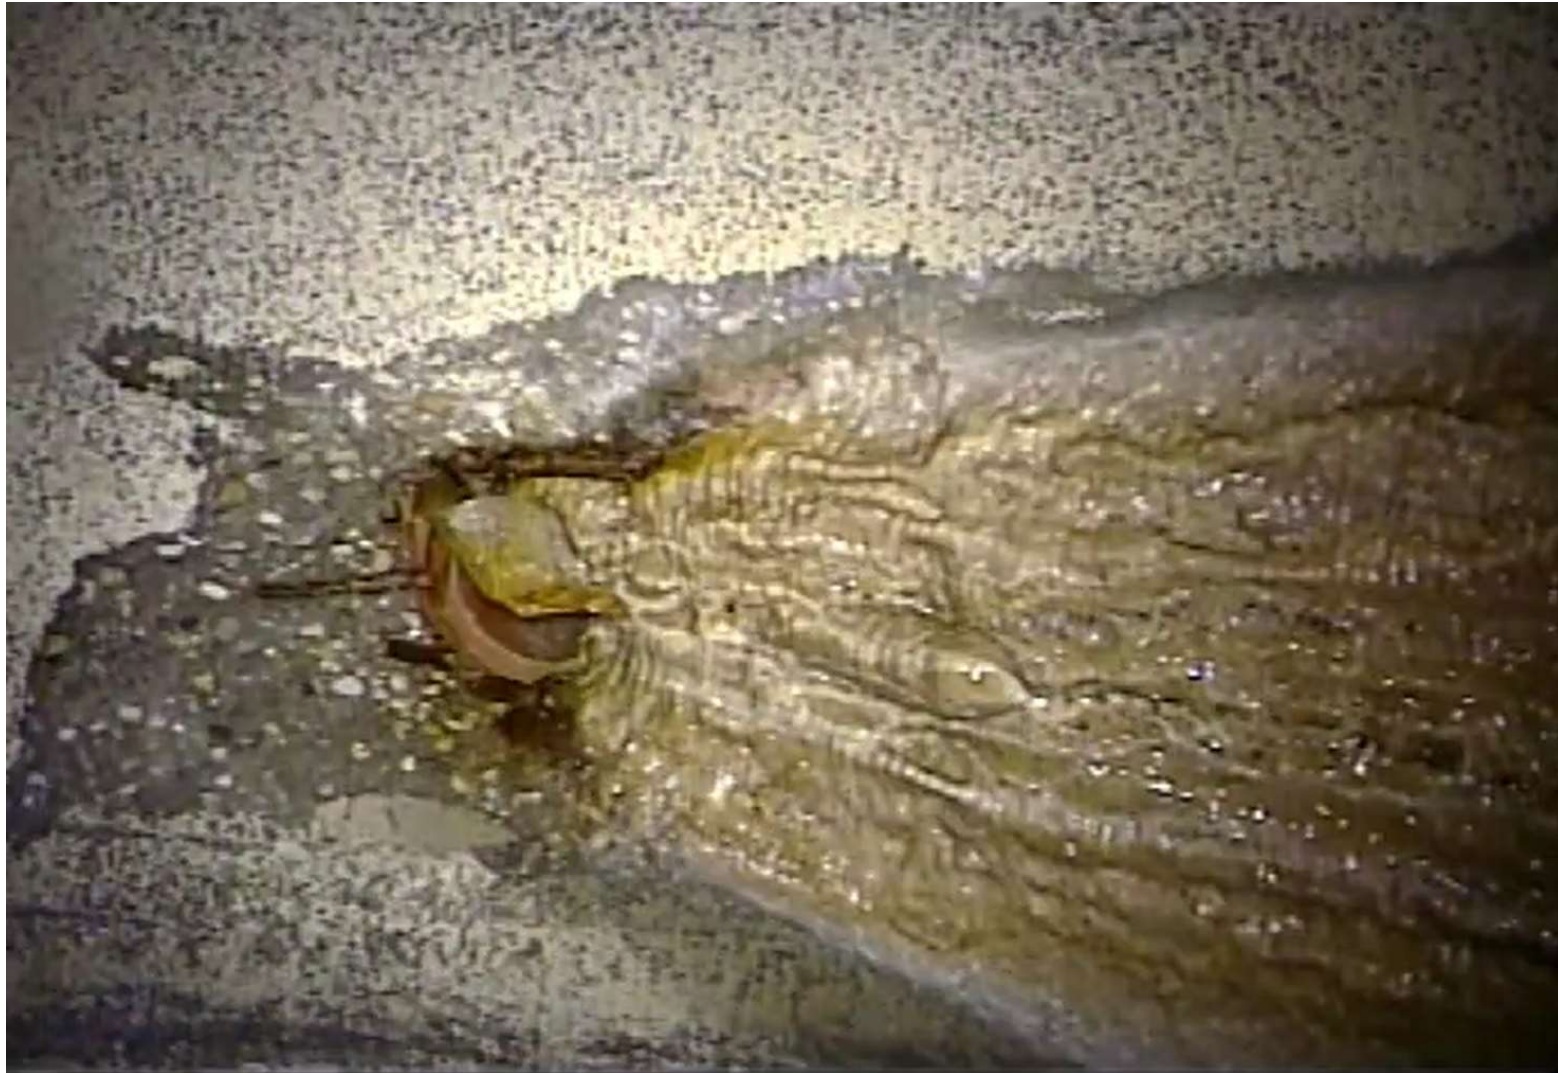
2 or 3 inch diameter pipe intrusion, ~150 feet north of outfall manhole

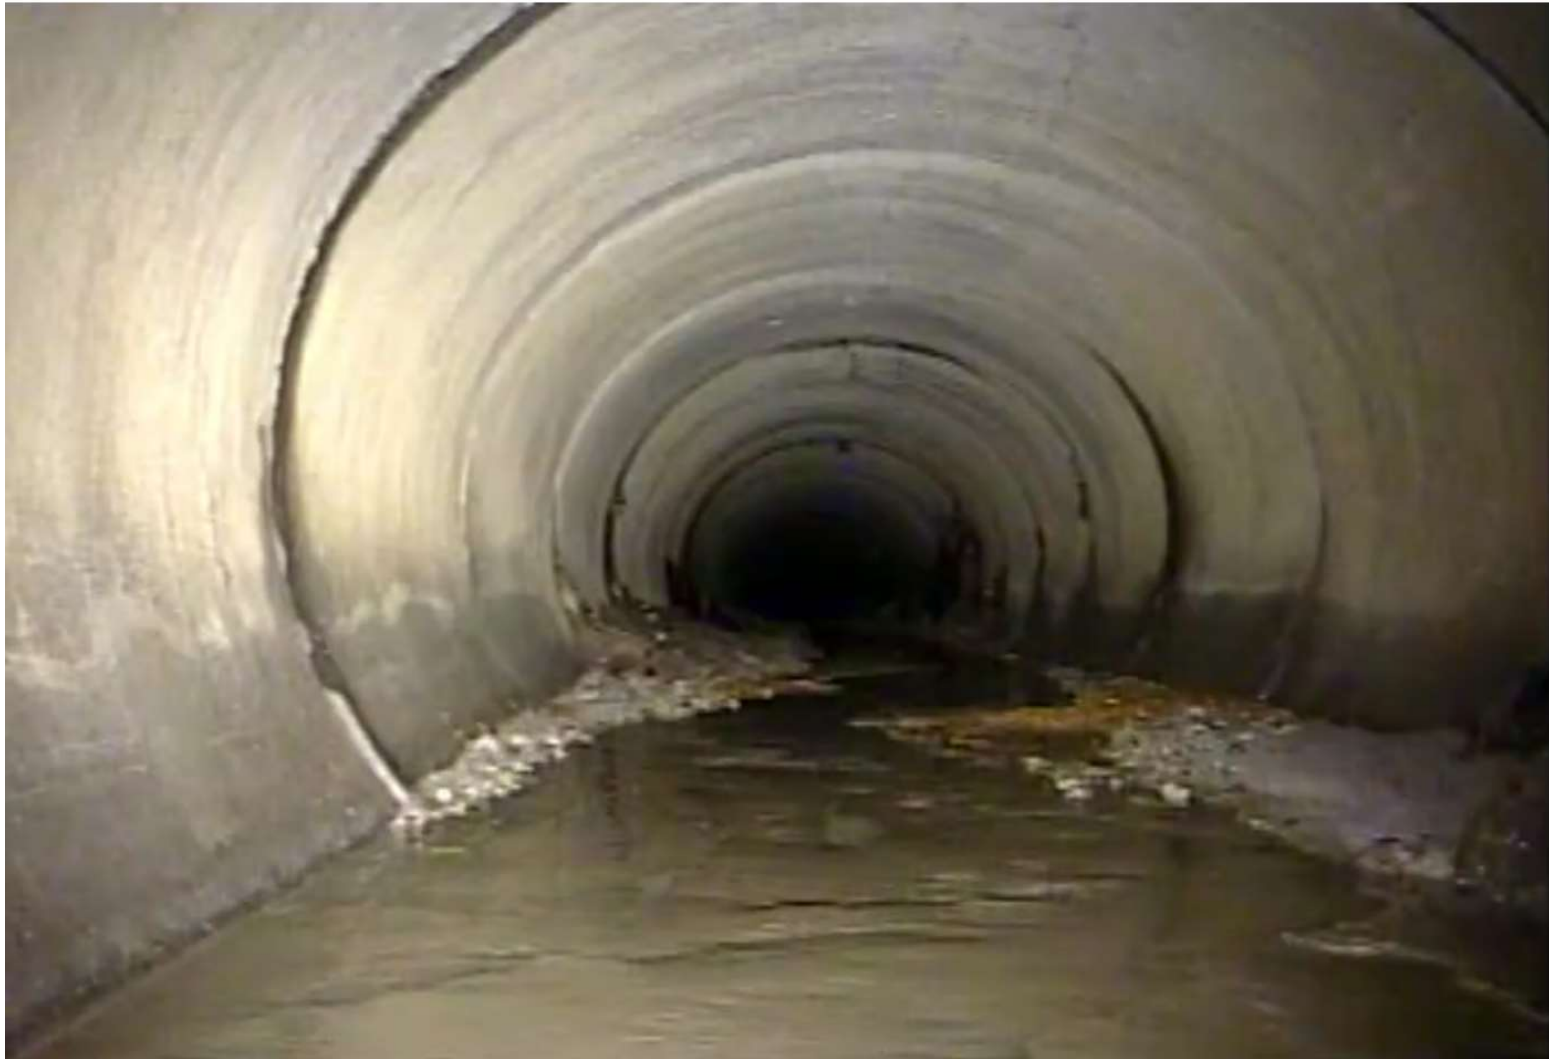
Heavy sediment accumulation, end of inspection, ~375 feet north of outfall manhole

Arcadis is proposing no further cleaning work on the 54-inch line based on:

- Limited sediment observed in the northern portion of the line
- No discharge from the RACER site, the small amount of flow observed is from offsite infiltration observed in video inspections
- Challenges/feasibility of cleaning the southern portion of the line that include:
 - Need for jet/vac trucks to pull up right next to the access manhole and the potential for equipment to damage WWTP property
 - Difficulties/feasibility of pulling back the sediment over the obstruction noted in the line

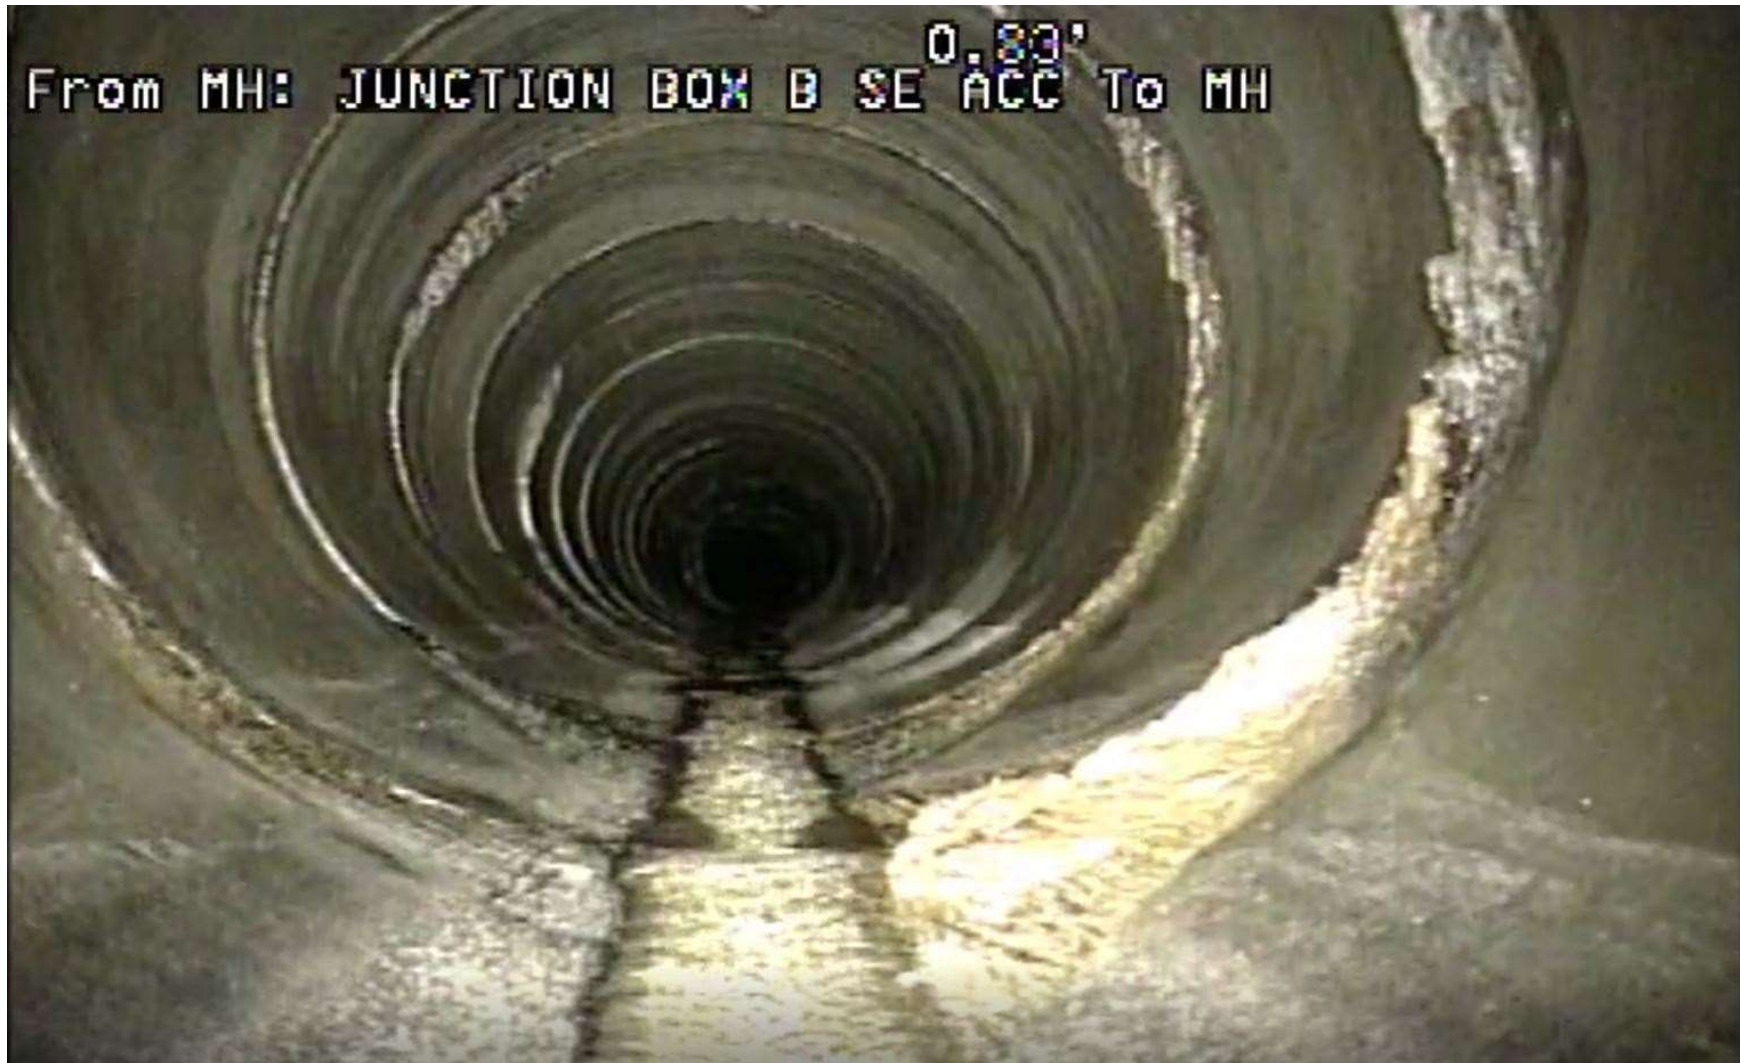
- Approximately ¼ inch of water flow and very minimal sediment were observed. Groundwater infiltration (slow drips) were observed at several locations.

Start of inspection at Junction Box B access manhole
Approximately ¼" water flow, minimal sediment, evidence of
groundwater infiltration

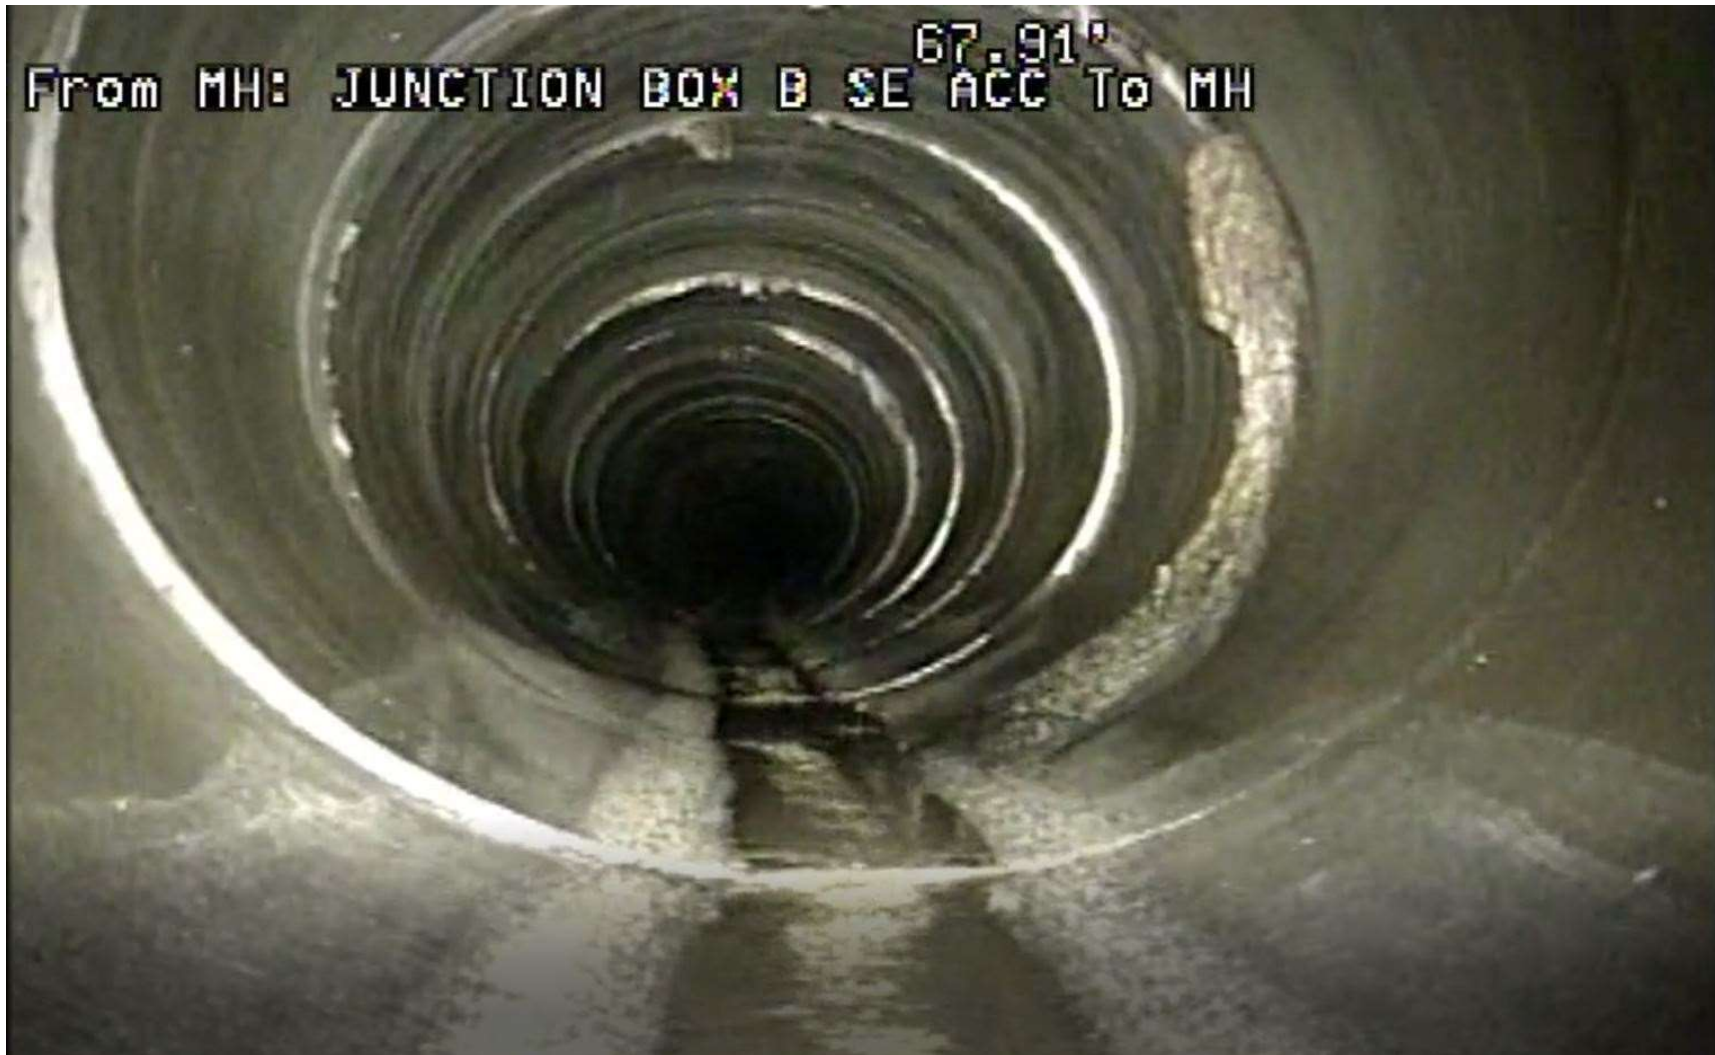
Minimal sediment, minimal water flow, infiltration encrustation, 68 feet
from manhole

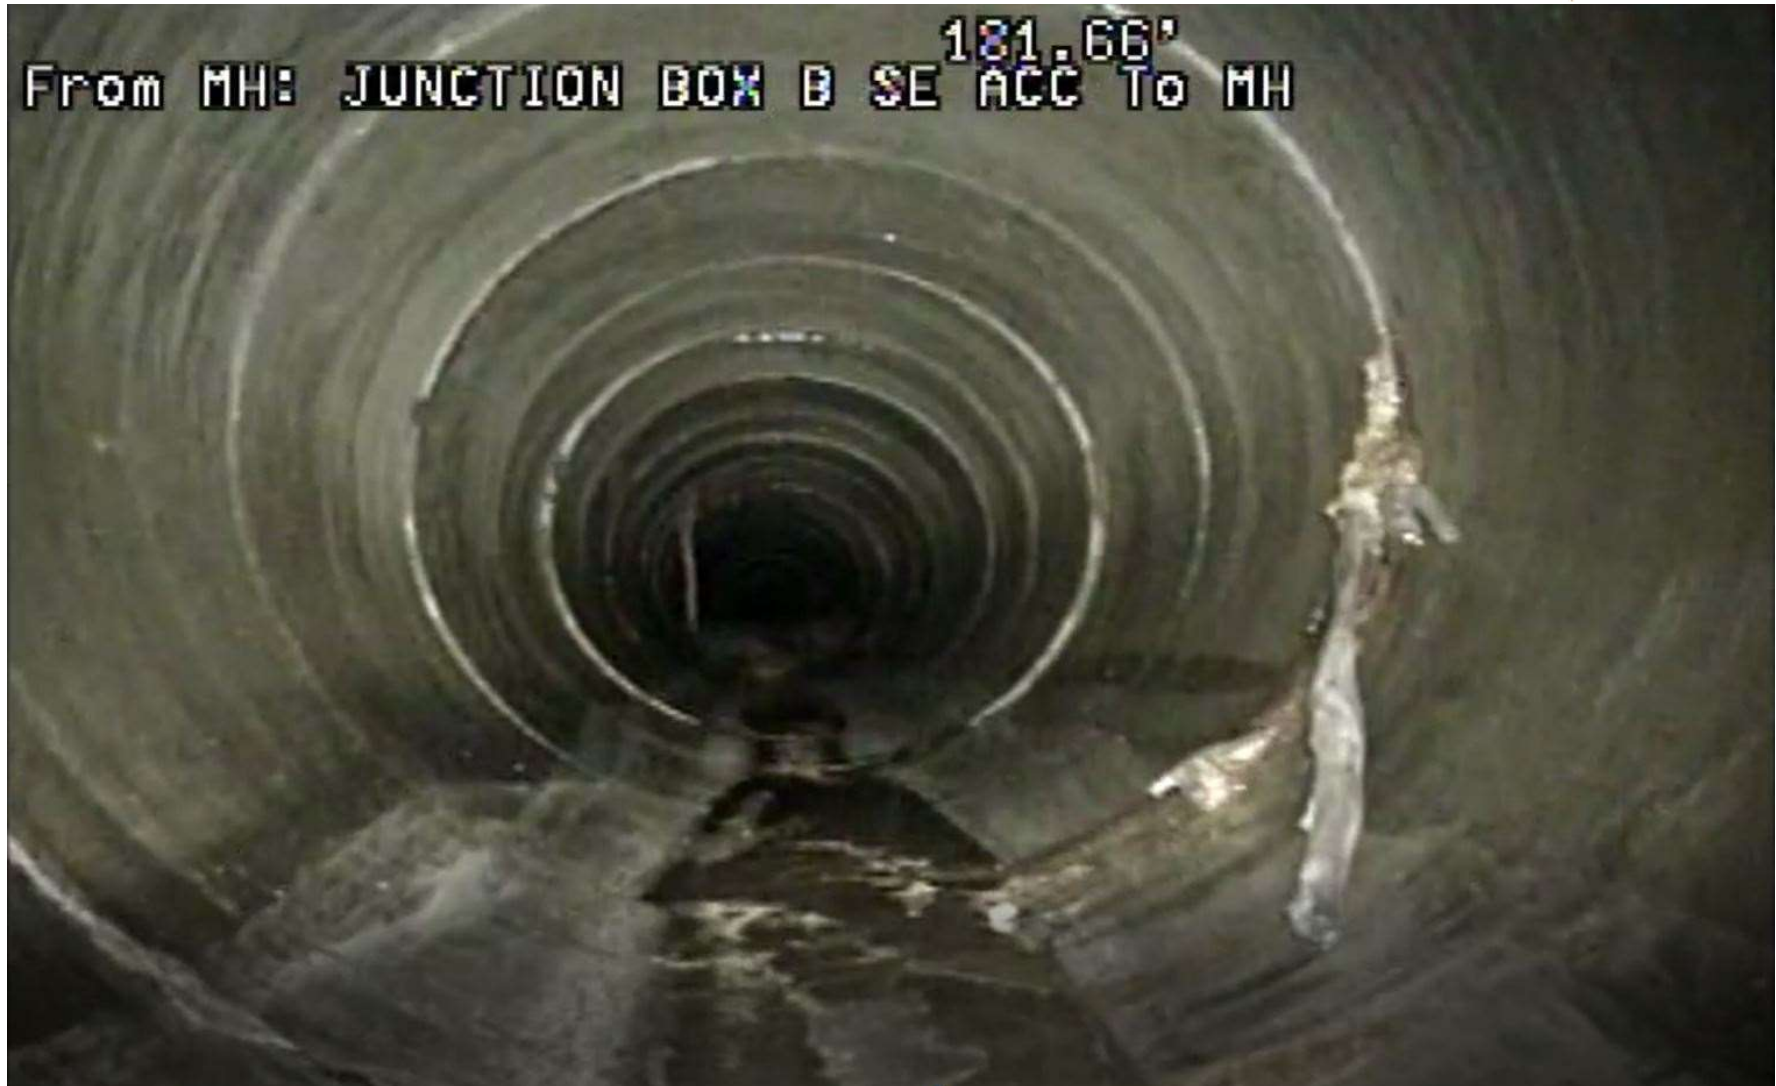
Minimal sediment, minimal water flow, possible tree roots, 182 feet from manhole

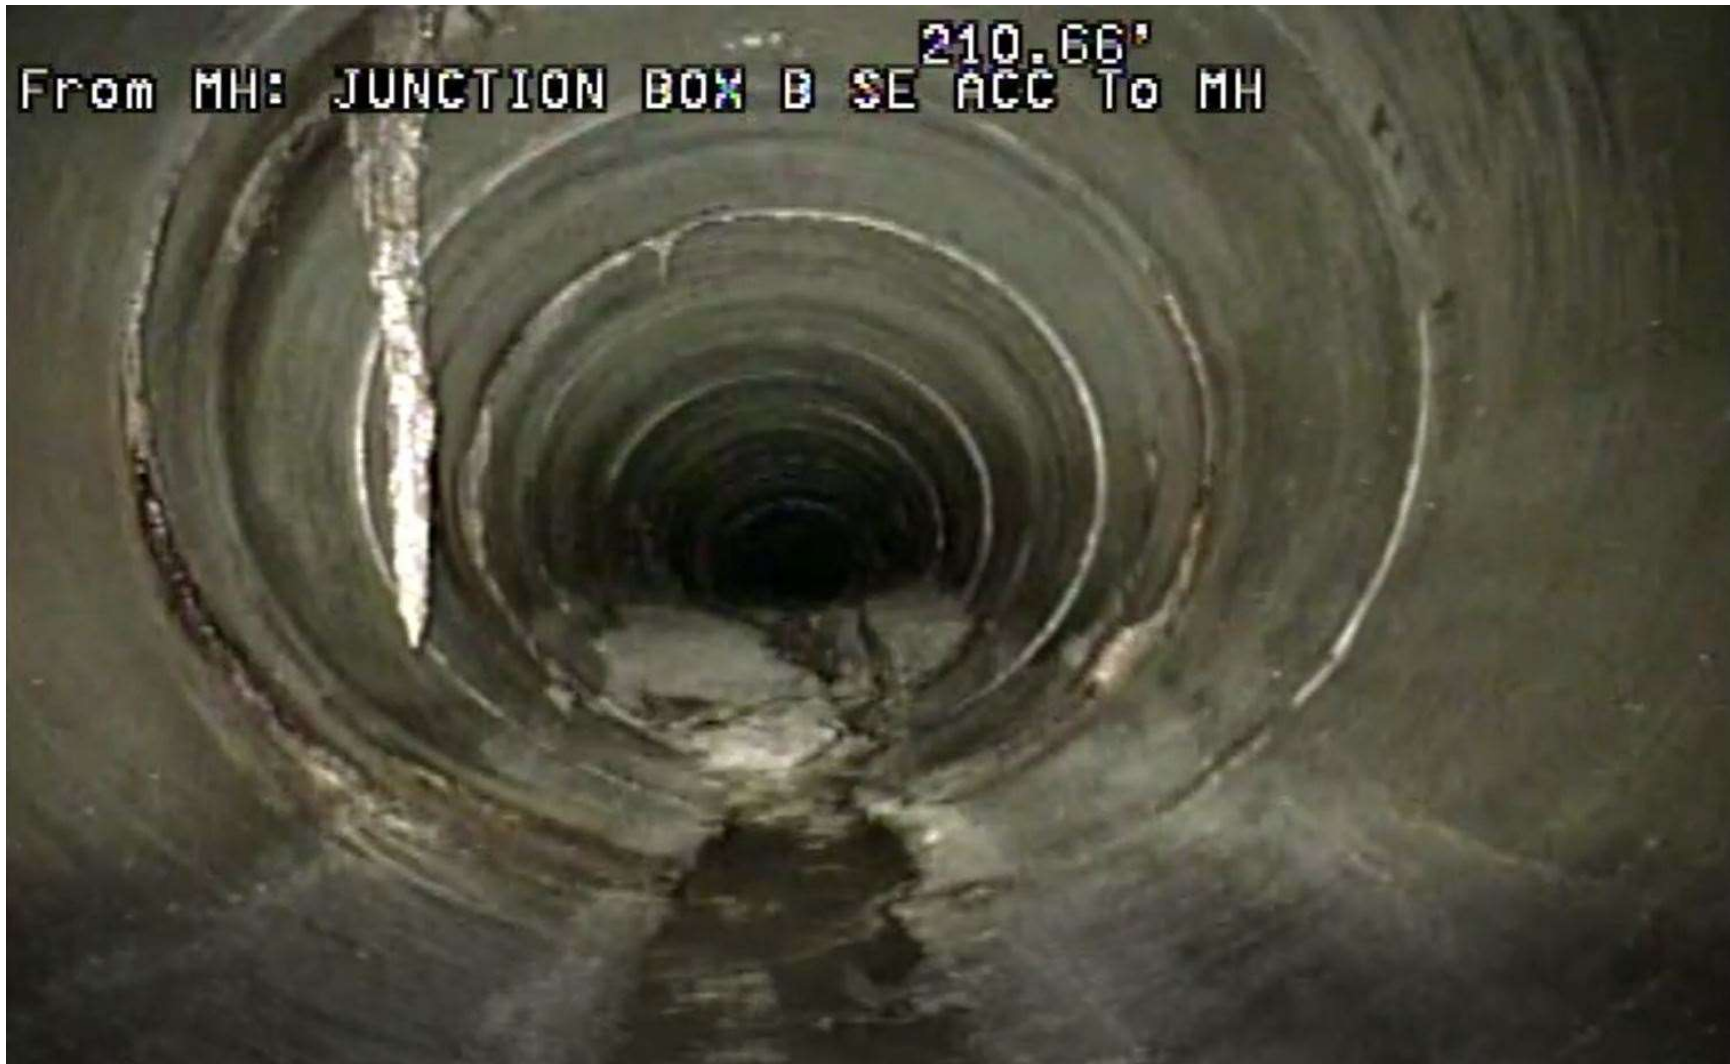
Tree roots, minimal water flow, pile of hardened concrete, 211 feet from manhole

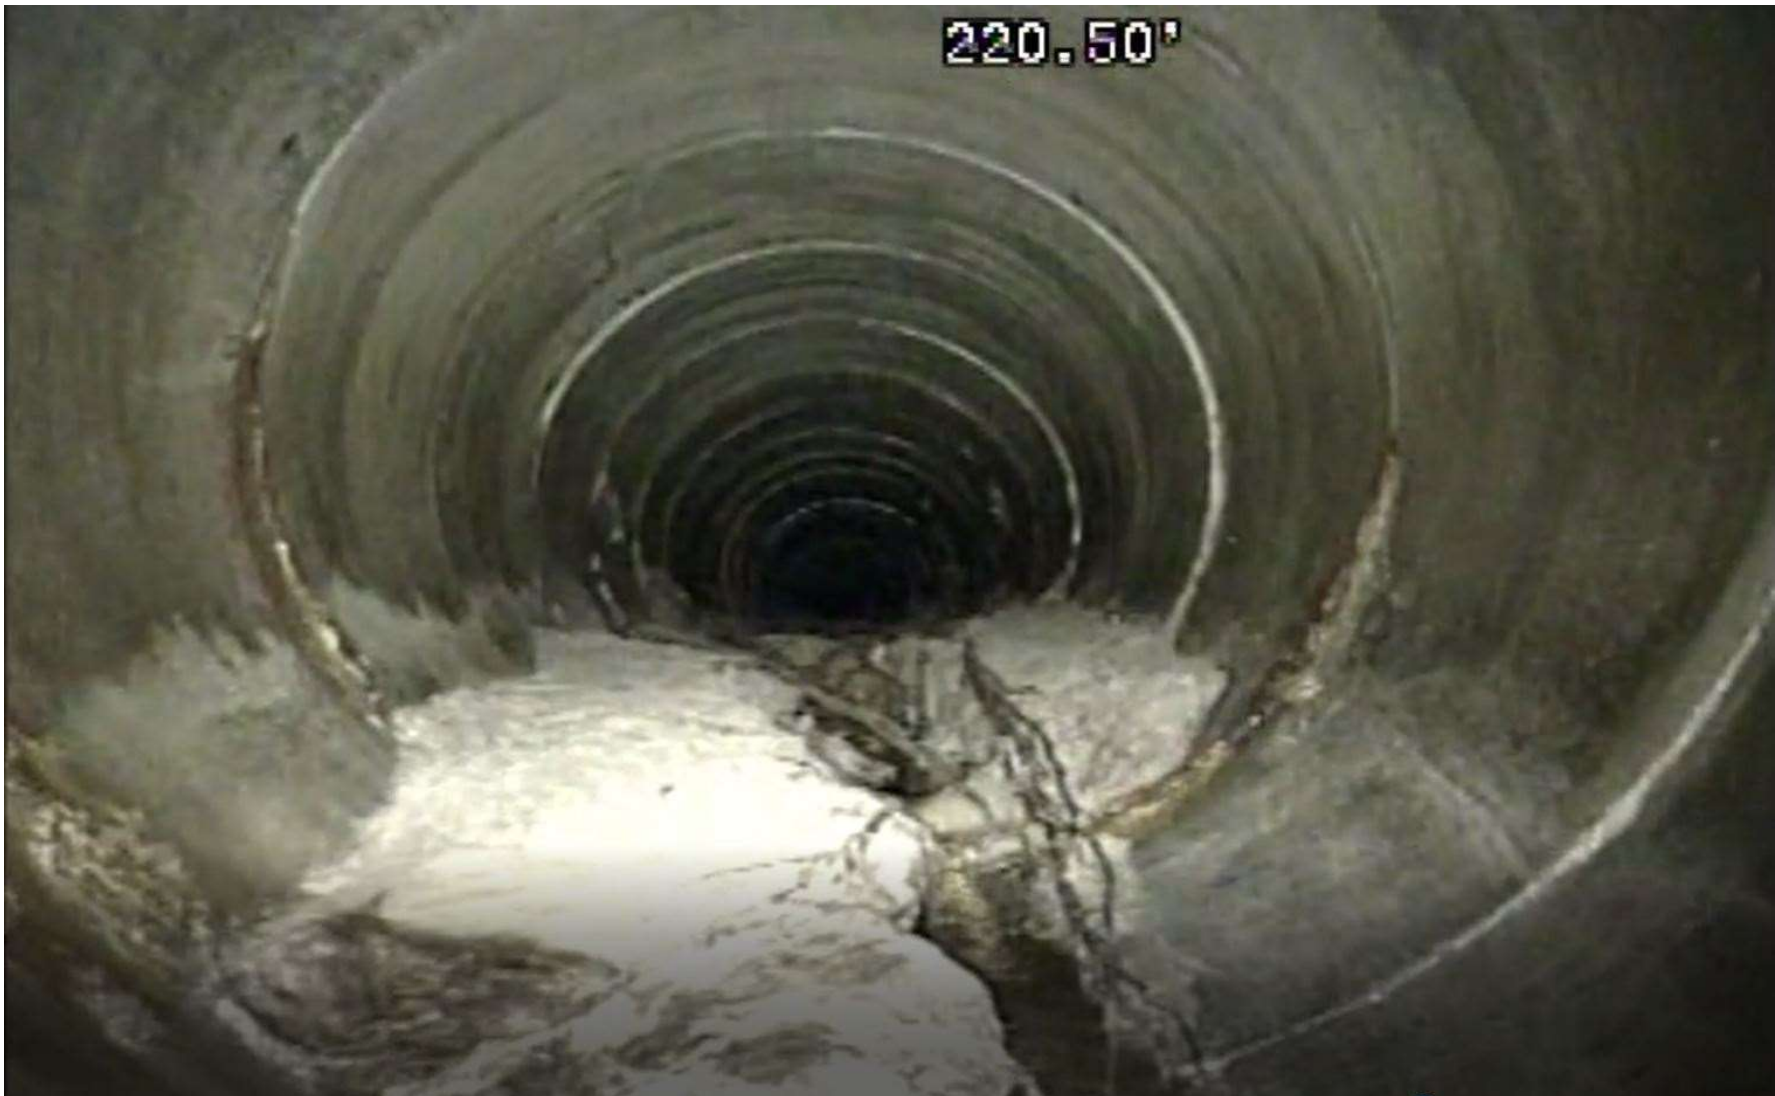
Pile of hardened concrete, end of inspection, 220 feet from manhole
