RE: Windiate Park/Dixieland Subdivision Landfill, Genesee County, Michigan (Site ID No. 25000689)  
FILE: 15388/60773 - Soil Cover Inspection Report

## WINDIATE PARK SOIL COVER MAINTENANCE CHECKLIST

# INSPECTION MAP

## WINDIATE PARK FLINT, MICHIGAN

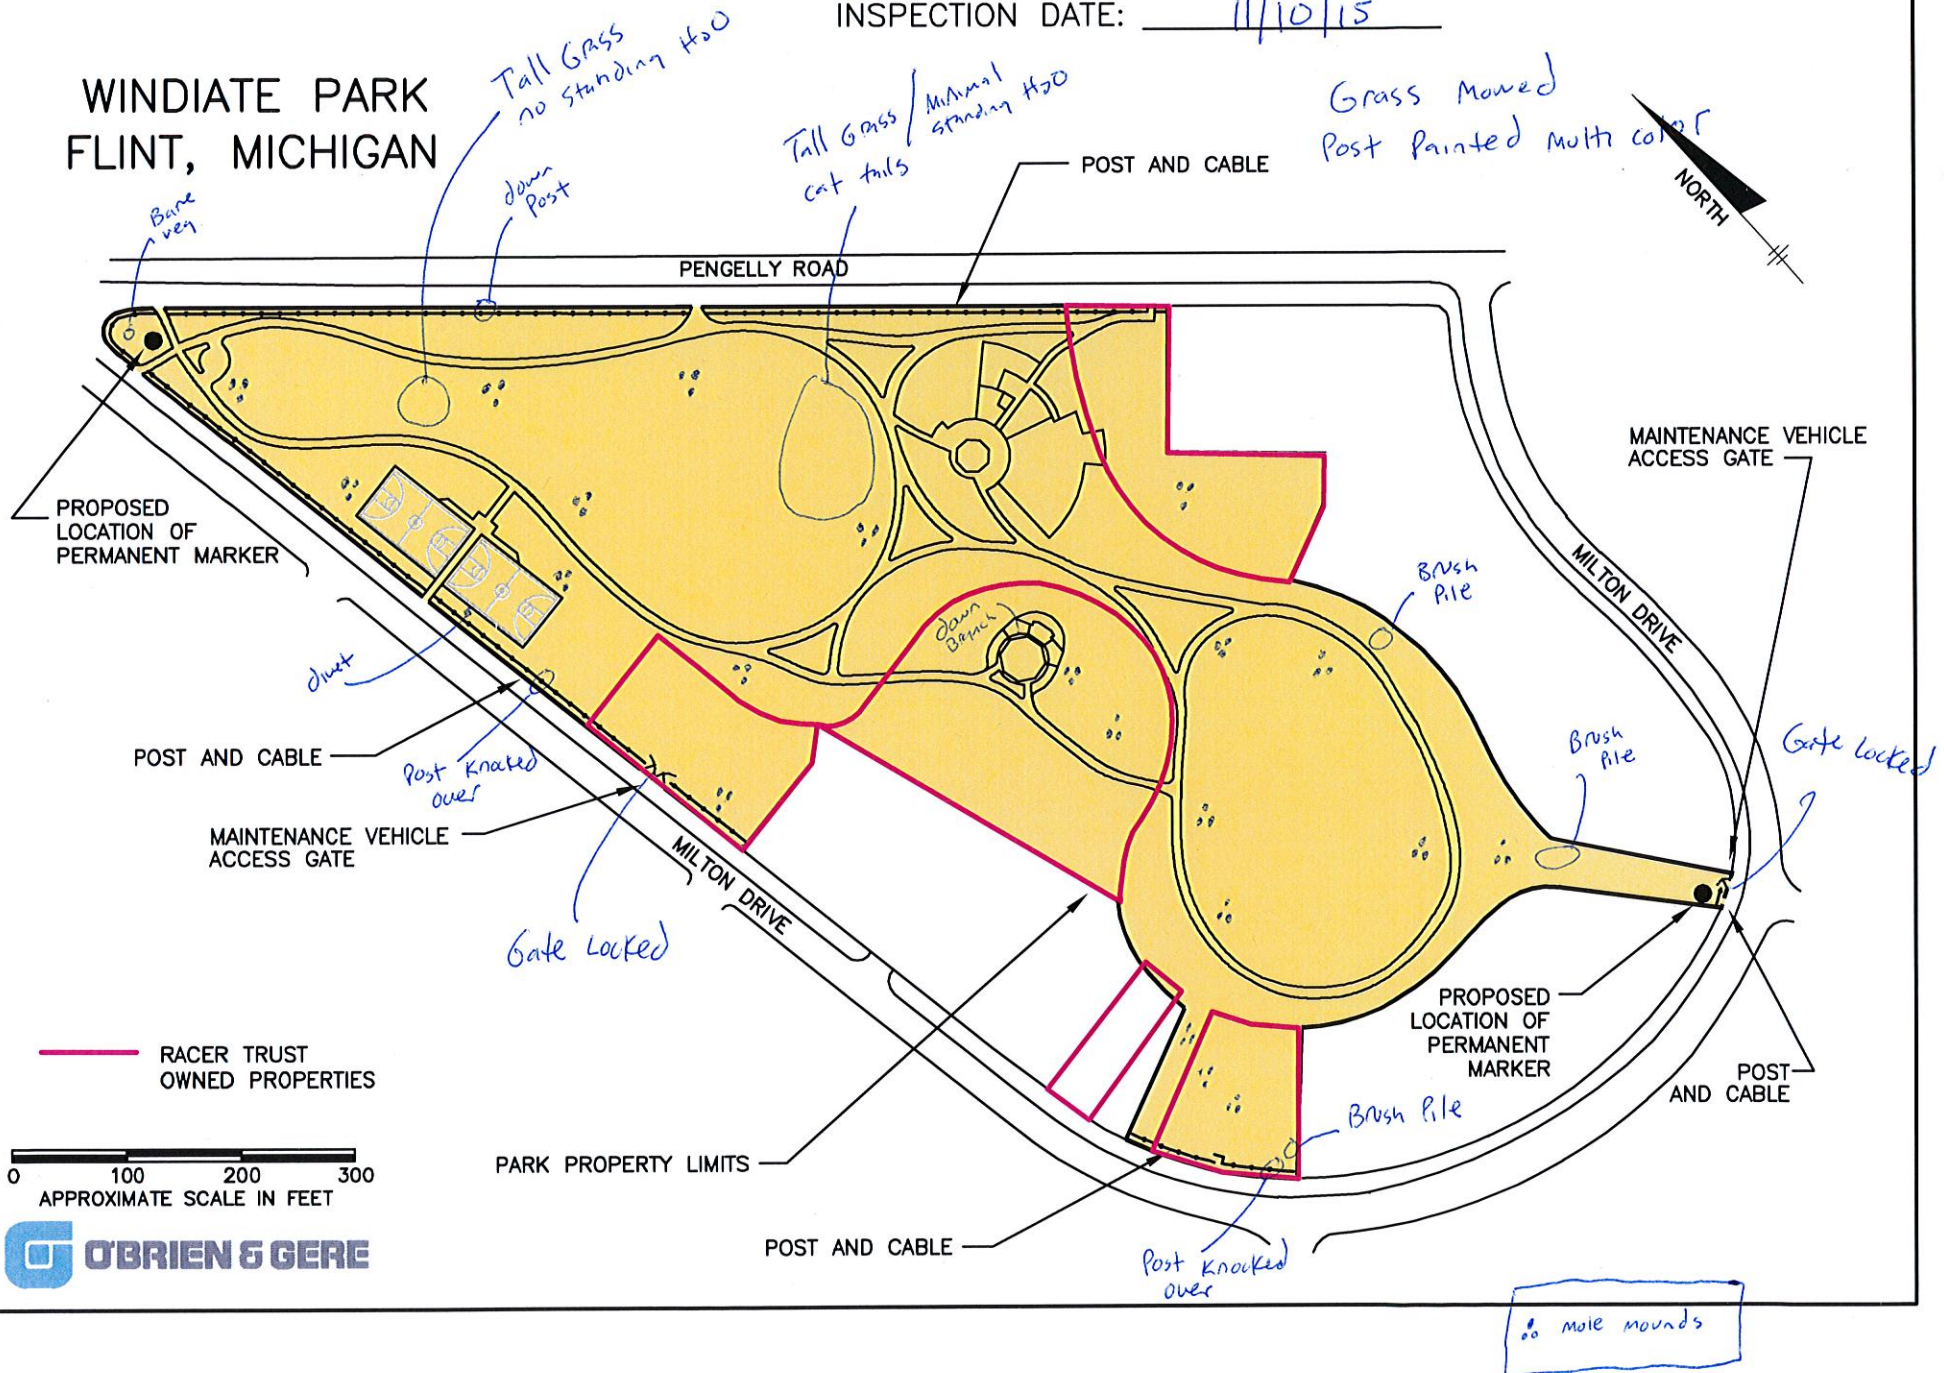
| Inspected Item: | Comments: |
|---|---|
| <i>GRASS/VEGETATIVE LAYER</i> | Acceptable. No maintenance required at this time. Two areas were observed where water had previously ponded after rain events. One is located northeast of basketball courts, and the other area is located west of the playground equipment. |
| <i>POST &amp; CABLE / VEHICLE GATES</i> | Acceptable. Two damaged posts were observed during the site inspection. Post have recently been painted. The south and west maintenance vehicle access gates were locked. |
| <i>OTHER OBSERVATIONS</i> | A number of mole mounds were observed. |

Trap moles as needed. Add additional soil to areas where water has ponded.
