Subject:
NPDES Permit No. MI0001597 – 2017 Yearly Stormwater Trend Monitoring Data
RACER – Buick City Site
Flint, Michigan

Date:
May 14, 2018

This report was prepared by Arcadis on behalf of the Revitalizing Auto Communities Environmental Response (RACER) Trust, for the Buick City Site (formerly known as the GM - Powertrain Flint North). The Buick City Site (Site) is located near 902 East Leith Street in Flint, Michigan, in Genesee County and encompasses approximately 364 acres of land as shown on **Figure 1**. The portion of the Site located north of Leith Street (hereafter referred to as the Northend) was in part occupied by General Motors LLC (GM LLC) for manufacturing operations until December 6, 2010. Since December 6, 2010 there have been no manufacturing operations at the Site. Demolition of the Northend of the Site was completed in April 2012. Building demolition was completed in 2001 in the portion of the property located south of Leith Street, which is referred to as the Southend.

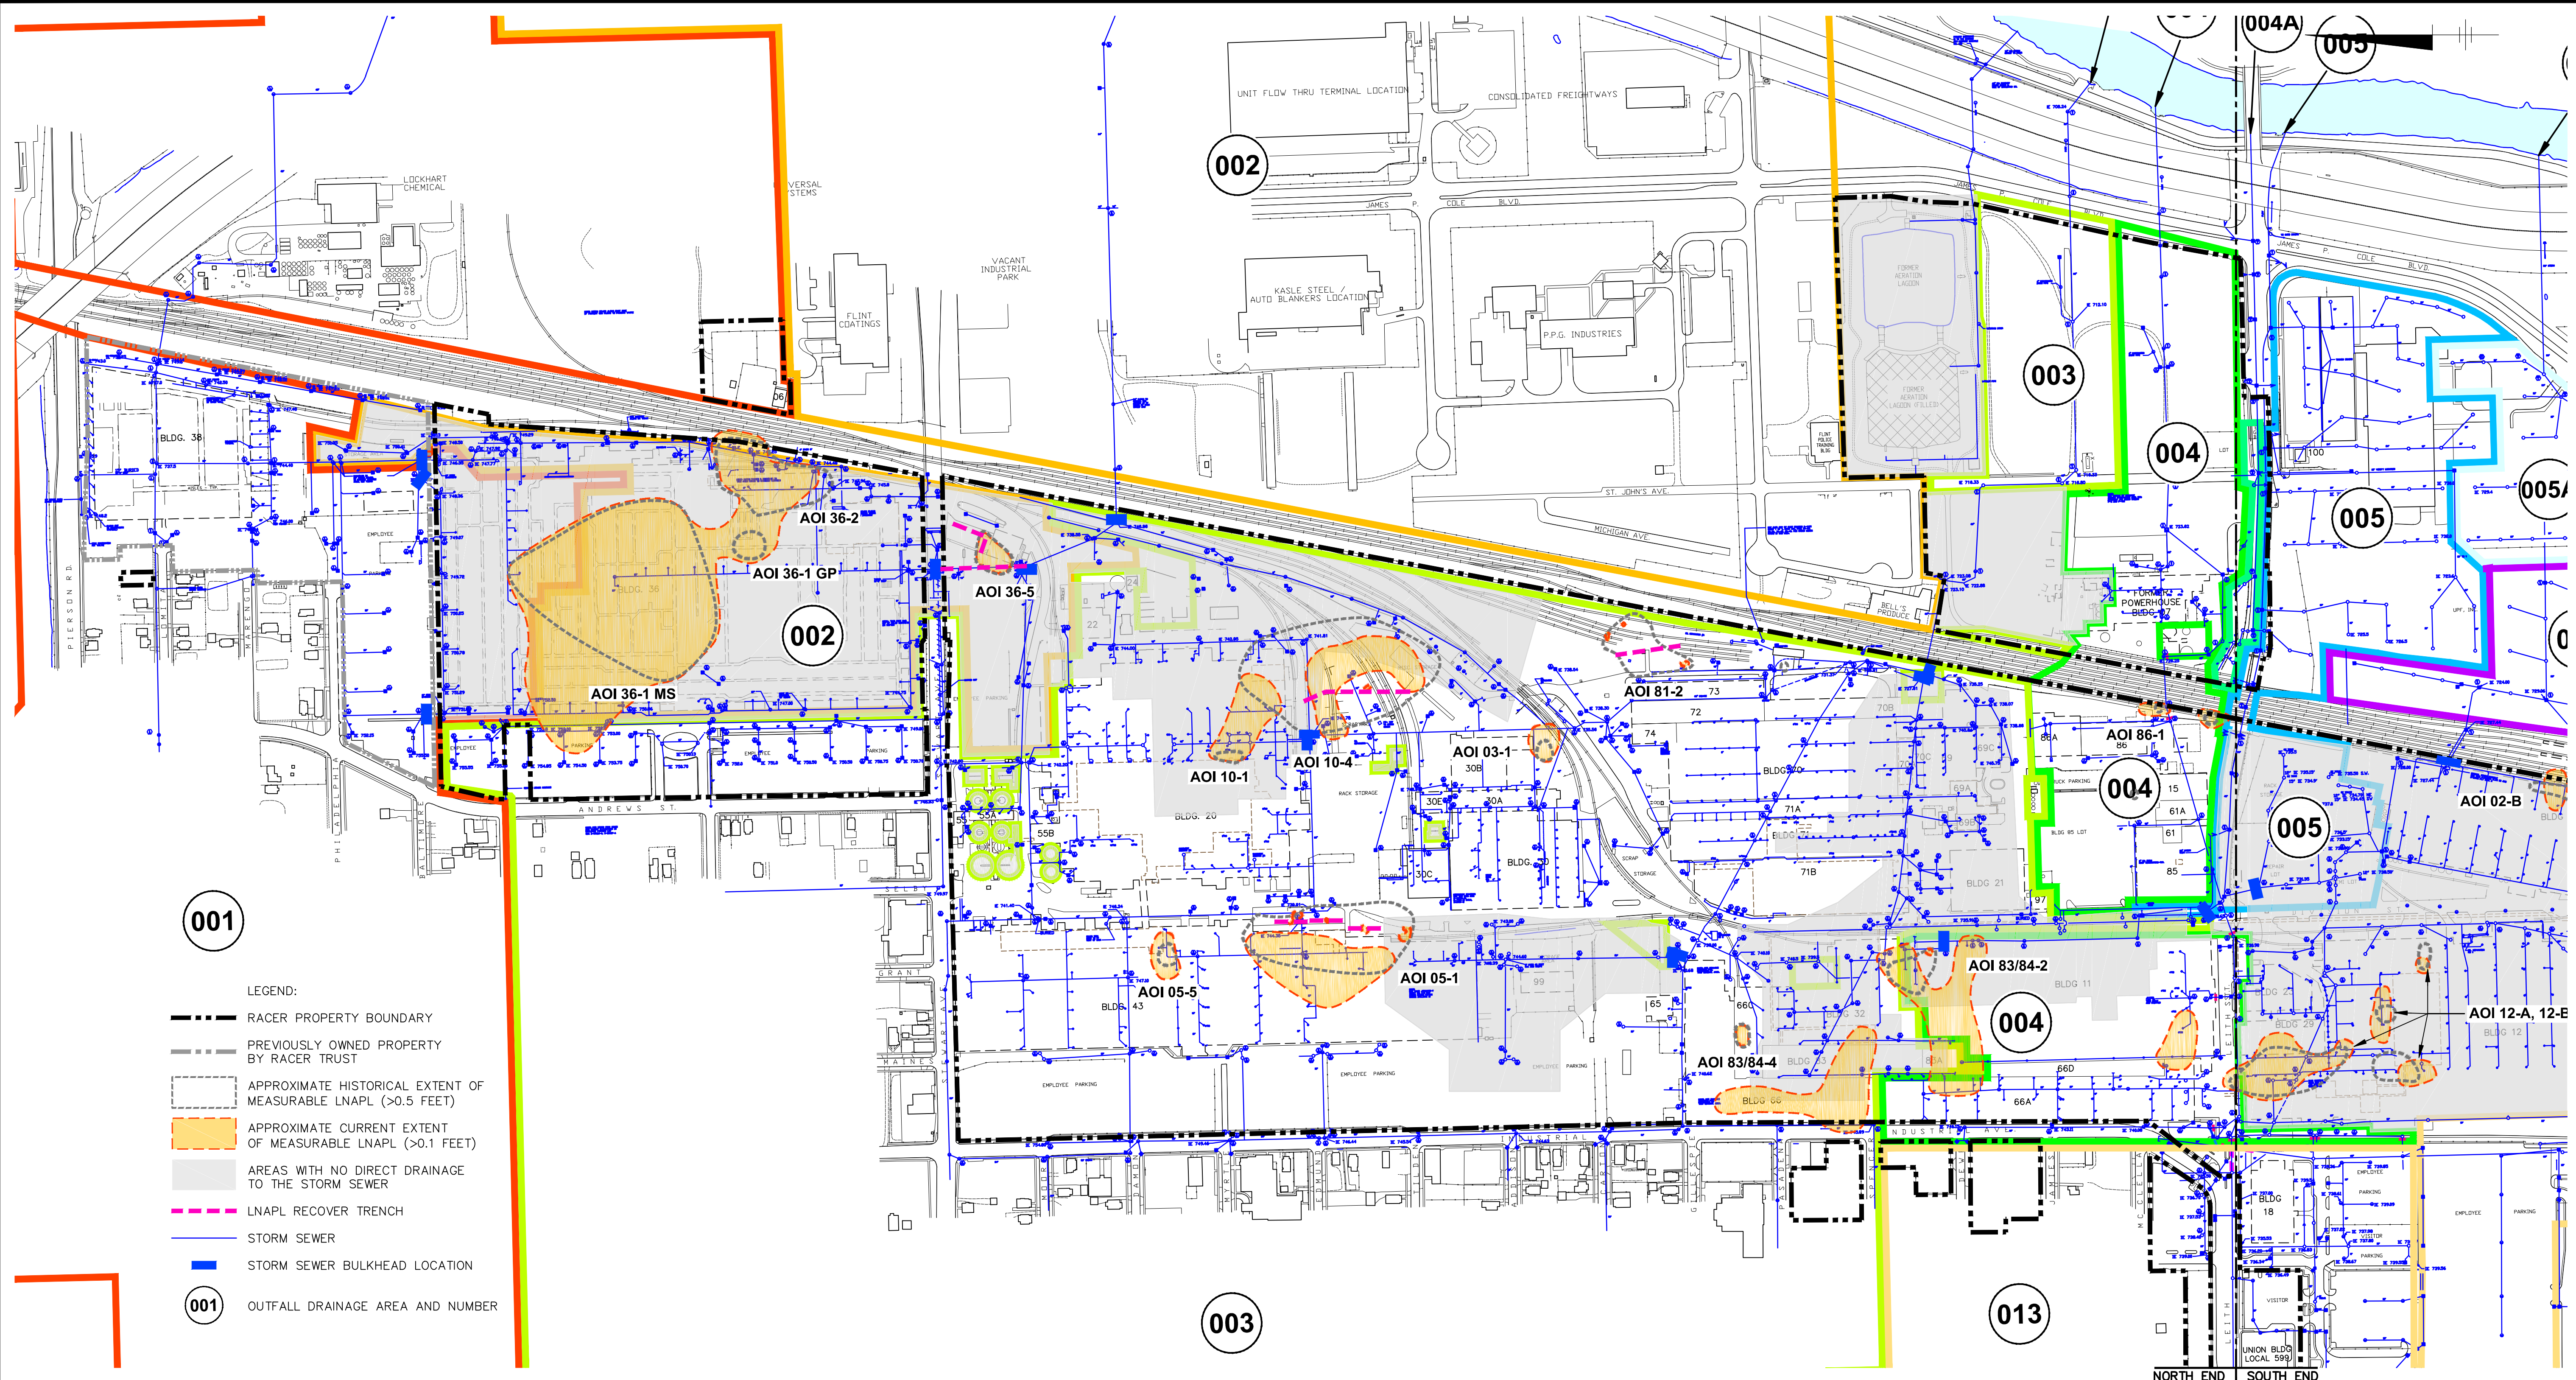
NORTHEND - STORM SEWER, DRAINAGE AREA, AND BULKHEAD LOCATIONS

NPDES Monitoring Point 003A (MP 003A) is the only remaining monitoring point along the Outfall 003 Sewer System. It is located downgradient of Oil Interceptor #2 and the Outfall 003/004 System. Note that during dry weather and first-flush stormwater flow water and oil are diverted through the Outfall 003/004 System from both the Outfall 003 and 004 storm sewers. As such, samples collected at MP 003A represent the combined flow of the Outfall 003 and 004 under these conditions. During stormwater flow conditions, however, flows are diverted around the Outfall 003/004 System and discharge through the individual outfalls. Therefore, water samples collected at MP003A during stormwater events are representative of flow only from the Outfall 003A storm sewer.

PCBs were not detected in the 2017 wet weather sample collected from Outfall 003 at MP 003A.

PCBs have not been detected during the yearly wet-weather sampling event since September 2010. The Outfall 003/004 System continues to operate and is functioning as intended.

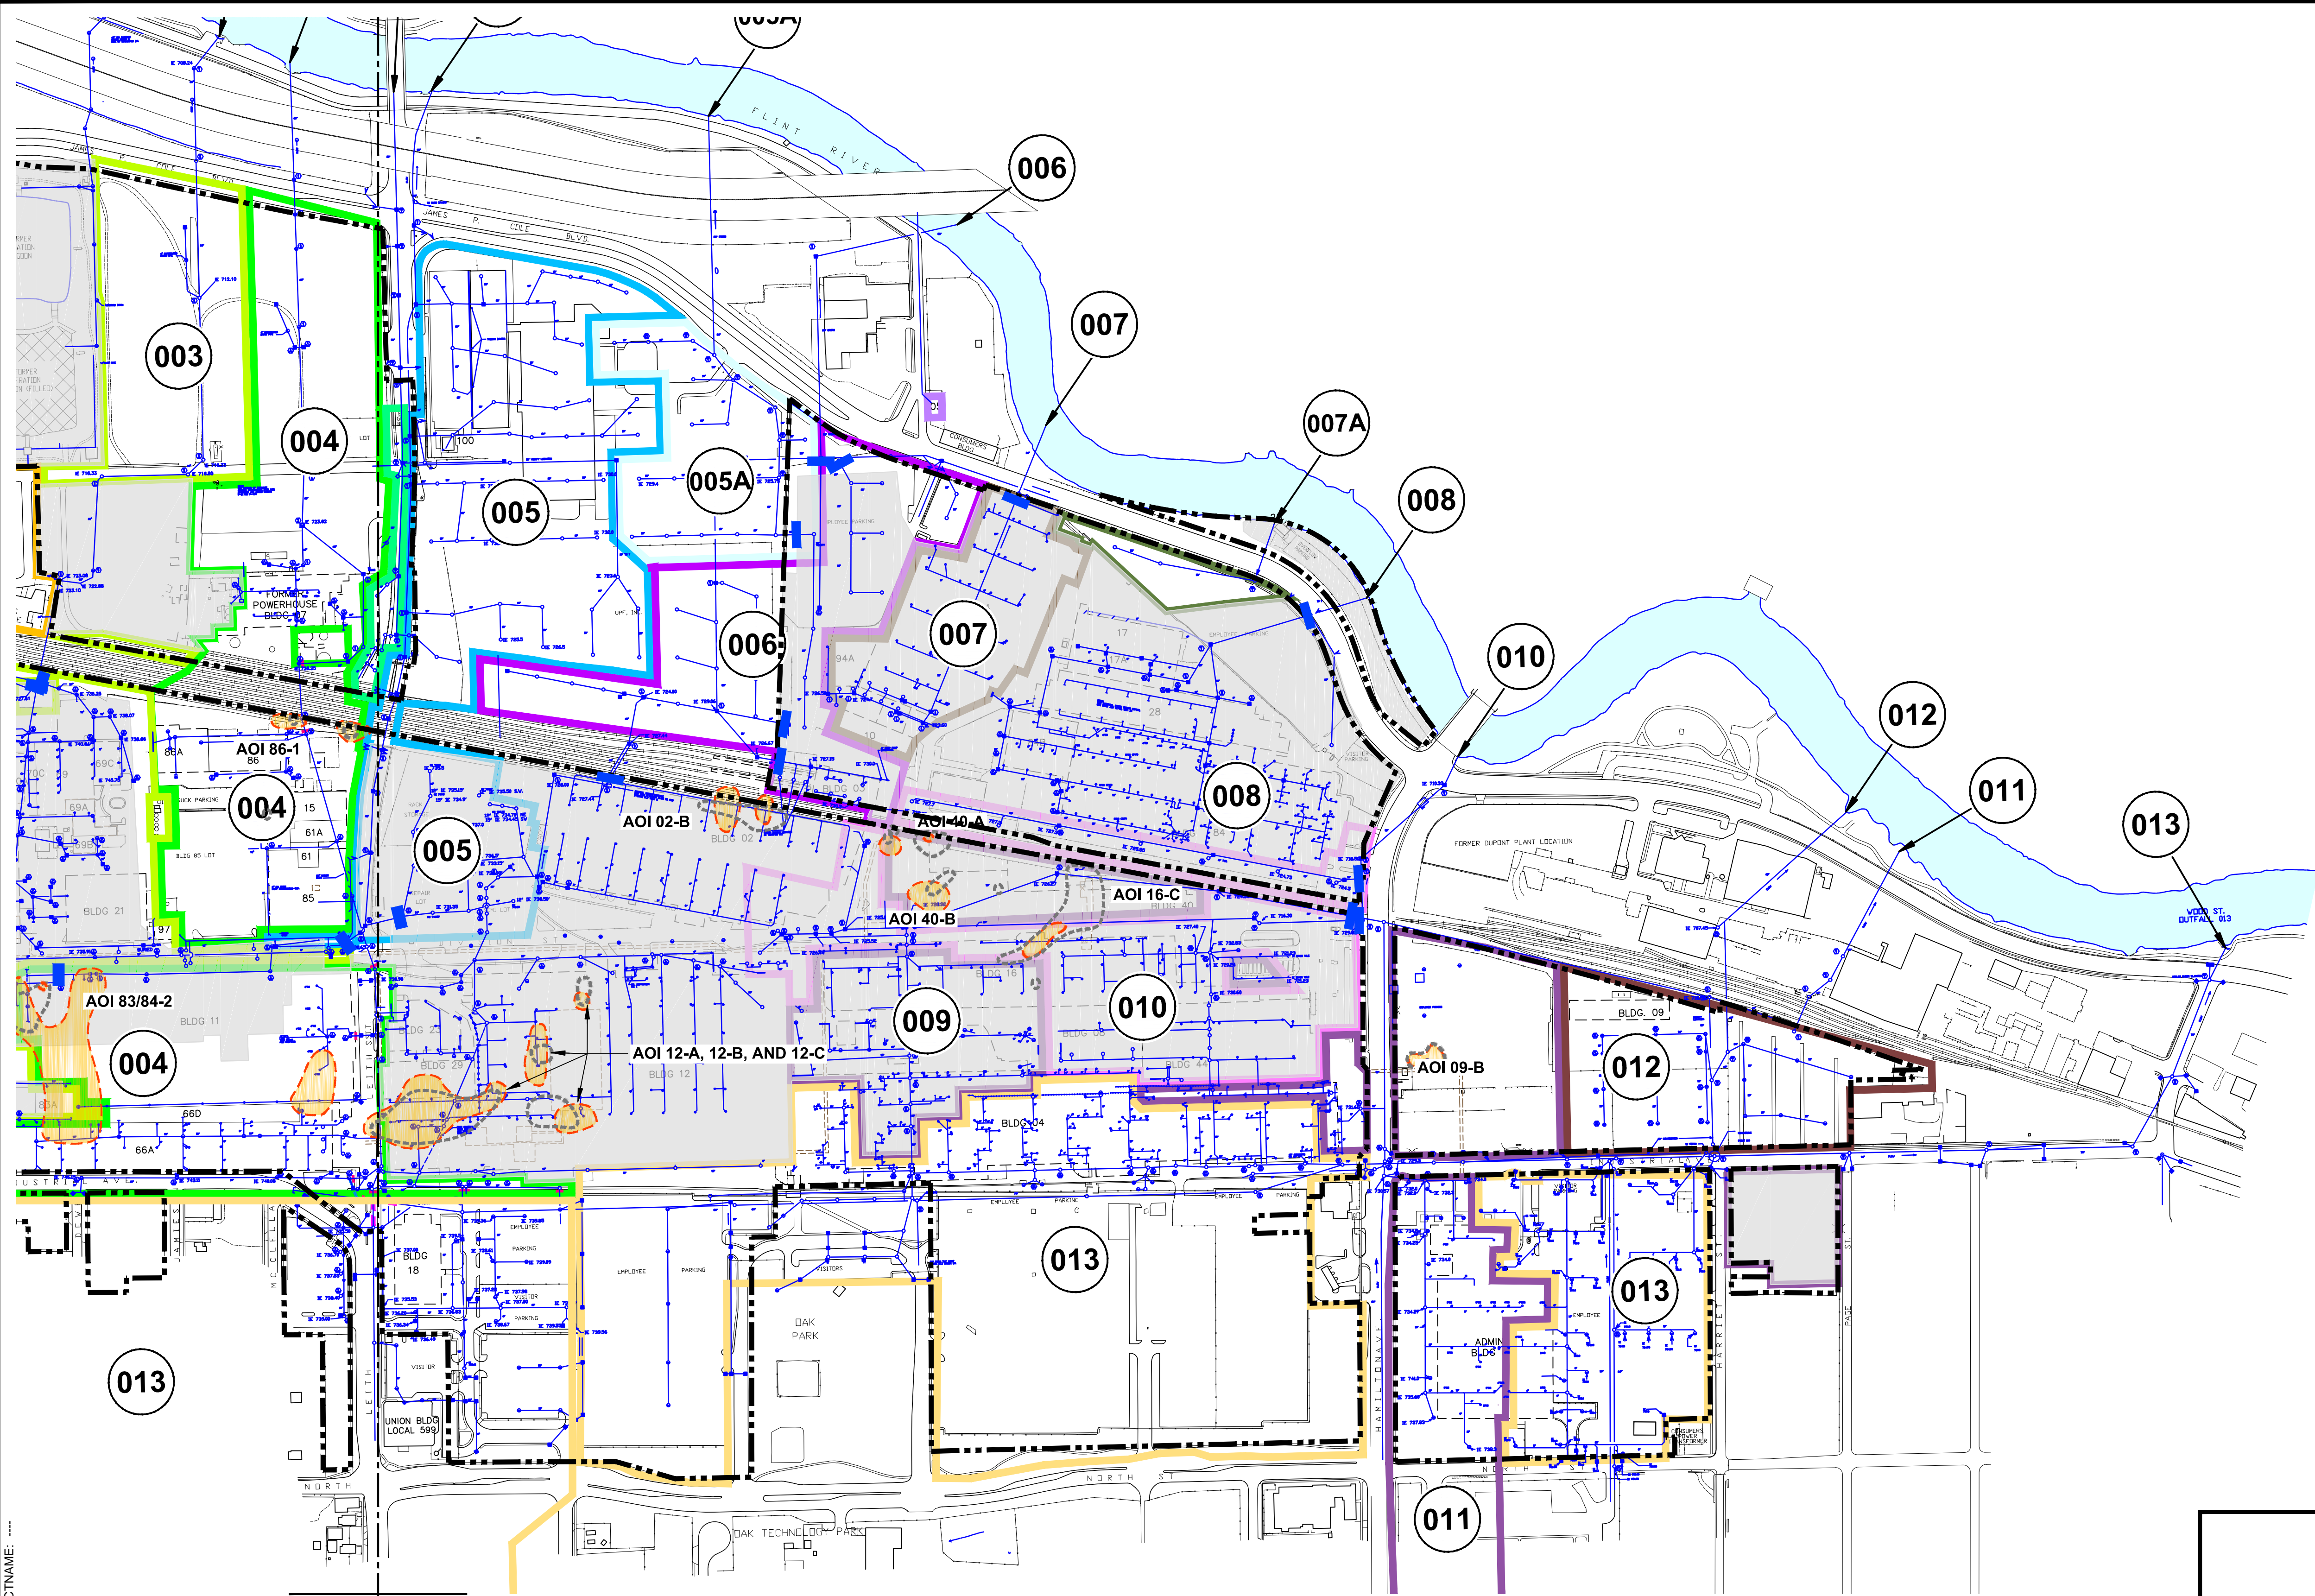
**SOUTHEND - STORM SEWER, DRAINAGE
 AREA, AND BULKHEAD LOCATIONS**

There is no data for Outfall 010 due to the installation of a permanent storm sewer bulkhead in the storm sewer line discharging into Manhole 10-5. In addition, the lateral line connecting Manhole MH 10-4 to the main was excavated, cut, and the void filled with concrete. As such, there is no longer a discharge from the Site to the Outfall 010 storm sewer and samples are no longer collected at this outfall. The MDEQ was notified of these activities in a May 6, 2014 letter to Tarek Buckmaster of MDEQ.

- In 2017 the portion of the Site draining to Outfall 012 was sold to a third party. Based on the limited survey data available the Outfall 012 storm sewer appears to be below the groundwater table in this area. While the Site no longer is responsible for storm water runoff contribution to the Outfall 012 storm sewer, the Site is still responsible for impacted groundwater infiltration to the storm sewer.

Copper was detected in the 2017 wet weather sample collected from Outfall 011 at a concentration of 9 µg/L. This concentration is well below the daily maximum goal for copper of 100 µg/L listed in the NPDES permit at this outfall.

Outfall 012 was observed several times 2017. No flow was observed and therefore no sample was collected during the 2017 wet weather event. Copper concentrations have historically been well below the daily maximum goal of 100 µg/L listed in the NPDES permit.
