April 7, 2020

Reference No. 017358

**Re: Groundwater Level Monitoring Update (through December 2019)
Willow Run Powertrain
Ypsilanti, Michigan**

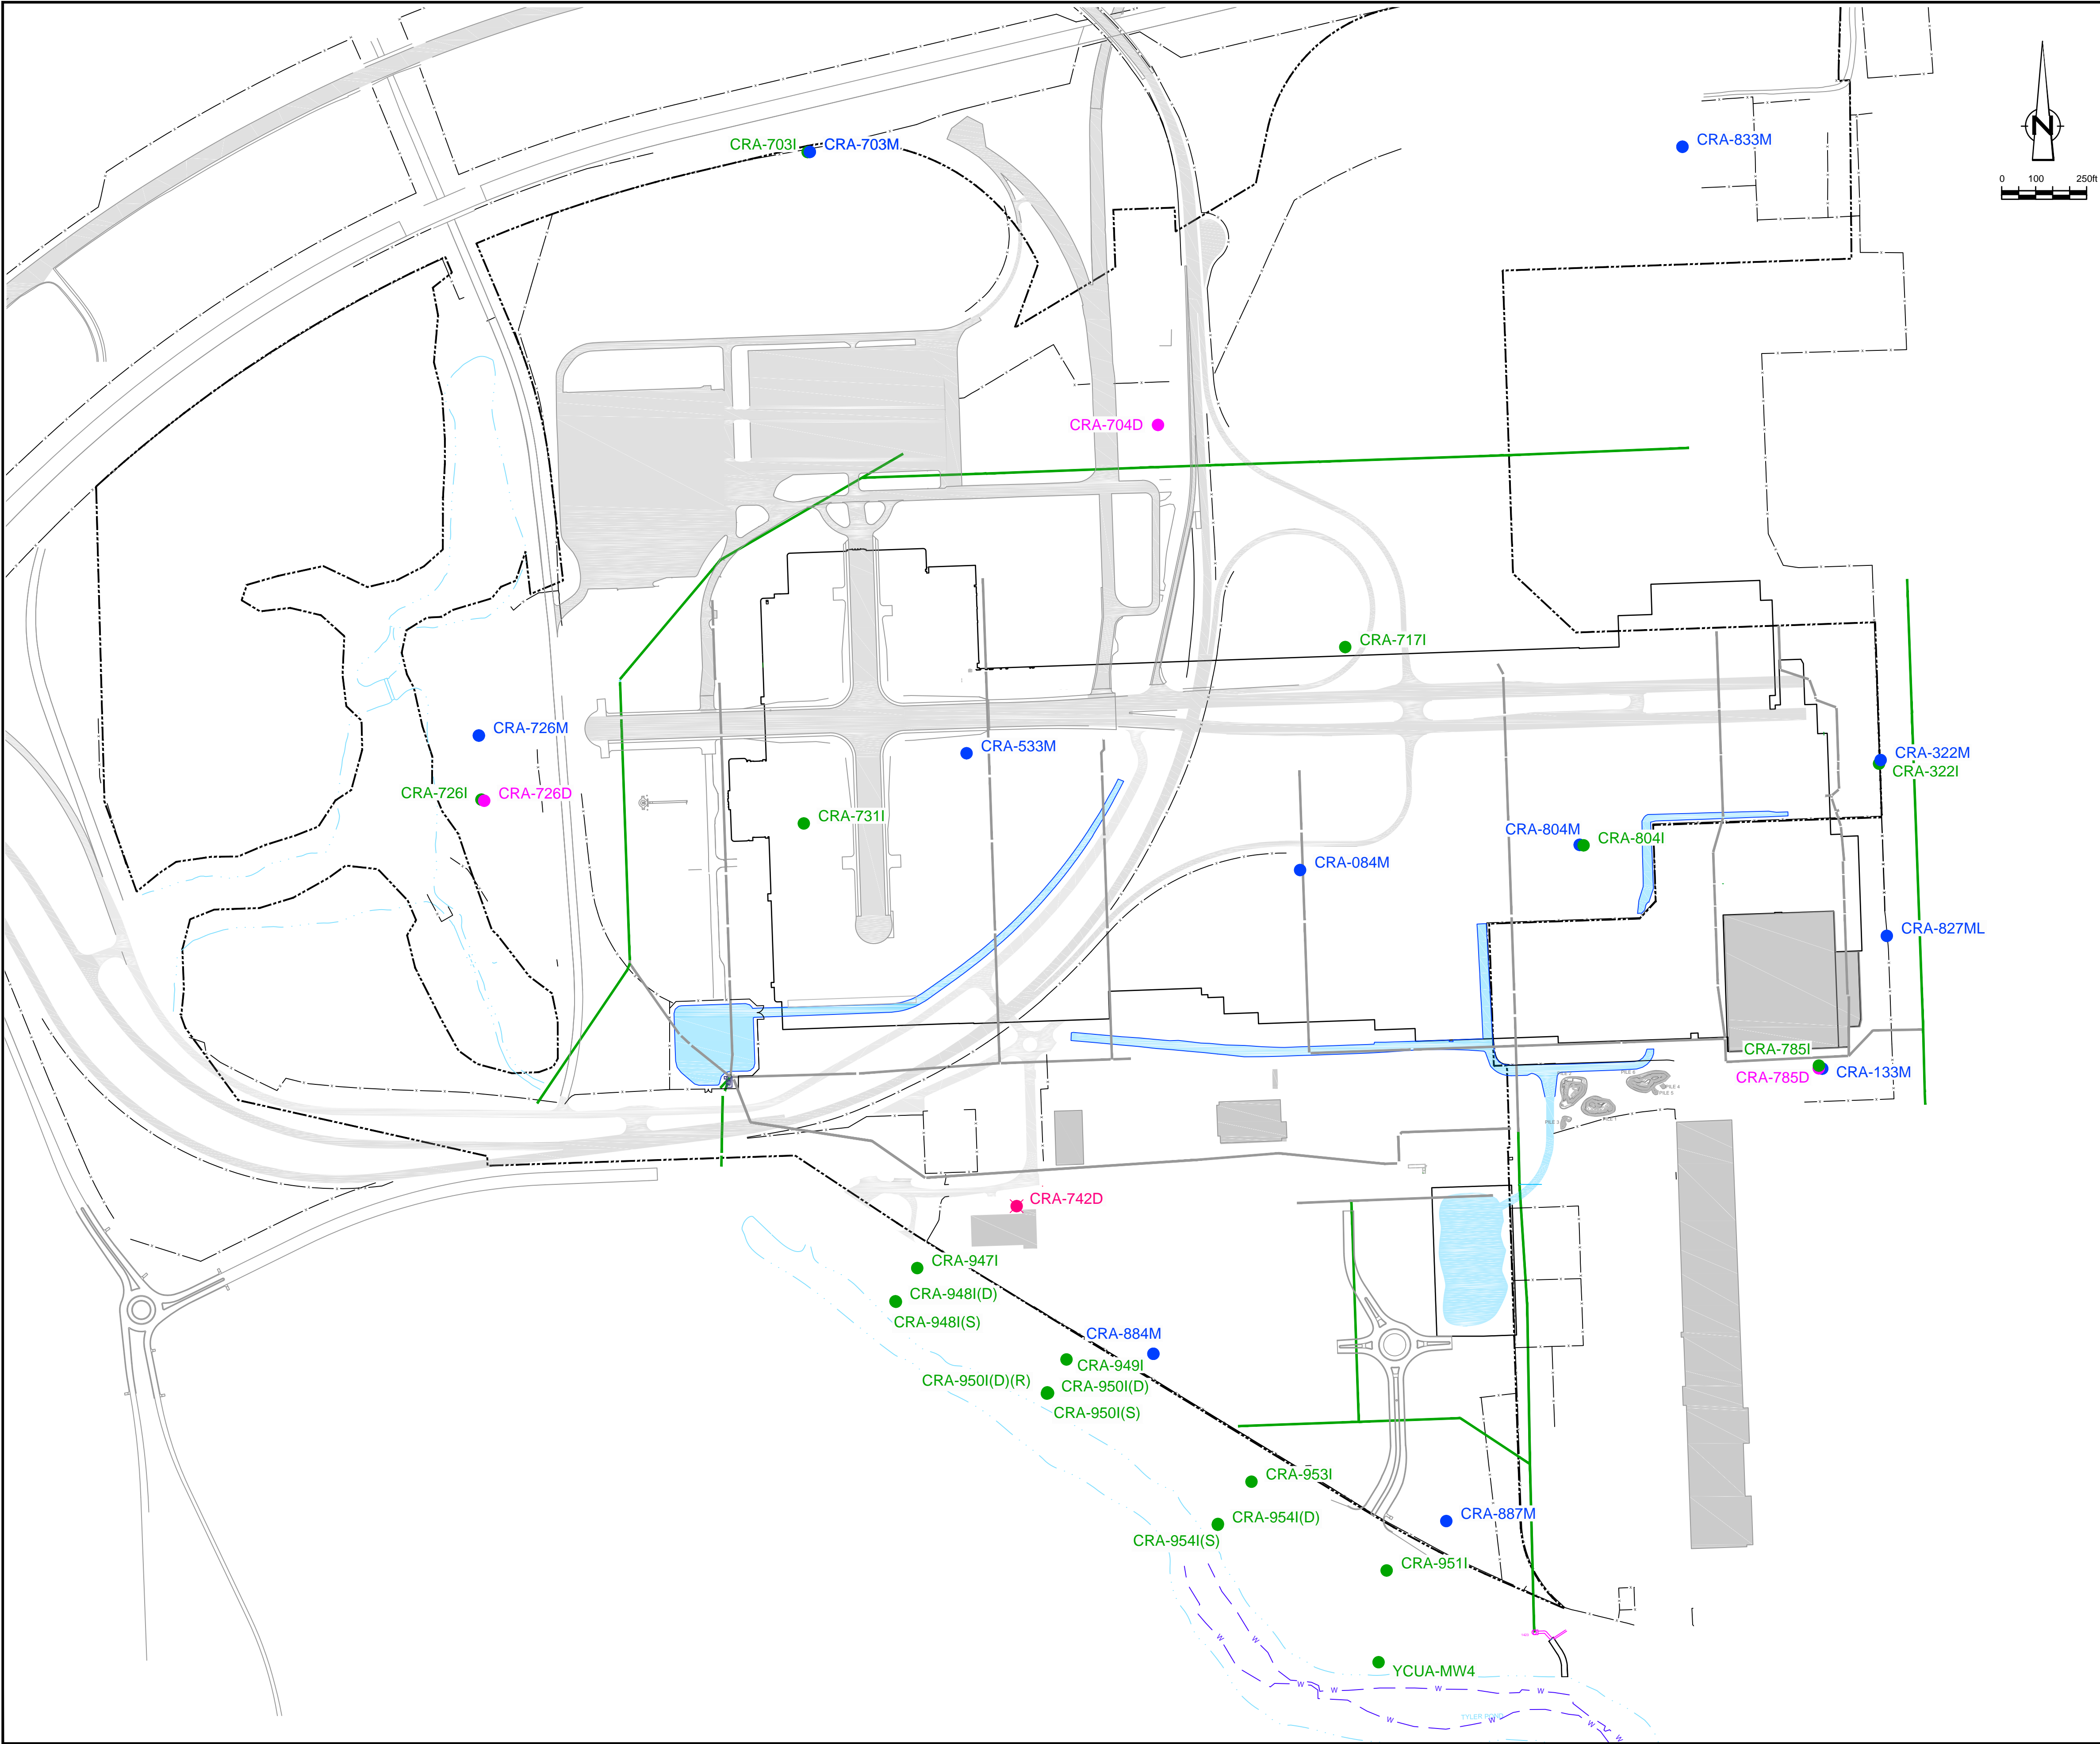
| | | Drawing Nº: figure A.0 |

Appendix A provides a series of hydrographs that examine the relative changes of groundwater elevation in background areas, and in areas beneath and surrounding the 85-acre former building footprint (concrete slab). Figure A.0 presents the locations of the wells featured in the hydrographs. The hydrographs also identify the timing of previous major site changes that could have affected groundwater conditions.

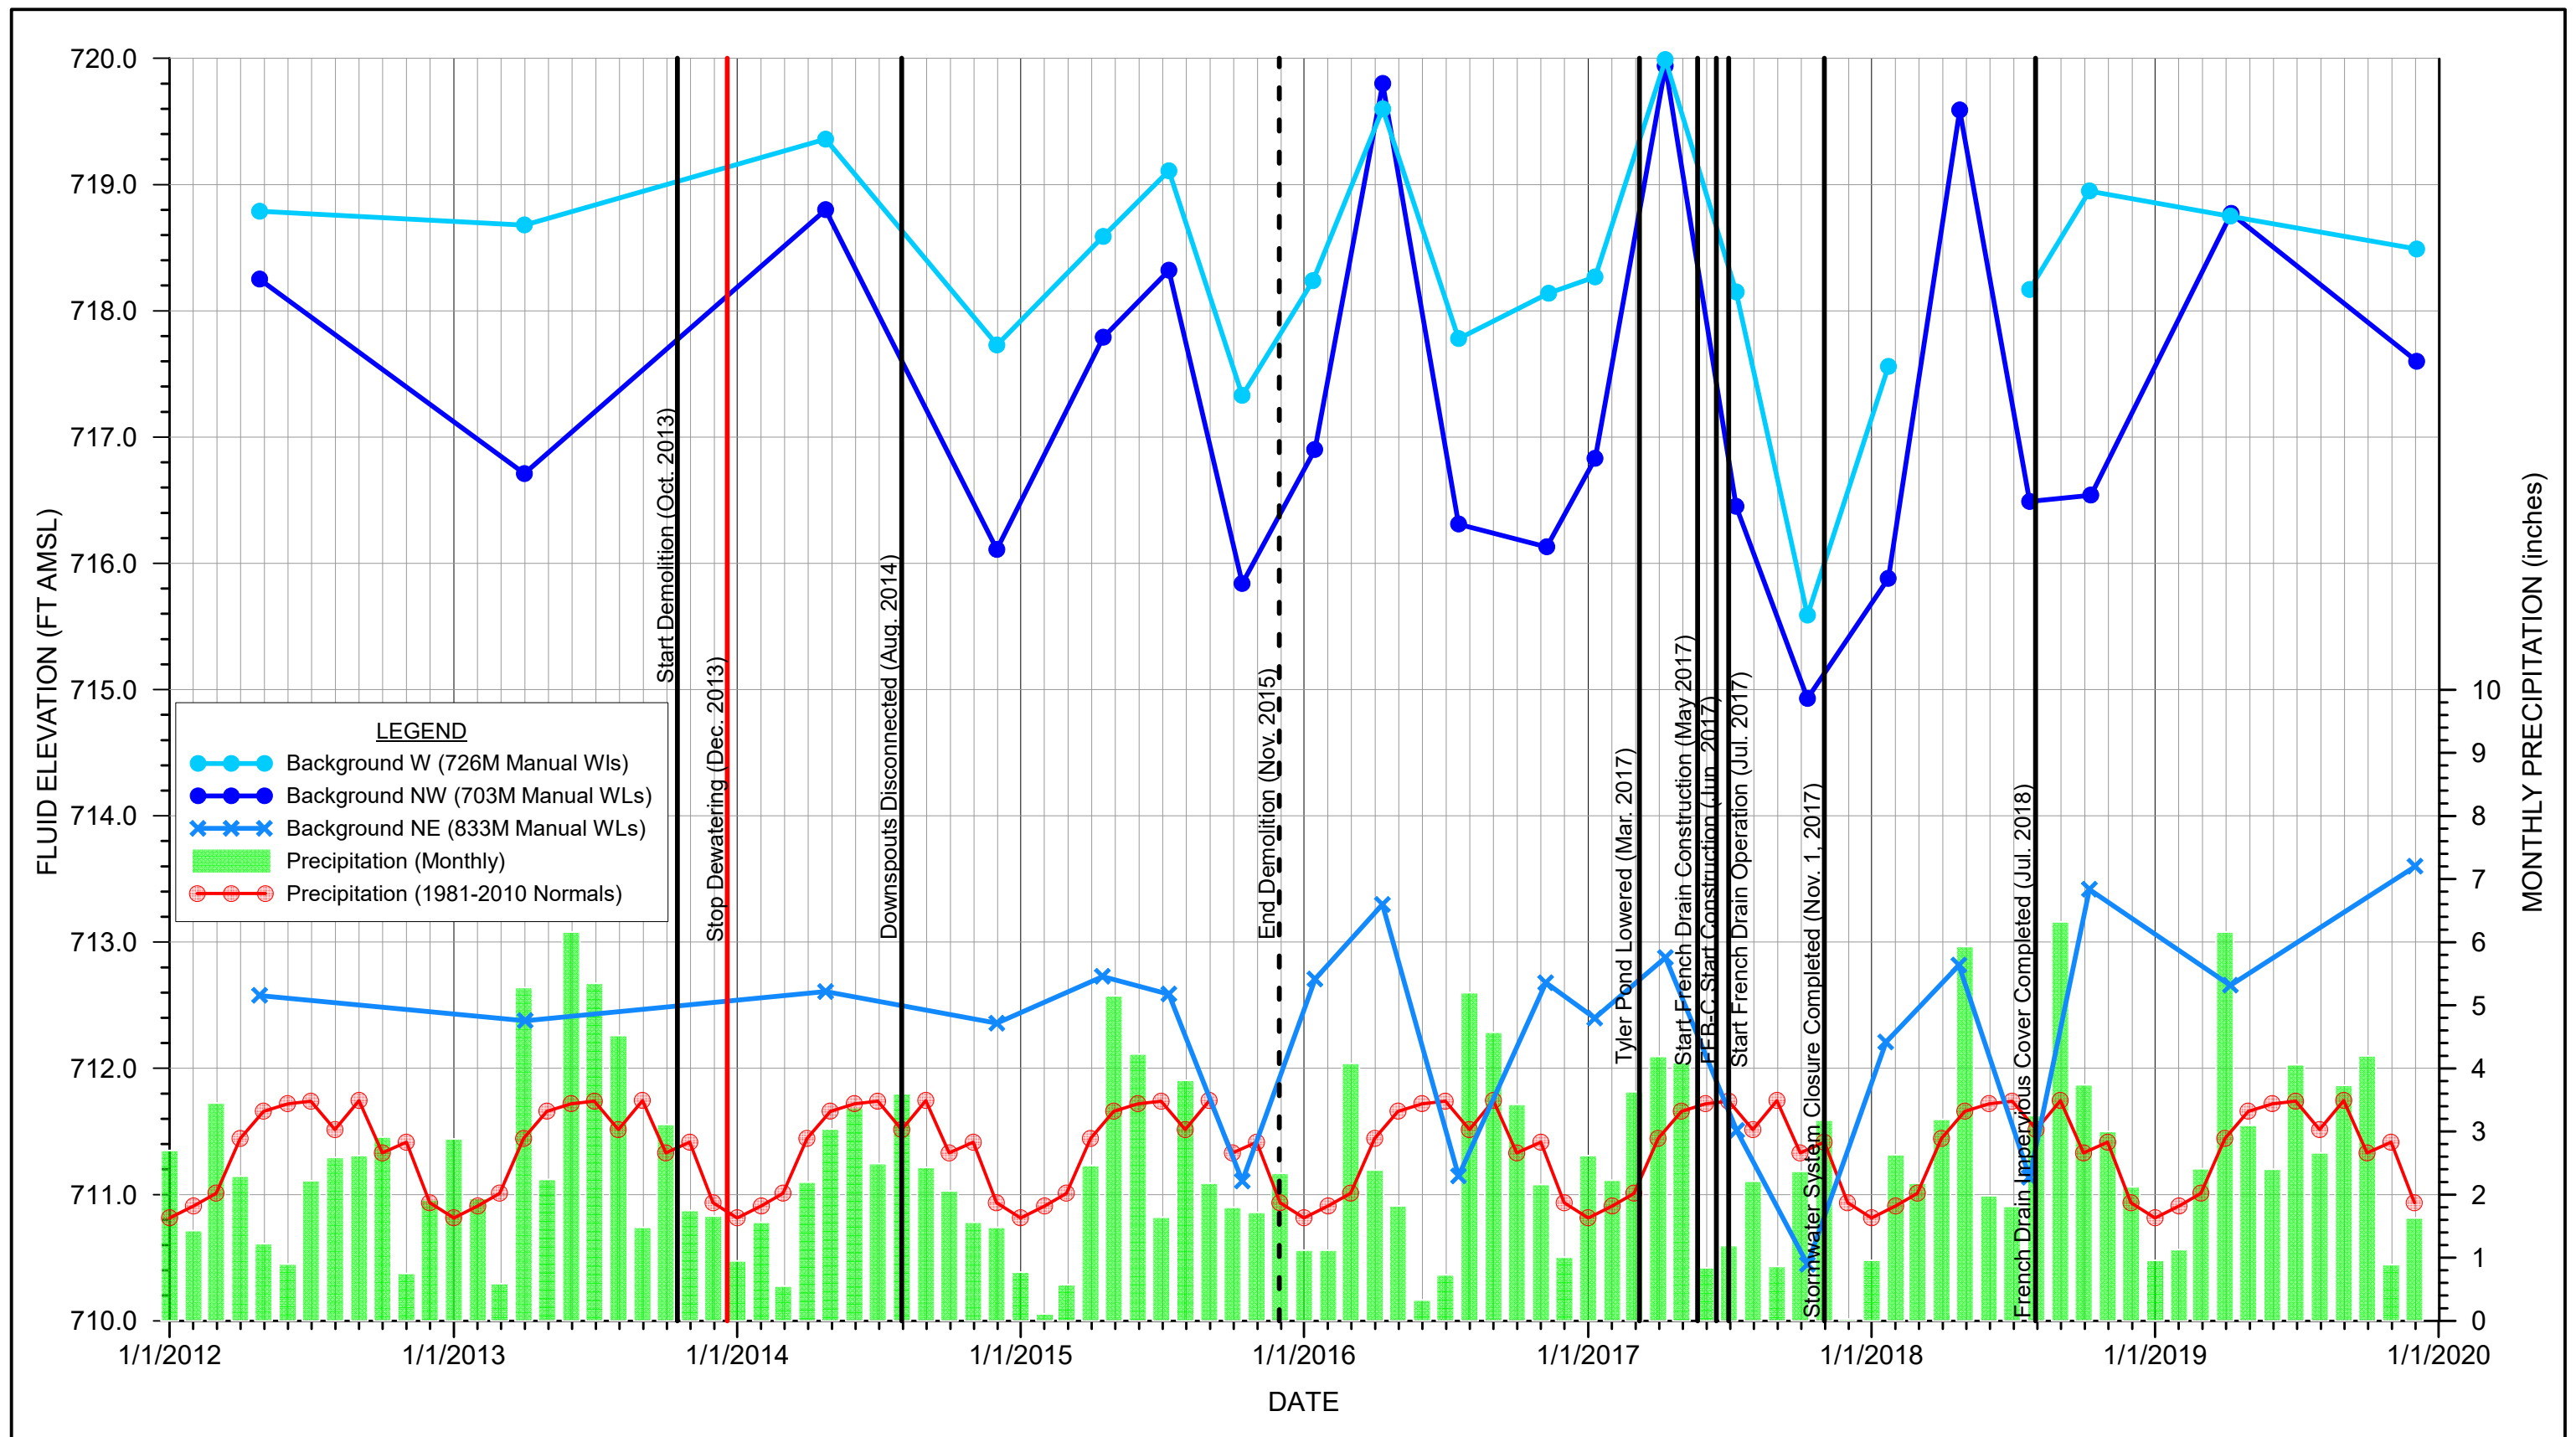
WATER LEVELS VS. TIME - SHALLOW ZONE (BACKGROUND)
GROUNDWATER LEVEL MONITORING UPDATE (TO DEC. 2020) **FIGURE A.1**

Background water levels in the shallow zone (west, northwest and northeast parts of Site) and monthly precipitation at the Willow Run Airport are shown on Figure A.1. In 2019, each of the locations responded differently and there is no clear correlation with monthly water levels or seasonal trends (spring typically high, fall typically low) with the exception of CRA-703M. It is noted that although April 2019 was a wet month overall, it was relatively dry prior to the April 8-12 levels event.

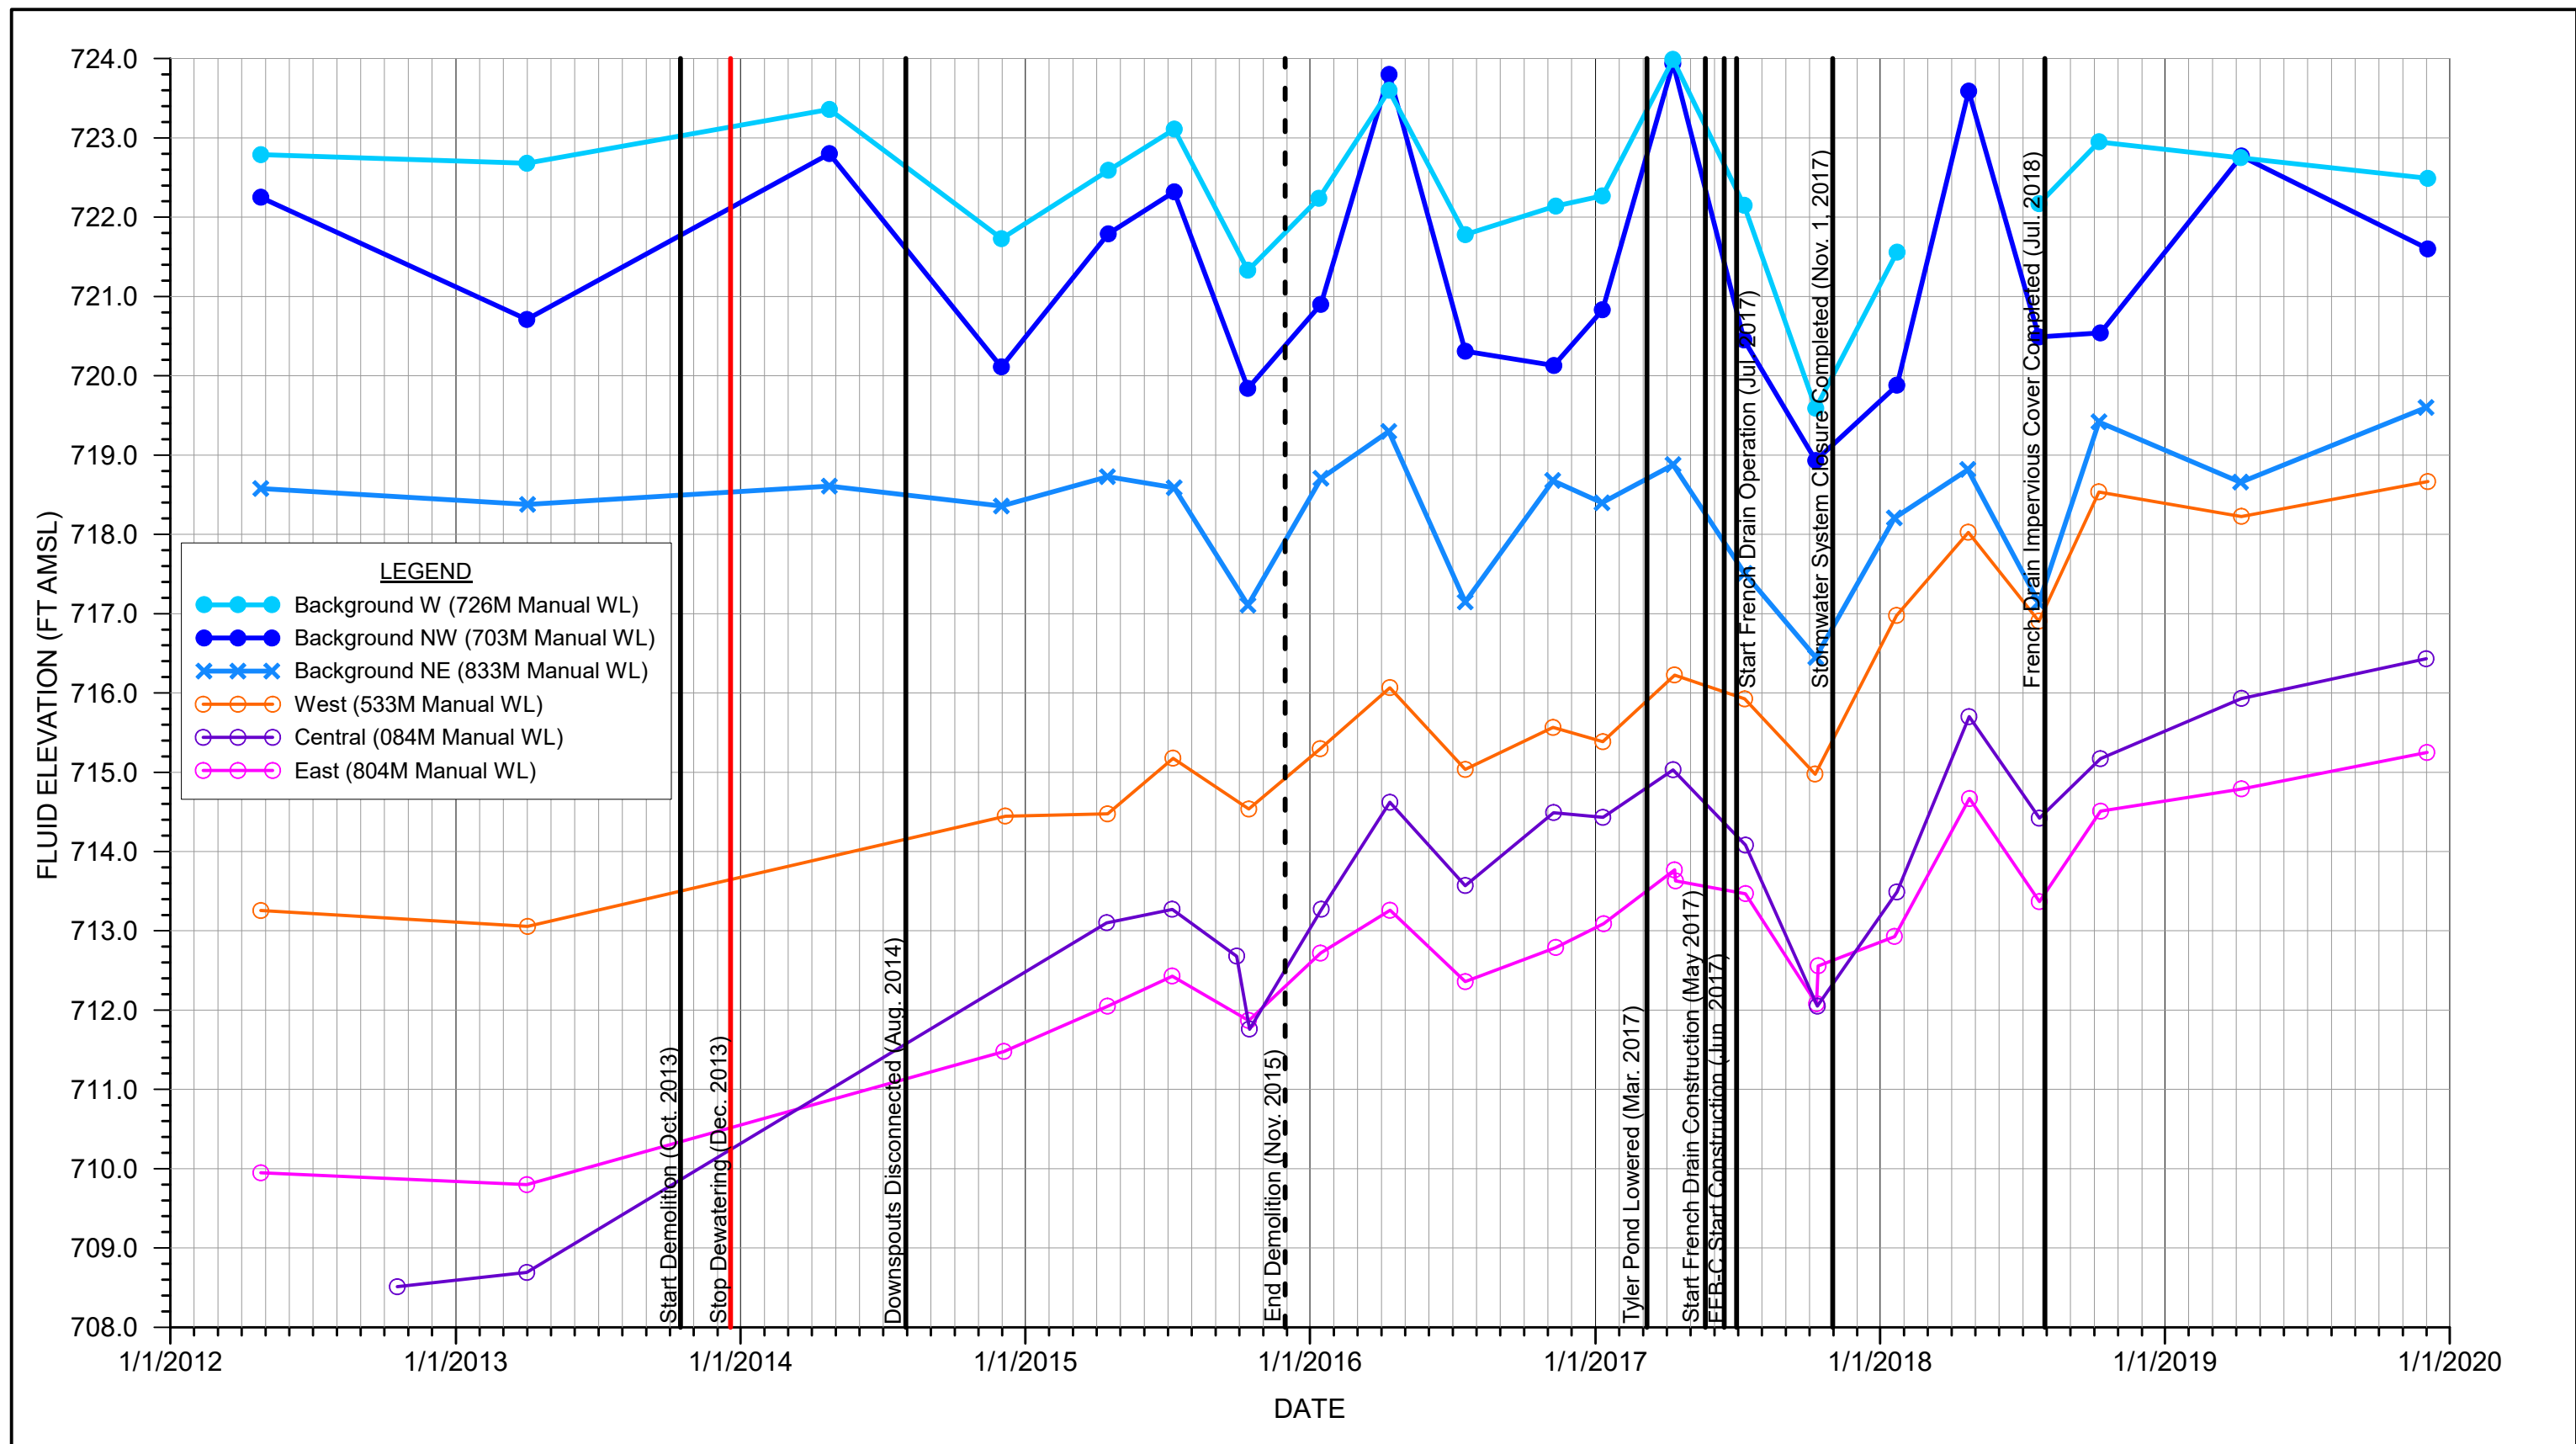
FIGURE A.2

- **Former Building Footprint:** Hydrographs for shallow zone wells on the west, center and east sides of the former building footprint are provided on Figure A.2. The hydrographs show that shallow zone groundwater levels beneath the west part of the former building footprint appear stable. Water levels in the central and east parts of the former building footprint appear to be approaching stabilization.

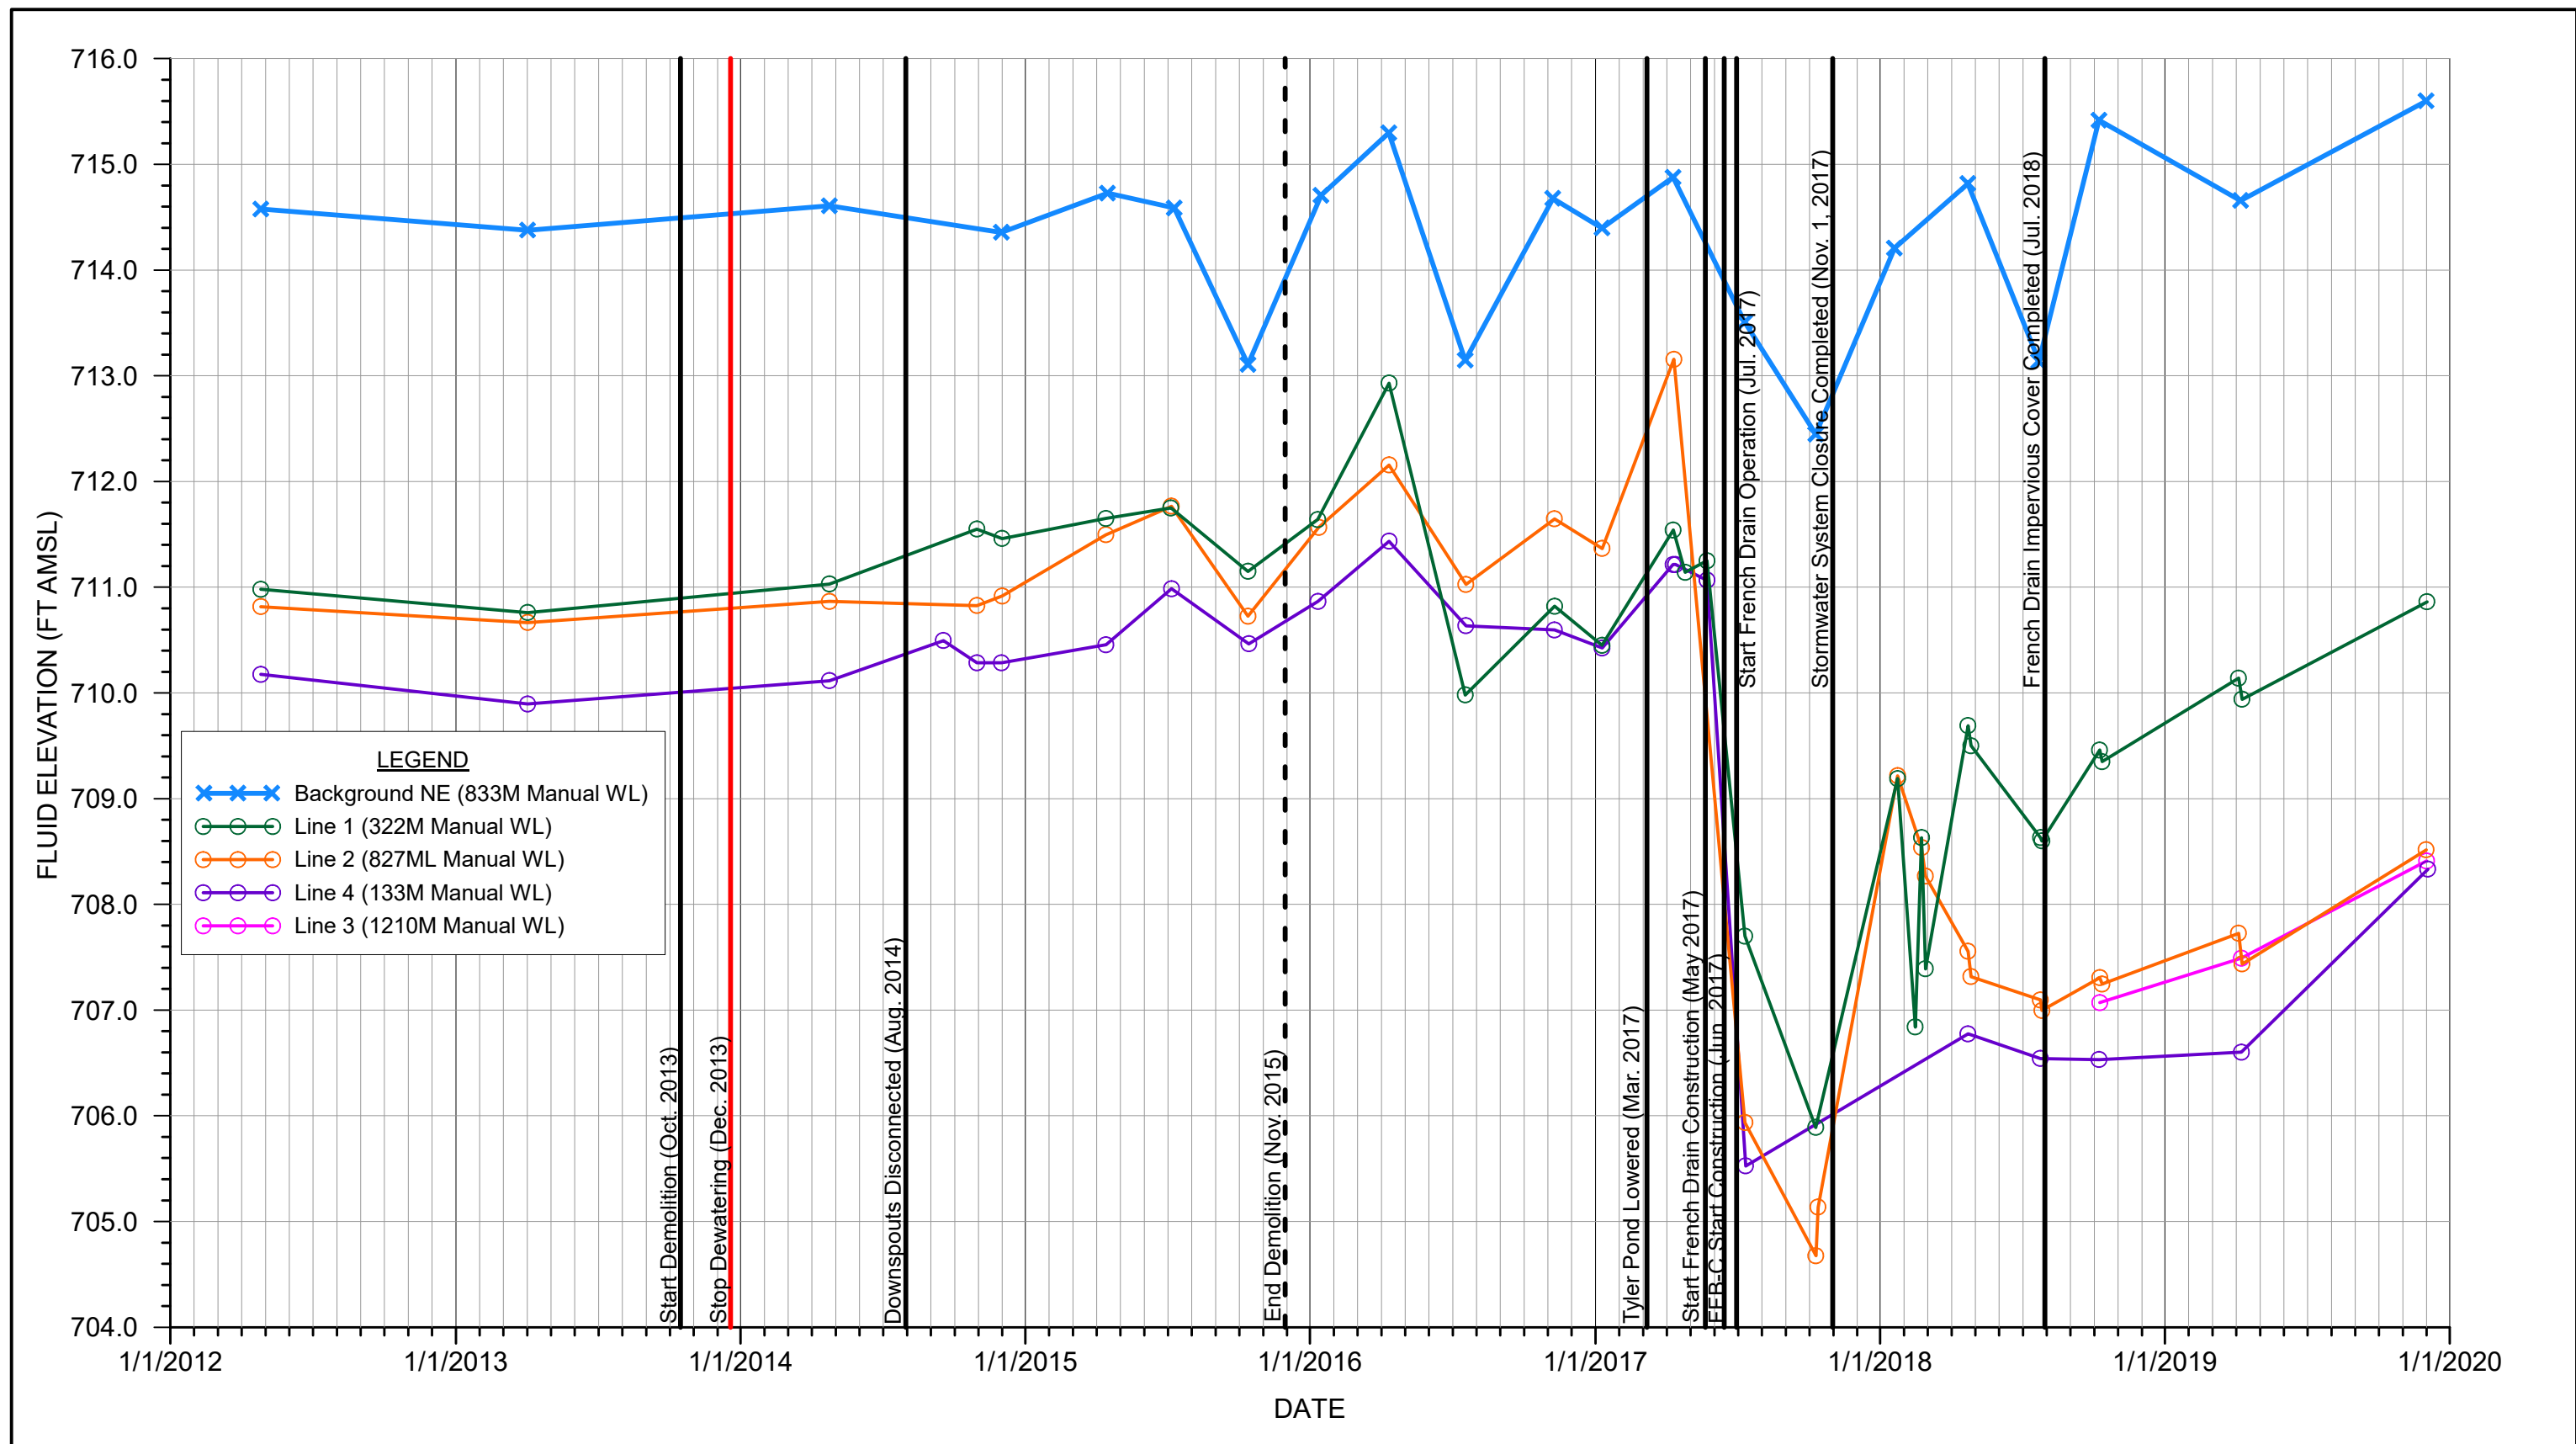
FIGURE A.3

- **East/Southeast Property Boundary:** Hydrographs for shallow zone wells on the downgradient side of the French drain (middle of Lines 1, 2 and 4) and on the French drain (Line 3) are provided on Figure A.3. The hydrographs show that:

- i) Shallow zone groundwater levels near the east/southeast property boundary have declined in response to operation of the drain.
 - ii) Shallow zone groundwater is captured by the drain (given that water levels on the downgradient side are lower than would be expected if the drain were off).

- iii) Shallow zone groundwater levels are effectively stable or near stable in this area, with respect to historic site changes (based on pre-drain trend) and now fluctuate primarily in response to operation of the drain. The increase in water levels from April to December of 0.9 to 1.7' reflects the increase of 1.4 to 2.4' in the average sump levels.

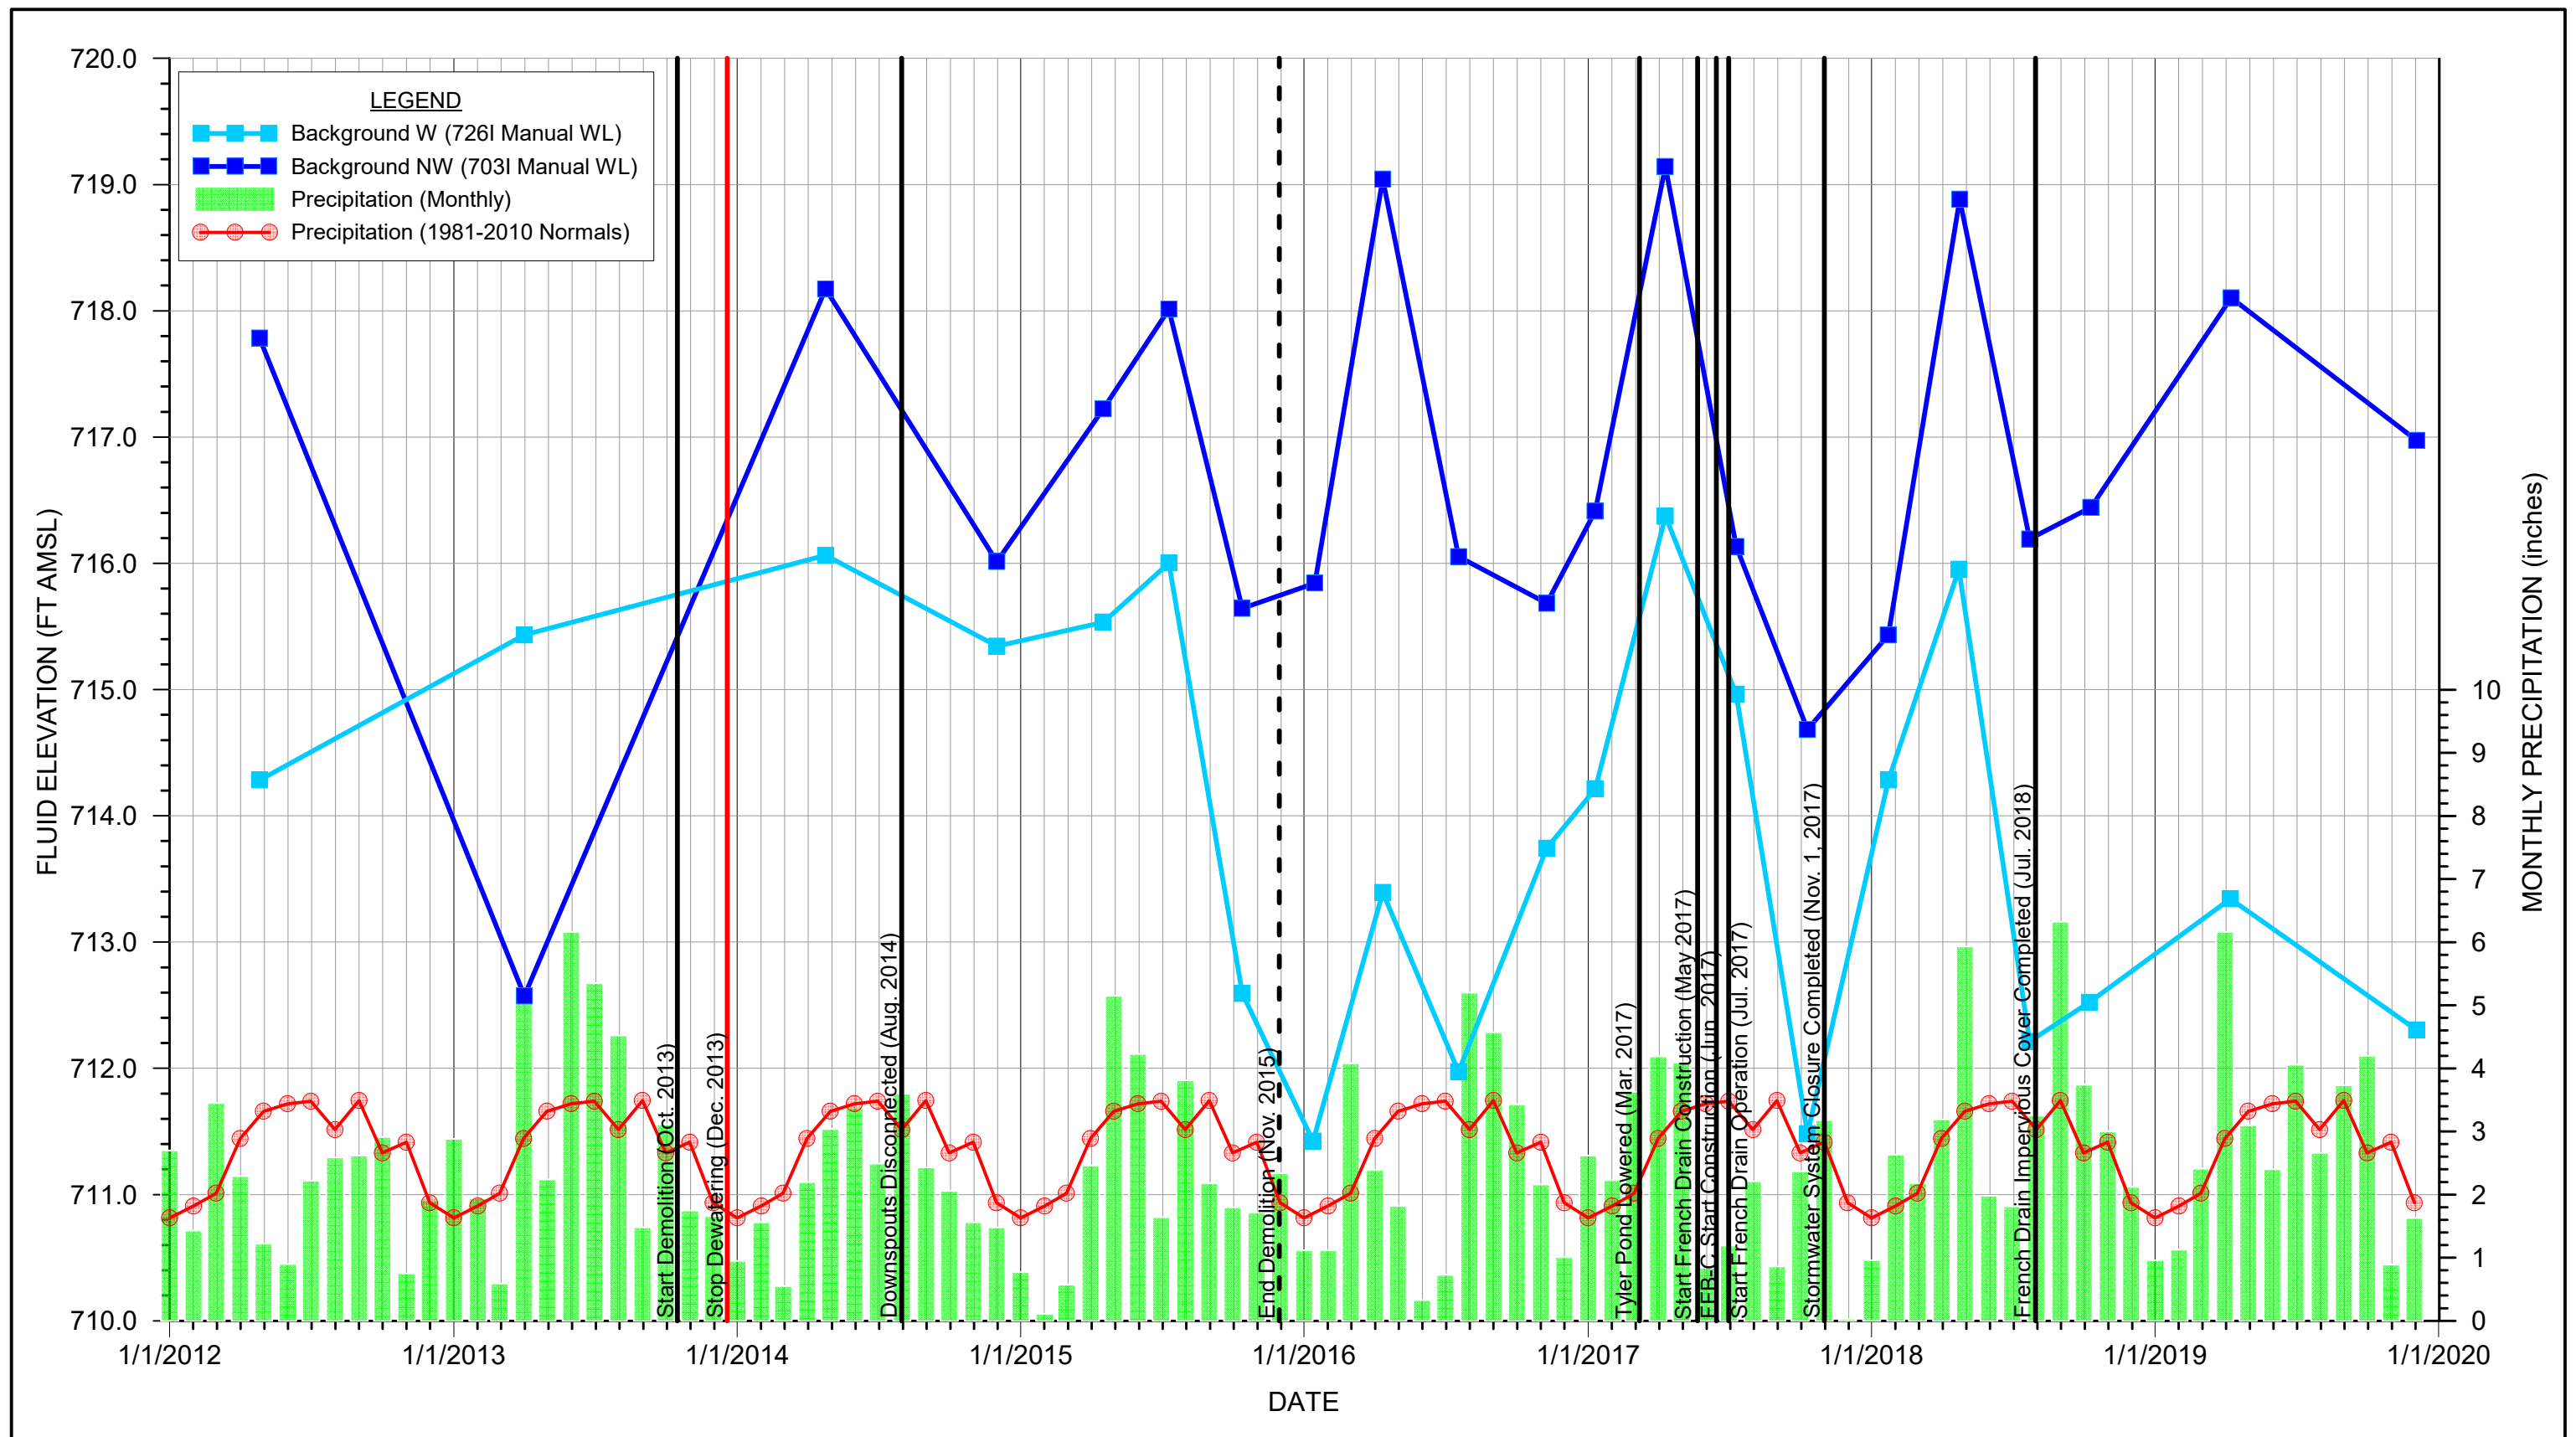
WATER LEVELS VS. TIME - INTERMEDIATE ZONE (BACKGROUND)
GROUNDWATER LEVEL MONITORING UPDATE (TO DEC. 2019) **FIGURE A.5**

- Background water levels in the intermediate zone (northwest and west) and monthly precipitation at the Willow Run Airport are shown on Figure A.5. In 2019 the background trends were similar with elevated water levels in the spring and lower water levels in the fall. CRA-703I is assumed to be a better representation of background levels since CRA-726I may be hydraulically connected to the Beyer Drain based on the extremely low water levels observed in 2016.

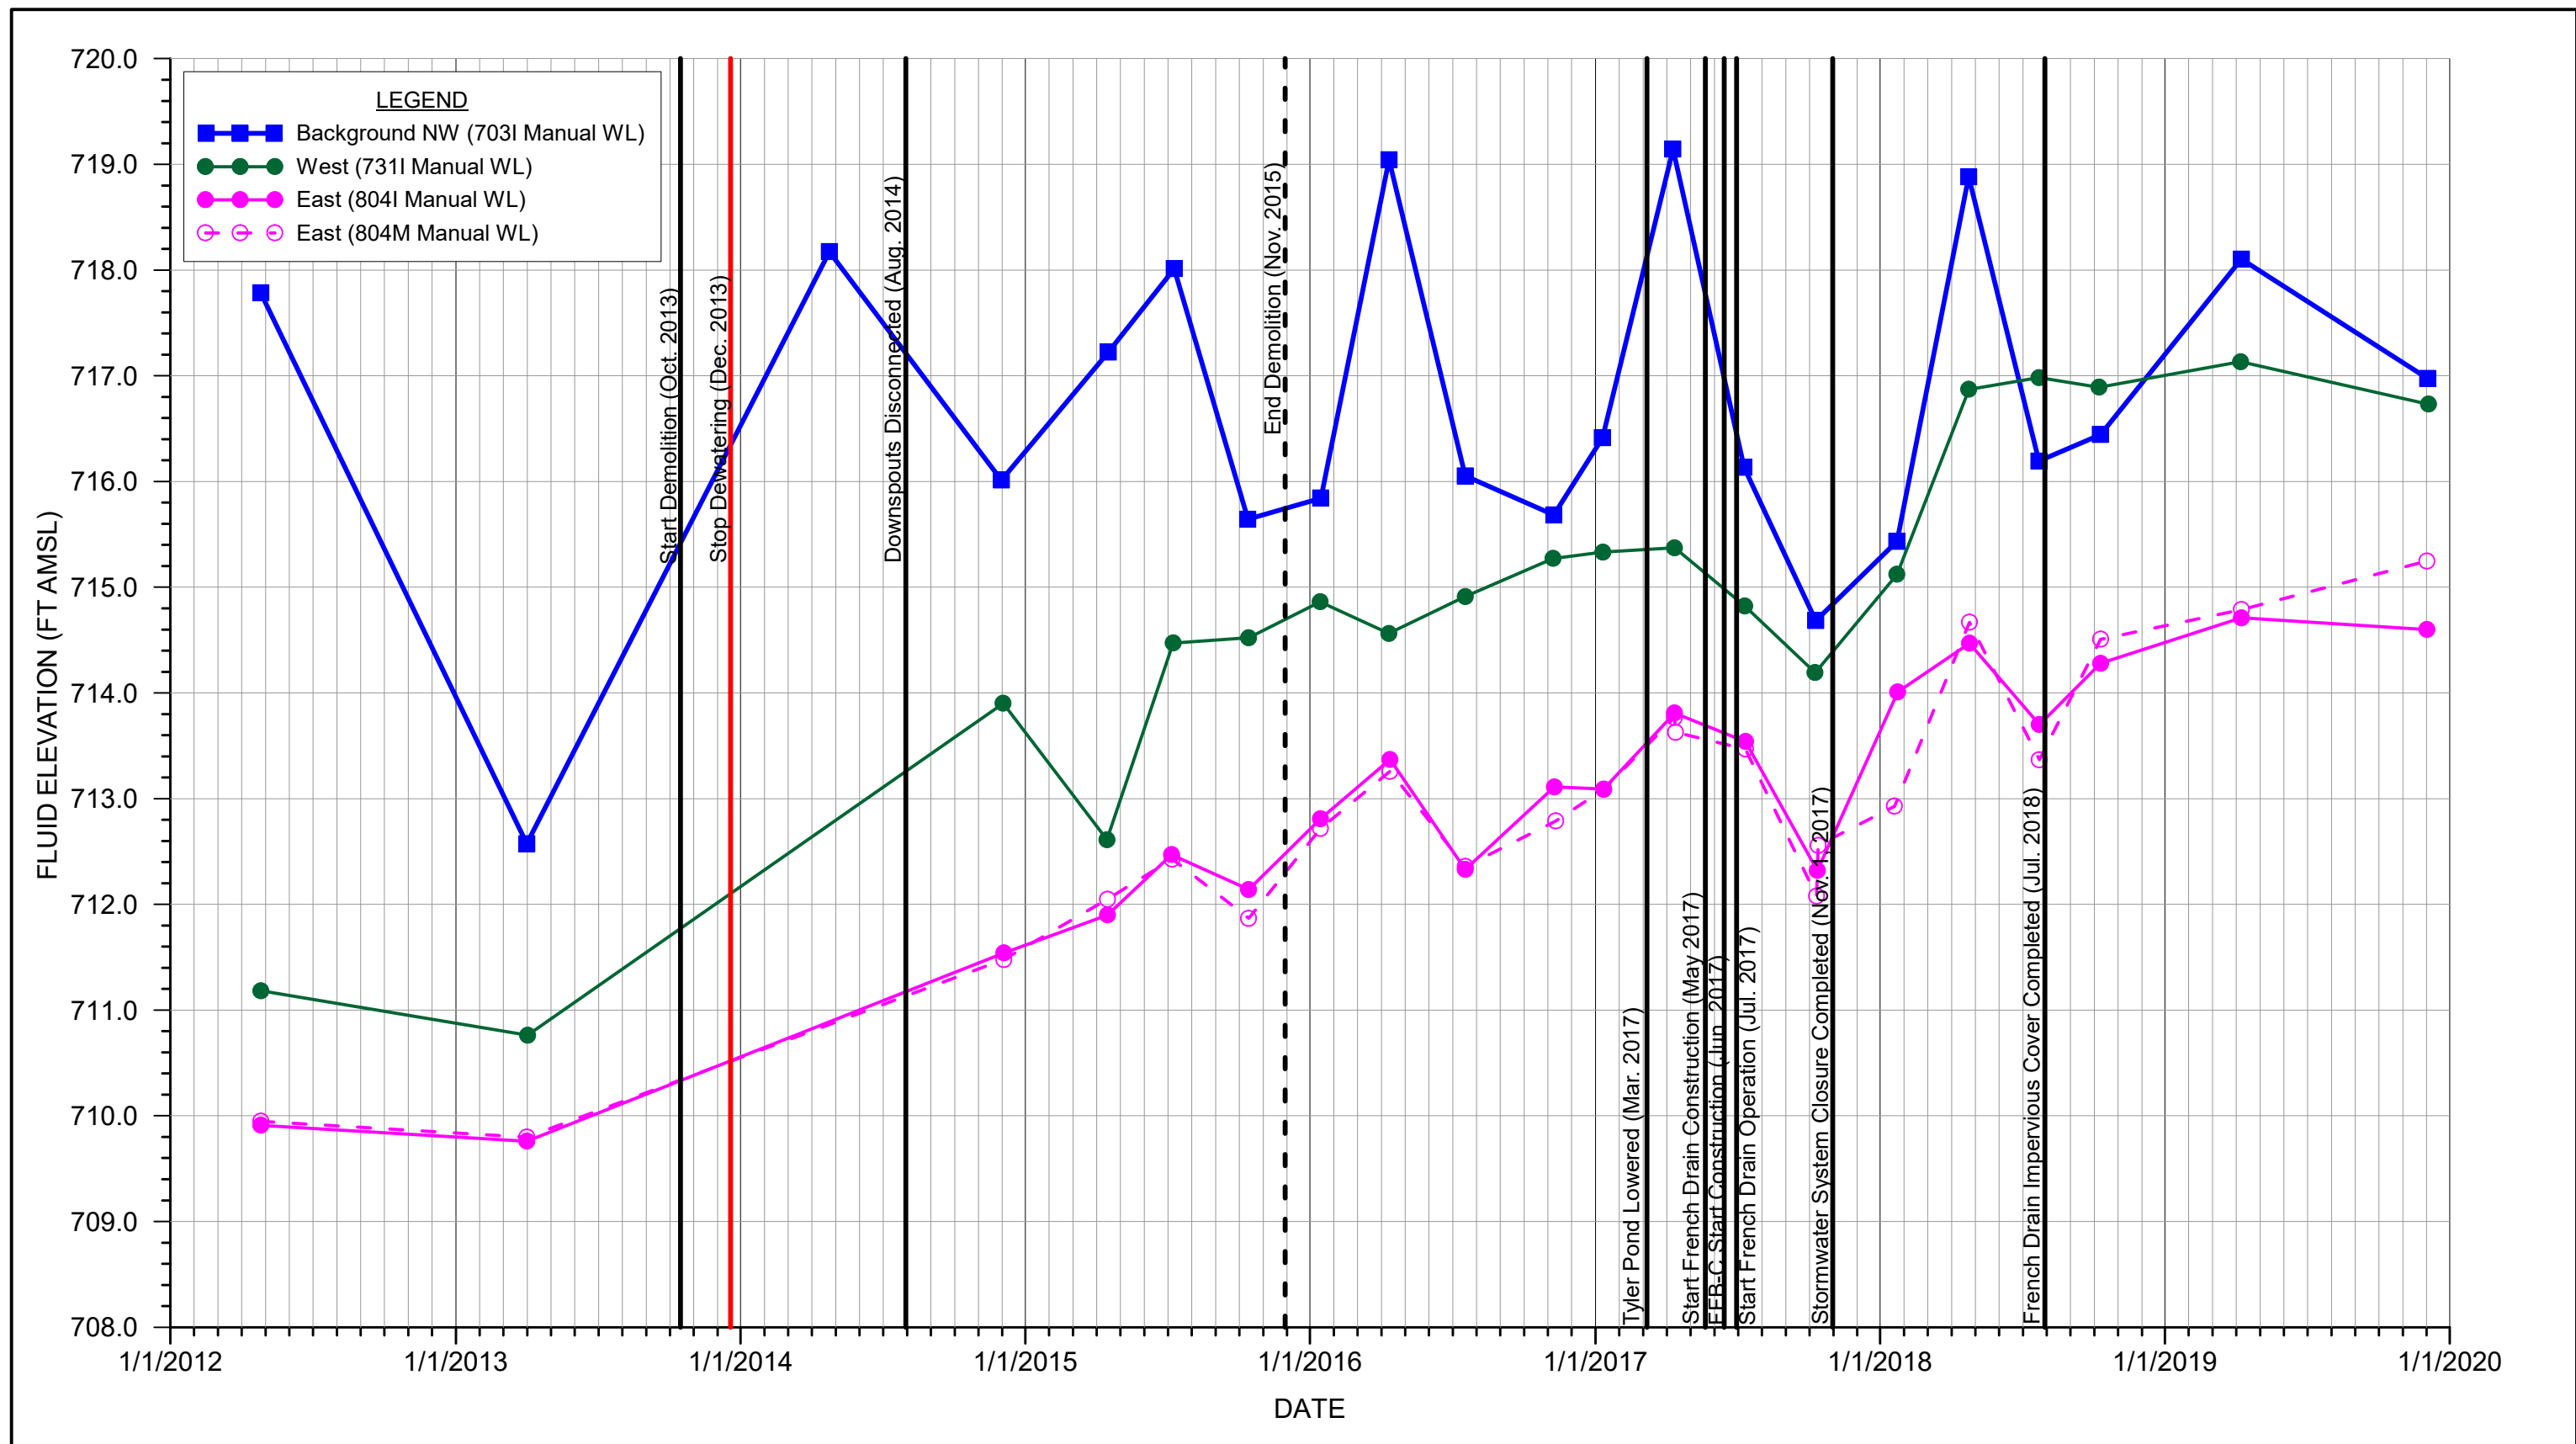
- **Former Building Footprint:** Hydrographs for intermediate zone wells on the west and east sides of the former building footprint are shown on Figure A.6. The hydrographs show that intermediate zone water levels appear to have stabilized or are close to stabilizing in this area.
