April 7, 2020

Reference No. 017358

**Re: Groundwater Level Monitoring Update (through December 2019)
Willow Run Powertrain
Ypsilanti, Michigan**

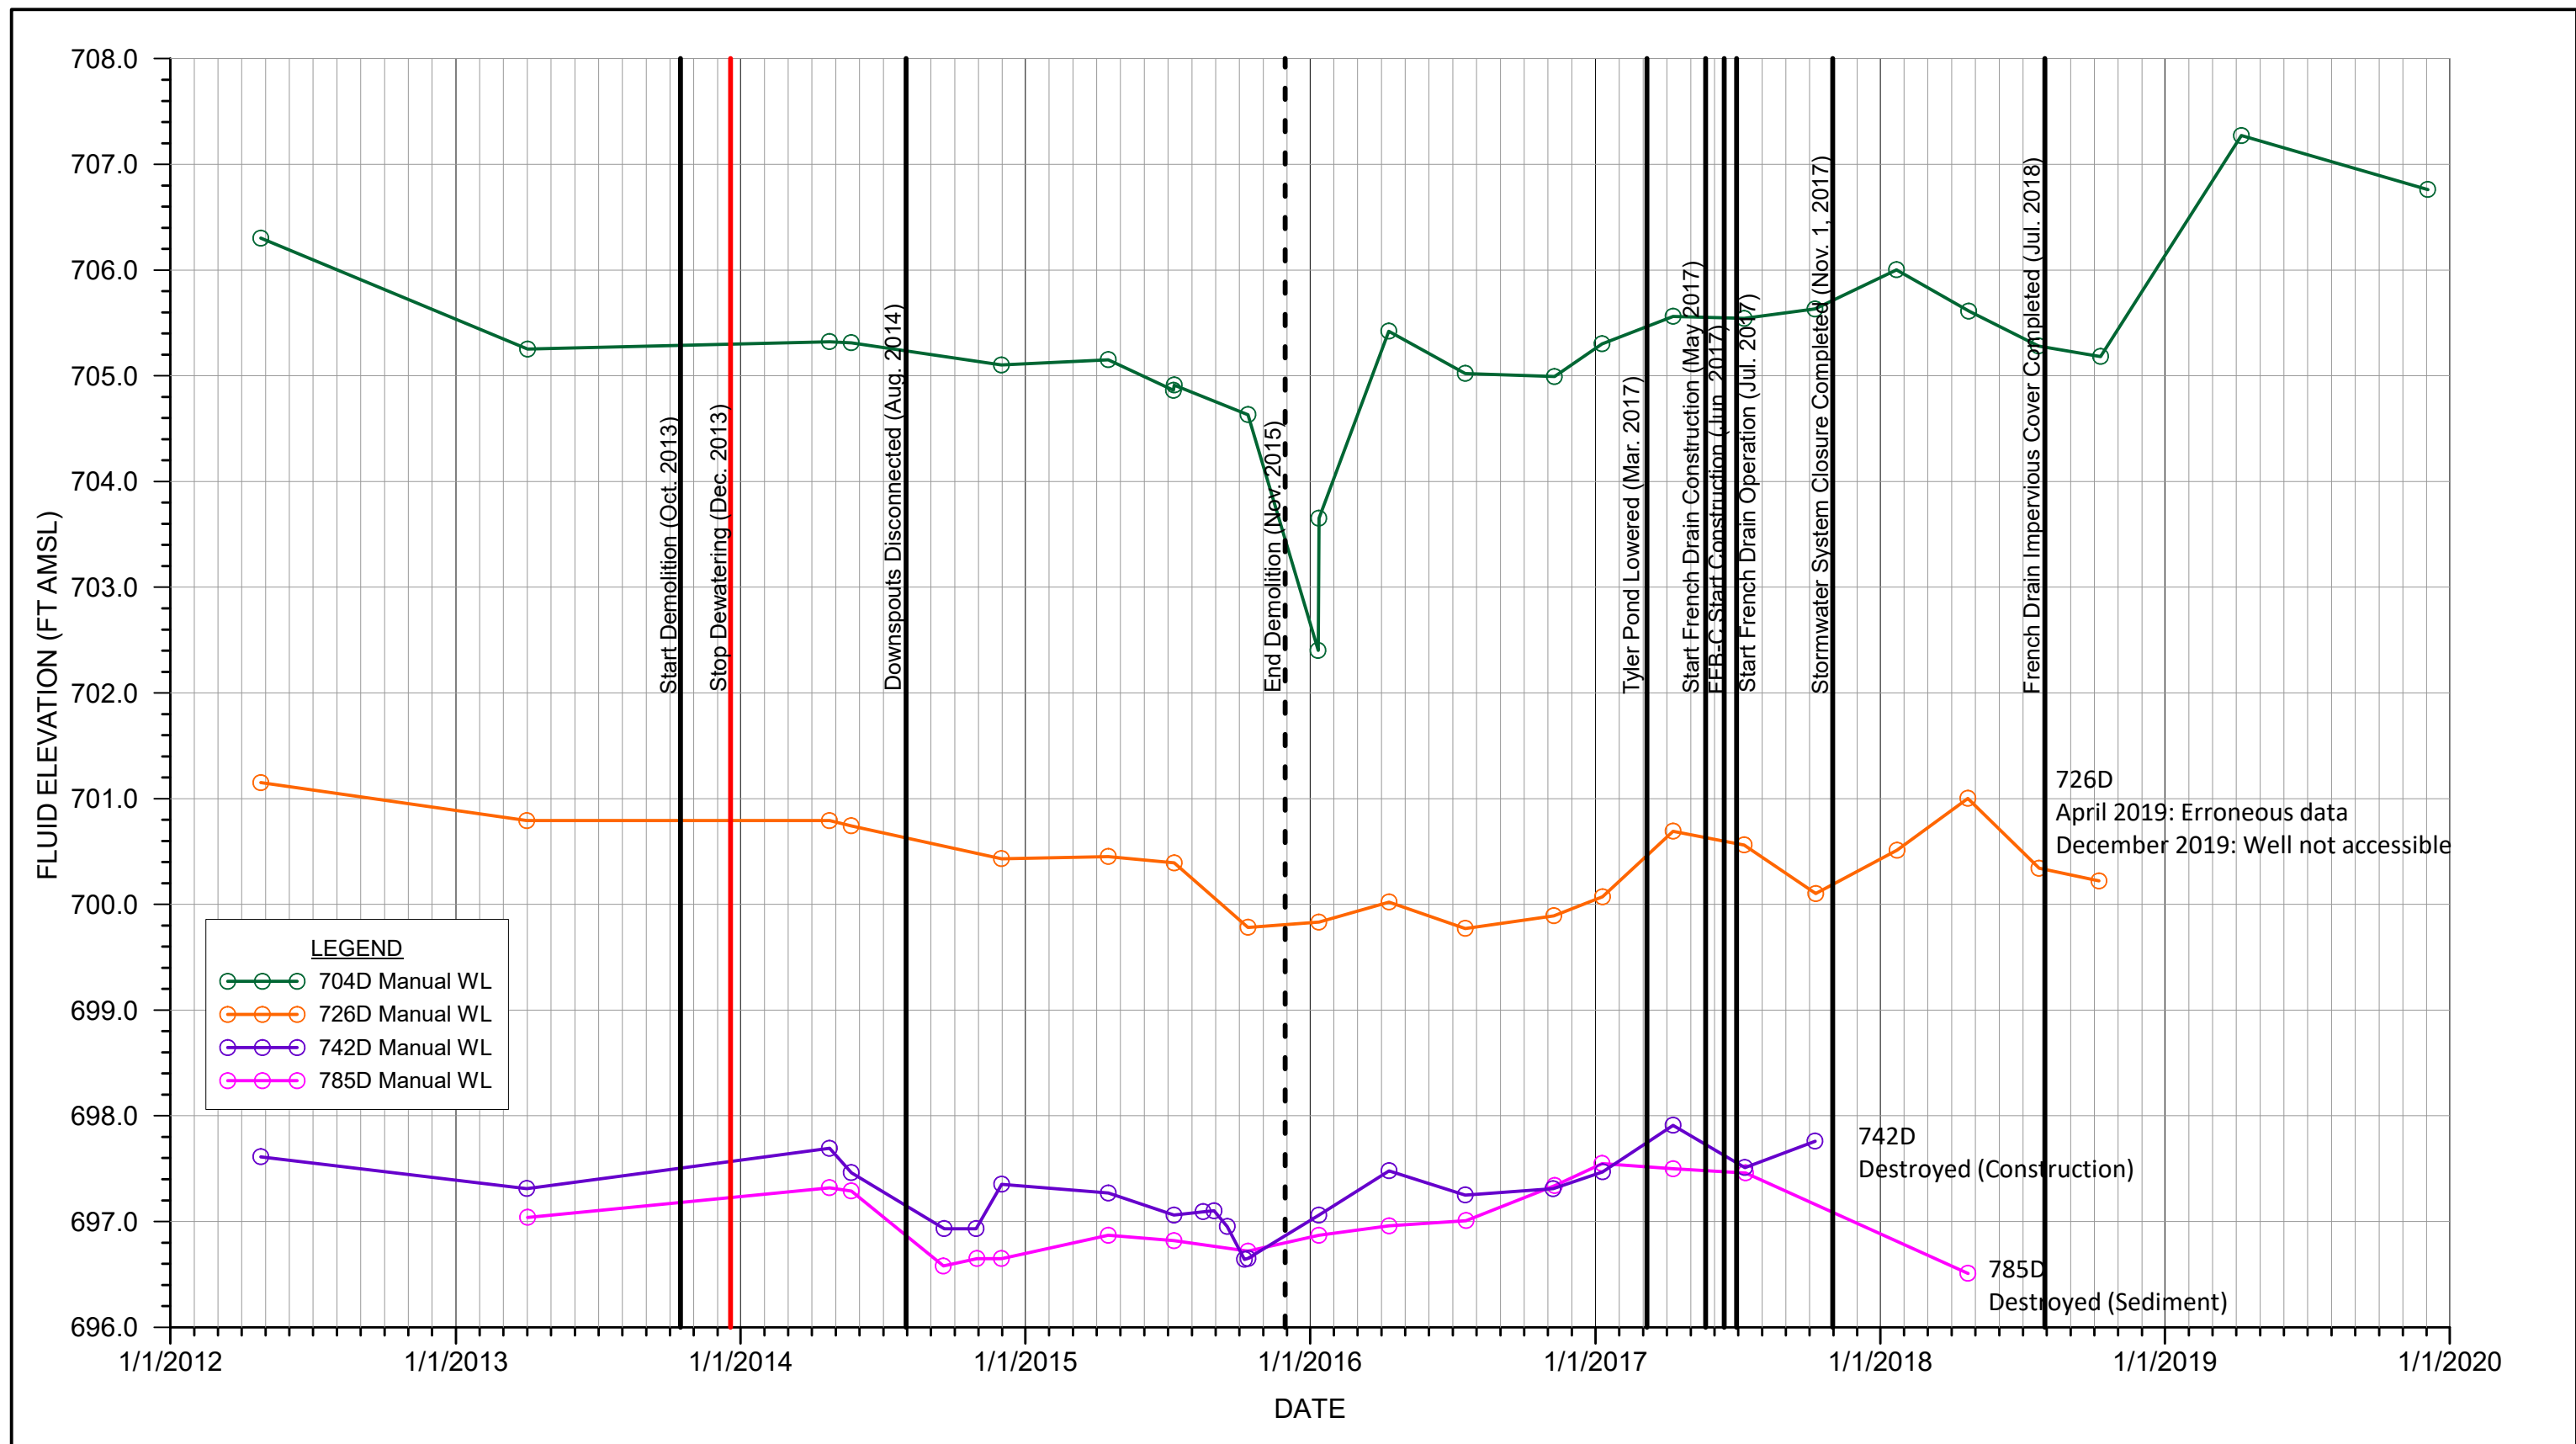
WATER LEVELS VS. TIME - DEEP ZONE
GROUNDWATER LEVEL MONITORING UPDATE (TO DEC. 2019) FIGURE A.11

Deep zone groundwater levels at one of the two remaining on-Site wells are shown as having increased in 2019 (Figure A.11). The reason for the increase is not known but is considered suspect given previously stable water levels. An additional water level and depth to bottom measurement taken March 12, 2020 indicated consistency with the 2019 levels. Due to the lack of deep monitoring wells remaining in the monitoring network, semi-annual monitoring of the deep zone will be discontinued. Curtailing deep zone monitoring is not considered an issue given that previous results have indicated consistent southerly flow and no analytical impacts.
