August 2, 2007

Re: Ley Creek PCB Dredgings Site
June 2007 OM&M Inspection

LEY CREEK PCB DREDGINGS SITE
SYRACUSE, NEW YORK
SITE REMEDIATION PROJECT

JUNE 2007
OM&M INSPECTION
PARTIAL SITE PLAN

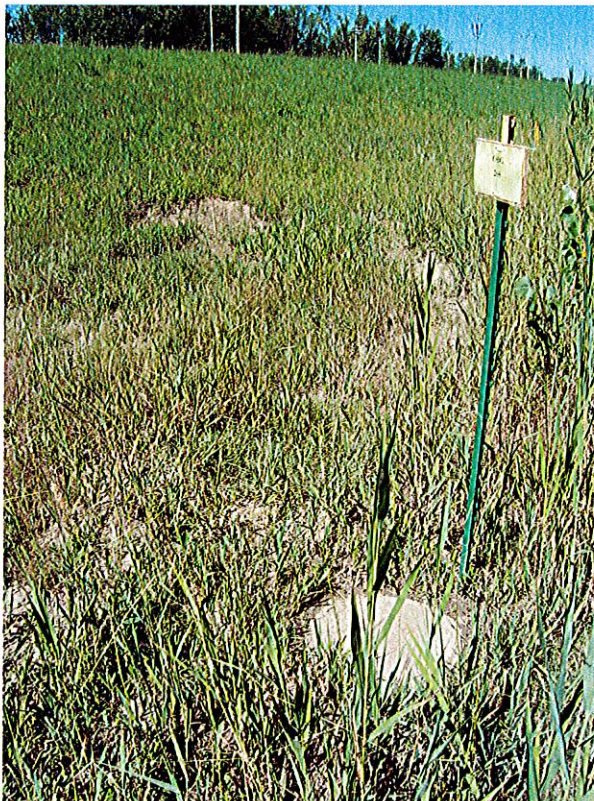
Establishment of vegetation in the areas that were repaired in the 2006 construction season to address erosion (Figures 3 and 4 and Photograph 4) has improved, but requires additional monitoring until fully established.

Photograph 4: View of area near OBG-26S, which was re-seeded in Fall of 2006.

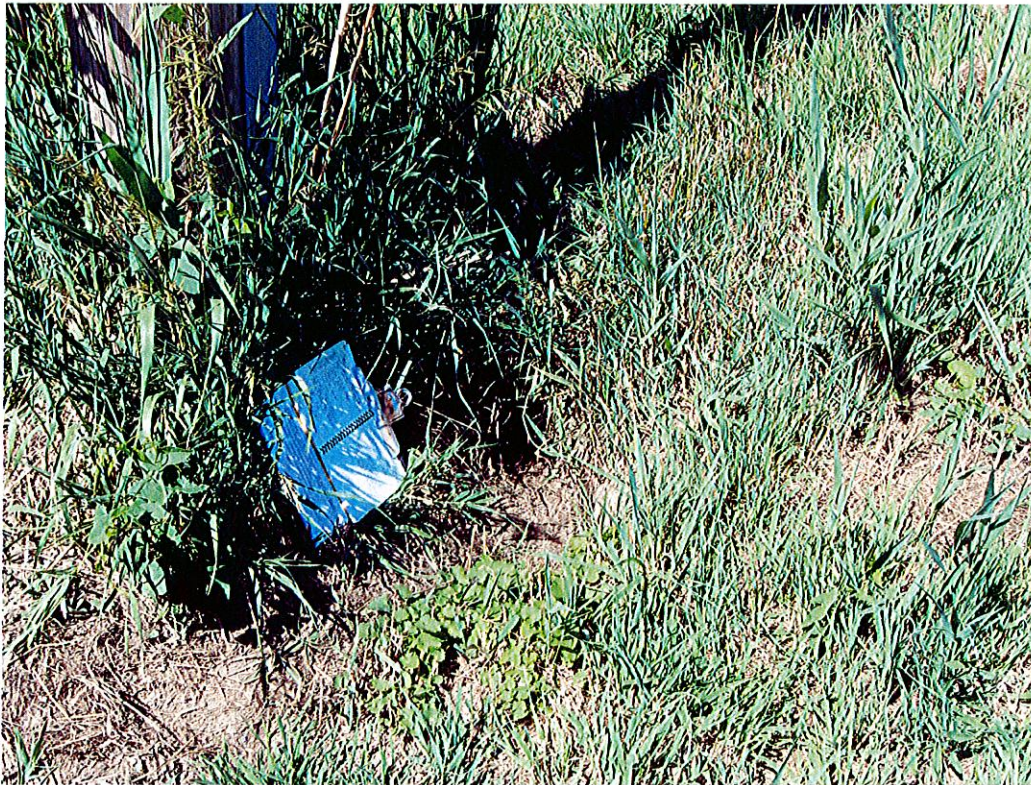
- Animal burrow in vegetative cover (Figures 1, 2, and 4 and Photographs 5, 10 and 14)
- Exposed erosion control fabric within CB-3 overflow spillway (Figure 3 and Photograph 7)
- Lack of vegetation within CB-3 overflow spillway (Figure 1, 2, and 3 and Photograph 6, 11, and 12)
- Soil covering MW-12 and MW-13 monitoring well due to animal burrow (Figures 1 and 2 and Photographs 10 and 15)
- Phragmites in asphalt (Figure 1 and 2 and Photograph 16)
- Garbage near Factory Avenue (Figure 3)

Photograph 5: Burrowing animal hole along fenceline southeast of OBG-21D.

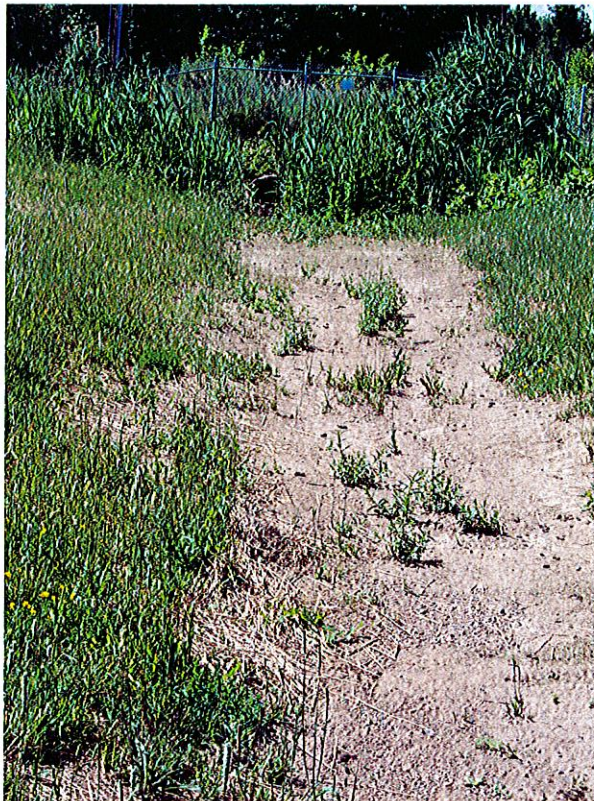
5. Lack or thinning vegetation?	<input checked="" type="checkbox"/>		Figures 1,2, and 3. Photographs 6, 11, and 12
	6. Presence of burrowing animals?	<input checked="" type="checkbox"/>		Figures 1,2, and 4. Photographs 5, 10, and 15

Photograph 6: Newly placed topsoil in CB-3 overflow spillway without vegetation establishment.

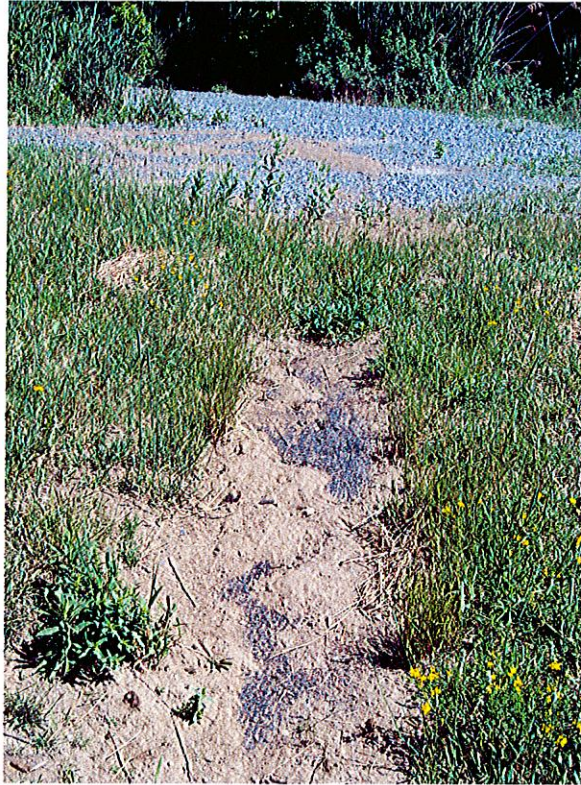
Photograph 7: View of eroded topsoil with visible erosion control fabric.

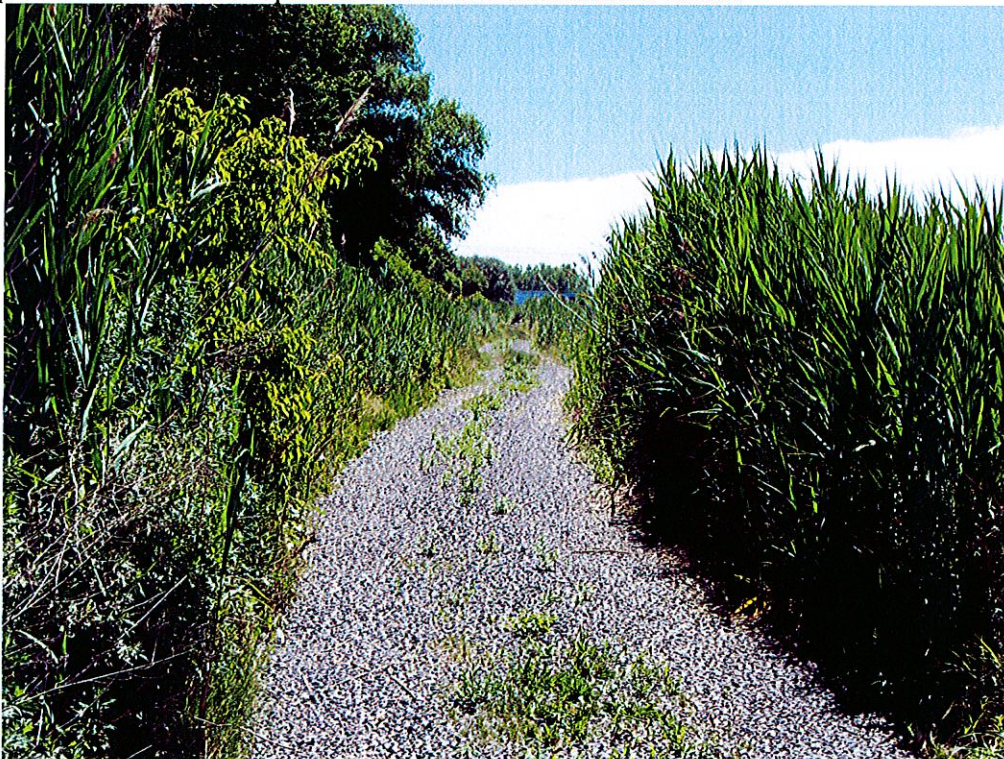
Photograph 8: View looking east from CB-3 outlet at repaired access road.

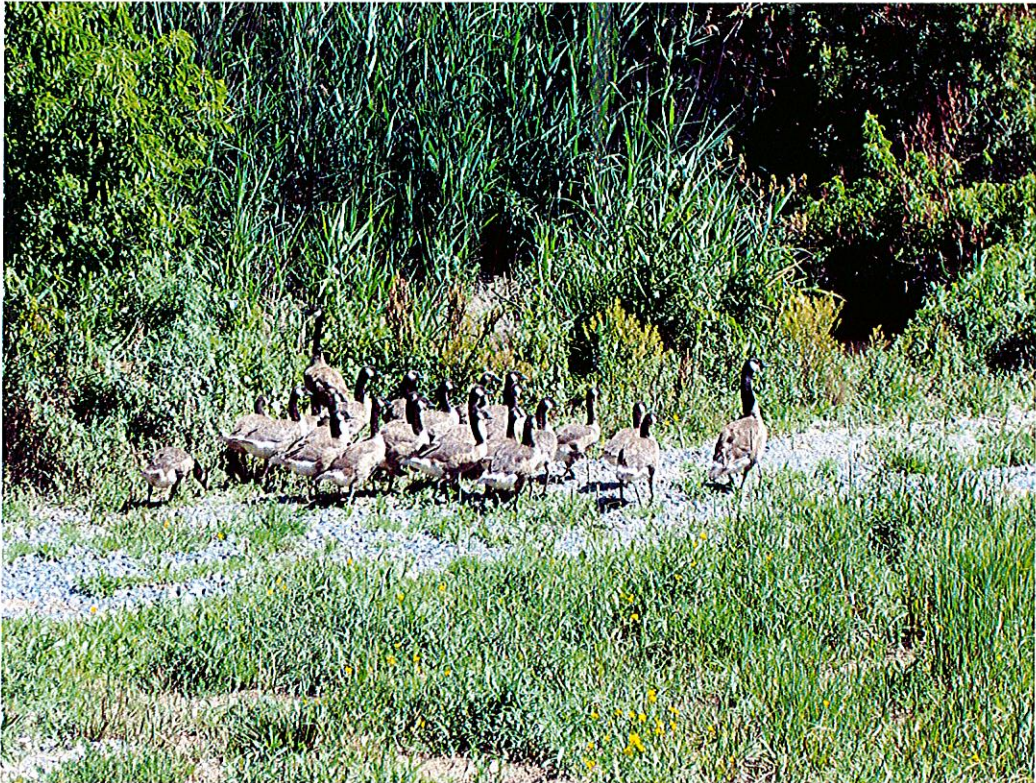
Photograph 9: View of Canada geese near CB-2 outlet.

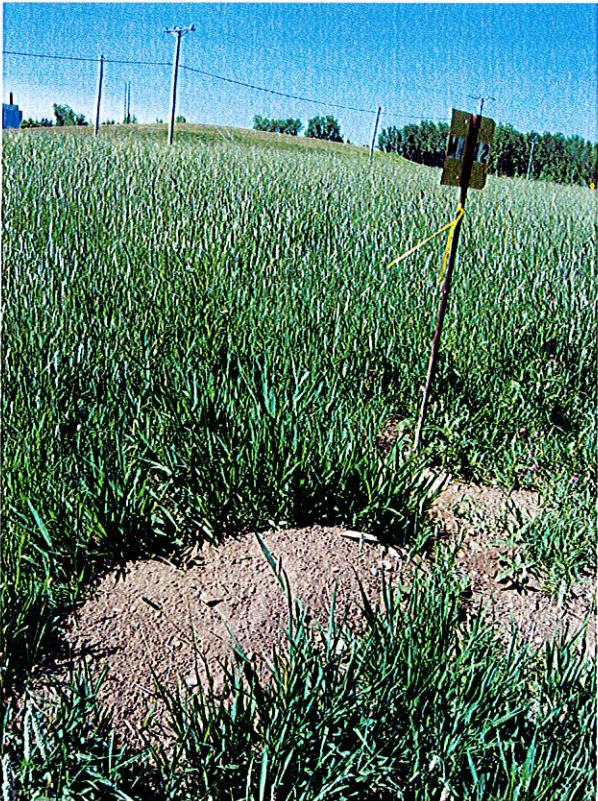
Photograph 10: View of burrowing animal hole near MW-12.

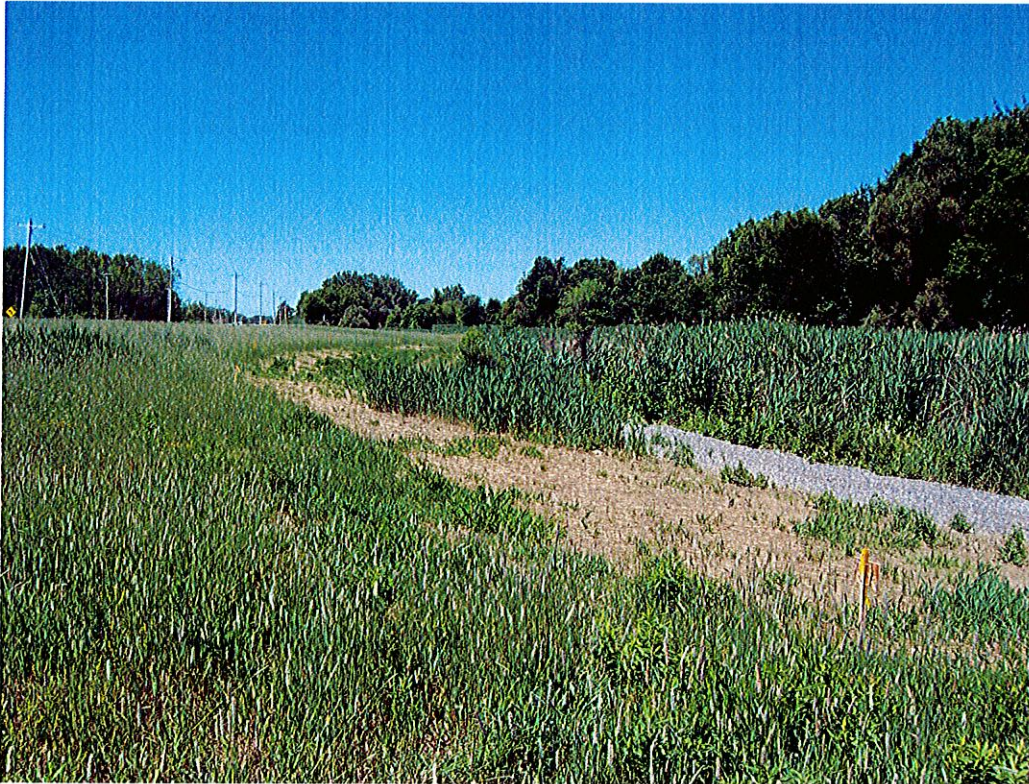
Also attached is a copy of the wetland vegetation mix that was placed by Royal Environmental, Inc. on May 25, 2007. The wetland area seeded is noted on Figures 1 and 2 and Photographs 11 and 12. This area will be inspected by O'Brien & Gere as part of the wetland inspection to be performed in Late Summer/Early Fall 2007.

Photograph 11: View looking west from eastern extent of re-seeded wetland area.

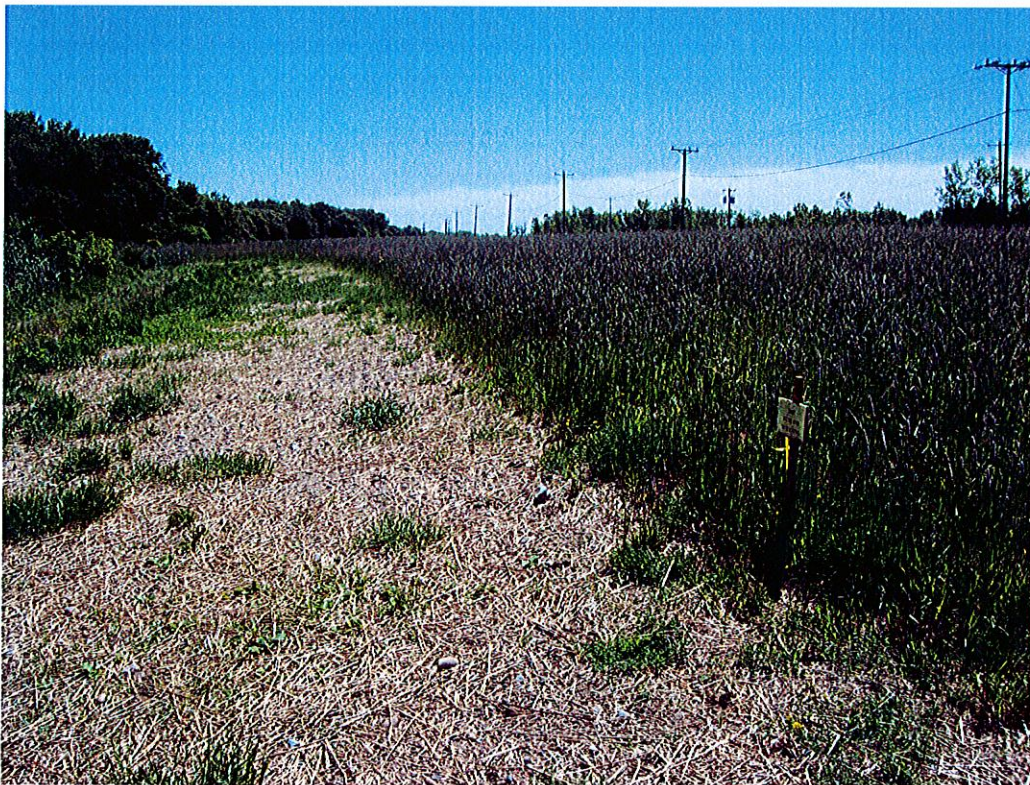
Photograph 12: View looking east from western extent of re-seeded wetland area.

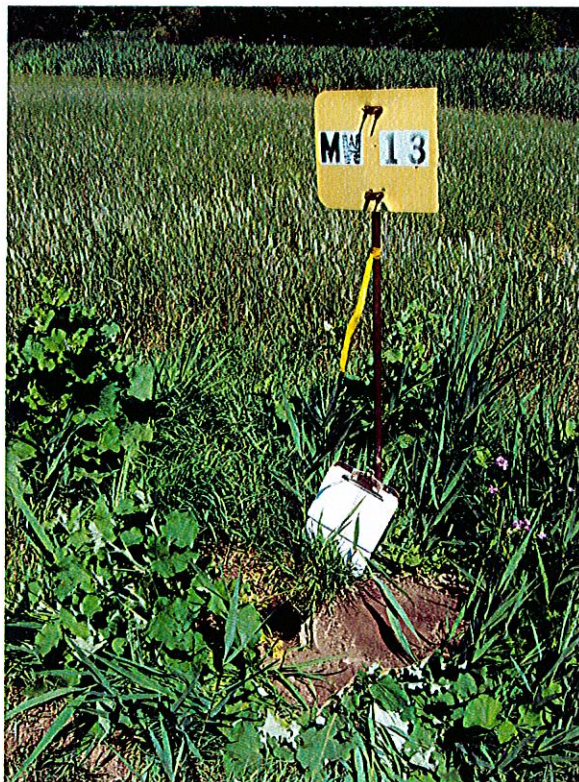
Photograph 14: View looking at burrowing animal hole at MW-13.

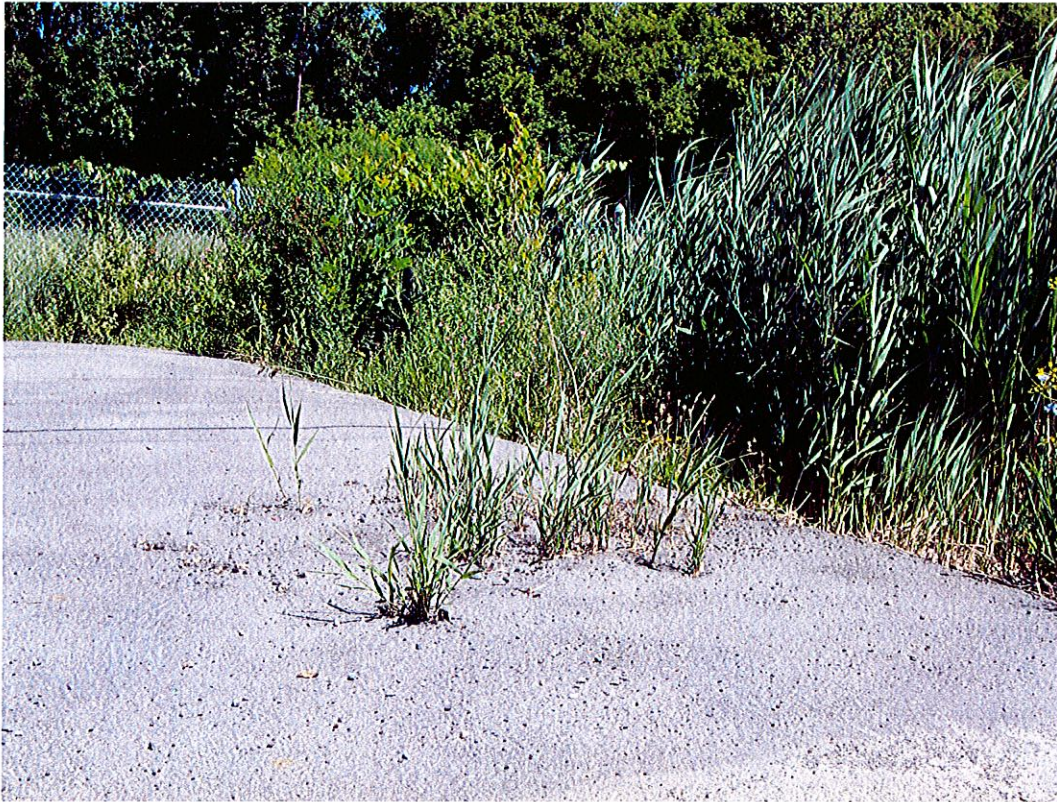
Photograph 15: View of phragmites in pavement access drive.
