July 13, 2011

Subject: *Quarterly Status Report – April 2011 – June 2011
Coldwater Road Landfill
1245 East Coldwater Road, Flint, MI
MID 005 356 860 / Consent Order No. 64-05-92*

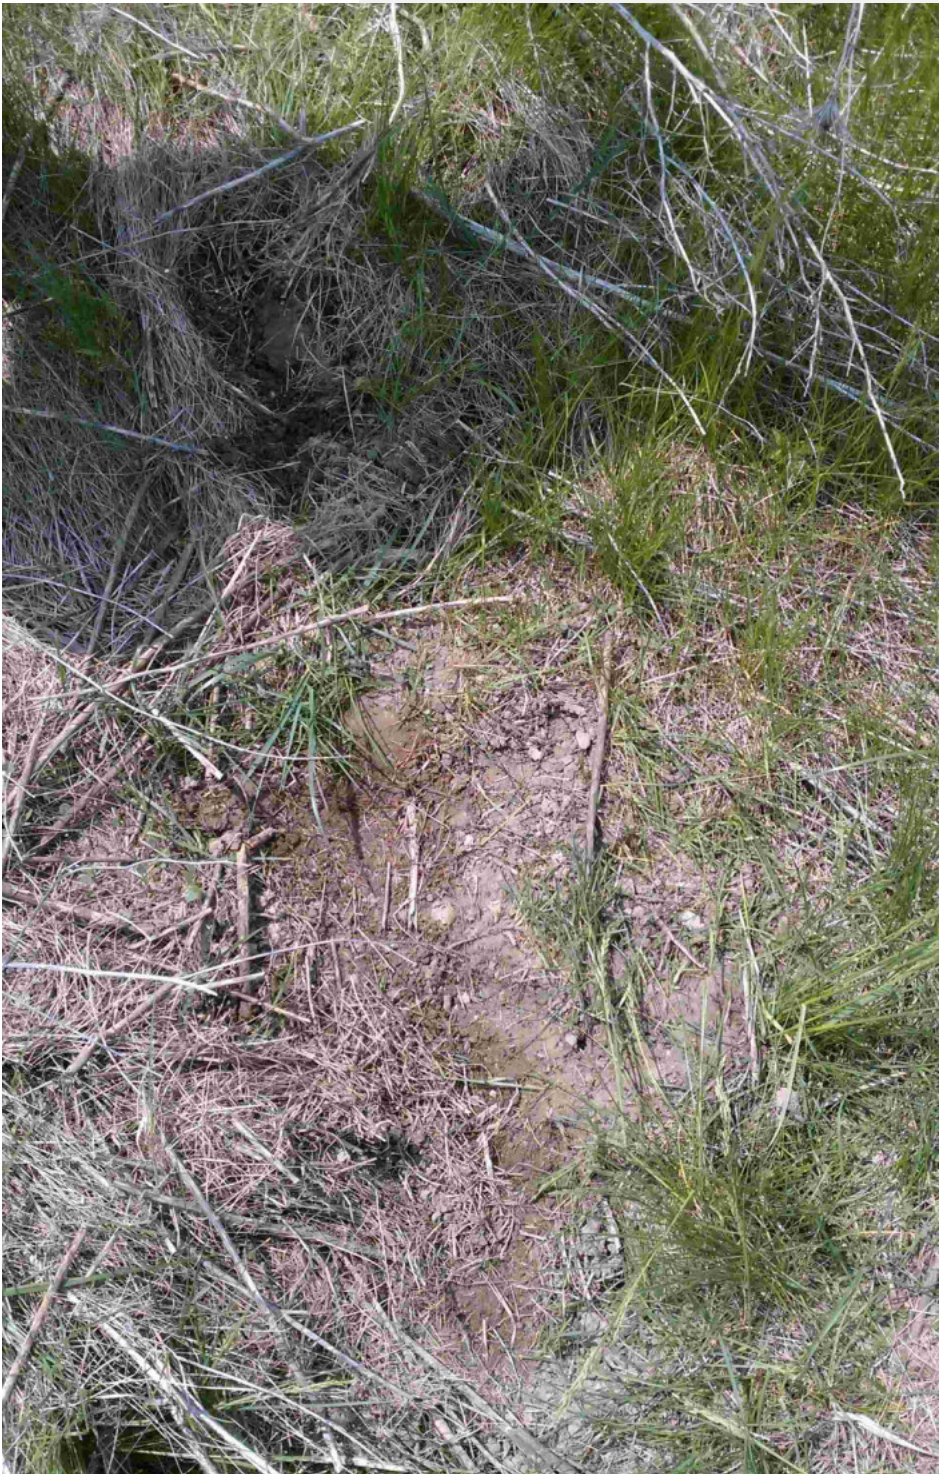
LOCATION: F3 - top of slope	APPROX. LENGTH: 1.5 feet	APPROX. DEPTH: 5 inches	APPROX. DIAMETER: 4 inches
---------------------------------------	------------------------------------	-----------------------------------	--------------------------------------

DATE FOUND: 3/31/11	DATE CLOSED: 5/13/11
-------------------------------	--------------------------------

NOTES:
 POST repair photo.
 Filled in burrows and spread grass seed over area.

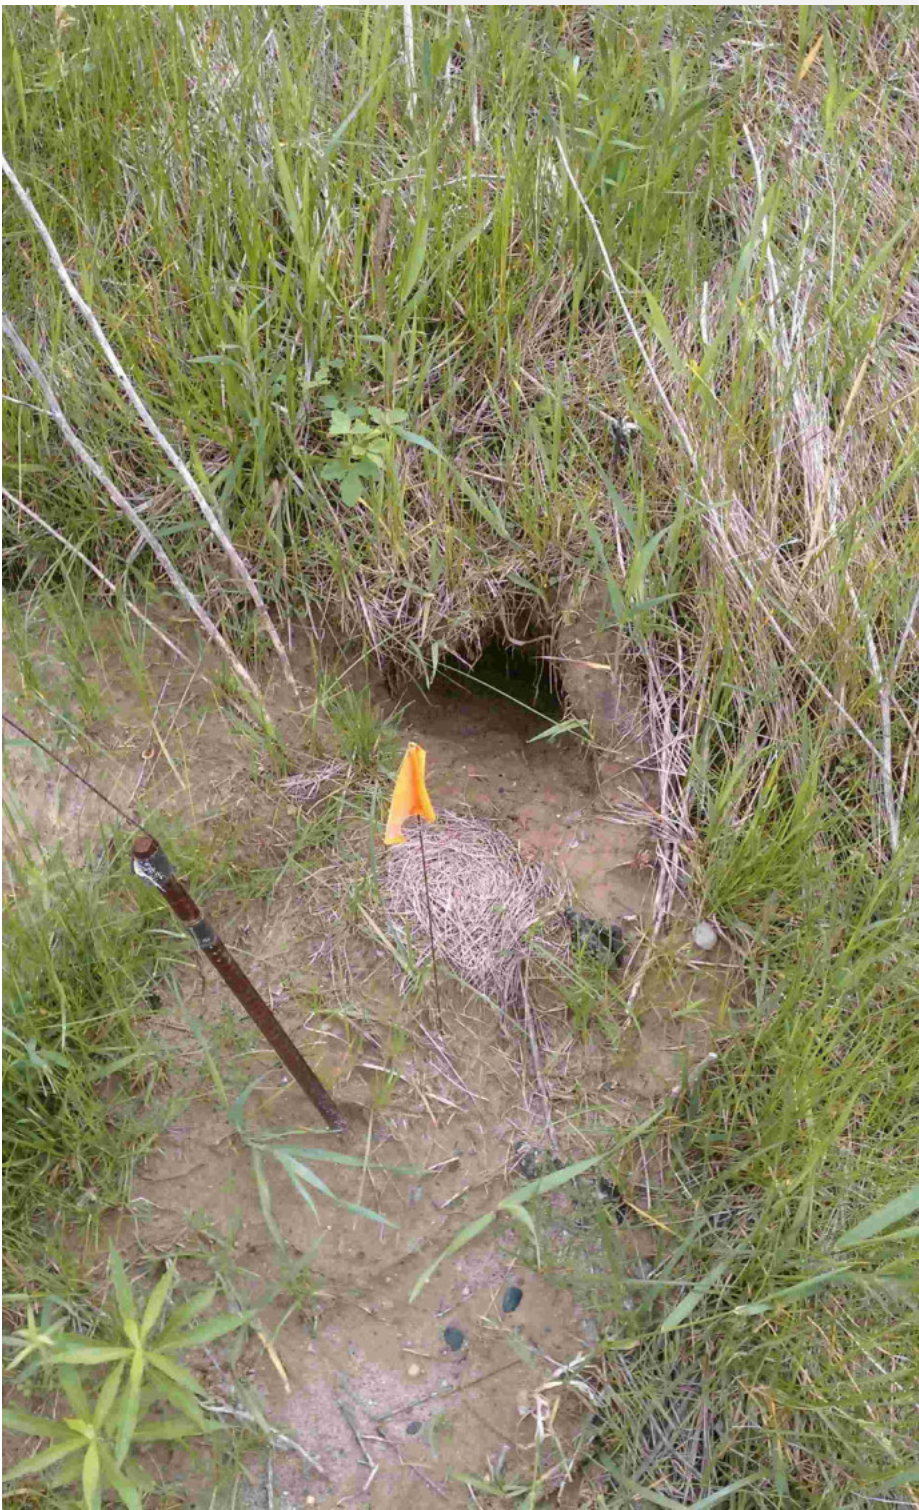
LOCATION: D1 – middle of slope	APPROX. LENGTH: 1 foot	APPROX. DEPTH: 3 inches	APPROX. DIAMETER: 5 inches
--	----------------------------------	-----------------------------------	--------------------------------------

DATE FOUND: 4 th 2010	DATE CLOSED: 5/19/11
--	--------------------------------

PRE repair photo.

Located during the 4th quarter 2010.

Burrow appeared inactive.

No trap set.

No signs of liner damage.

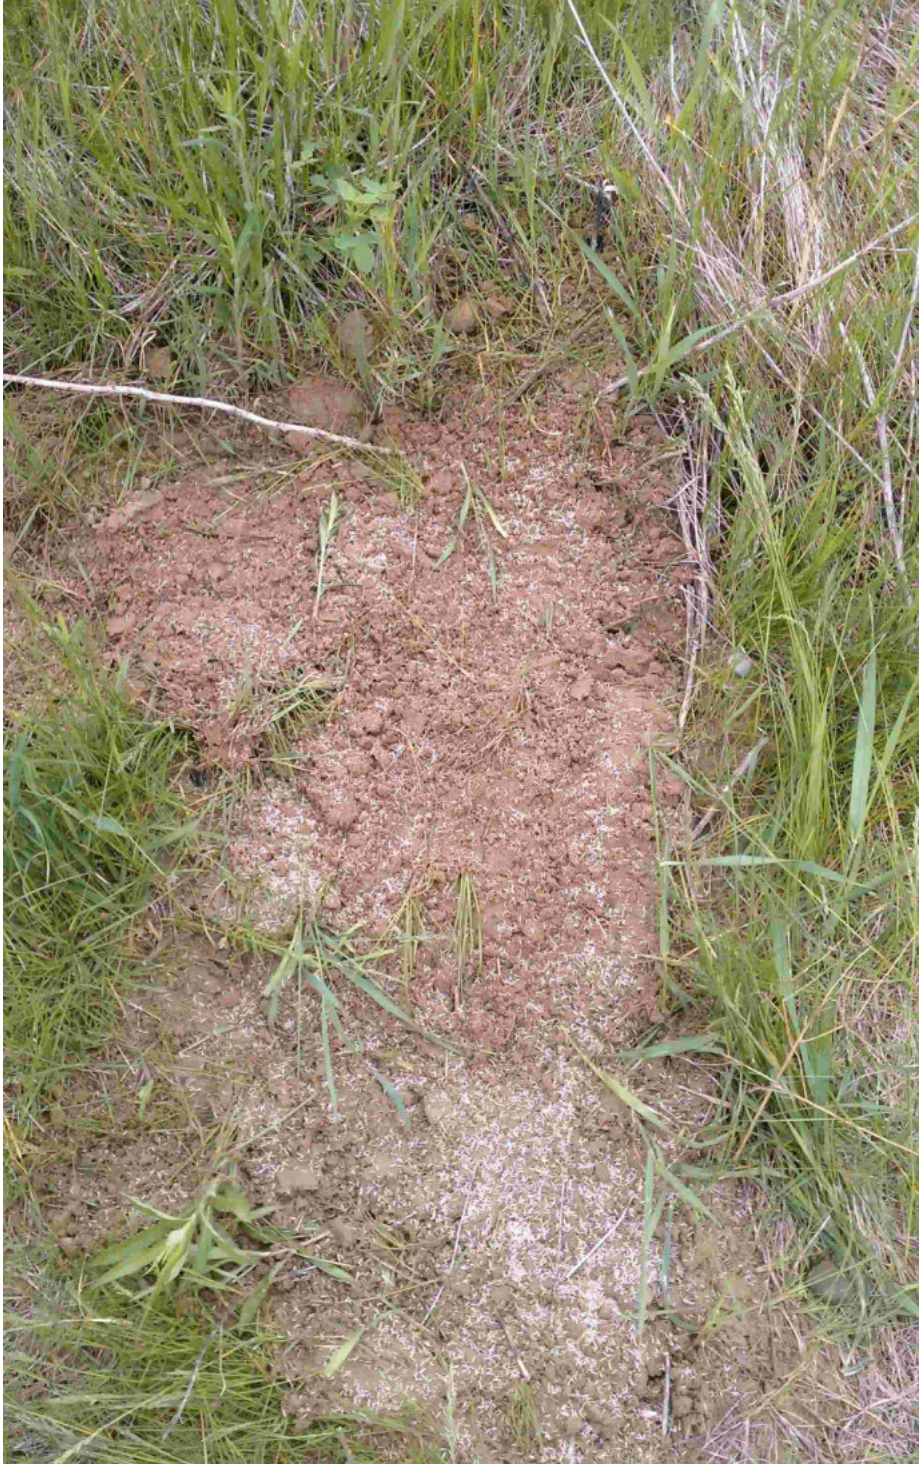
LOCATION: D1 – middle of slope	APPROX. LENGTH: 1 foot	APPROX. DEPTH: 3 inches	APPROX. DIAMETER: 5 inches
--	----------------------------------	-----------------------------------	--------------------------------------

DATE FOUND: 4 th 2010	DATE CLOSED: 5/19/11
--	--------------------------------

NOTES:
POST repair photo.
Filled in burrow and spread grass seed over area.

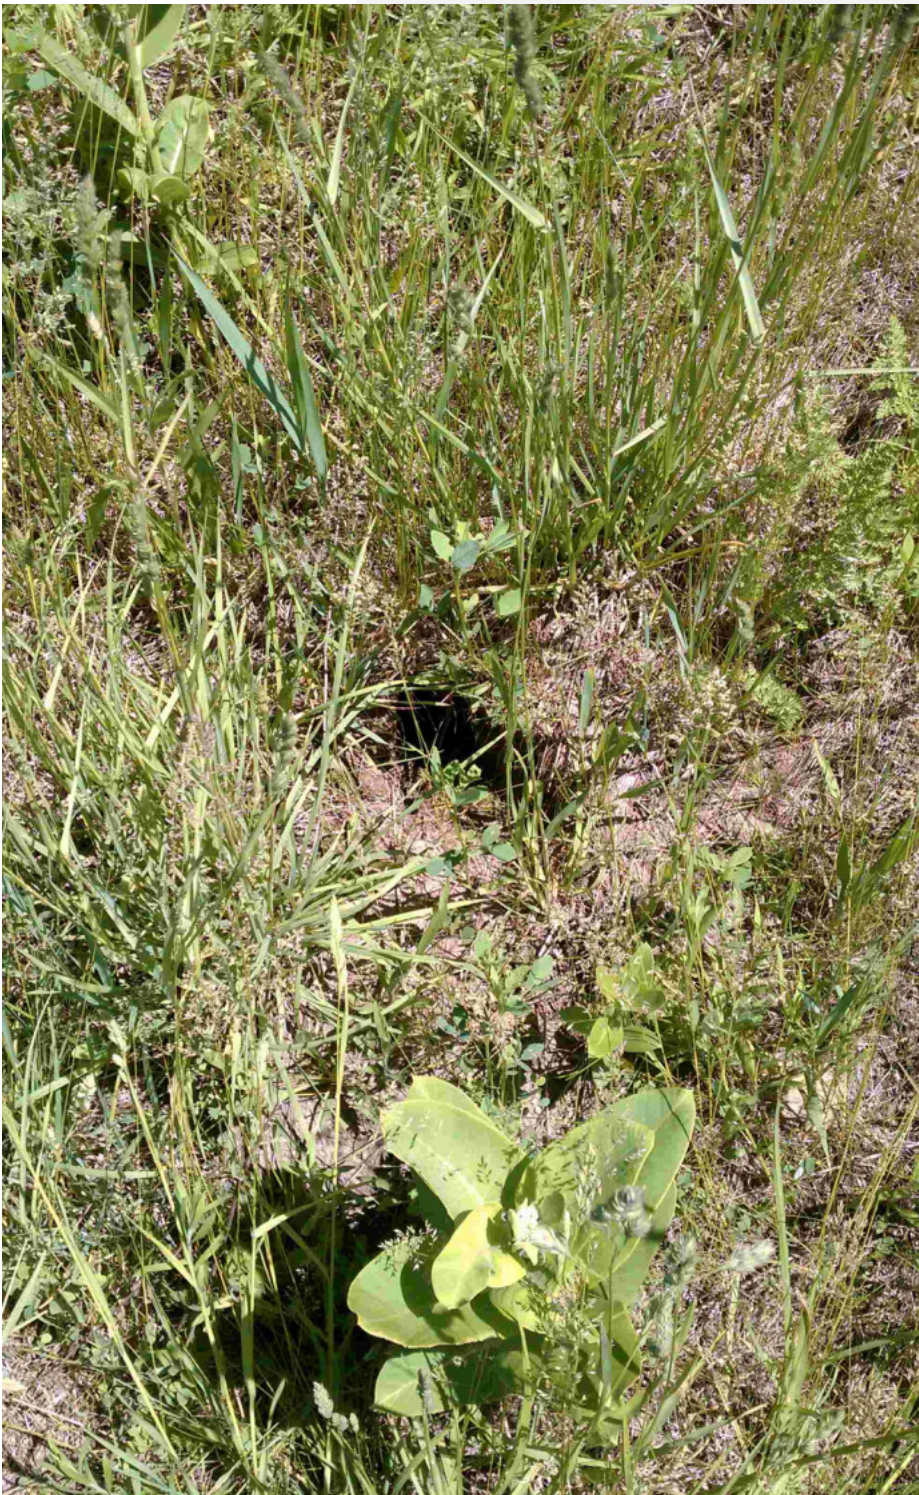
LOCATION: C1 – middle of slope		APPROX. LENGTH: 1.5 feet	APPROX. DEPTH: 6 inches	APPROX. DIAMETER: 3 inches
DATE FOUND: 6/1/11	DATE CLOSED: 6/1/11

NOTES: PRE repair EXIT photo. Entry and exit. Burrow appeared inactive. No trap set. No signs of liner damage.

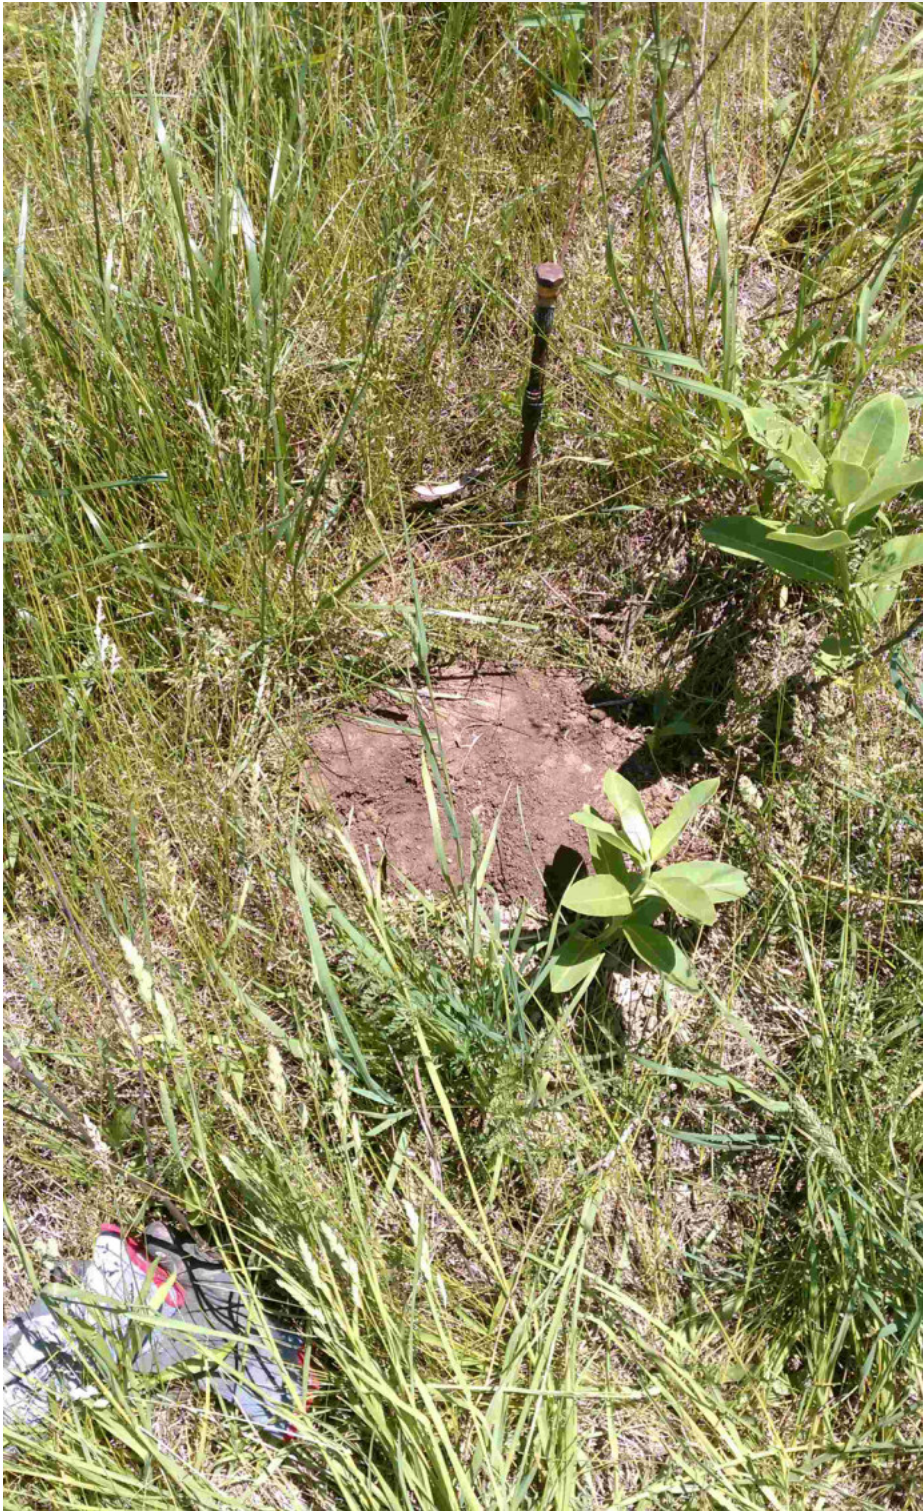
LOCATION: C1 – middle of slope	APPROX. LENGTH: 1.5 feet	APPROX. DEPTH: 6 inches	APPROX. DIAMETER: 3 inches
--	------------------------------------	-----------------------------------	--------------------------------------

DATE FOUND: 6/1/11	DATE CLOSED: 6/1/11
------------------------------	-------------------------------

POST repair ENTRY photo.

Two small burrows (1 inch length and 1 inch deep) located adjacent to the burrows and filled in as well.

Filled in burrow and spread grass seed over area.

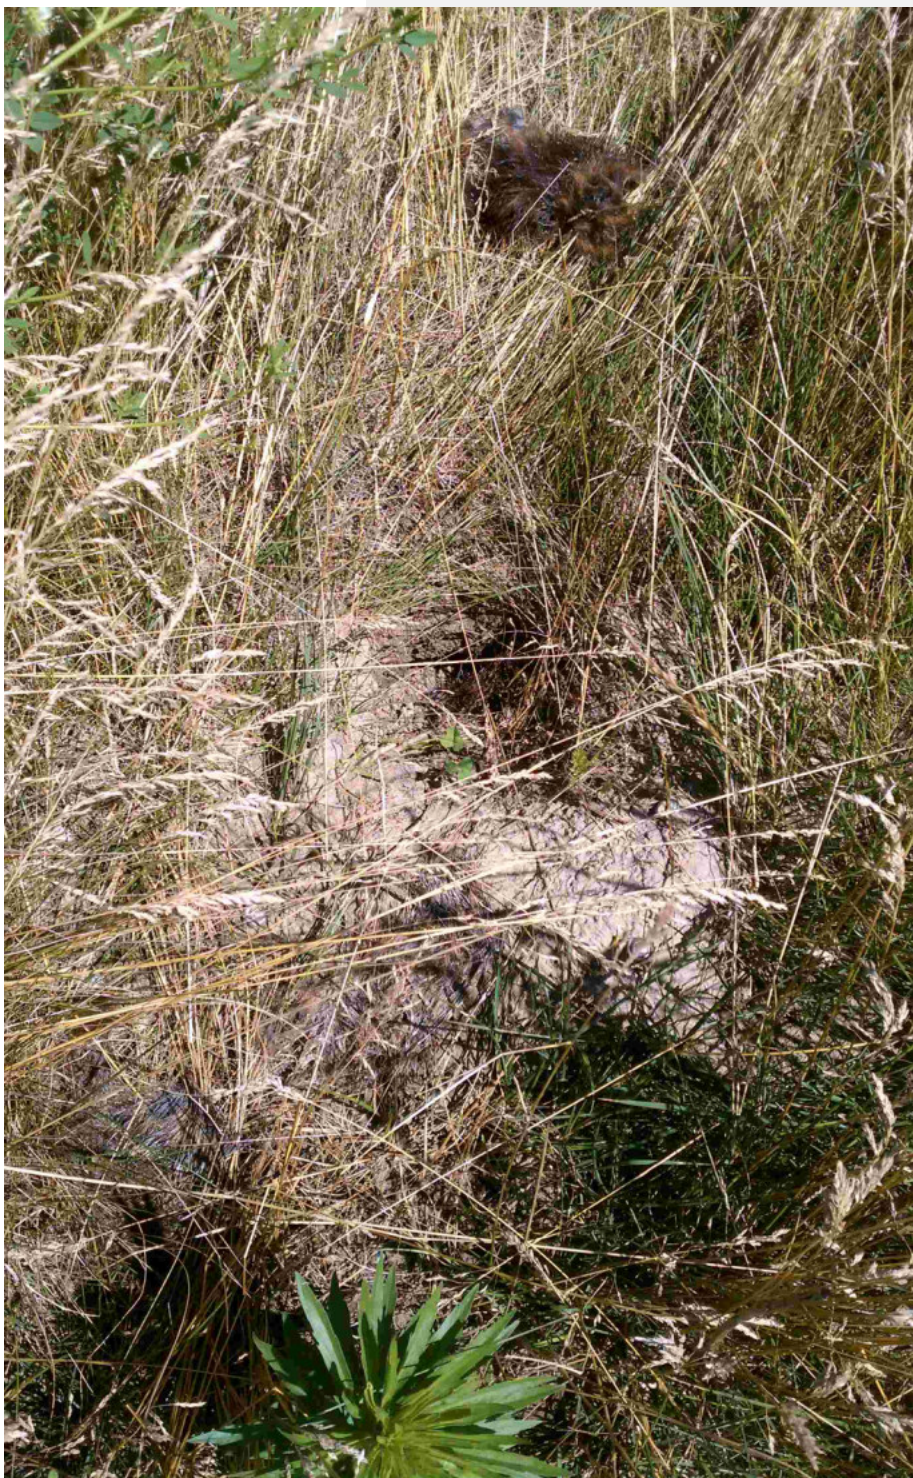
LOCATION: F4 – middle of slope	APPROX. LENGTH: 2 feet	APPROX. DEPTH: 6 inches	APPROX. DIAMETER: 5 inches
--	----------------------------------	-----------------------------------	--------------------------------------

DATE FOUND: 6/17/11	DATE CLOSED: 6/30/11
-------------------------------	--------------------------------

PRE repair photo.

Located and filled in during the 4th quarter 2010.

On 6/17/11 a new burrow was located at same area and appeared active.

No signs of liner damage.

Set trap at burrow.
