SUBJECT: Cap Inspection Report; RACER Coldwater Road Landfill; Flint, Michigan;
MID 005 356 860; Waste Data System Number 393431

Cap Inspection Report

**RACER Coldwater Road Landfill
6220 Horton Street
Flint, Michigan
MID 005 356 860**

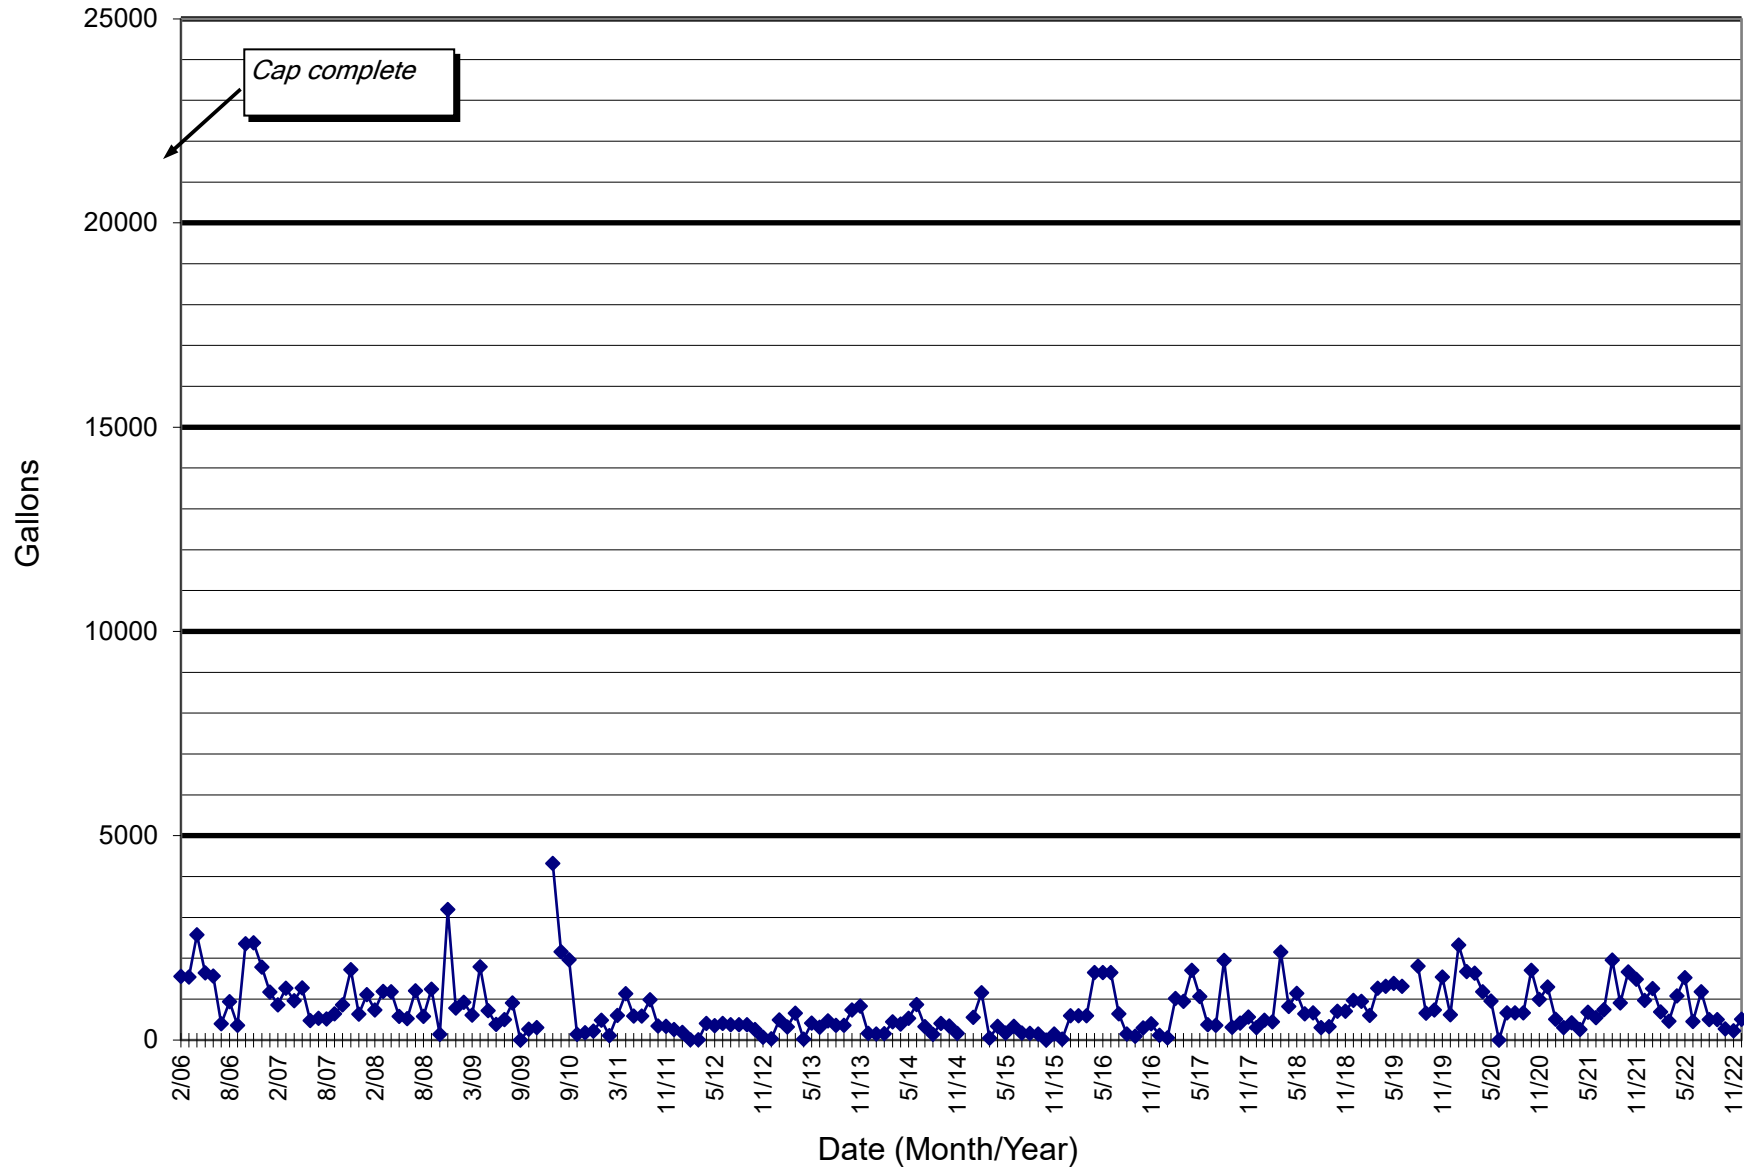
**FIGURE 1 - RACER LANDFILL, COLDWATER ROAD
LEACHATE REMOVED**

As can be seen in **Figure 1**, the volume of leachate pumped from the LCS has generally remained under 2,000 gallons monthly for the past twenty years (with the exception of several anomalous spikes). These data are as would be expected, and generally support satisfactory performance of the cap. It should be noted that, from the time period from

mid-2004 to mid-2005, accurate leachate generation volumes were unknown due to problems with the flow meter used to record the volume of leachate and leak detection liquid pumped to the accumulation tank. This problem was resolved in mid-2005. Since that time, recorded leachate volumes have increased slightly as compared to data from 2000 to 2004; however, it is unknown how much of this minor increase is due to a more accurate flow meter. Leachate flow volume monitoring will continue as required by the approved Postclosure Plan.

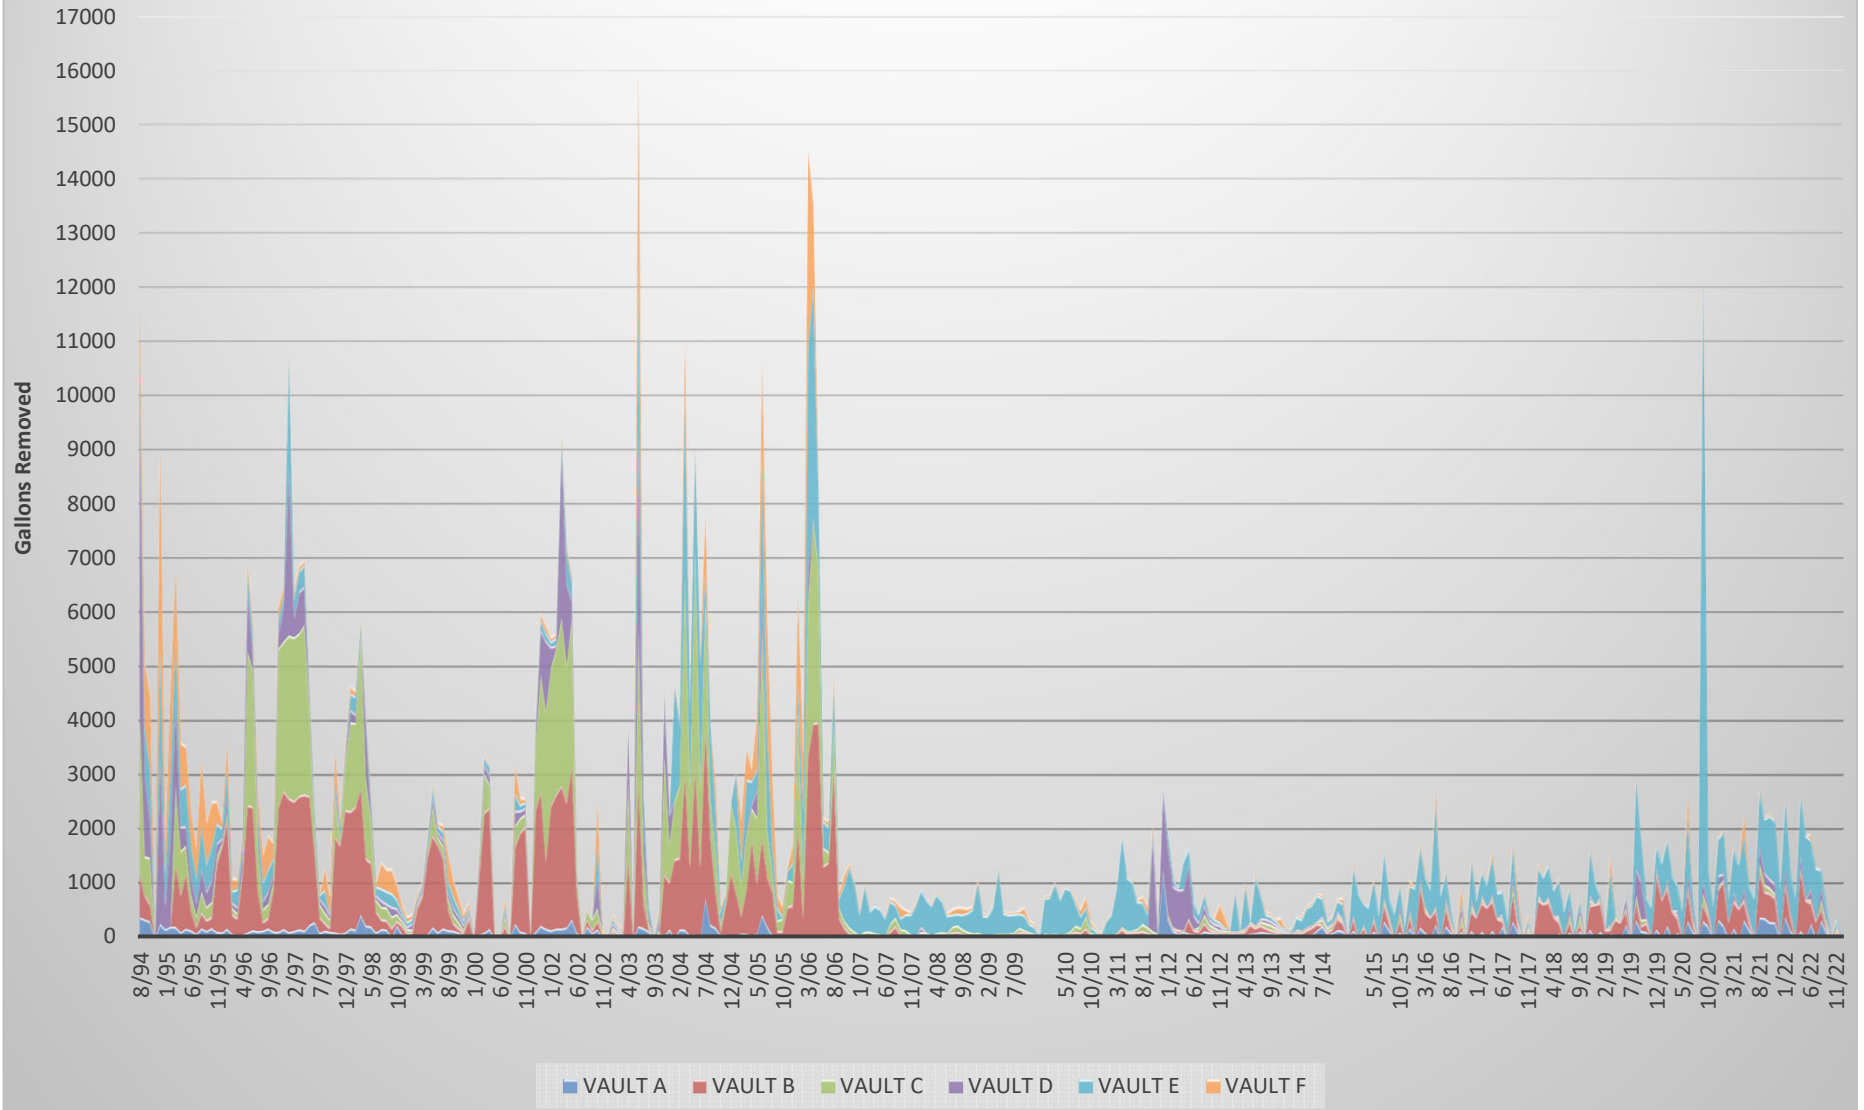
FIGURE 2 - RACER Coldwater Road Landfill Leak Detection System Water Removal

Due to the historical continual presence of excessive water in the LDS sumps, in August 2003 the MMD requested that the facility investigate the source of the water infiltrating into the LDS. From 2003 to 2006, the facility conducted several investigations and implemented several repairs that substantially reduced the volume of water infiltrating and being recovered from the LDS. This improvement can be seen graphically in **Figure 2**. This is especially pronounced for Vaults B and C where monthly recovered volumes have been reduced from thousands of gallons to under one hundred gallons.

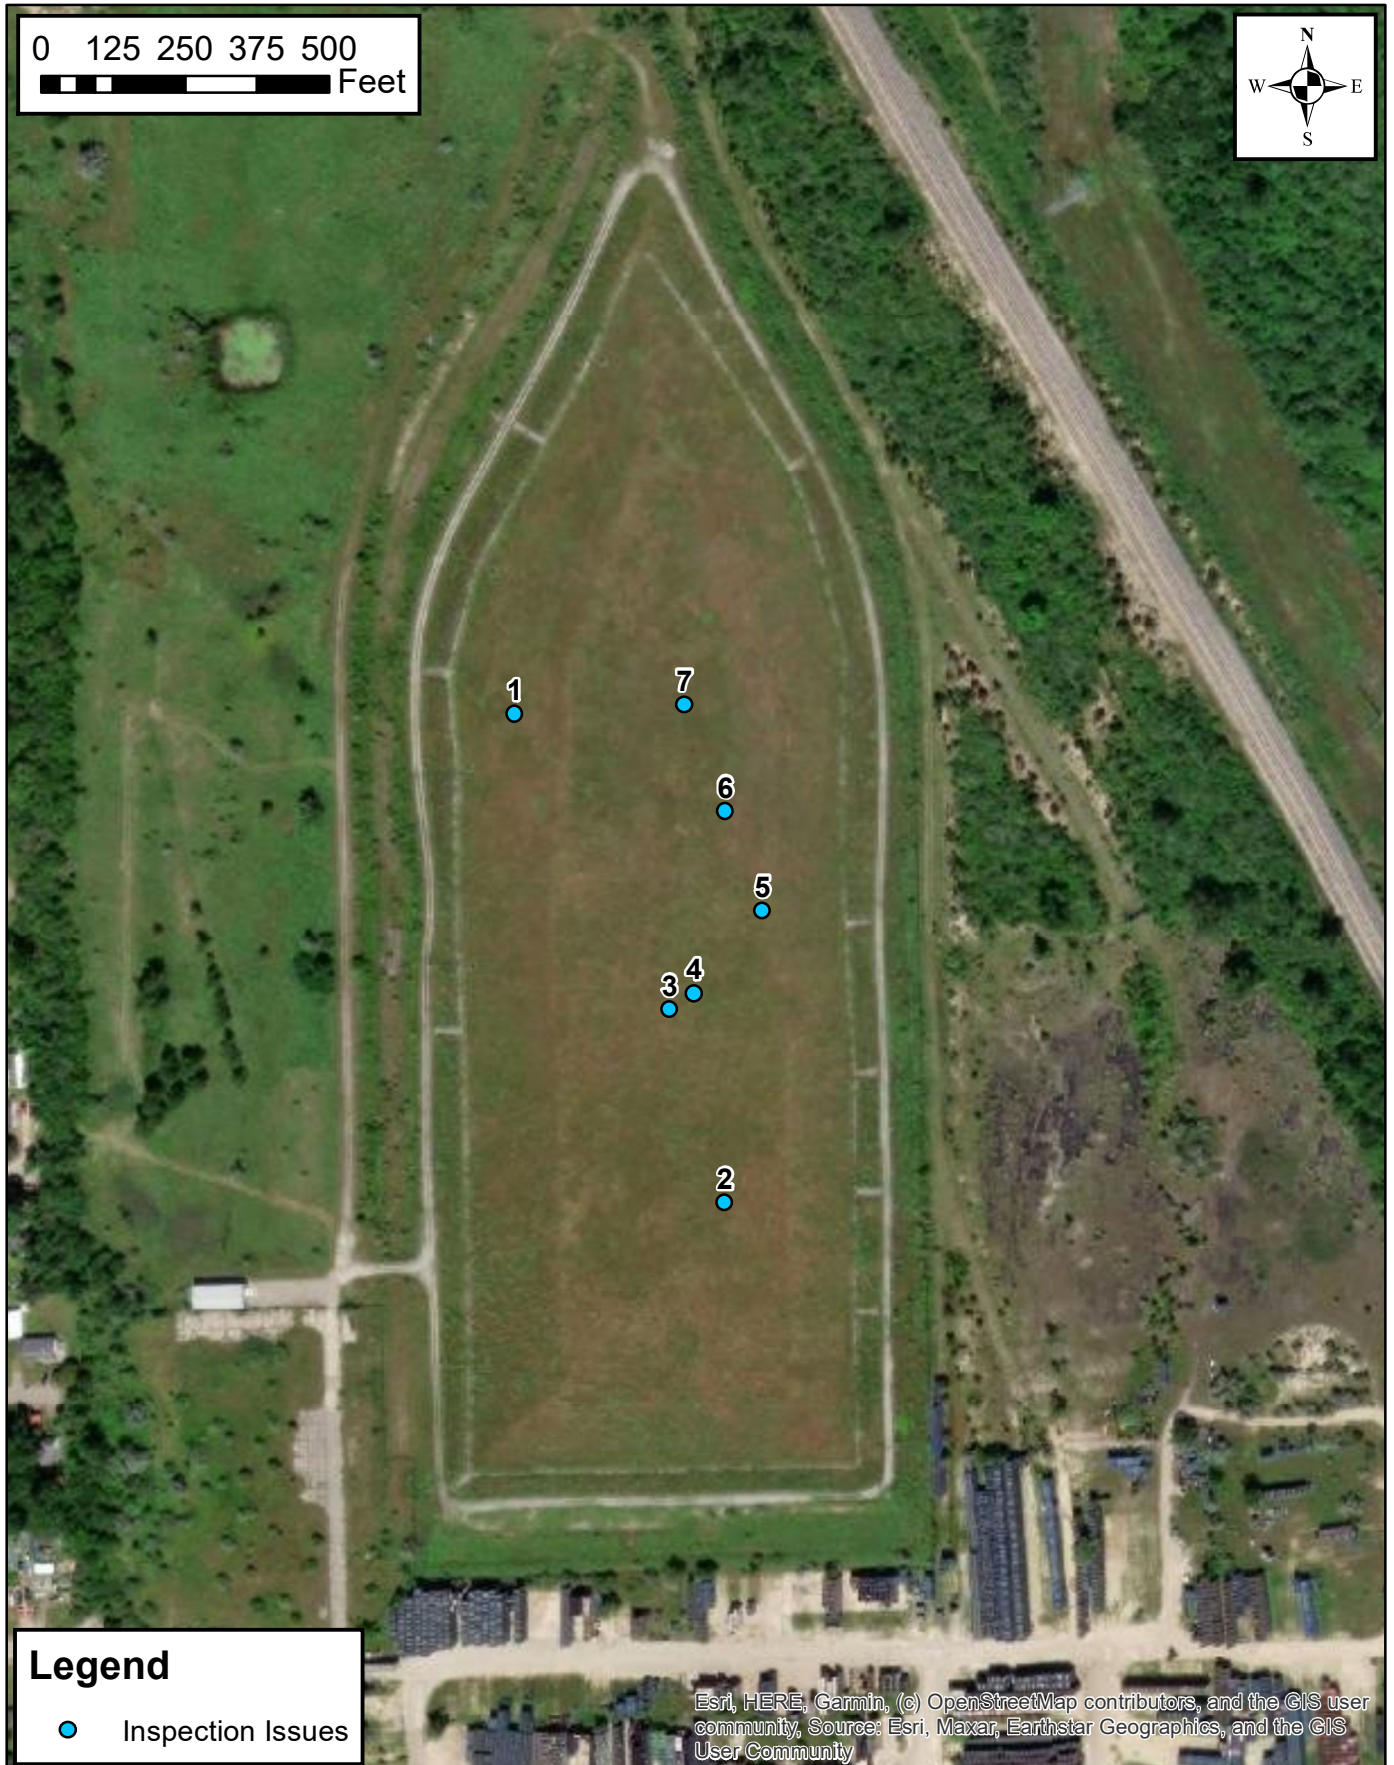
Coldwater Road Landfill 2023 Cap Inspection

1. **Overgrown Vegetation:** Vegetation on the entire cap was extremely overgrown making it difficult to assess cap integrity.
2. **Small Woody Plants:** Several small woody plants were noted at various locations across the cap. The exact location of the area is noted on **Attachment 1**, and is documented in a photograph provided in **Attachment 2**.

1. **Overgrown Cap Vegetation:** Cap vegetation must be regularly maintained at a height that will provide sufficient protection, but will not hinder inspections of the cap.
2. **Small Woody Plants:** The various small woody plants indicated in **Attachment 1** must be removed from the cap. Photo-documentation of the repaired area must be provided within 30 days of receipt of this report.

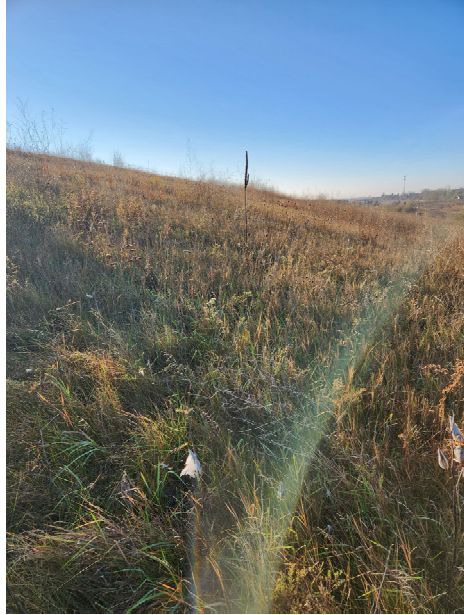
1

Inspection Issue 1: Small Woody Plants

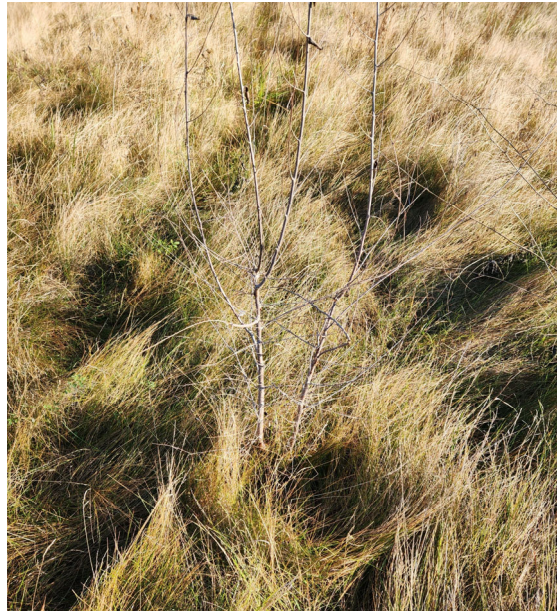
2

Inspection Issue 2: Small Woody Plant

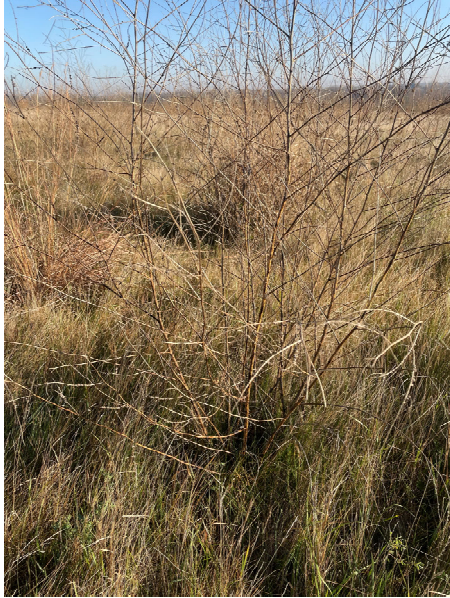
3

Inspection Issue 3: Small Woody Plants

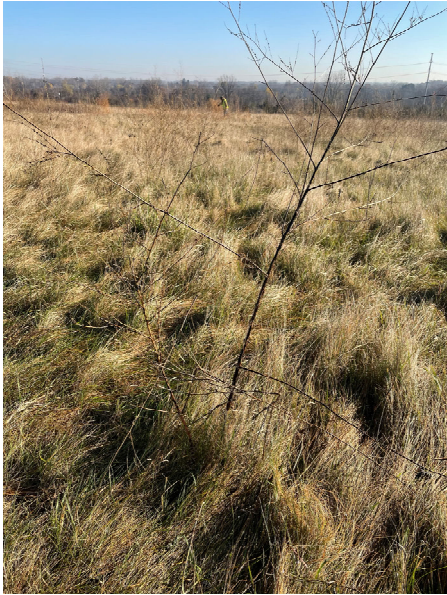
4

Inspection Issue 4: Small Woody Plants

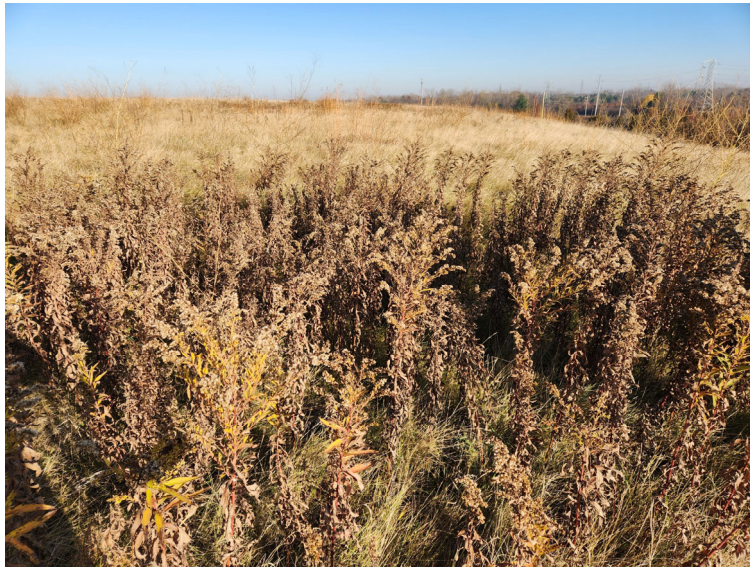
5

Inspection Issue 5: Overgrown Vegetation, Possible Woody Plants

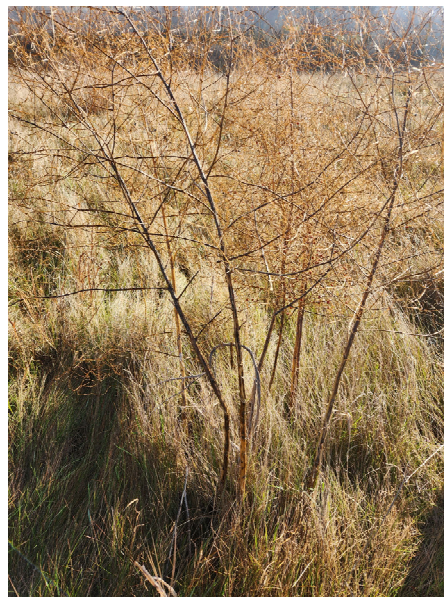
6

Inspection Issue 6: Small Woody Plants

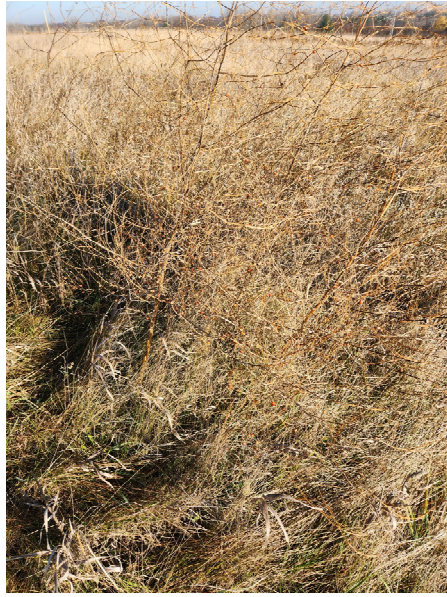
Inspection Issue 7: Small Woody Plant
