RE: *Quarterly Status Report –July 2013 – September 2013*
Coldwater Road Landfill
1245 East Coldwater Road, Flint, MI
MID 005 356 860
FILE: 15388/50137/Docs

COLDWATER RD LANDFILL – ANIMAL BURROW PHOTO LOG

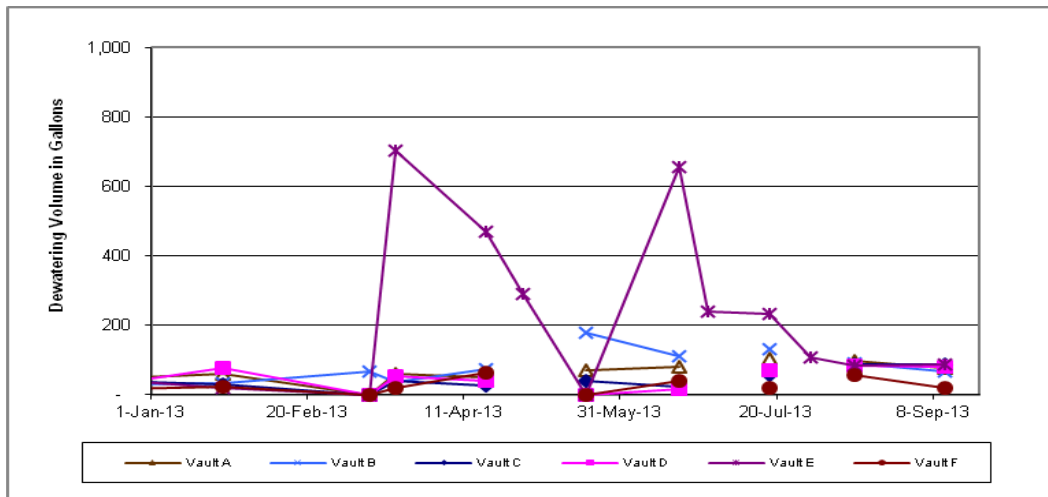
The following graph presents the vault dewatering data in graphical format for the past year:

Vault E exceeded 200 gallons during the July dewatering and was dewatered a second time during that month to help keep the vault dewatered.

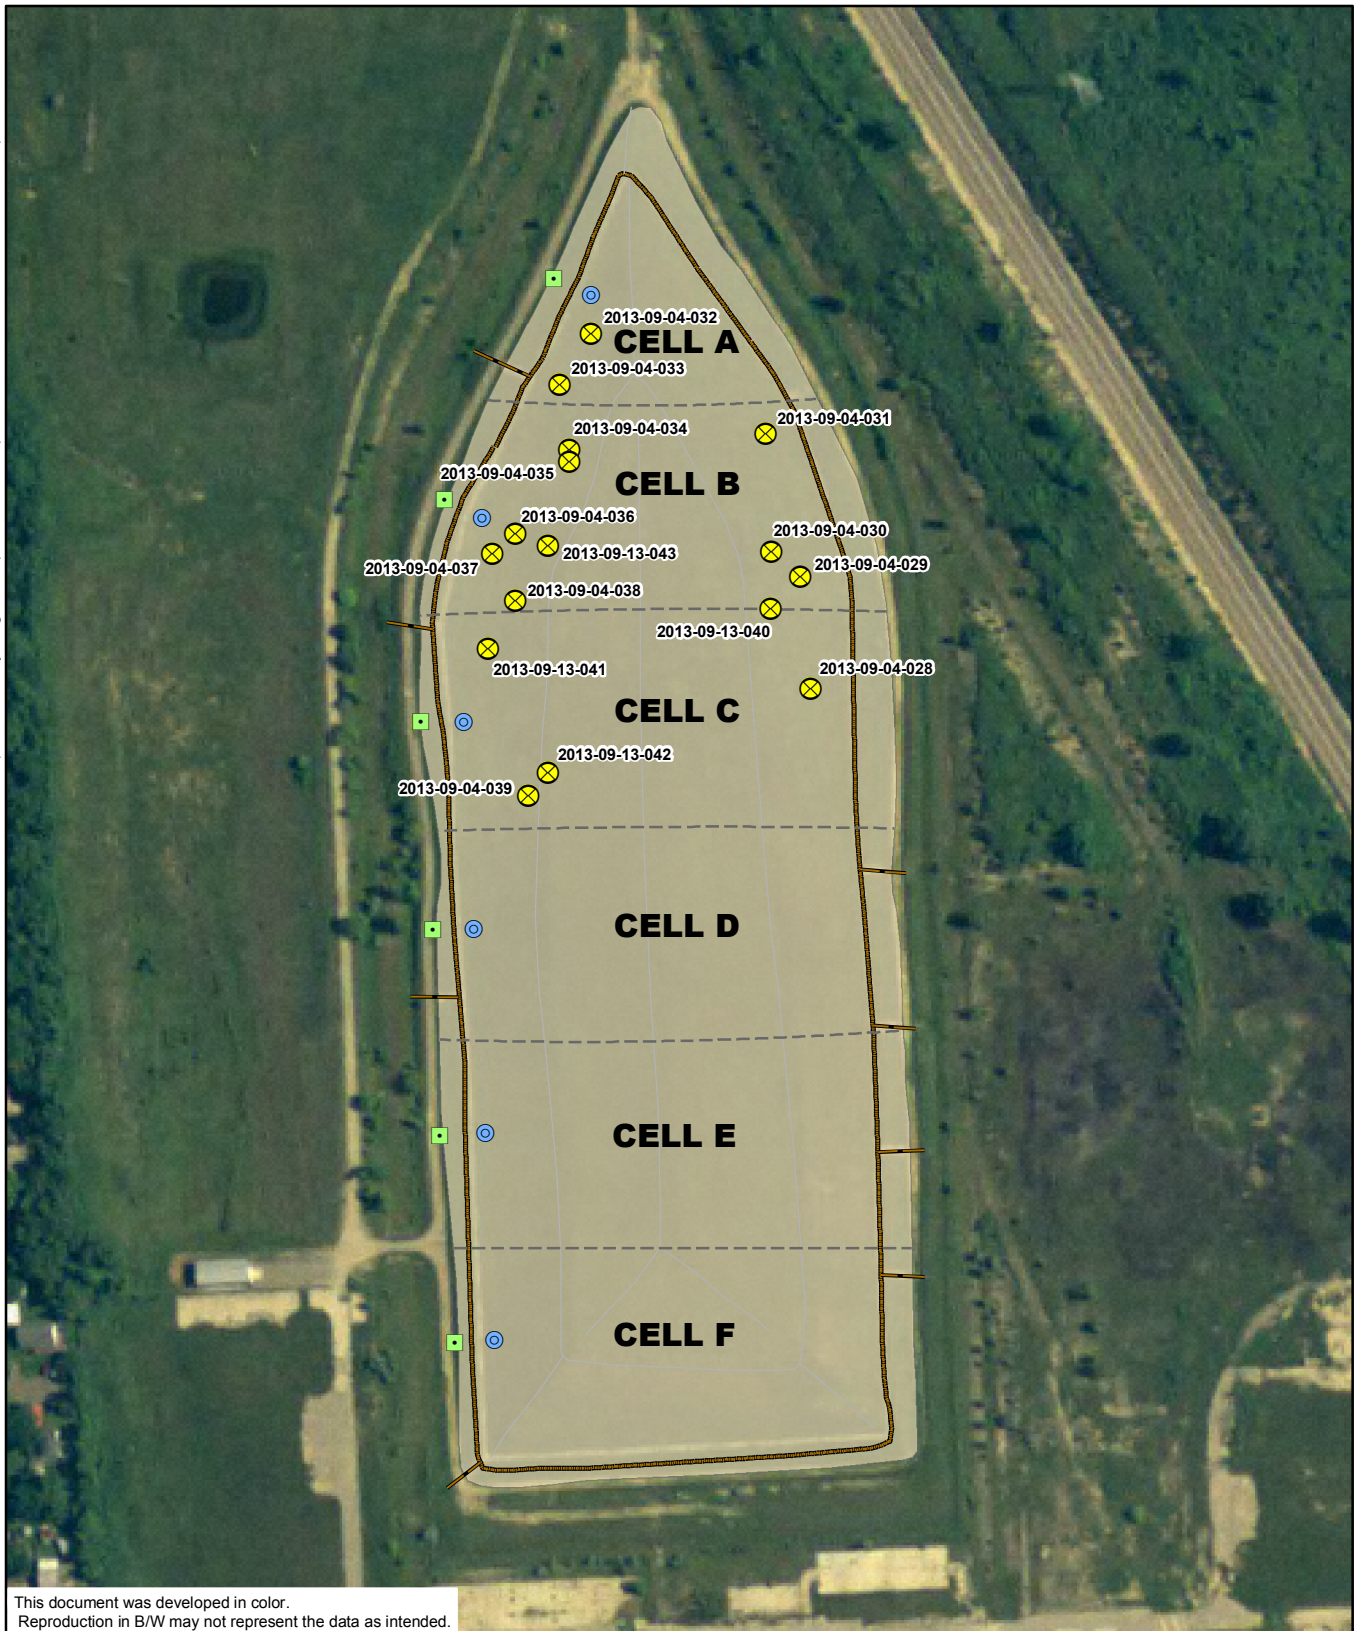
**3RD QUARTER 2013
 BURROW LOCATION
 MAP**

- » The perimeter fence was repaired at three locations along the western side of the site on August 6, 2013.
- » Observed 15 potentially active animal burrows on September 4, 2013 and September 13, 2013 and set traps. See attached figure for animal burrow locations and photo log for detailed information concerning animal burrow activities for this quarter.

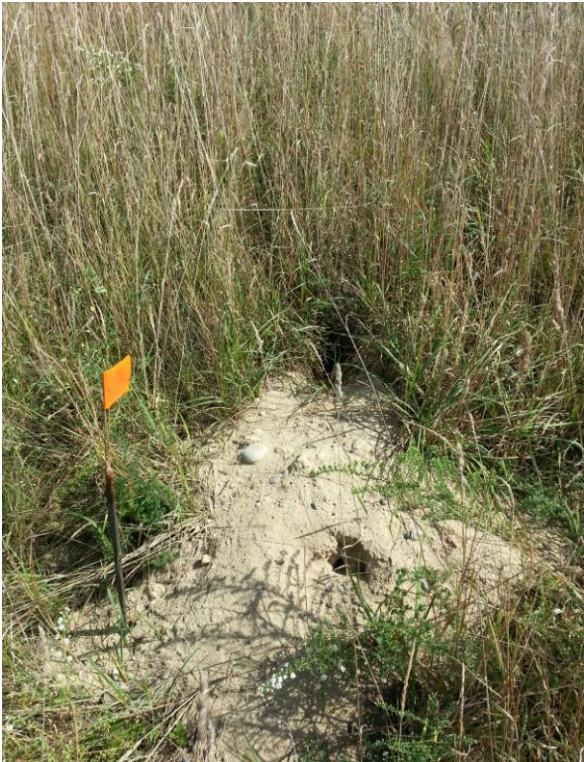
LOCATION: A1 – Middle of Slope		APPROX. LENGTH: 5+ ft	APPROX. DEPTH: 6 inch	APPROX. DIAMETER: 5 inch
DATE FOUND: 9/4/13	DATE CLOSED: 9/17/13

NOTES: ID: 2013-09-04-032 PRE repair photo. Trap set up for a week. No activity. No signs of liner damage.				
LOCATION: A1 – Middle of Slope		APPROX. LENGTH: 5+ ft	APPROX. DEPTH: 6 inch	APPROX. DIAMETER: 5 inch
DATE FOUND: 9/4/13	DATE CLOSED: 9/17/13

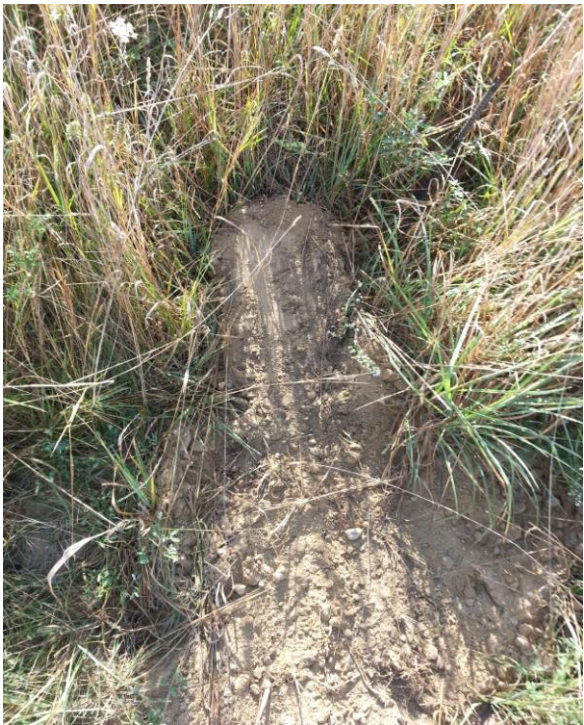
NOTES: POST repair photo. Filled in burrow.

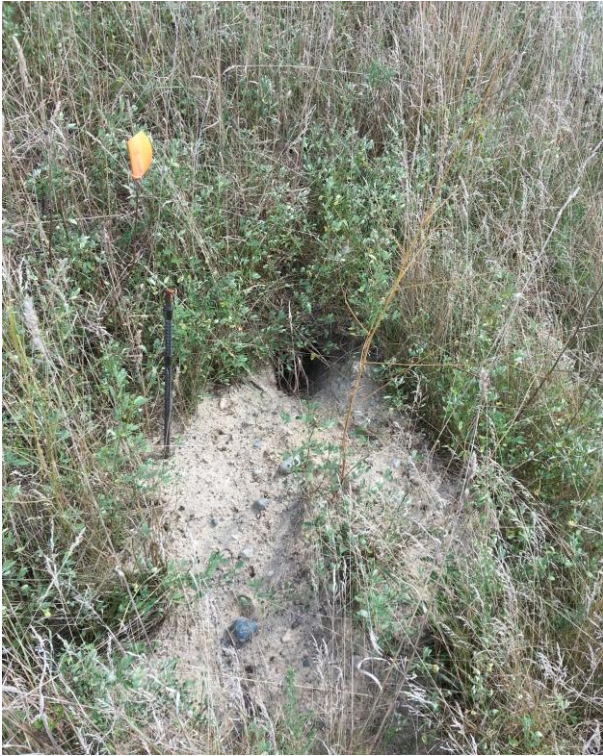
LOCATION: B1 – Middle of Slope		APPROX. LENGTH: 5 + ft	APPROX. DEPTH: 1 ft	APPROX. DIAMETER: 7 inch
DATE FOUND: 9/4/13	DATE CLOSED: 9/19/13

NOTES: ID: 2013-09-04-037 PRE repair photo. Trap set up for a week. No activity. Possibly connected with 2013-09-04-036. No signs of liner damage.				
LOCATION: B1 – Middle of Slope		APPROX. LENGTH: 5 + ft	APPROX. DEPTH: 1 ft	APPROX. DIAMETER: 7 inch
DATE FOUND: 9/4/13	DATE CLOSED: 9/19/13

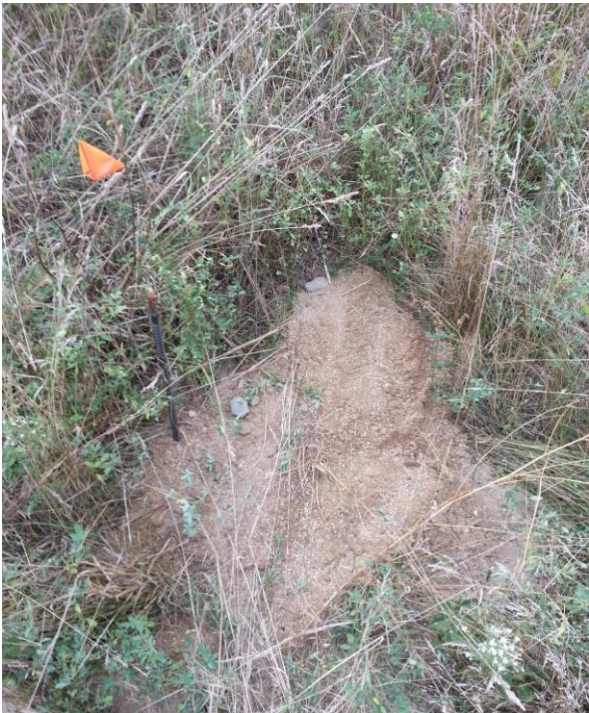
NOTES: POST repair photo. Filled in burrow.
