RE: Windiate Park/Dixieland Subdivision Landfill, Pengelly Road Site, Genesee County, Michigan  
(Site ID No. 25000689)

FILE: 15388/75088 - Soil Cover Inspection Report

## WINDIATE PARK SOIL COVER MAINTENANCE CHECKLIST

# INSPECTION MAP

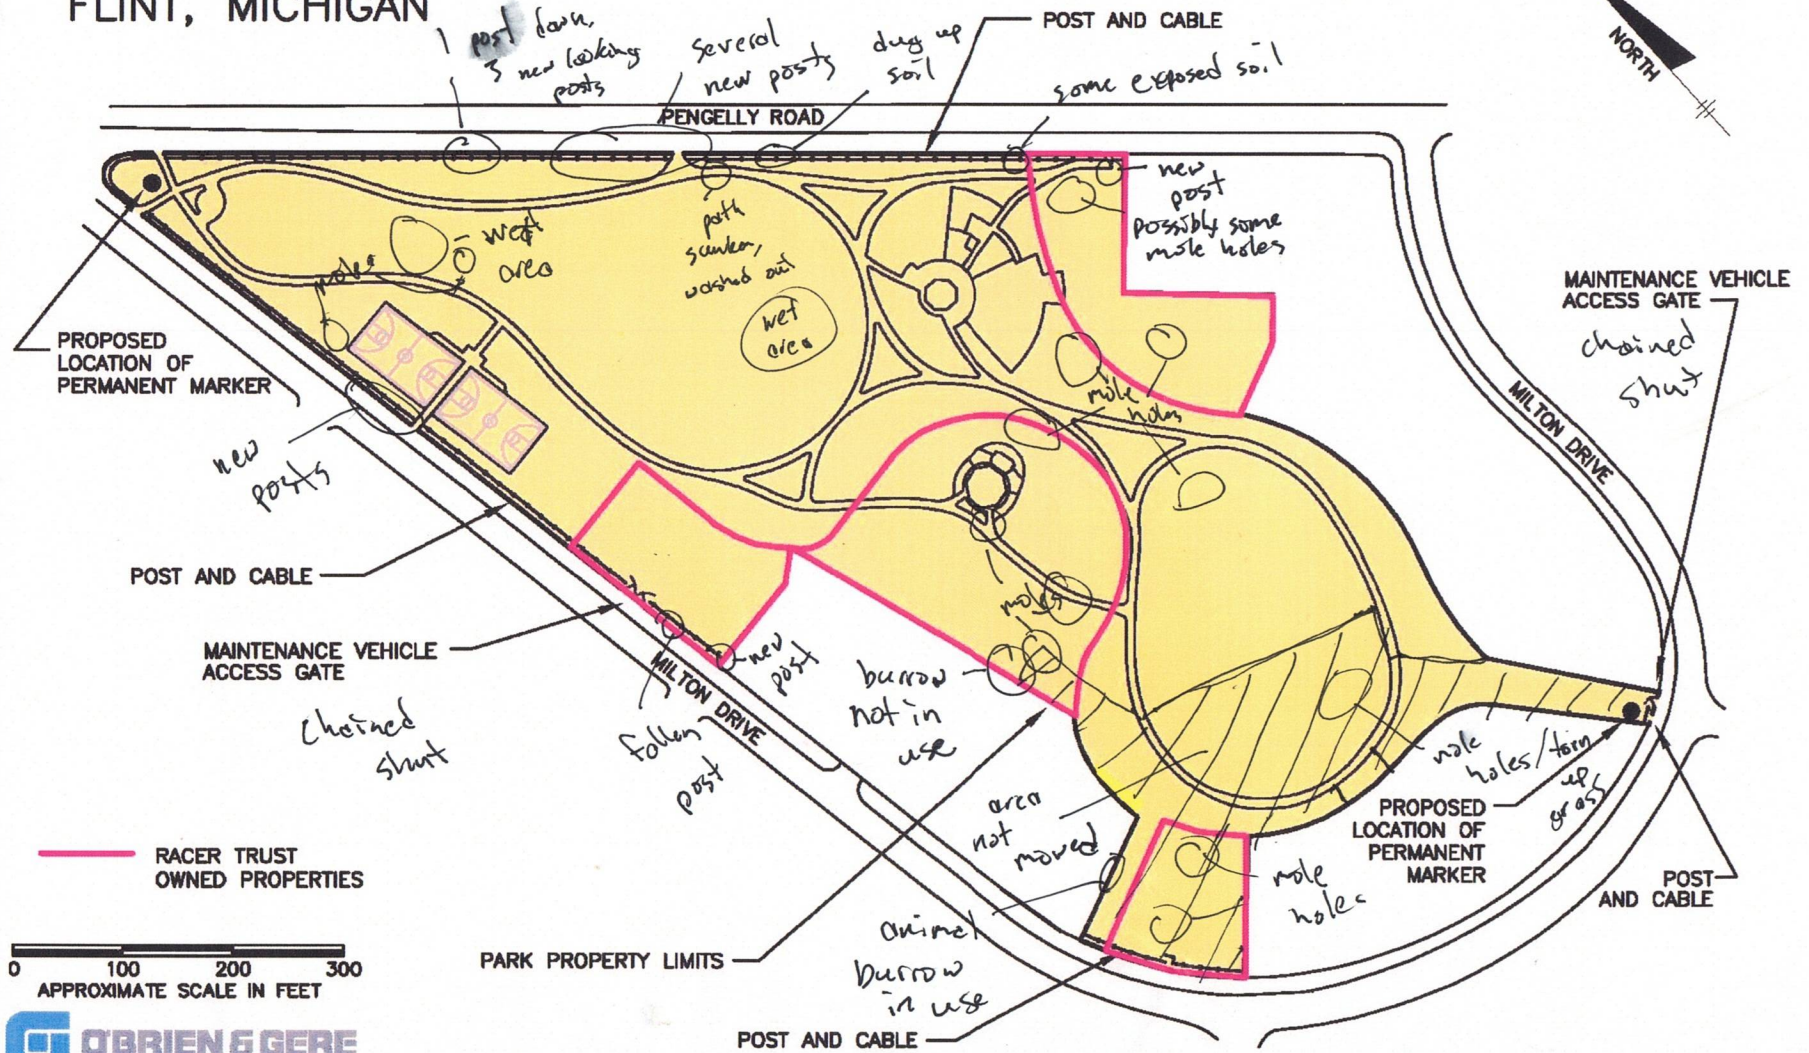
During the inspection the soil cover was observed to be in good condition and no soil cover repairs are necessary at this time. An area was observed where water has ponded after rain events on the City of Flint property.

One potential active animal burrow was noted during the inspection. Ramboll will attempt to remove the animal and repair the area during the next visit to the site. Please refer to the attached inspection sheet and map for further details.

| Inspected Item: | Comments: |
|---|---|
| GRASS/VEGETATIVE LAYER | Acceptable. No maintenance required at this time. One area was observed with standing water, tall grass and tall woody plants. The area around the baseball field and the area adjacent to the Pengelly Apartment complex had not been mowed recently. |
| POST & CABLE / VEHICLE GATES | Acceptable. Approximately twelve damaged posts were observed during the site inspection (either partially down or completely down). Four sections of down cable were observed. The south and west maintenance vehicle access gates were locked. |
| OTHER OBSERVATIONS | A number of mole mounds and/or trails were observed. Unable to determine if the mounds are from recent activity or from older activity. Two animal burrows were observed. One appeared to currently be in use. The other doesn't appear to have been used recently. One large tree limb was down and one brush pile were observed. One section of concrete had collapsed around manhole on sidewalk along Pengelly Road. A yellow substance, suspected to be some type of fungi was seen on the woodchipped playground area. |

Add additional soil to area where water has ponded. Remove animal from active burrow.
