RE: *Quarterly Status Report –July 2015 – September 2015*
Coldwater Road Landfill
1245 East Coldwater Road, Flint, MI
MID 005 356 860

In accordance with requirements of the approved Post-Closure Care Plan, we are providing you with this Quarterly Status Report for the third quarter 2015.

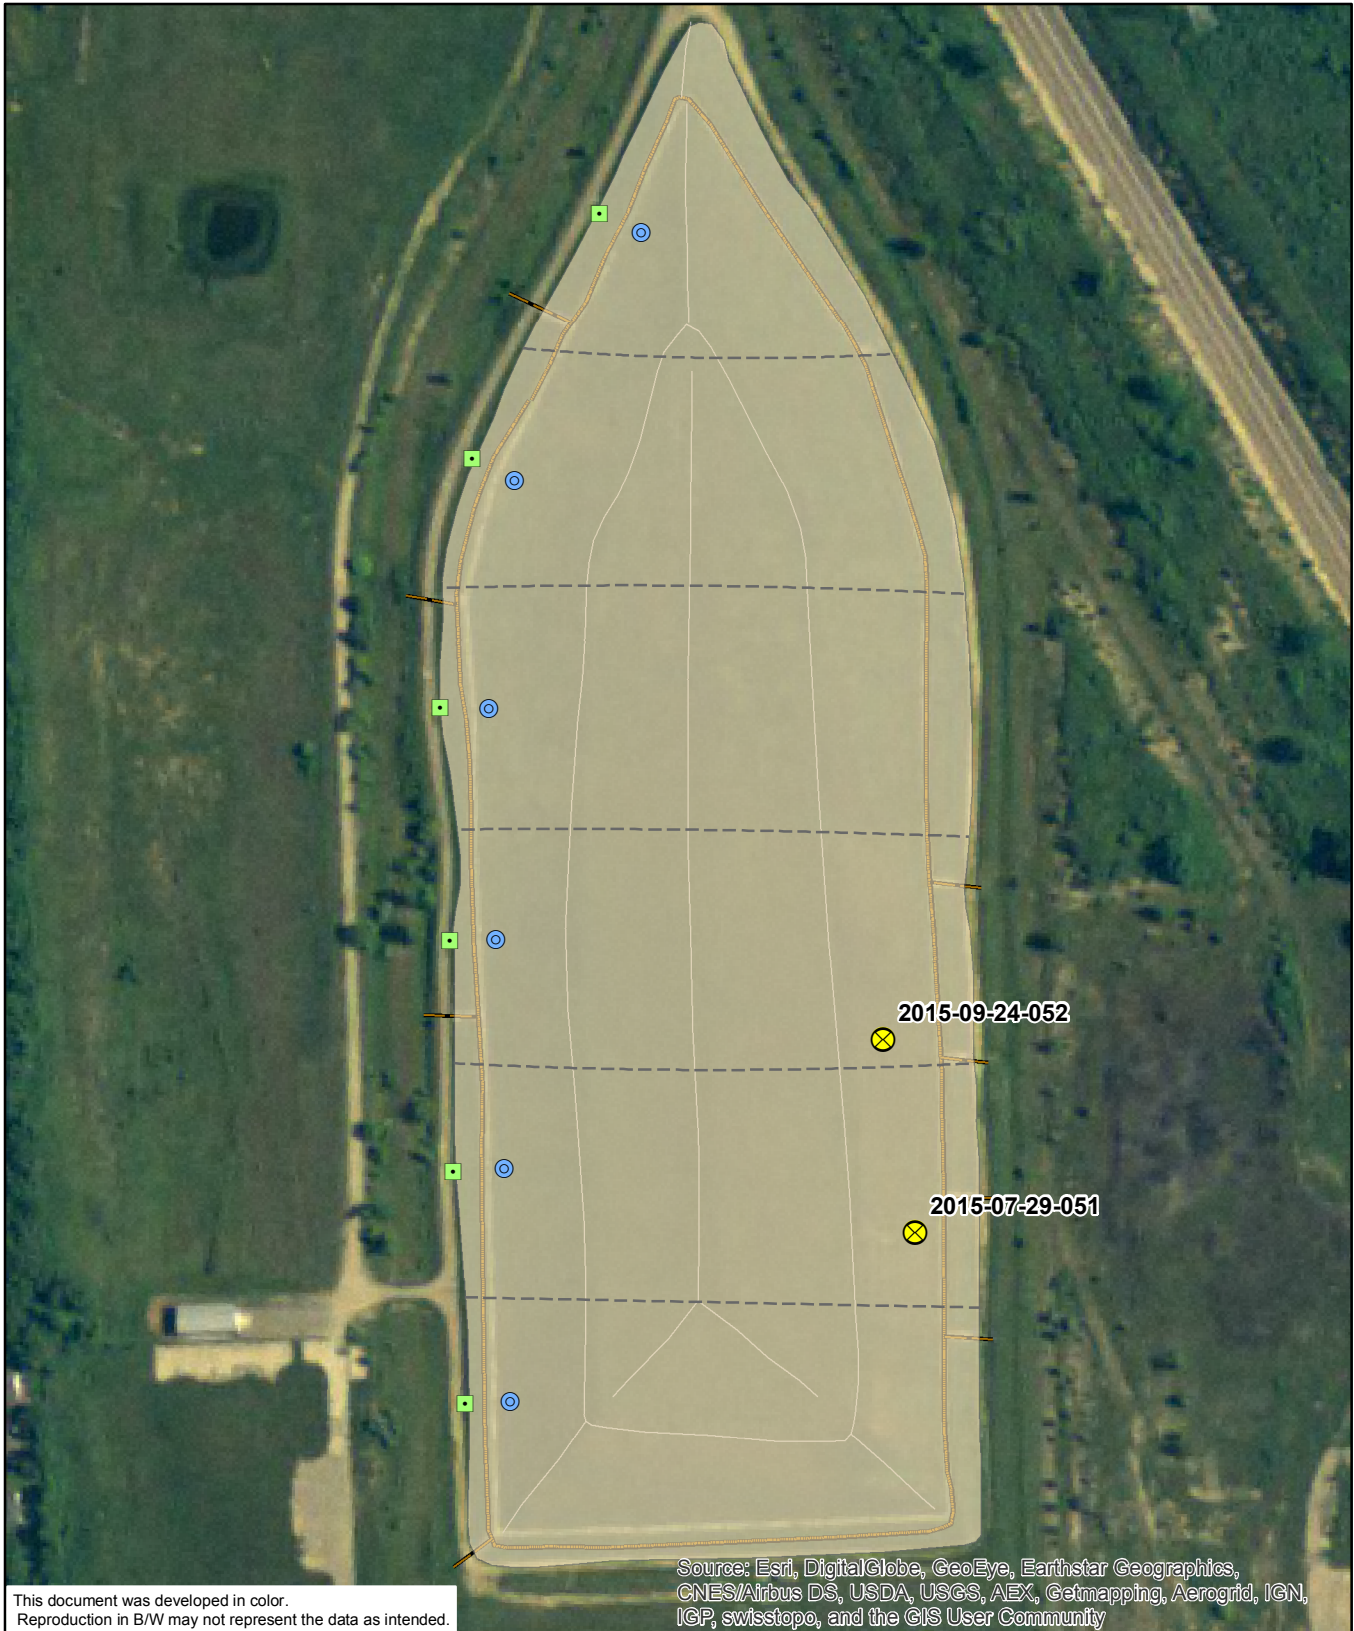
**3RD QUARTER 2015
BURROW LOCATION
MAP**

- » Observed 2 potentially active animal burrows on June 19, 2015 and September 24, 2015 and set traps. On July 29, 2015 a trapped animal was observed and the burrow was closed out. On September 24, 2015 an animal was trapped and the burrow was closed out. See attached figure for animal burrow locations and photo log for detailed information concerning animal burrow activities for this quarter.
