RE: *Quarterly Status Report –July 2012 – September 2012*
Coldwater Road Landfill
1245 East Coldwater Road, Flint, MI
MID 005 356 860
FILE: 15388/48630/Docs

**3RD QUARTER 2012
BURROW LOCATION
MAP**

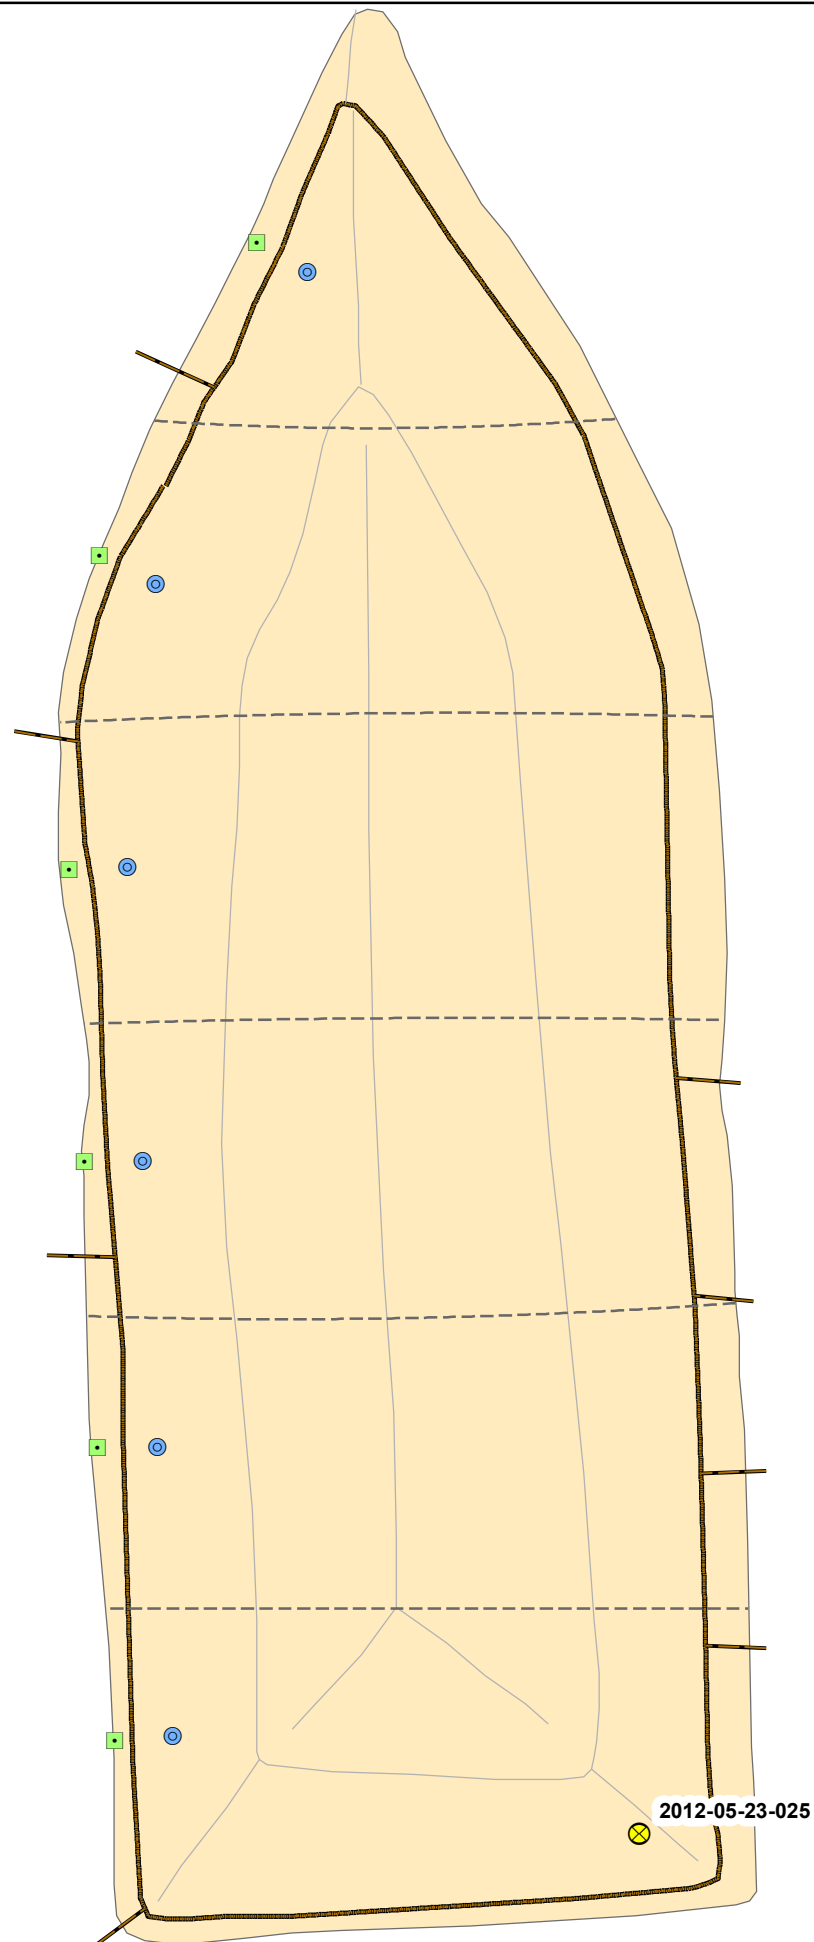
FIGURE 1

- » Observed one potentially active animal burrow on May 23, 2012, and set a trap. The animal burrow appeared inactive and was filled in on August 21, 2012. See attached figure for animal burrow locations and photo log for detailed information concerning animal burrow activities for this quarter.
