RE: Windiate Park/Dixieland Subdivision Landfill, Pengelly Road Site, Genesee County, Michigan  
(Site ID No. 25000689)

FILE: 1088190/1940103639 - Soil Cover Inspection Report

## WINDIATE PARK SOIL COVER MAINTENANCE CHECKLIST

# INSPECTION MAP

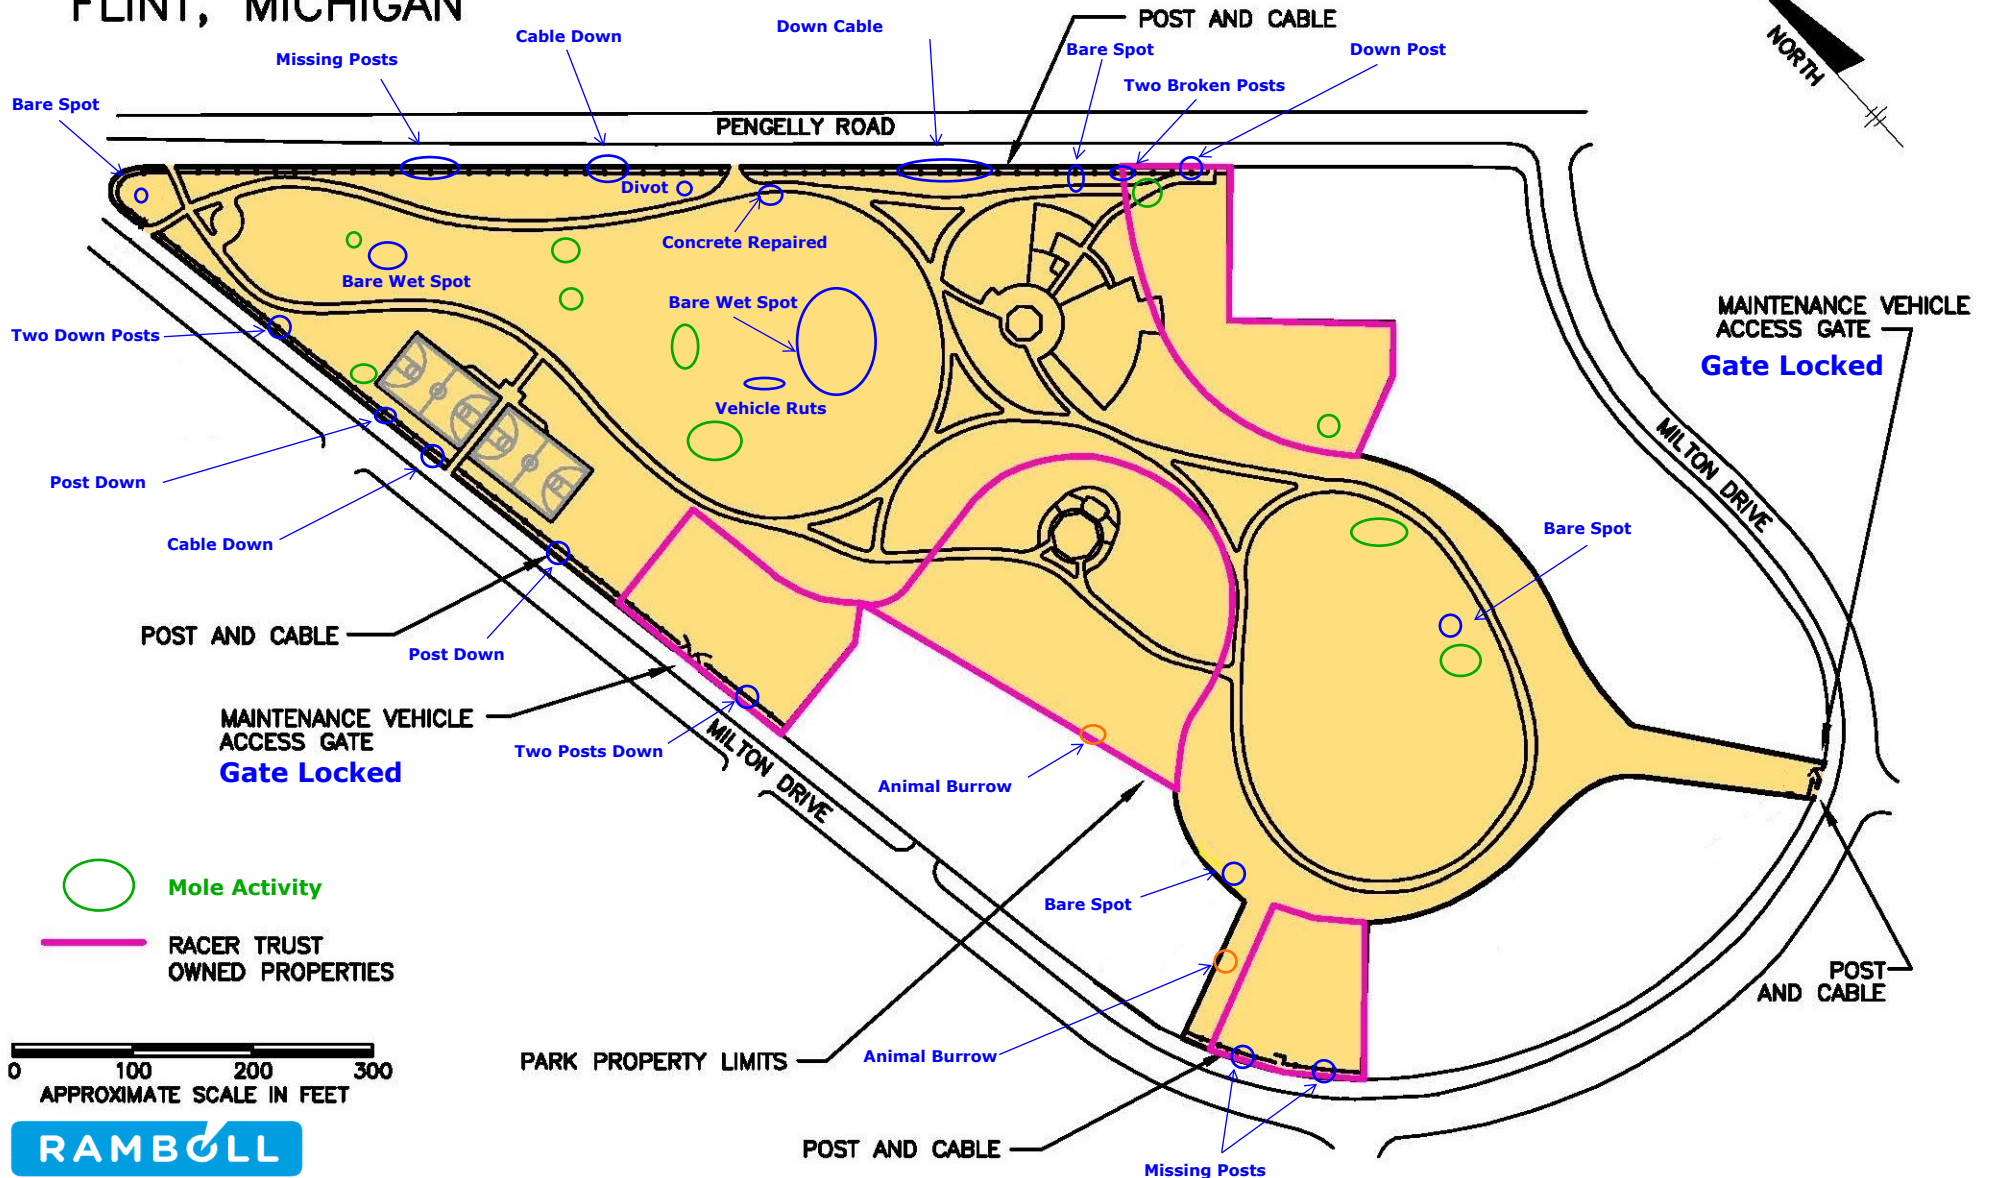
| Inspected Item: | Comments: |
|---|---|
| <i>SOIL COVER</i> | Some small areas of exposed soil throughout site due to mole activity (mole mounds/trails). |
| <i>OTHER OBSERVATIONS</i> | A number of mole mounds and/or trails were observed. Unable to determine if the mounds are from recent activity or from older activity. Two animal burrows were observed. At one burrow an entry and exit were observed and at the other burrow only an entry was observed. Efforts will be needed to remove the animals from the burrows. No signs of waste were observed in the animal burrow spoils. On the City of Flint property, the section of concrete collapsed around the manhole along Pengelly Road previously observed was repaired. Vehicle ruts were observed near the wet areas. |

Grass has been mowed

Avoid entering wet areas with vehicles.  
Manage animal burrows and mole activities.  
Replace cable and posts that are missing or damaged.
