**Landfill Inspection Report  
Coldwater Road Landfill  
Flint, Michigan  
MID 005 356 860**

**RACER TRUST  
Detroit, Michigan**

February 2019

RE: 2018 Annual Landfill Inspection Report  
Coldwater Road Landfill, Flint, Michigan  
MID 005 356 860

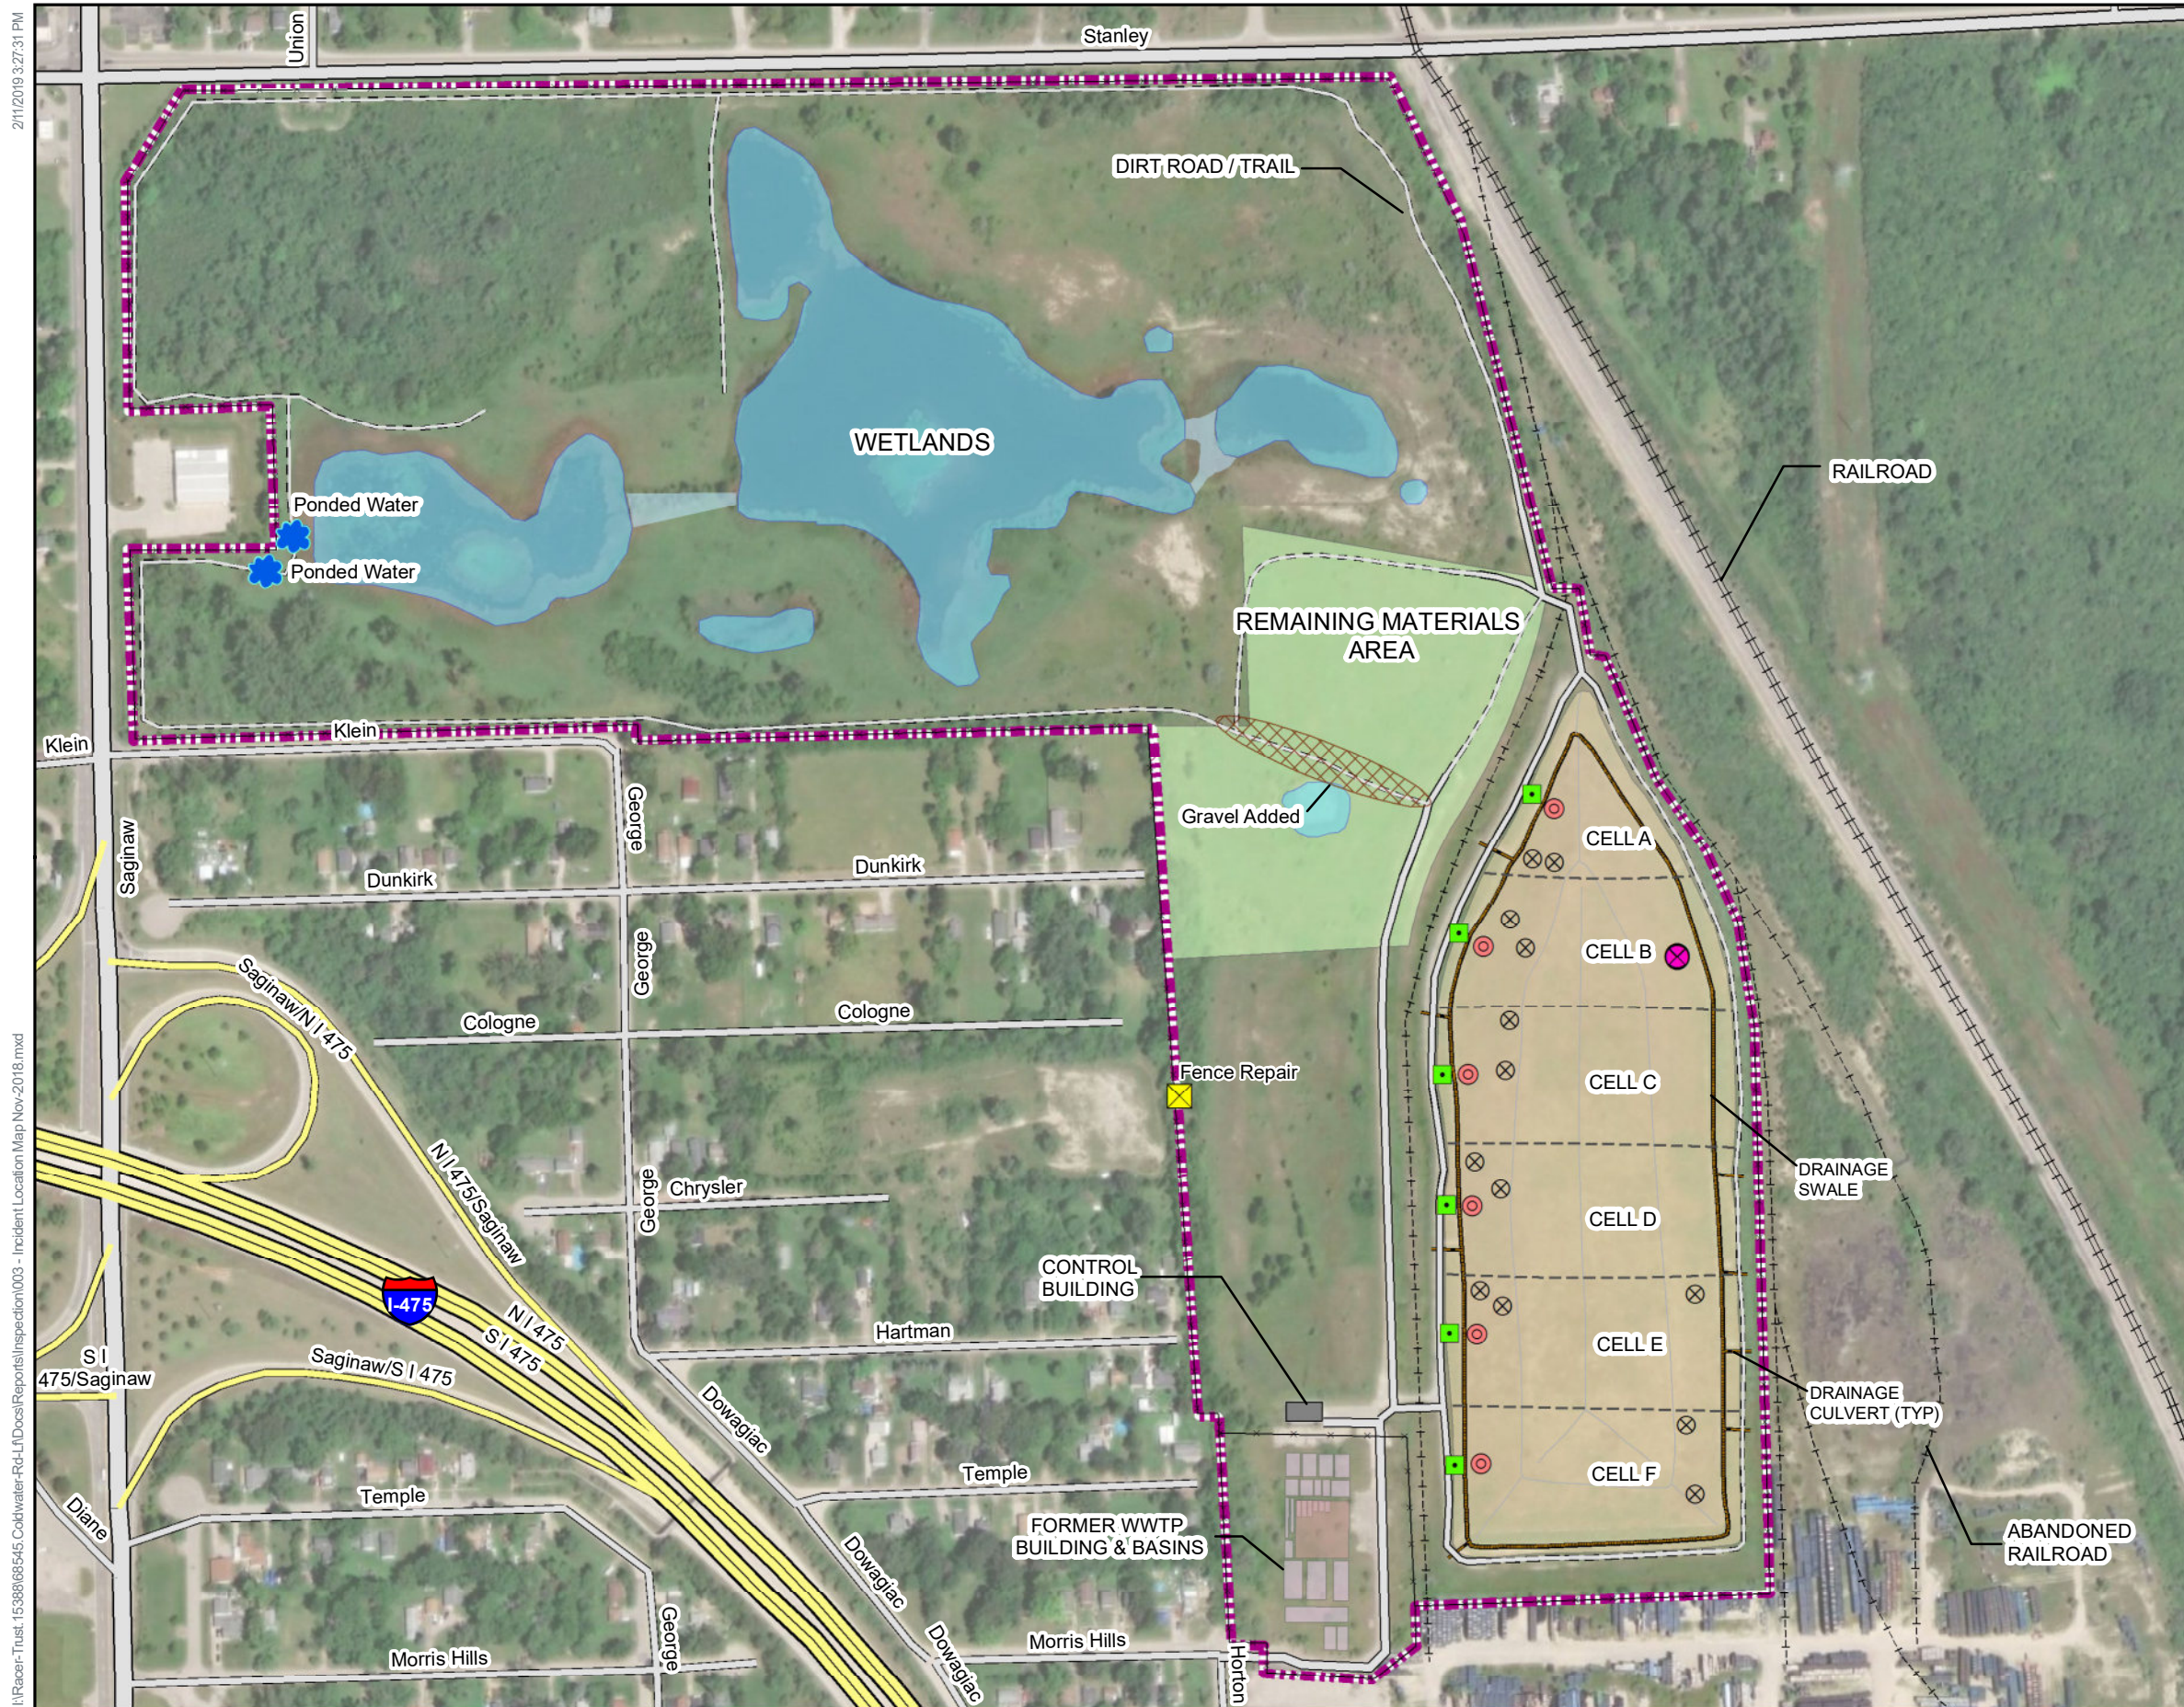
**2018  
INCIDENT LOCATION  
MAP**

Mole activity was observed during the 1<sup>st</sup> through 4<sup>th</sup> quarter inspections at Cell A, Cell B, Cell D, Cell E, and Cell F. The mole activity is noted on [Figure 3](#). It was not confirmed whether the mole mounds observed were new activity or signs of previous activity. Mole traps were set along the trails where located.

The burrow was deemed inactive and filled in. The burrow was filled using methods approved by the Michigan Department of Environmental Quality (MDEQ), which included collecting the approximate length (6 inches), depth (2 inches), and diameter (4 inches). No signs of liner damage were observed during the inspection and repair of the animal burrow. A log of burrow activity throughout the year is maintained at the landfill. The log contains information on the date that a burrow was identified, response activities, and the date the burrow was filled and seeded. The animal burrow located during the quarterly inspection is noted on [Figure 3](#).

During the 1<sup>st</sup> quarterly inspection the access road west of the wetlands had two areas of ponded water. The wet sections of road were avoided until the road was dry. Due to the per- and polyfluorinated substances (PFAS) investigation during the 3<sup>rd</sup> and 4<sup>th</sup> quarters the perimeter access roads were rutted and the grass was worn down. Gravel was added and spread to the access road south of the Remaining Materials Area (RMA) ([Figure 3](#)) to reinforce the road for truck access to the western wetland berm area. At the end of the PFAS investigation the road will be repaired.

During the 2<sup>nd</sup> quarter and 4<sup>th</sup> quarter, one previously repaired hole along the west perimeter fence had been reopened. The hole was repaired during the site inspections [Figure 3](#).

During the 1<sup>st</sup> quarter of 2019 grass seed will be spread to reestablish a base for the perimeter road. No other problems to the access roads were observed during 2018.

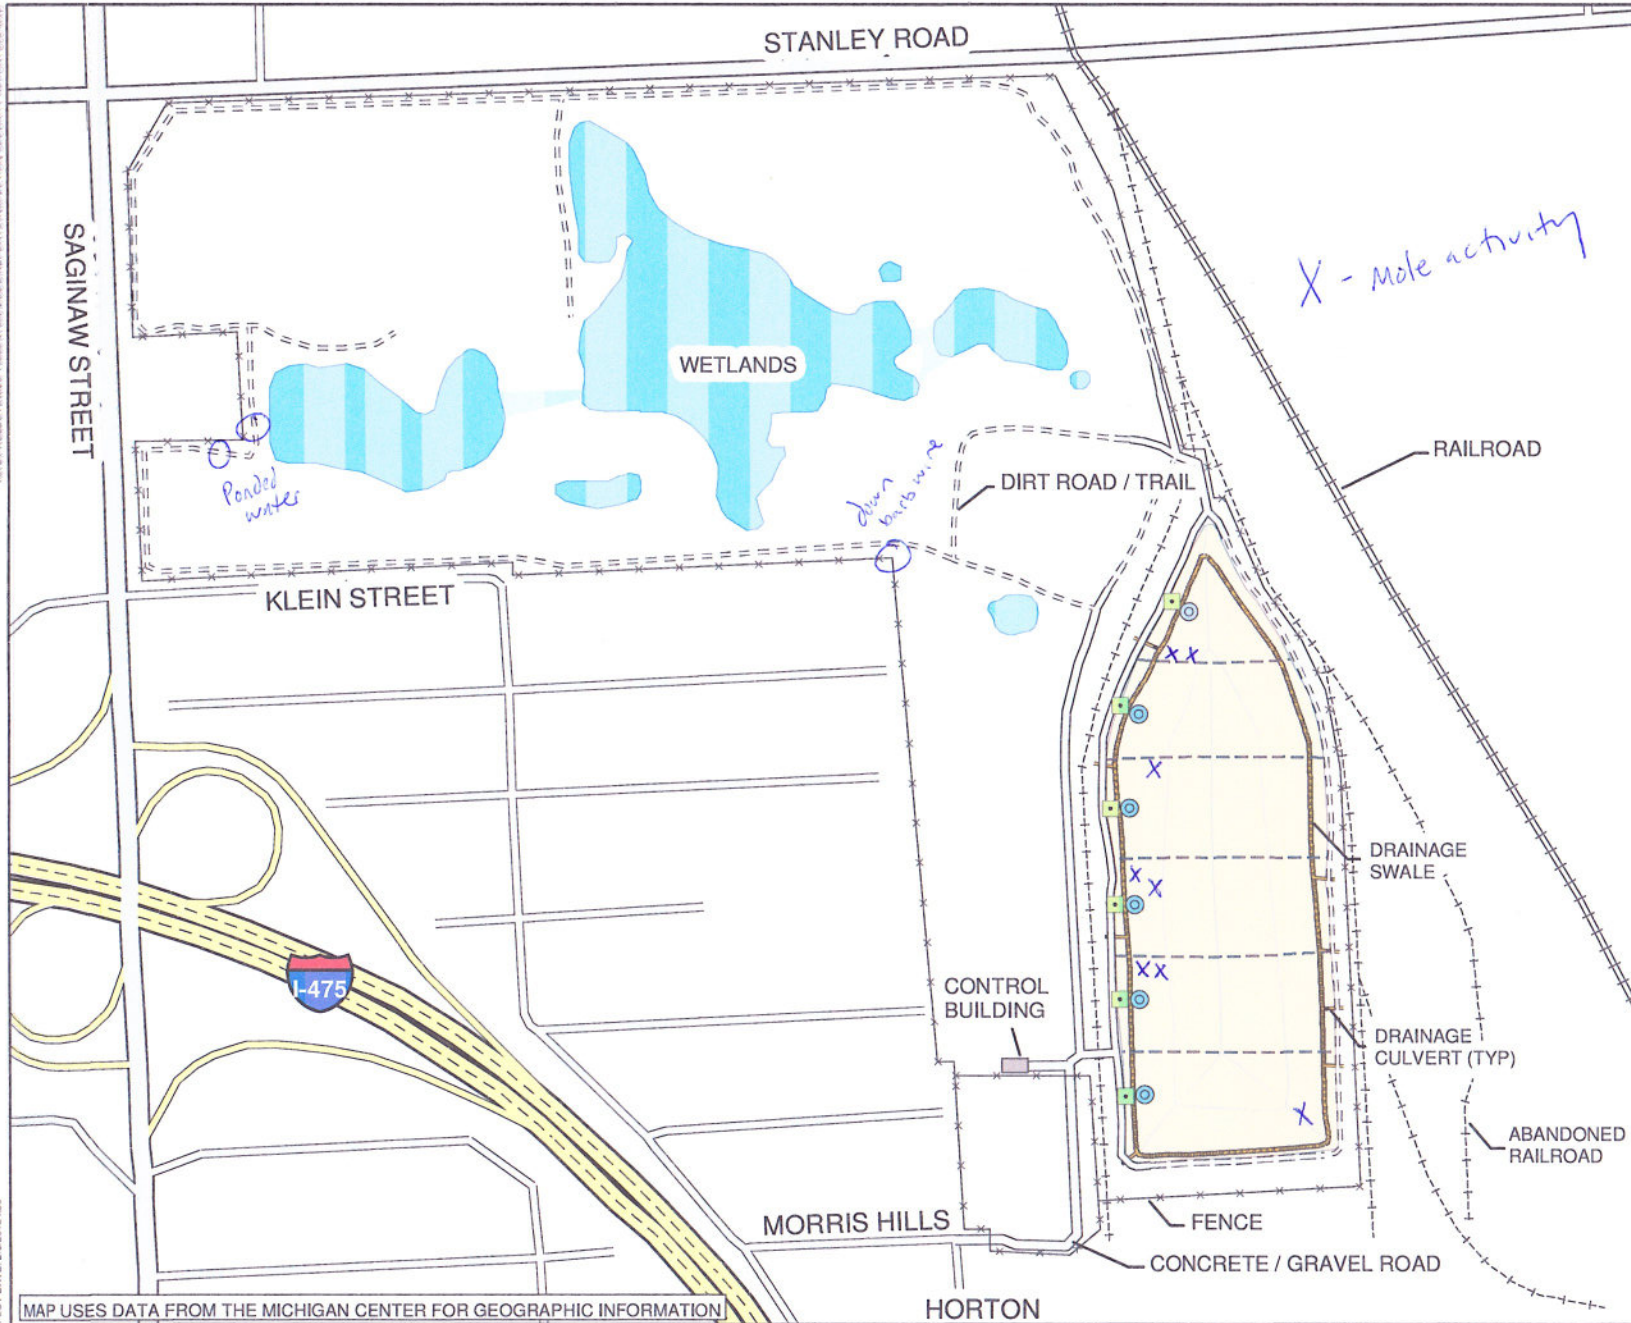
FIGURE 2

Area of Inspection	Animal Burrows?	Soil Erosion	Slope Failures?	Ponding?	Washouts?	Liner damage or exposure?	If yes to any, describe issue, location, and actions taken	Date Corrected
Cell A	Mole activity cell A1	No	No	No	No	No		
Cell B	No	No	No	No	No	No		
Cell C	No	No	No	No	No	No		
Cell D	Mole activity cell D1	No	No	No	No	No		
Cell E	Mole activity cell E1	No	No	No	No	No		
Cell F	Mole activity F4	No	No	No	No	No		
Berms	No	No	No	No	No	No

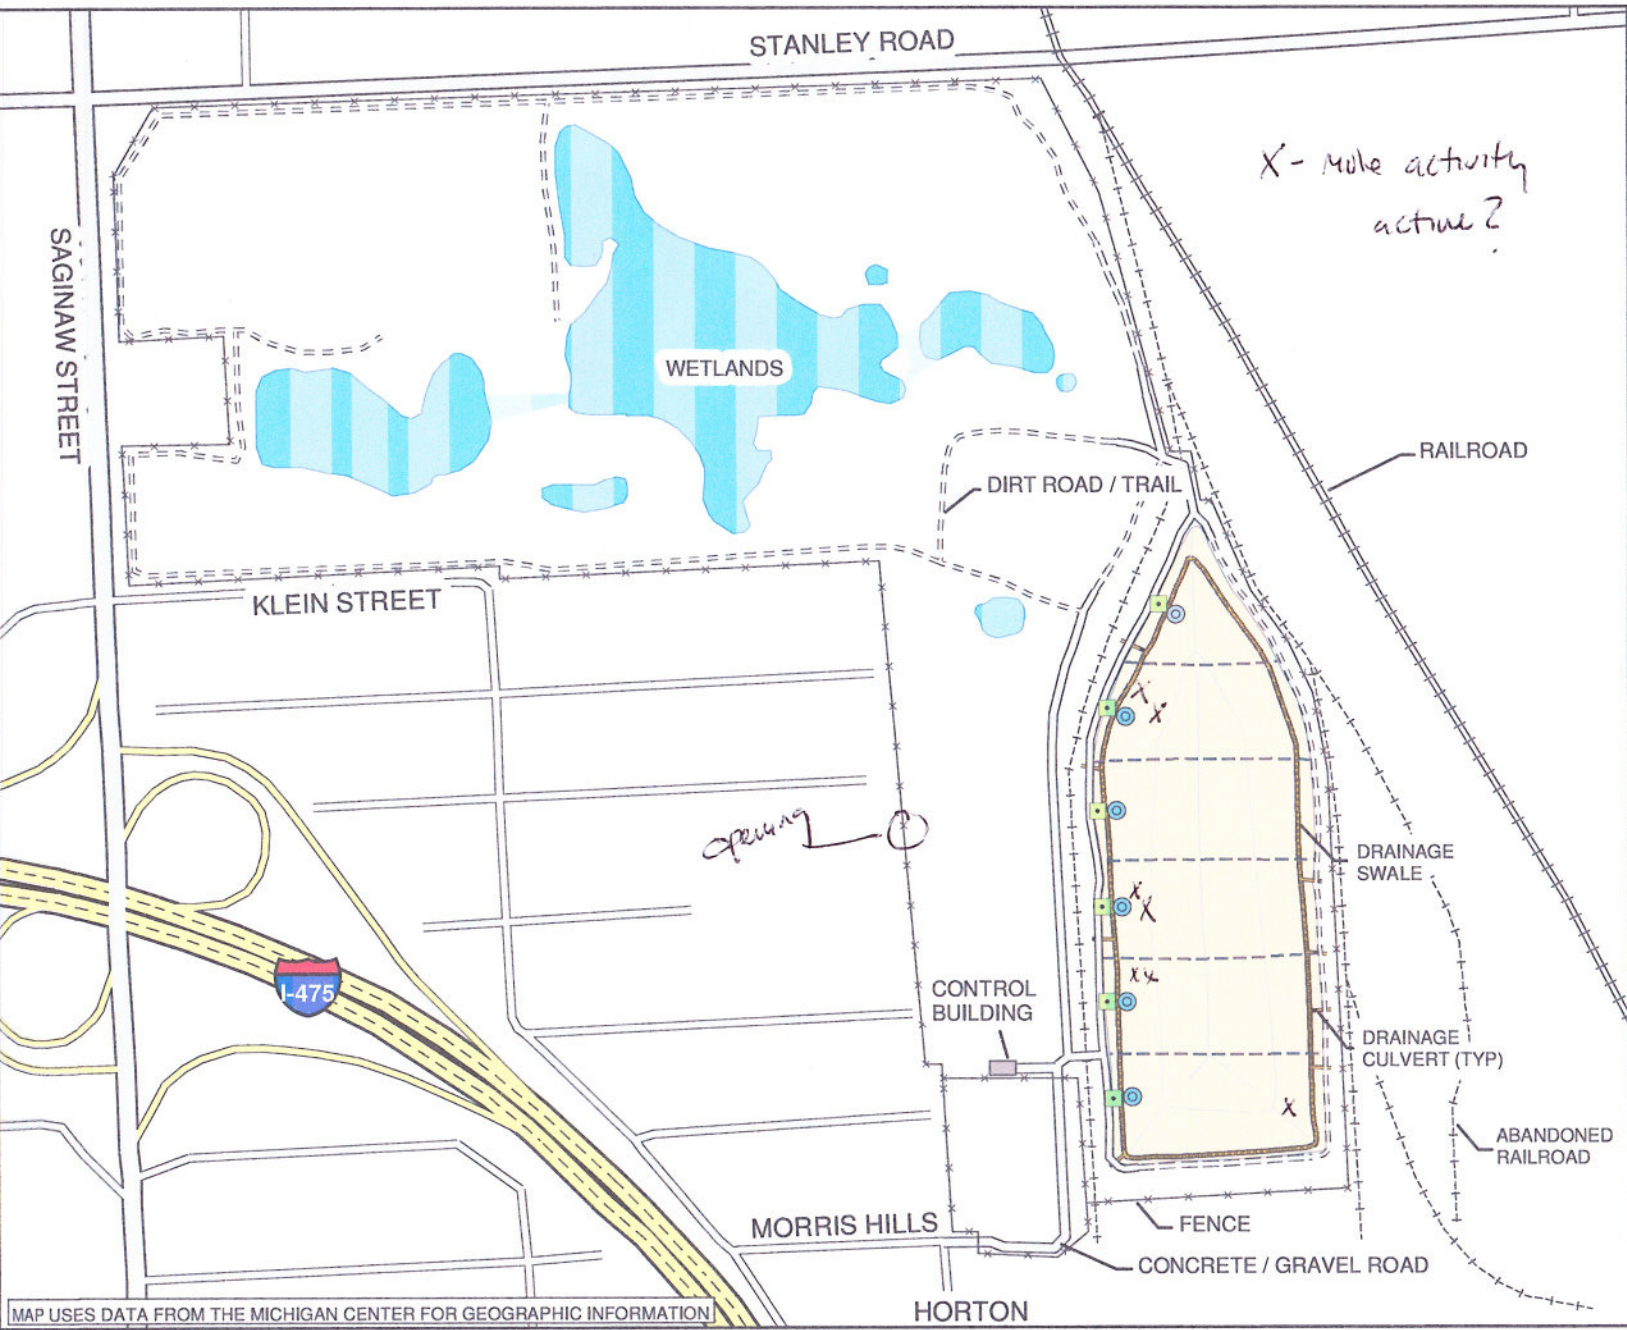
FIGURE 2

Area of Inspection	Animal Burrows?	Soil Erosion	Slope Failures?	Ponding?	Washouts?	Liner damage or exposure?	If yes to any, describe issue, location, and actions taken	Date Corrected
Cell A	No	No	No	No	No	No		
Cell B	Mole activity cell B1	No	No	No	No	No	can't determine if old or active	
Cell C	No	No	No	No	No	No		
Cell D	Mole activity cell D1	No	No	No	No	No	can't determine if old or active	
Cell E	Mole activity cell E1	No	No	No	No	No	can't determine if old or active	
Cell F	Mole activity cell F1	No	No	No	No	No	can't determine if old or active	
Berms	No	No	No	No	No	No

Area	Any damage present?	Signs of unauthorized entry?	Broken or damaged locks on gates?	"Trespassing Prohibited" and "Private Property" Signs Missing?	If yes to any, describe issue, and actions taken	Date Corrected
Fences along north property line	No	No	No	No		
Fences along south property line	No	No	No	No		
Fences along west property line	Yes	No	No	No	closed opening along west fence	6/13/18
Fences along east property line	No	No	No	No

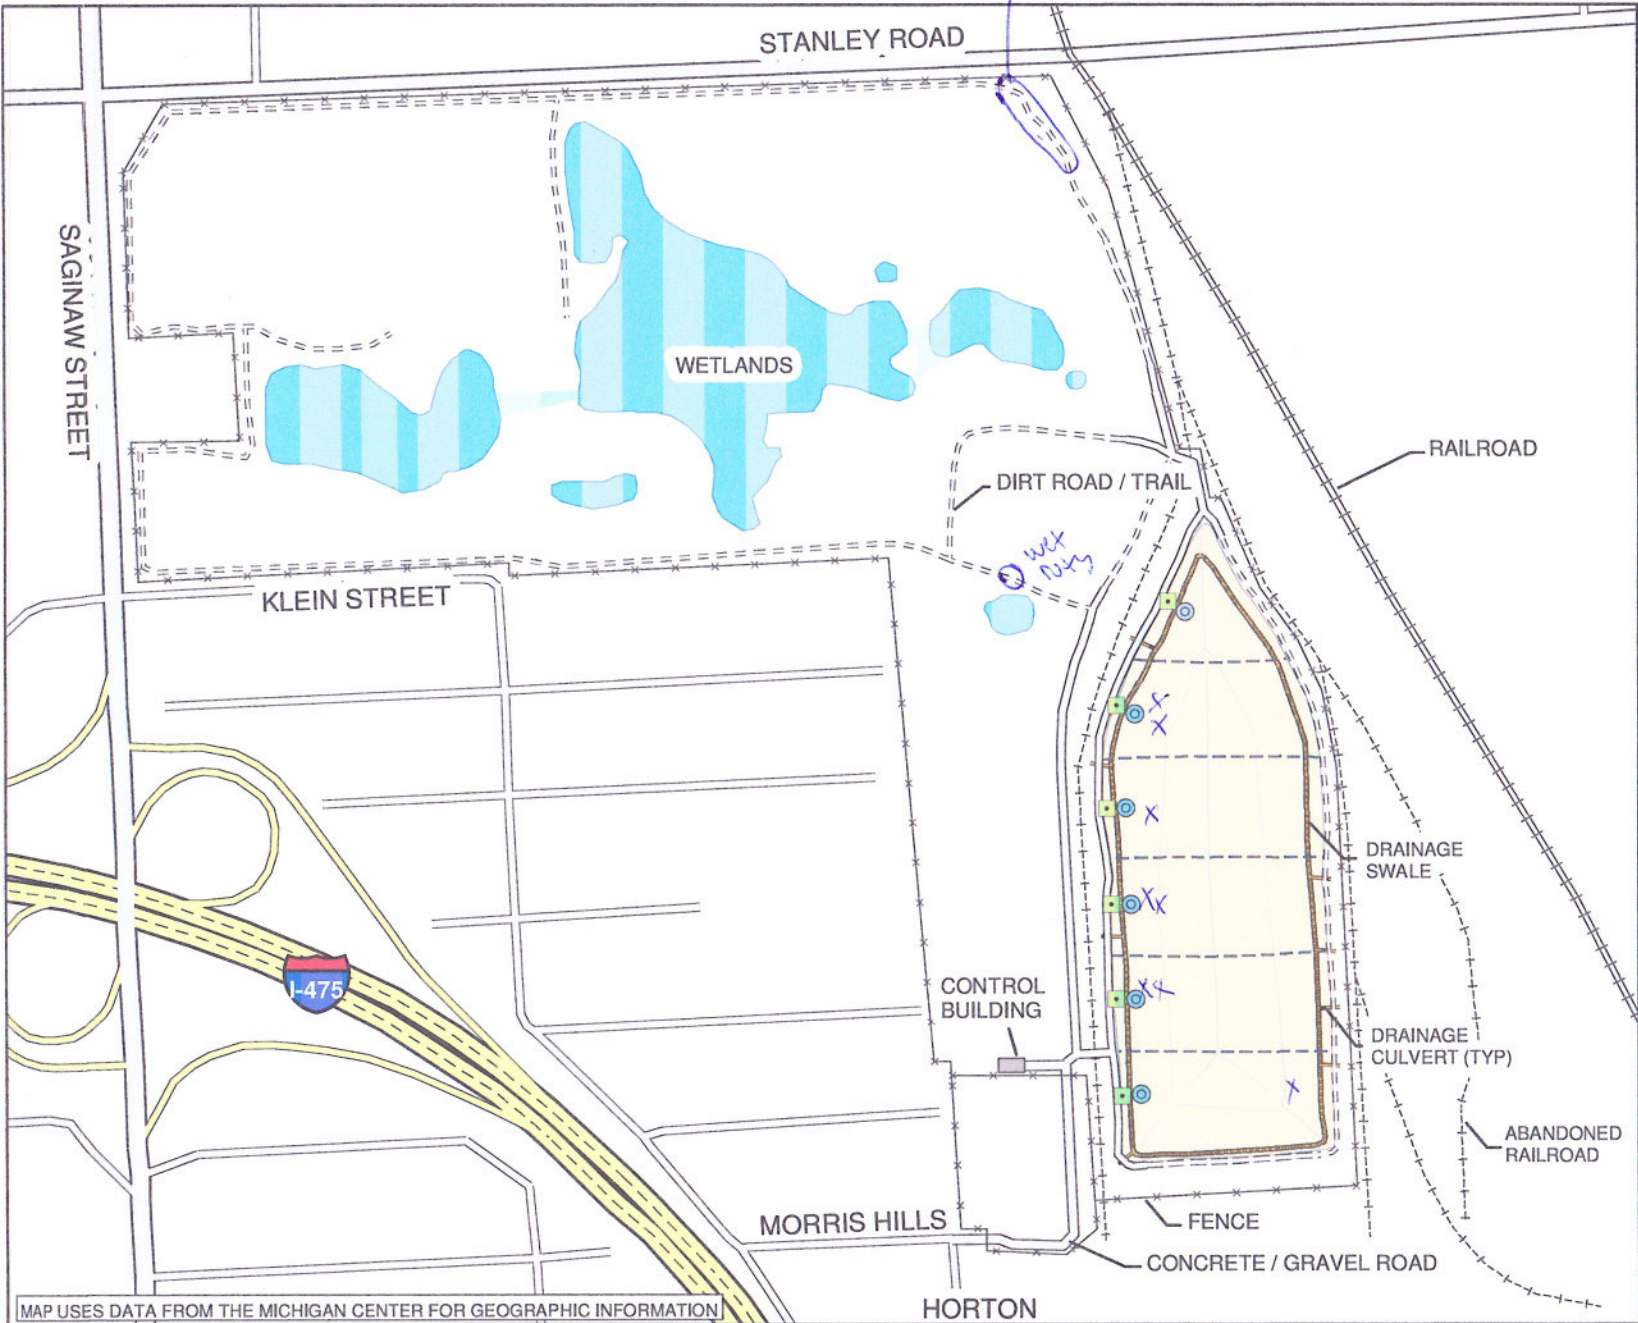
Area of Inspection	Animal Burrows?	Soil Erosion	Slope Failures?	Ponding?	Washouts?	Liner damage or exposure?	If yes to any, describe issue, location, and actions taken	Date Corrected
Cell A	No	No	No	No	No	No		
Cell B	Mole activity cell B1	No	No	No	No	No	old activity?	
Cell C	No	No	No	No	No	No		
Cell D	Mole activity cell D1	No	No	No	No	No	old activity?	
Cell E	Mole activity cell E1	No	No	No	No	No	old activity?	
Cell F	Mole activity cell F1	No	No	No	No	No	old activity	
Berms	No	No	No	No	No	No

*Water/stains on containment floor from city water*

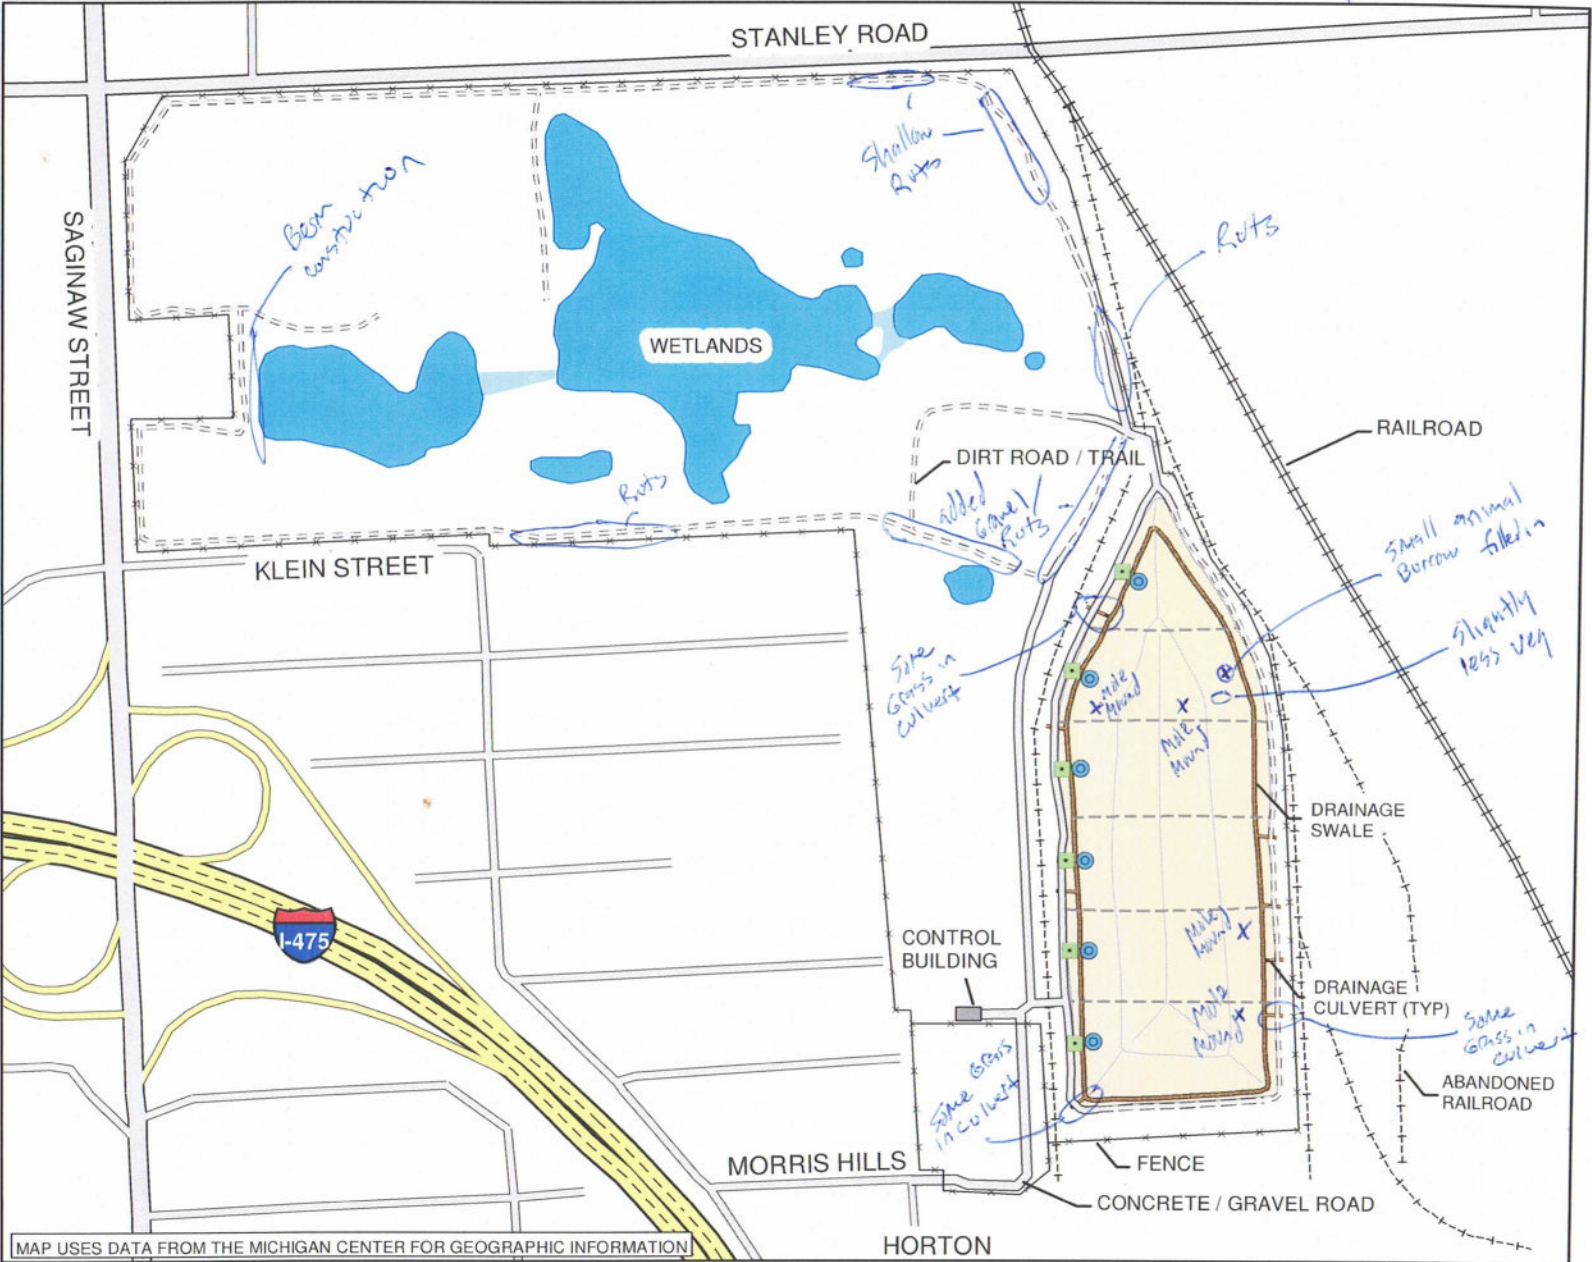
FIGURE 2

Area of Inspection	Animal Burrows?	Soil Erosion	Slope Failures?	Ponding?	Washouts?	Liner damage or exposure?	If yes to any, describe issue, location, and actions taken	Date Corrected
Cell A	No	No	No	No	No	No		
Cell B	Small animal Burrow B1, B2 Mole mound	No	No	No	No	No	filled in Burrow	12/20/18
Cell C	No	No	No	No	No	No		
Cell D	Cell D1 Mole mound	No	No	No	No	No		
Cell E	Cell E4 Mole mound	No	No	No	No	No		
Cell F	Cell F3 Mole mound	No	No	No	No	No		
Berms

*water stains on containment floor due to dripping city water. Think Ball valve leaks and*

Area	Sufficient gravel present?	Proper drainage present?	If no, describe issue, and actions taken	Date Corrected
Roads located approx. west of landfill	Ruts and damage due to site activity			
Roads located approx. east of landfill	Yes	Yes		
Roads located approx. north of wetlands	Ruts and damage due to site activity			
Roads located approx. south of wetlands	" "			
Roads located approx. west of wetlands	" "			
Roads located approx. east of wetlands	" "

Area	Any damage present?	Signs of unauthorized entry?	Broken or damaged locks on gates?	"Trespassing Prohibited" and "Private Property" Signs Missing?	If yes to any, describe issue, and actions taken	Date Corrected
Fences along north property line	No	No	No	No		
Fences along south property line	No	No	No	No		
Fences along west property line	Fixed hole about 1/2 mile previously open	No	No	No		10/20/18
Fences along east property line	No	No	No	No
