Landfill Inspection Report 2024

COLDWATER ROAD LANDFILL - MID 005 356 860 LANDFILL INSPECTION REPORT

Project name **RACER Trust Coldwater Road Landfill**
Project no. **15388/1940107203**
Recipient **Nicole Sanabria (EGLE), Christina Hebert (EGLE), & EGLE MMD**
Document type **Annual Report**
Version **1**
Date **February 28, 2025**
Prepared by **Kevin Schneider**
Checked by **Clifford Yantz**
Approved by **Clifford Yantz**
Description **Landfill Inspection Annual Report**

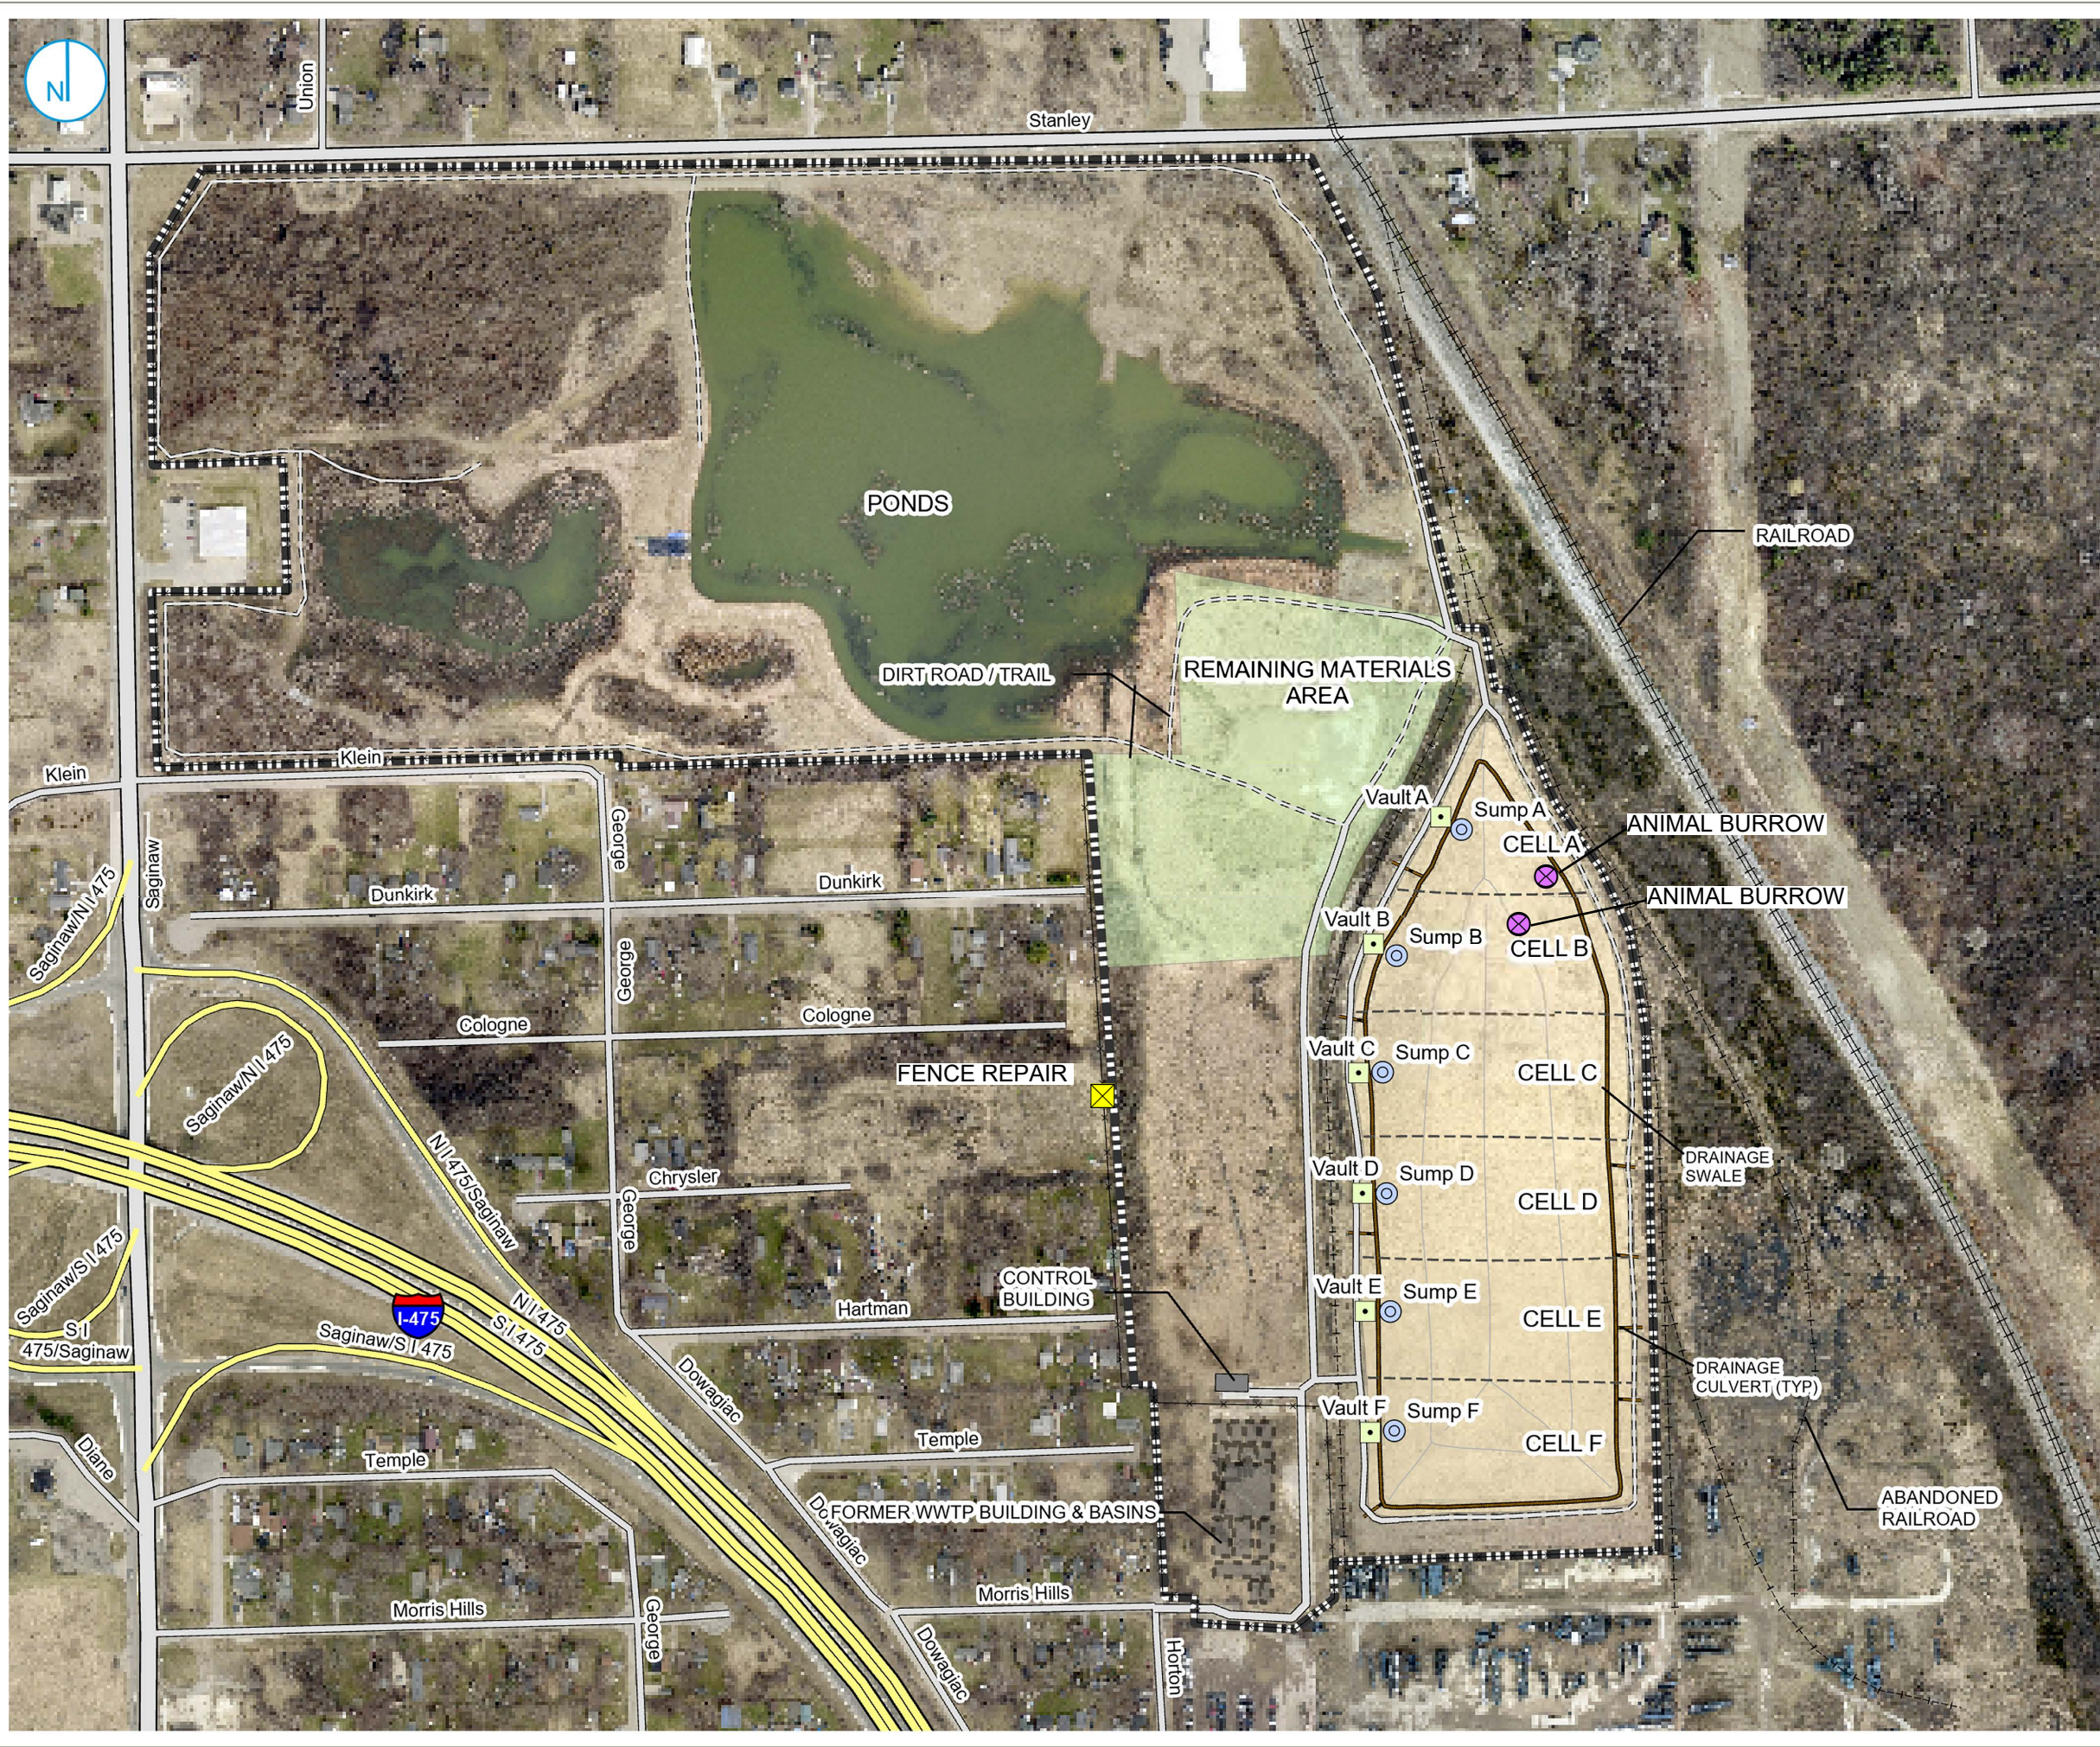
FIGURE 02

Two potentially active animal burrow were observed on October 17, 2024, and a trap was set at each burrow. One of the burrows was found to be inactive and was closed on October 29, 2024. The other animal burrow was found to be active, as an animal was trapped. This animal burrow was also closed out on October 29, 2024. The burrow was filled using methods approved by EGLE, which included measuring the approximate length, depth, and diameter, and recording the location.

An opening in the perimeter fence was repaired during the 1st semiannual of 2024. This was an opening that had previously been repaired, the opening was repaired and reinforced to deter future openings. See **Figure 2** for the location of the fence repair.

2024 INCIDENT LOCATION MAP

Once the burrow was filled in, the area was raked smooth and grass seed was spread. No signs of liner damage were observed during the inspection and repair of the animal burrow. A log of burrow activity throughout the year is maintained at the landfill. The log contains information on the date that a burrow was identified, response activities, and the date the burrow was filled and seeded. A photo log and figure containing the location of the burrow was also included in the Semiannual Status Report. The location of the animal burrows can be found on **Figure 2** in this report. Animal activity will continue to be addressed during future landfill cap maintenance.

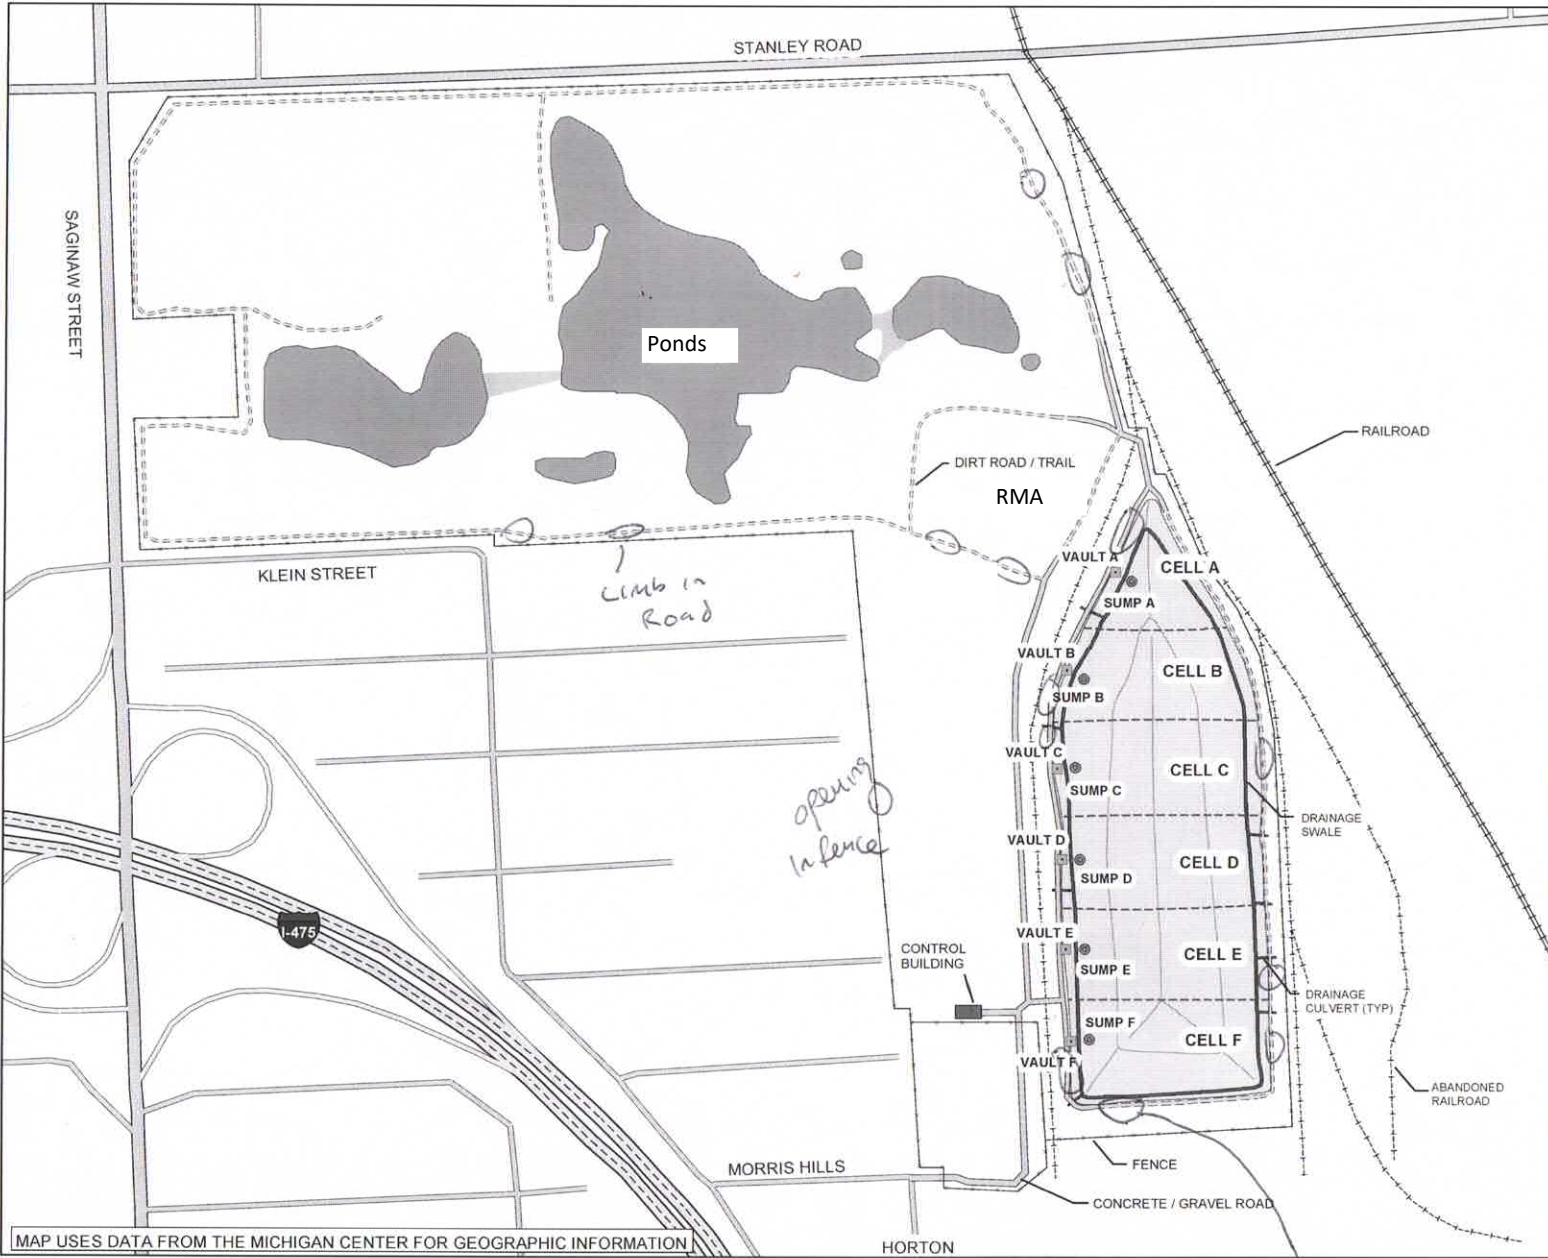
FIGURE 1

Area	Any damage present?	Signs of unauthorized entry?	Broken or damaged locks on gates?	“Trespassing Prohibited” and “Private Property” Signs Missing?	If yes to any, describe issue, and actions taken	Date Corrected
Fences along north property line	No	No	No	No		
Fences along south property line	No	No	No	No		
Fences along west property line	Yes	No	No	No	Previous hole reopened. Limbs down on fence.	Repaired during inspection.
Fences along east property line	No	No	No	No

Area of Inspection	Animal Burrows?	Soil Erosion	Slope Failures?	Ponding?	Washouts?	If yes to any, describe issue, location, and actions taken	Date Corrected
RMA	No	Yes, in road by rain	No	No	No	Shallow erosion gully across road due to rain. No action required at this time.

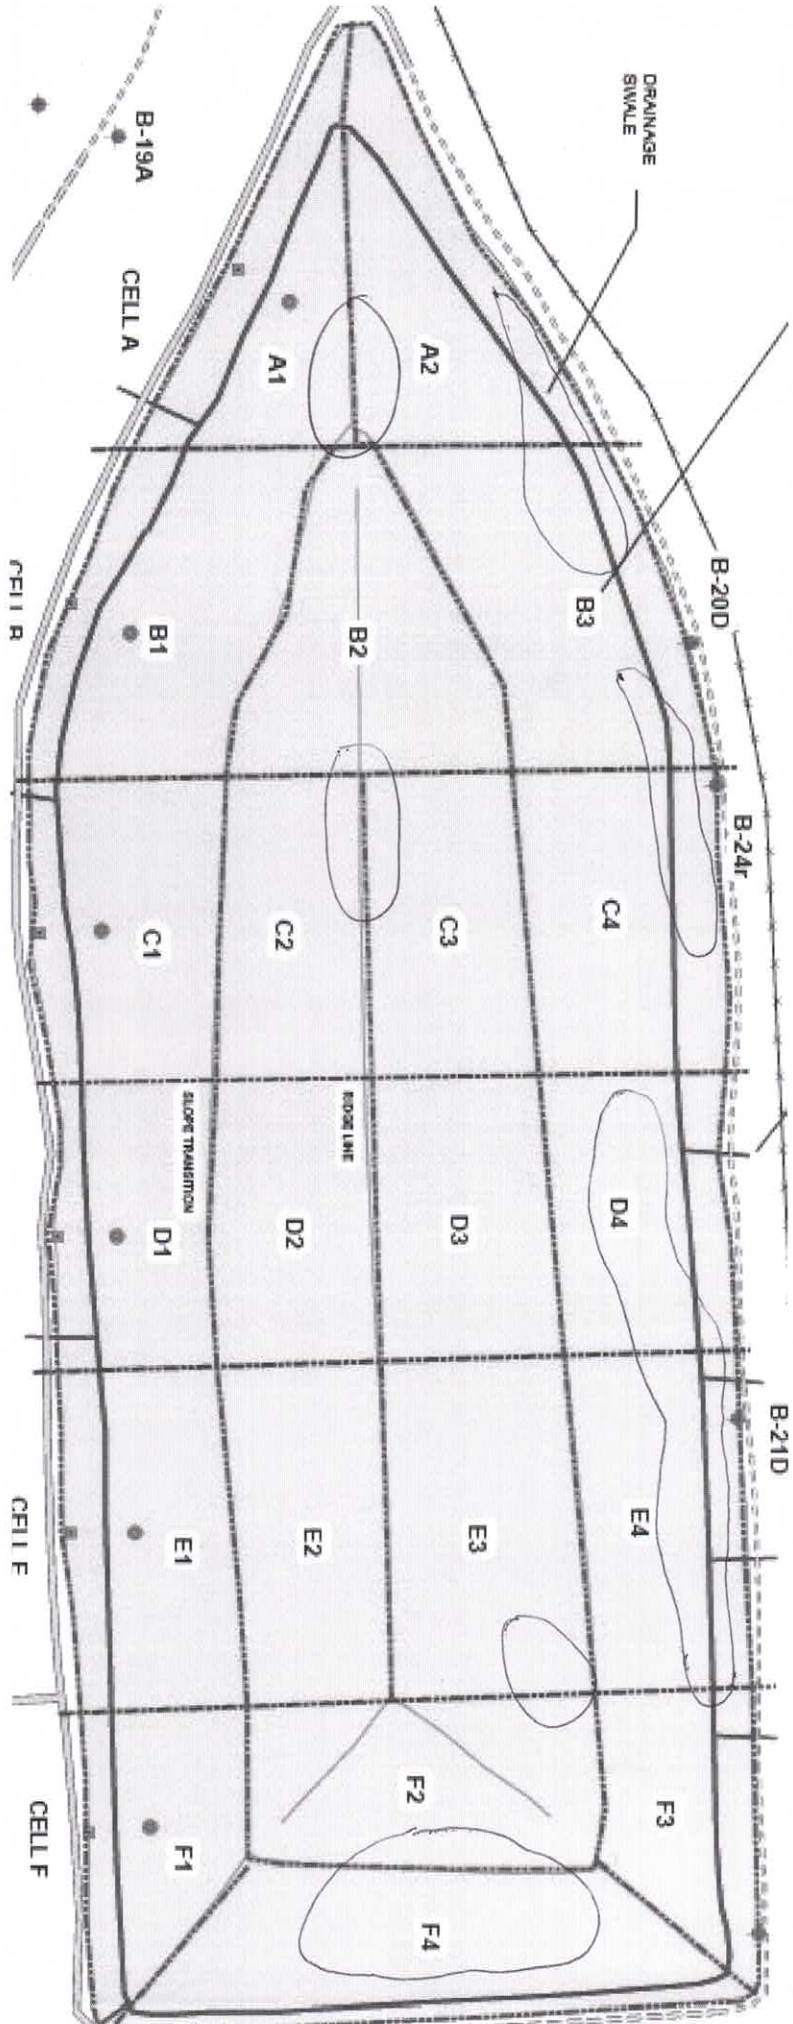
4/25/24
 ○ - Tall Dead weeds

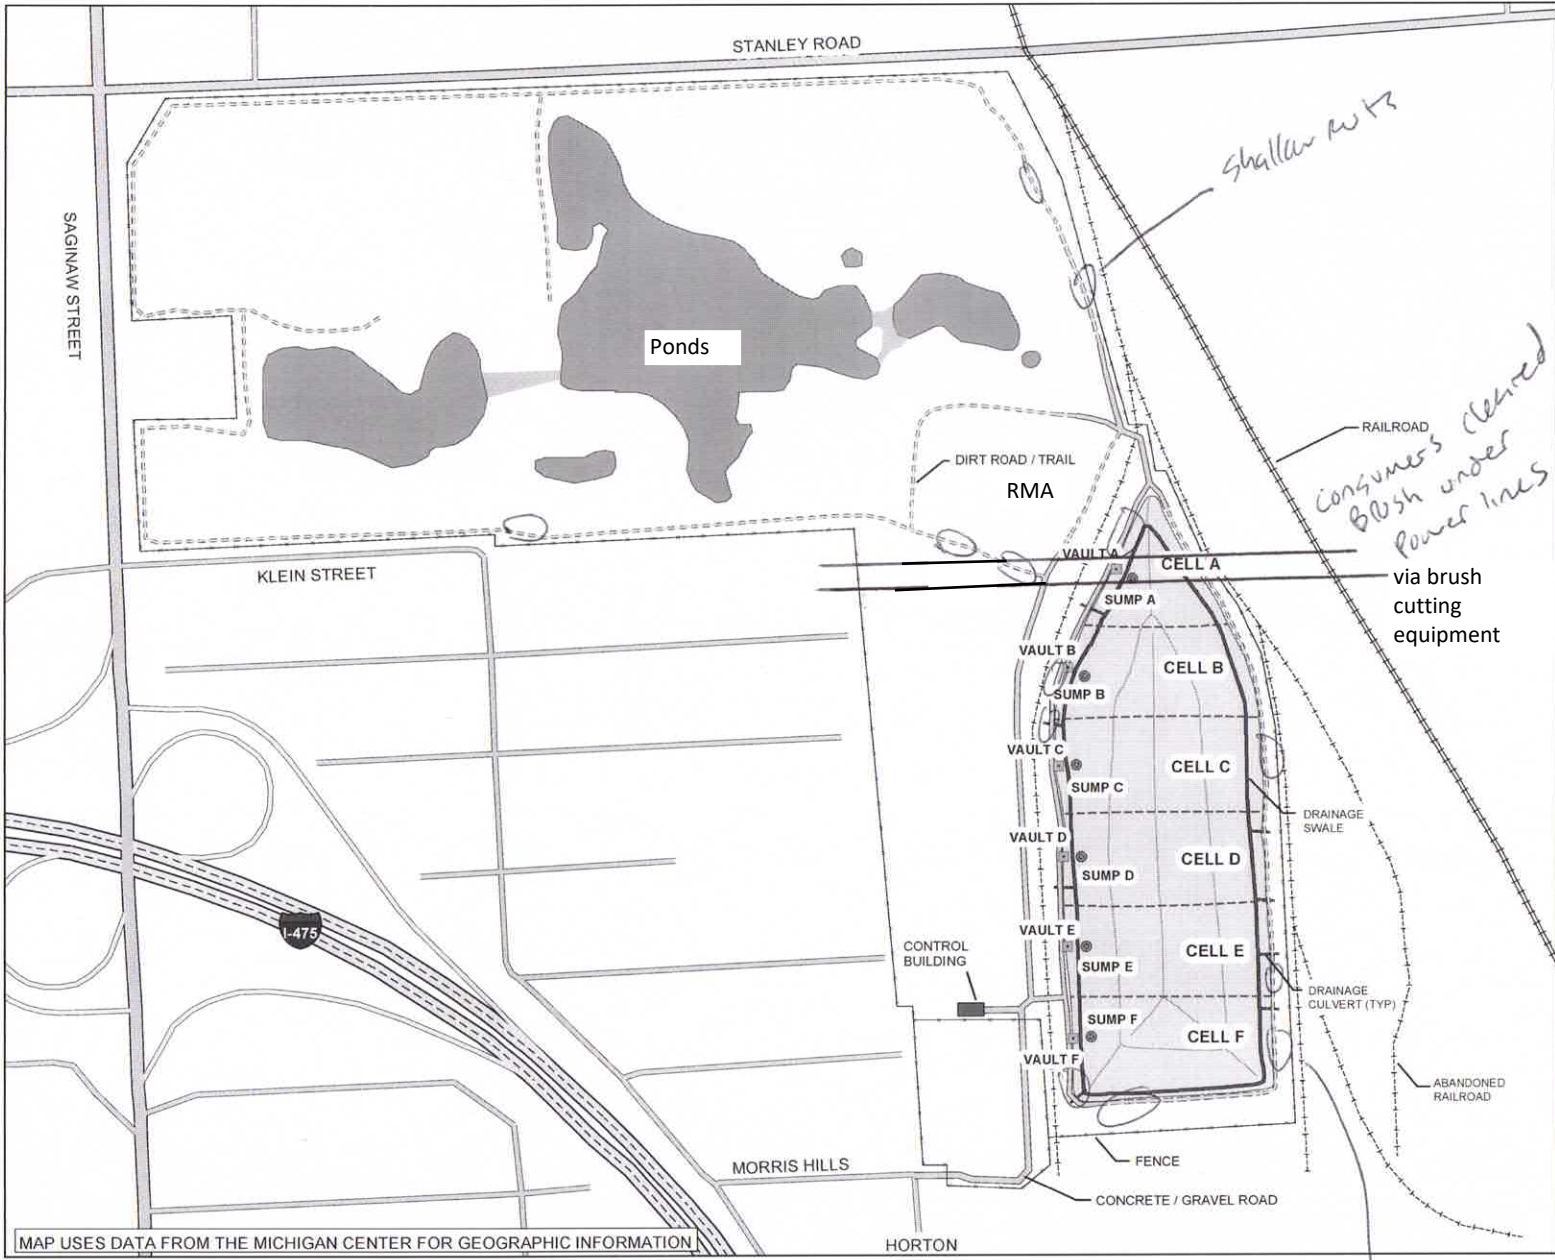
FIGURE 1

Shallow cuts

*Consumers Cleared
Brush under
Power lines*

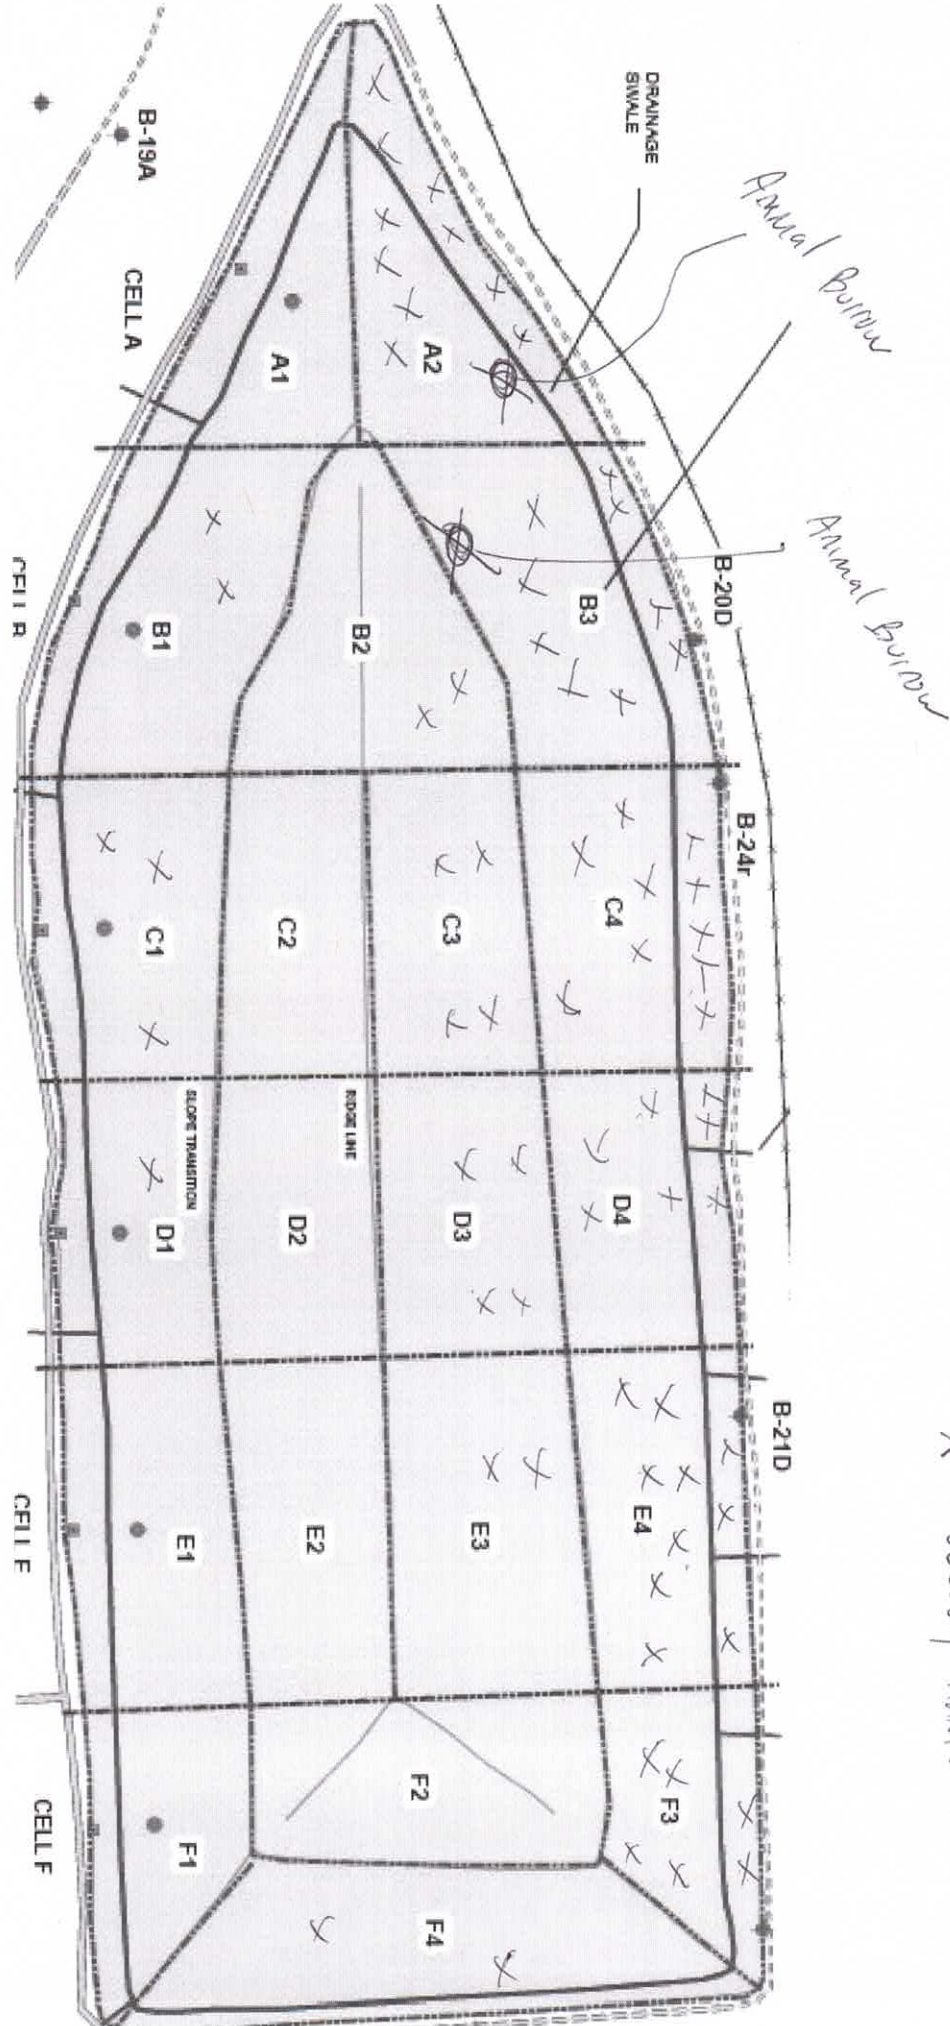
X - Woody Plants removed

Summarize monthly activities: Several woody plants (coniferous type) removed during inspection and during 4th quarter.
