**Landfill Inspection Report
Coldwater Road Landfill
Flint, Michigan
MID 005 356 860**

**RACER Trust
Ypsilanti, Michigan**

February 2013

RE: 2012 Annual Landfill Inspection Report Coldwater Road Landfill
Flint, Michigan
FILE: 14774/48630 #5

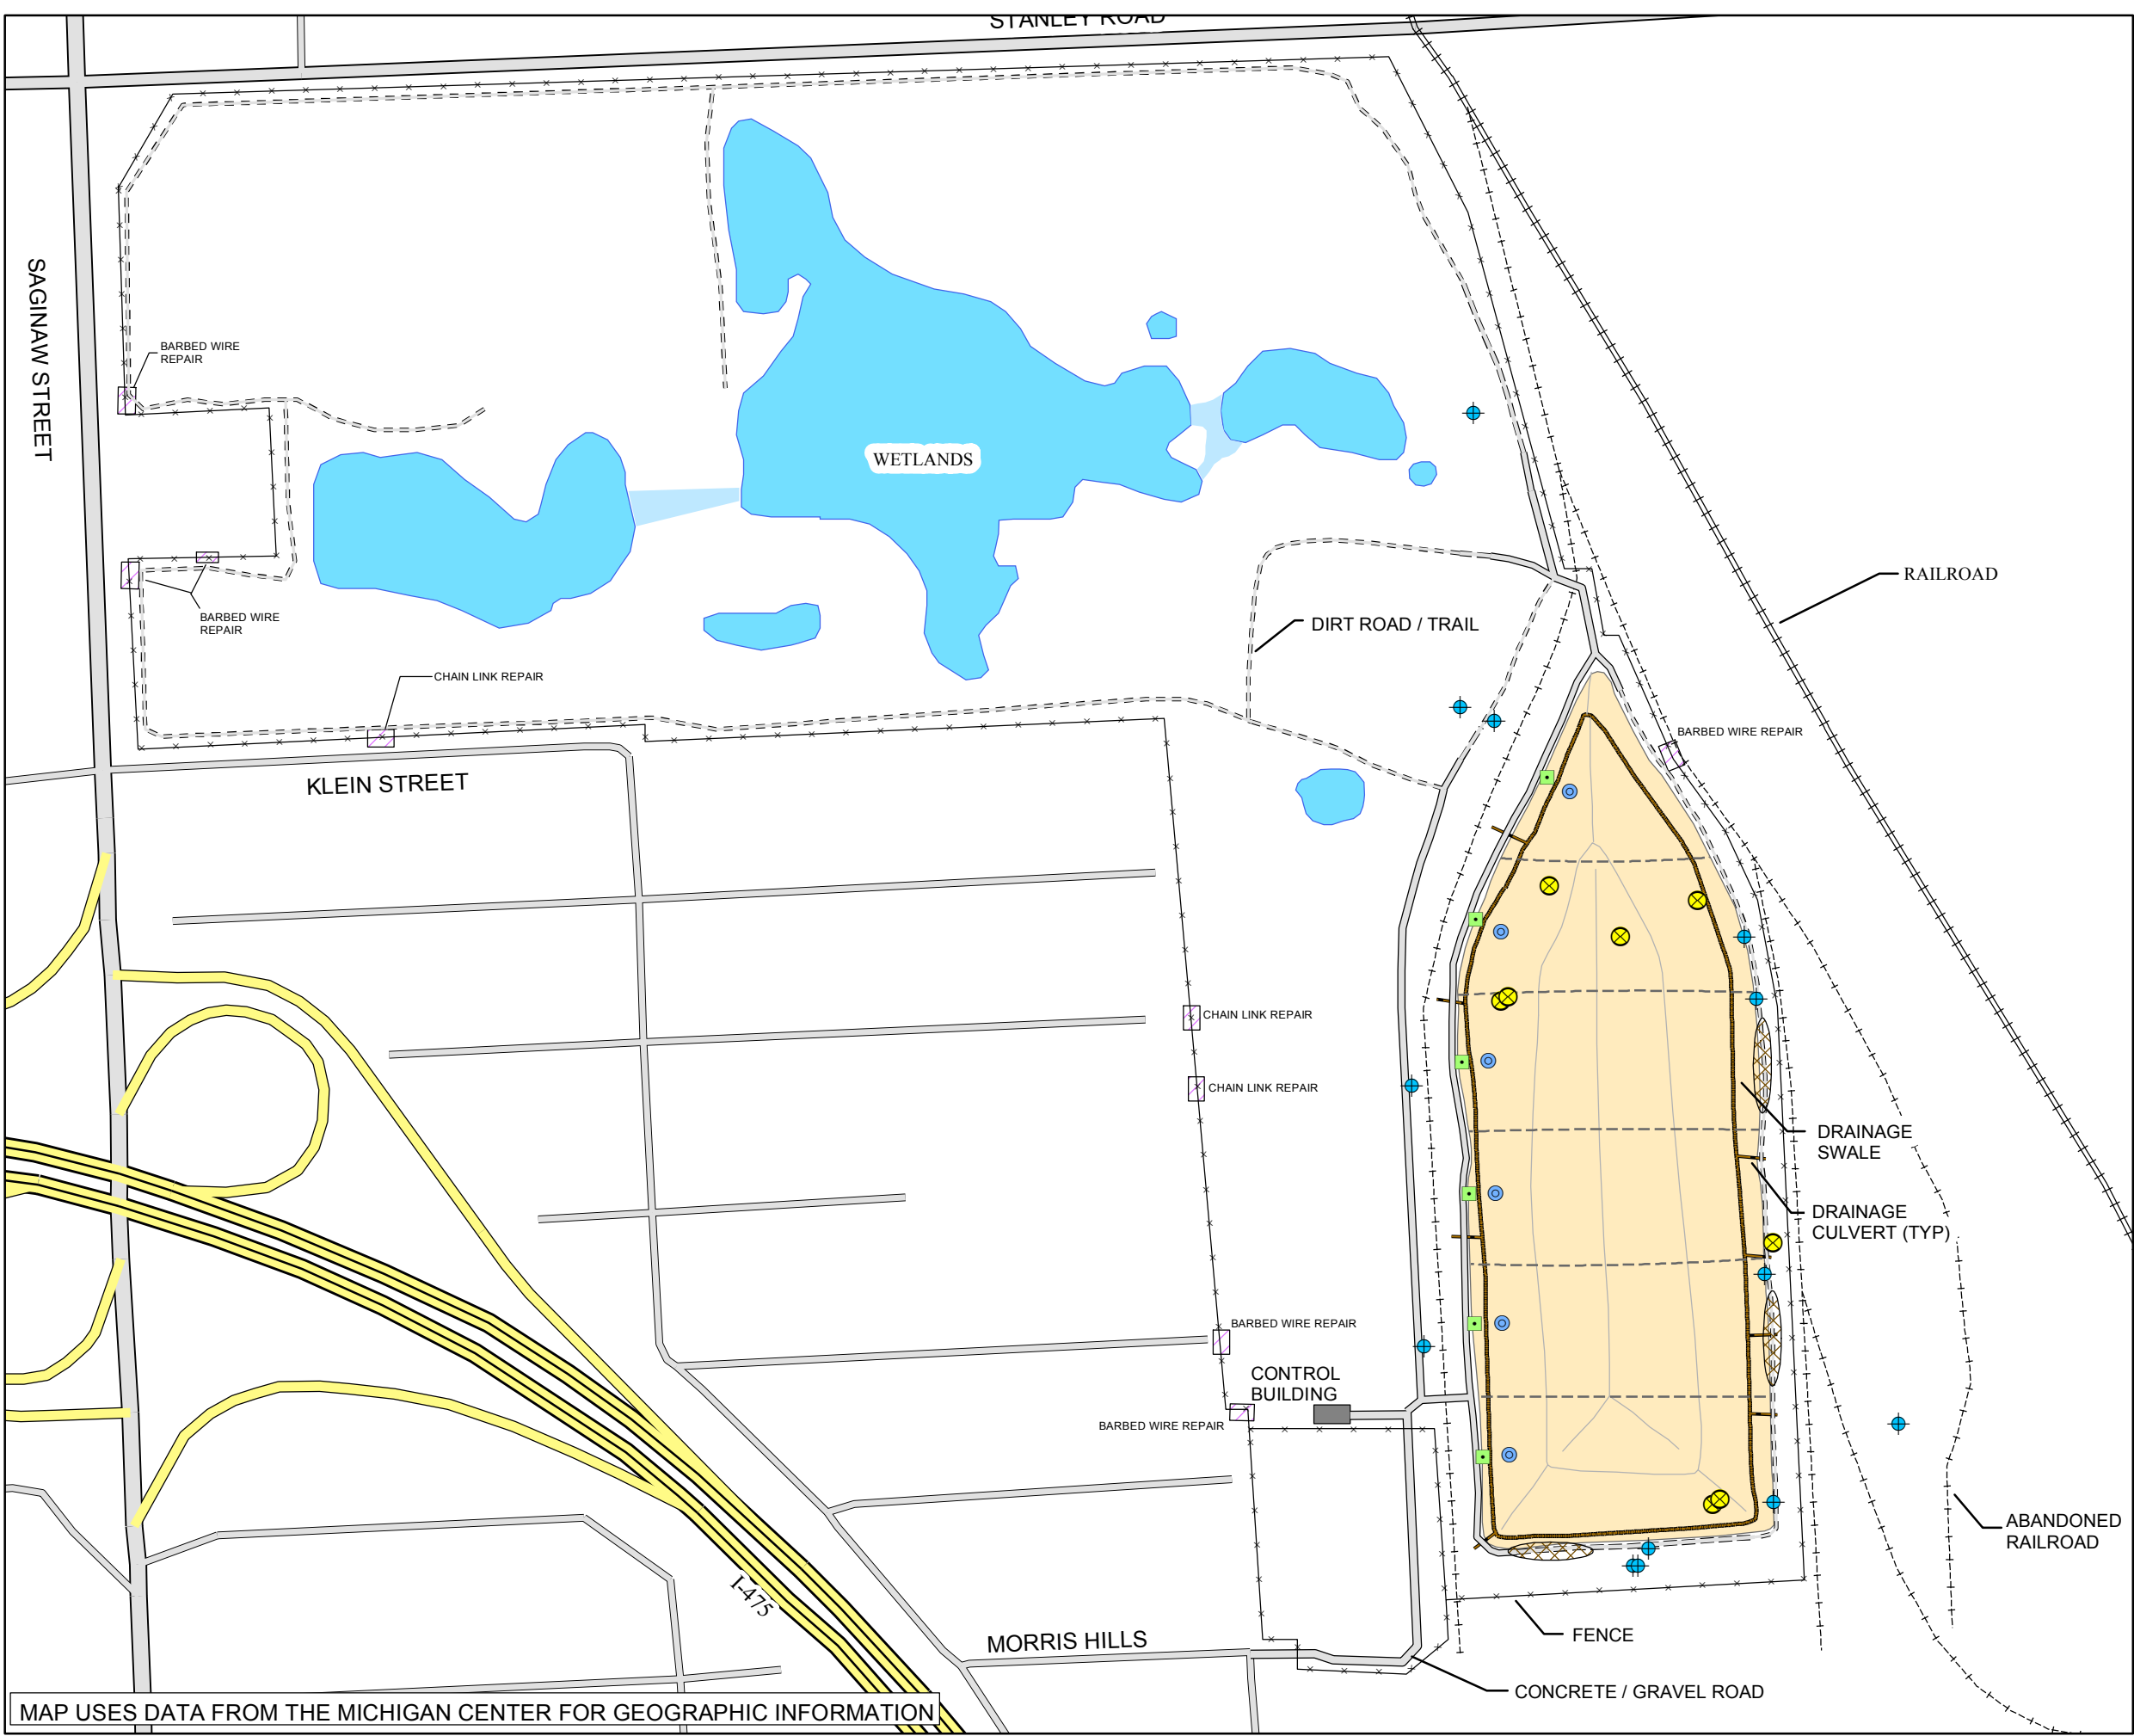
FIGURE 3

Eight animal burrows were identified and closed throughout the year. Animal burrows were photographically documented (before and after repair), and the approximate size and configuration of the burrows were documented and included in the Quarterly Status Reports.

The landfill access and perimeter roads were inspected for sufficient gravel and proper drainage during the quarterly inspections. During the 2nd quarter inspection, shallow ruts in the road were observed along the south and east landfill access road (Figure 3). The shallow ruts were filled in with gravel during the 3rd quarter and will continue to be monitored and addressed as necessary. No other problems to the access roads were observed during 2012.

Damage to the site perimeter fence and/or the barbwire was noted at a number of locations during the quarterly inspections. During the 1st quarter inspection, two sections of downed barbwire were observed along the east and west perimeter fence. During the 3rd quarter inspection, three previously repaired holes were reopened along the west perimeter fence. During the 4th quarter inspection, a section of downed barbwire was observed along the west perimeter fence.

The holes in the perimeter fence and downed barbwire were repaired either during the inspections or shortly thereafter.
