Re: Ley Creek PCB Dredgings Site (Registry # 7-34-044)
NYSDEC Order on Consent Index # D-7-0008-97-06
2004 Annual OM&M Inspection Report

Re: Ley Creek PCB Dredgings Site
August 2004 OM&M Inspection

**AUGUST 2004
OM&M INSPECTION
PARTIAL SITE PLAN**

Re: Ley Creek PCB Dredgings Site
2004 OM&M Wetland Evaluation

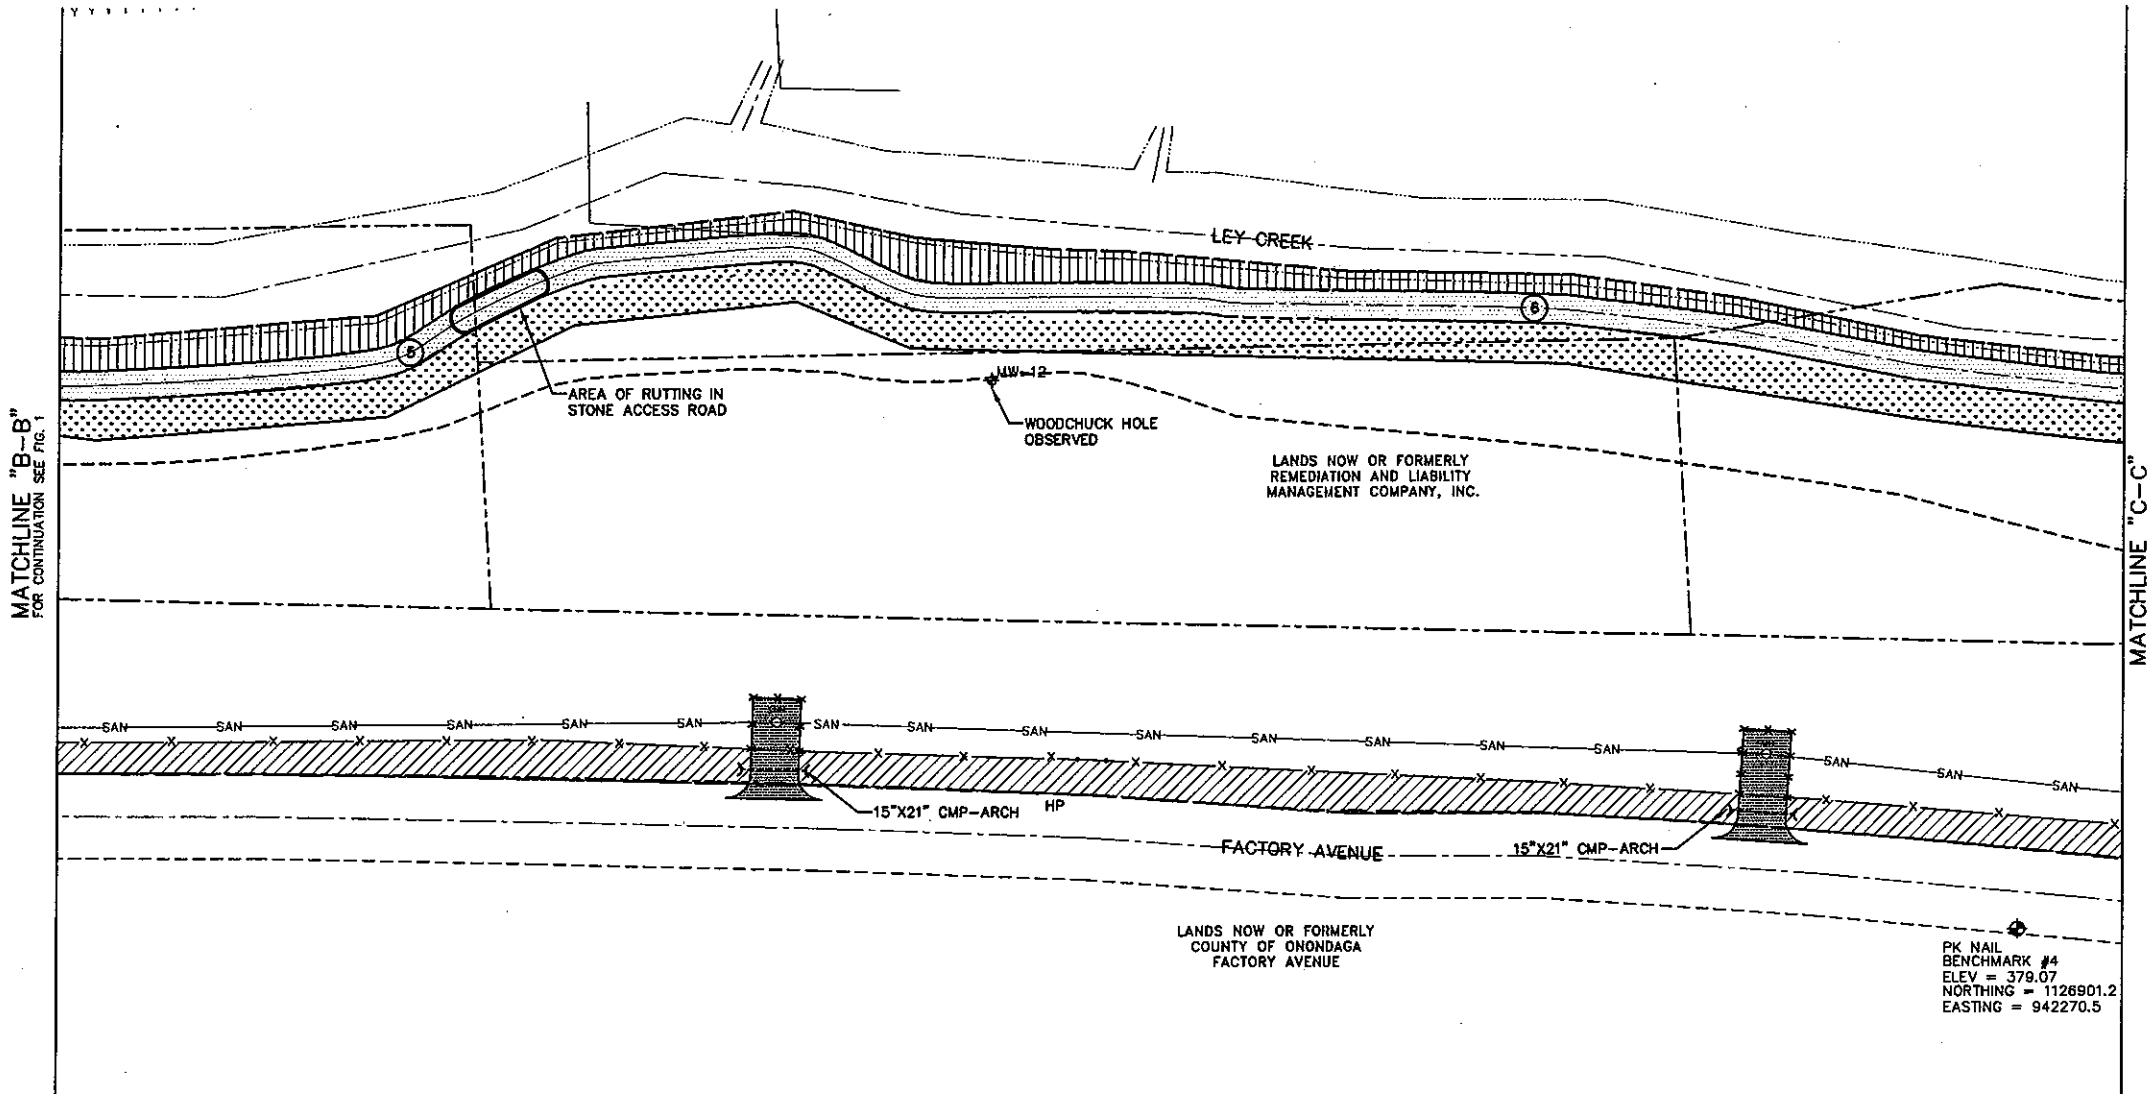
FIGURE 2

- Burrowing animals: (Figures 2 and 3.) A woodchuck hole near MW-12 and the one observed in the June 2003 inspection, in the area of catch basin CB-3, require repair.

- Stone access road drainage: (Figure 2.) One area of the stone access road observed during the June 2003 inspection to have rutting and poor drainage, which was characterized by ponded water being visible within the stone access road, requires repair.

- Remove the woodchuck(s) from the Site, place topsoil in the holes, and apply seed and fertilizer
- Repair the area of rutting of the stone access road by placement of additional crushed stone and improve drainage of the stone access road by constructing small drainage channels to convey ponded water from the stone access road to Ley Creek. This could be performed by removal of less than 1 foot of vegetative cover material with subsequent replacement of crushed stone

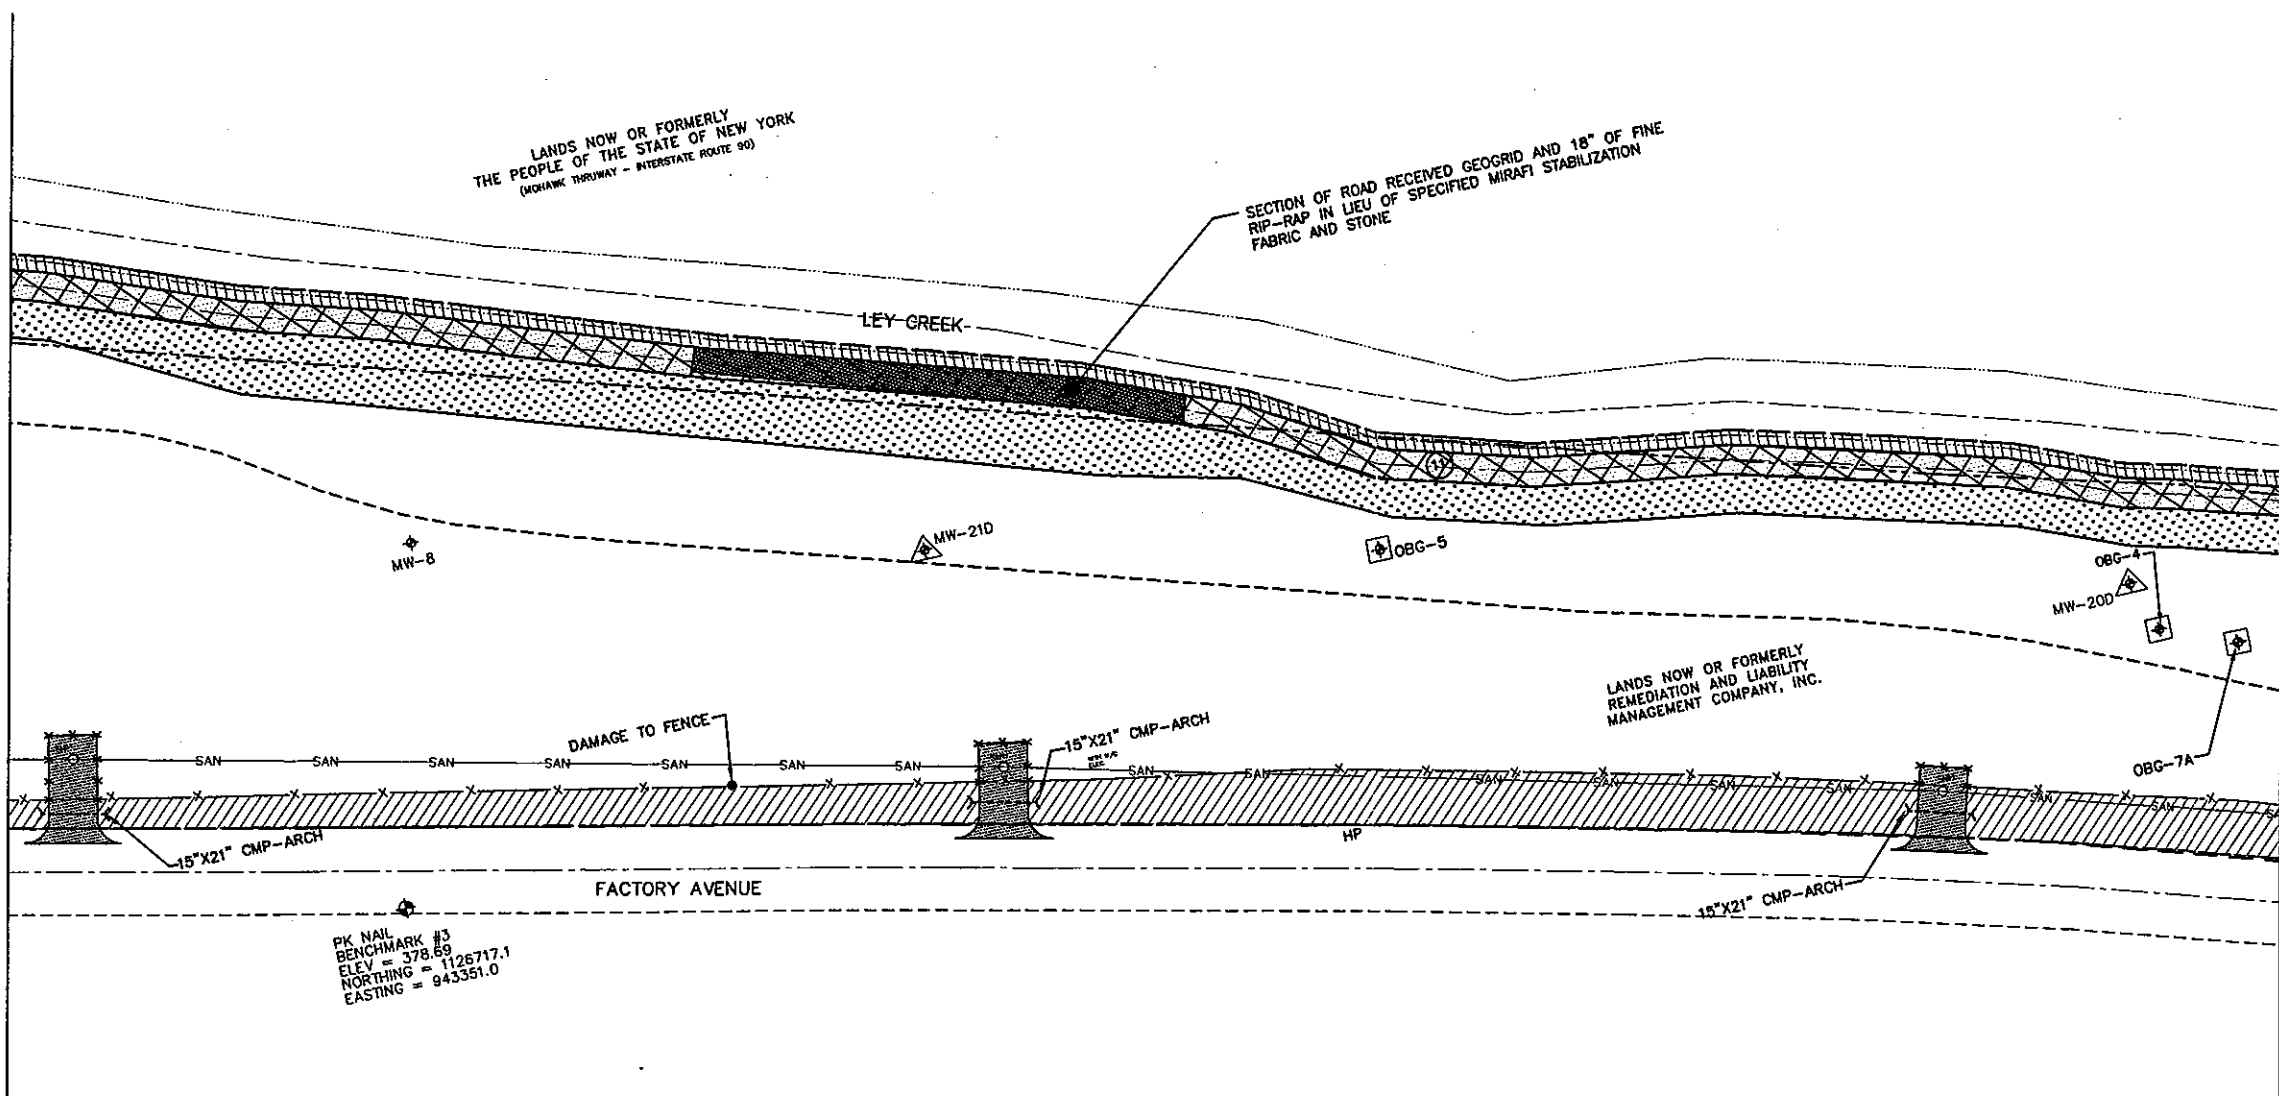
FIGURE 4

The two areas of the site security fence that were observed to be damaged during the August 2002 site inspection (Figures 4 and 5) have not been repaired and should be repaired as soon as practicable.

- Repair the damaged site security fence
- Repair eroded areas of the vegetative cover by placement of topsoil and subsequent application of seed and fertilizer

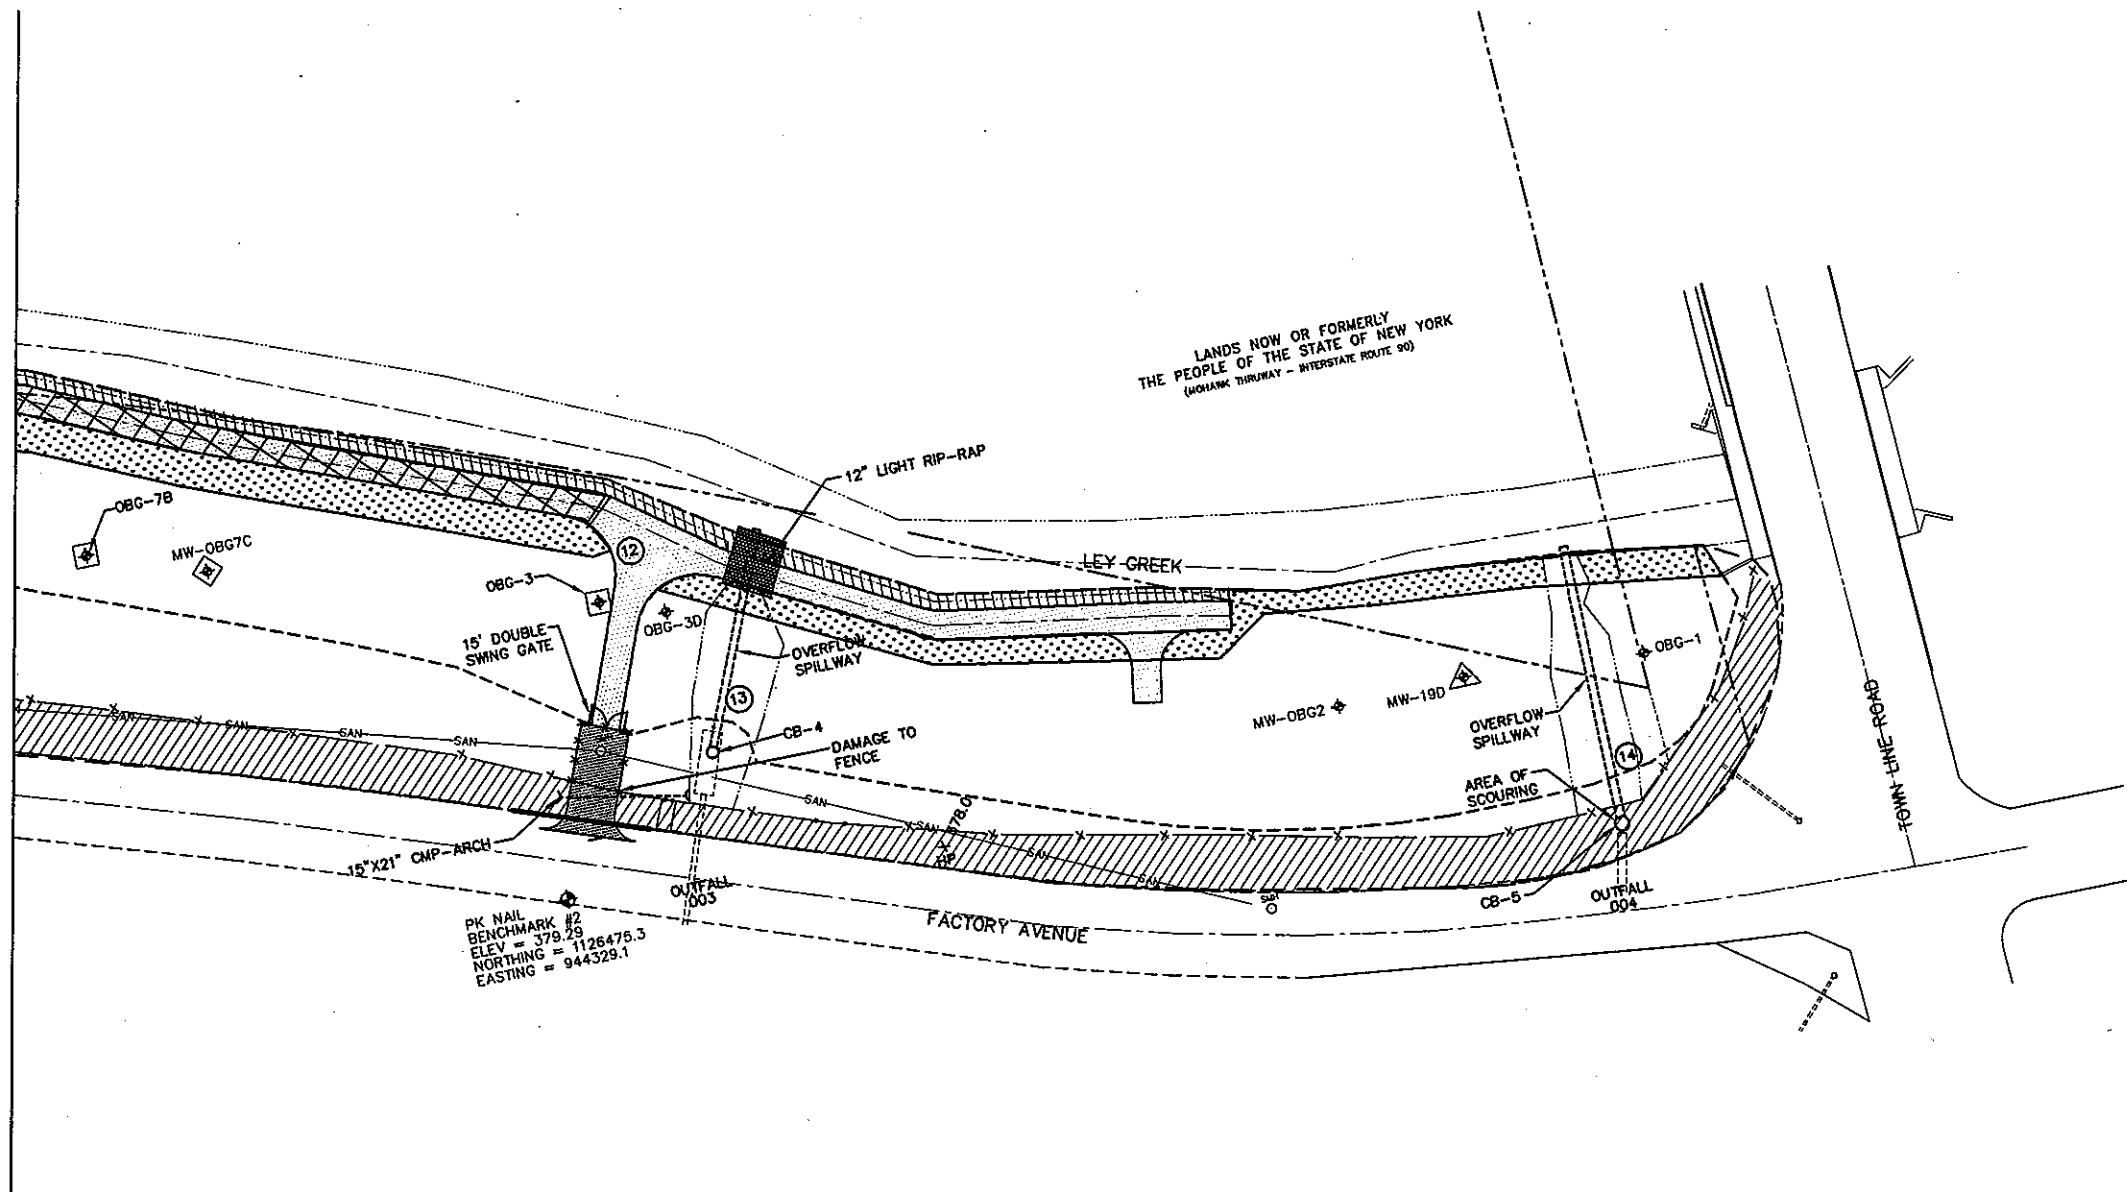
FIGURE 5

- Excessive scouring: (Figure 5.) The excessive scouring that was observed in the August 2002 inspection requires repair.
- Area requiring mowing: The vegetation around the catch basins, monitoring wells, utility poles, guy wires, and along the fence line requires mowing

- Remove the debris around catch basin CB-1 and catch basin CB-2 grates
- Repair the area of excessive scouring by removal of rip-rap, placement of compacted crushed stone to meet surrounding grade, and replacement of rip-rap
