30214041.00006

RACER Pontiac North Campus – 2023 Property Inspection Report

IC/EC Inspection Report for Pontiac North, MI at Pontiac North Campus Industrial Land (#11970) on October 10, 2023

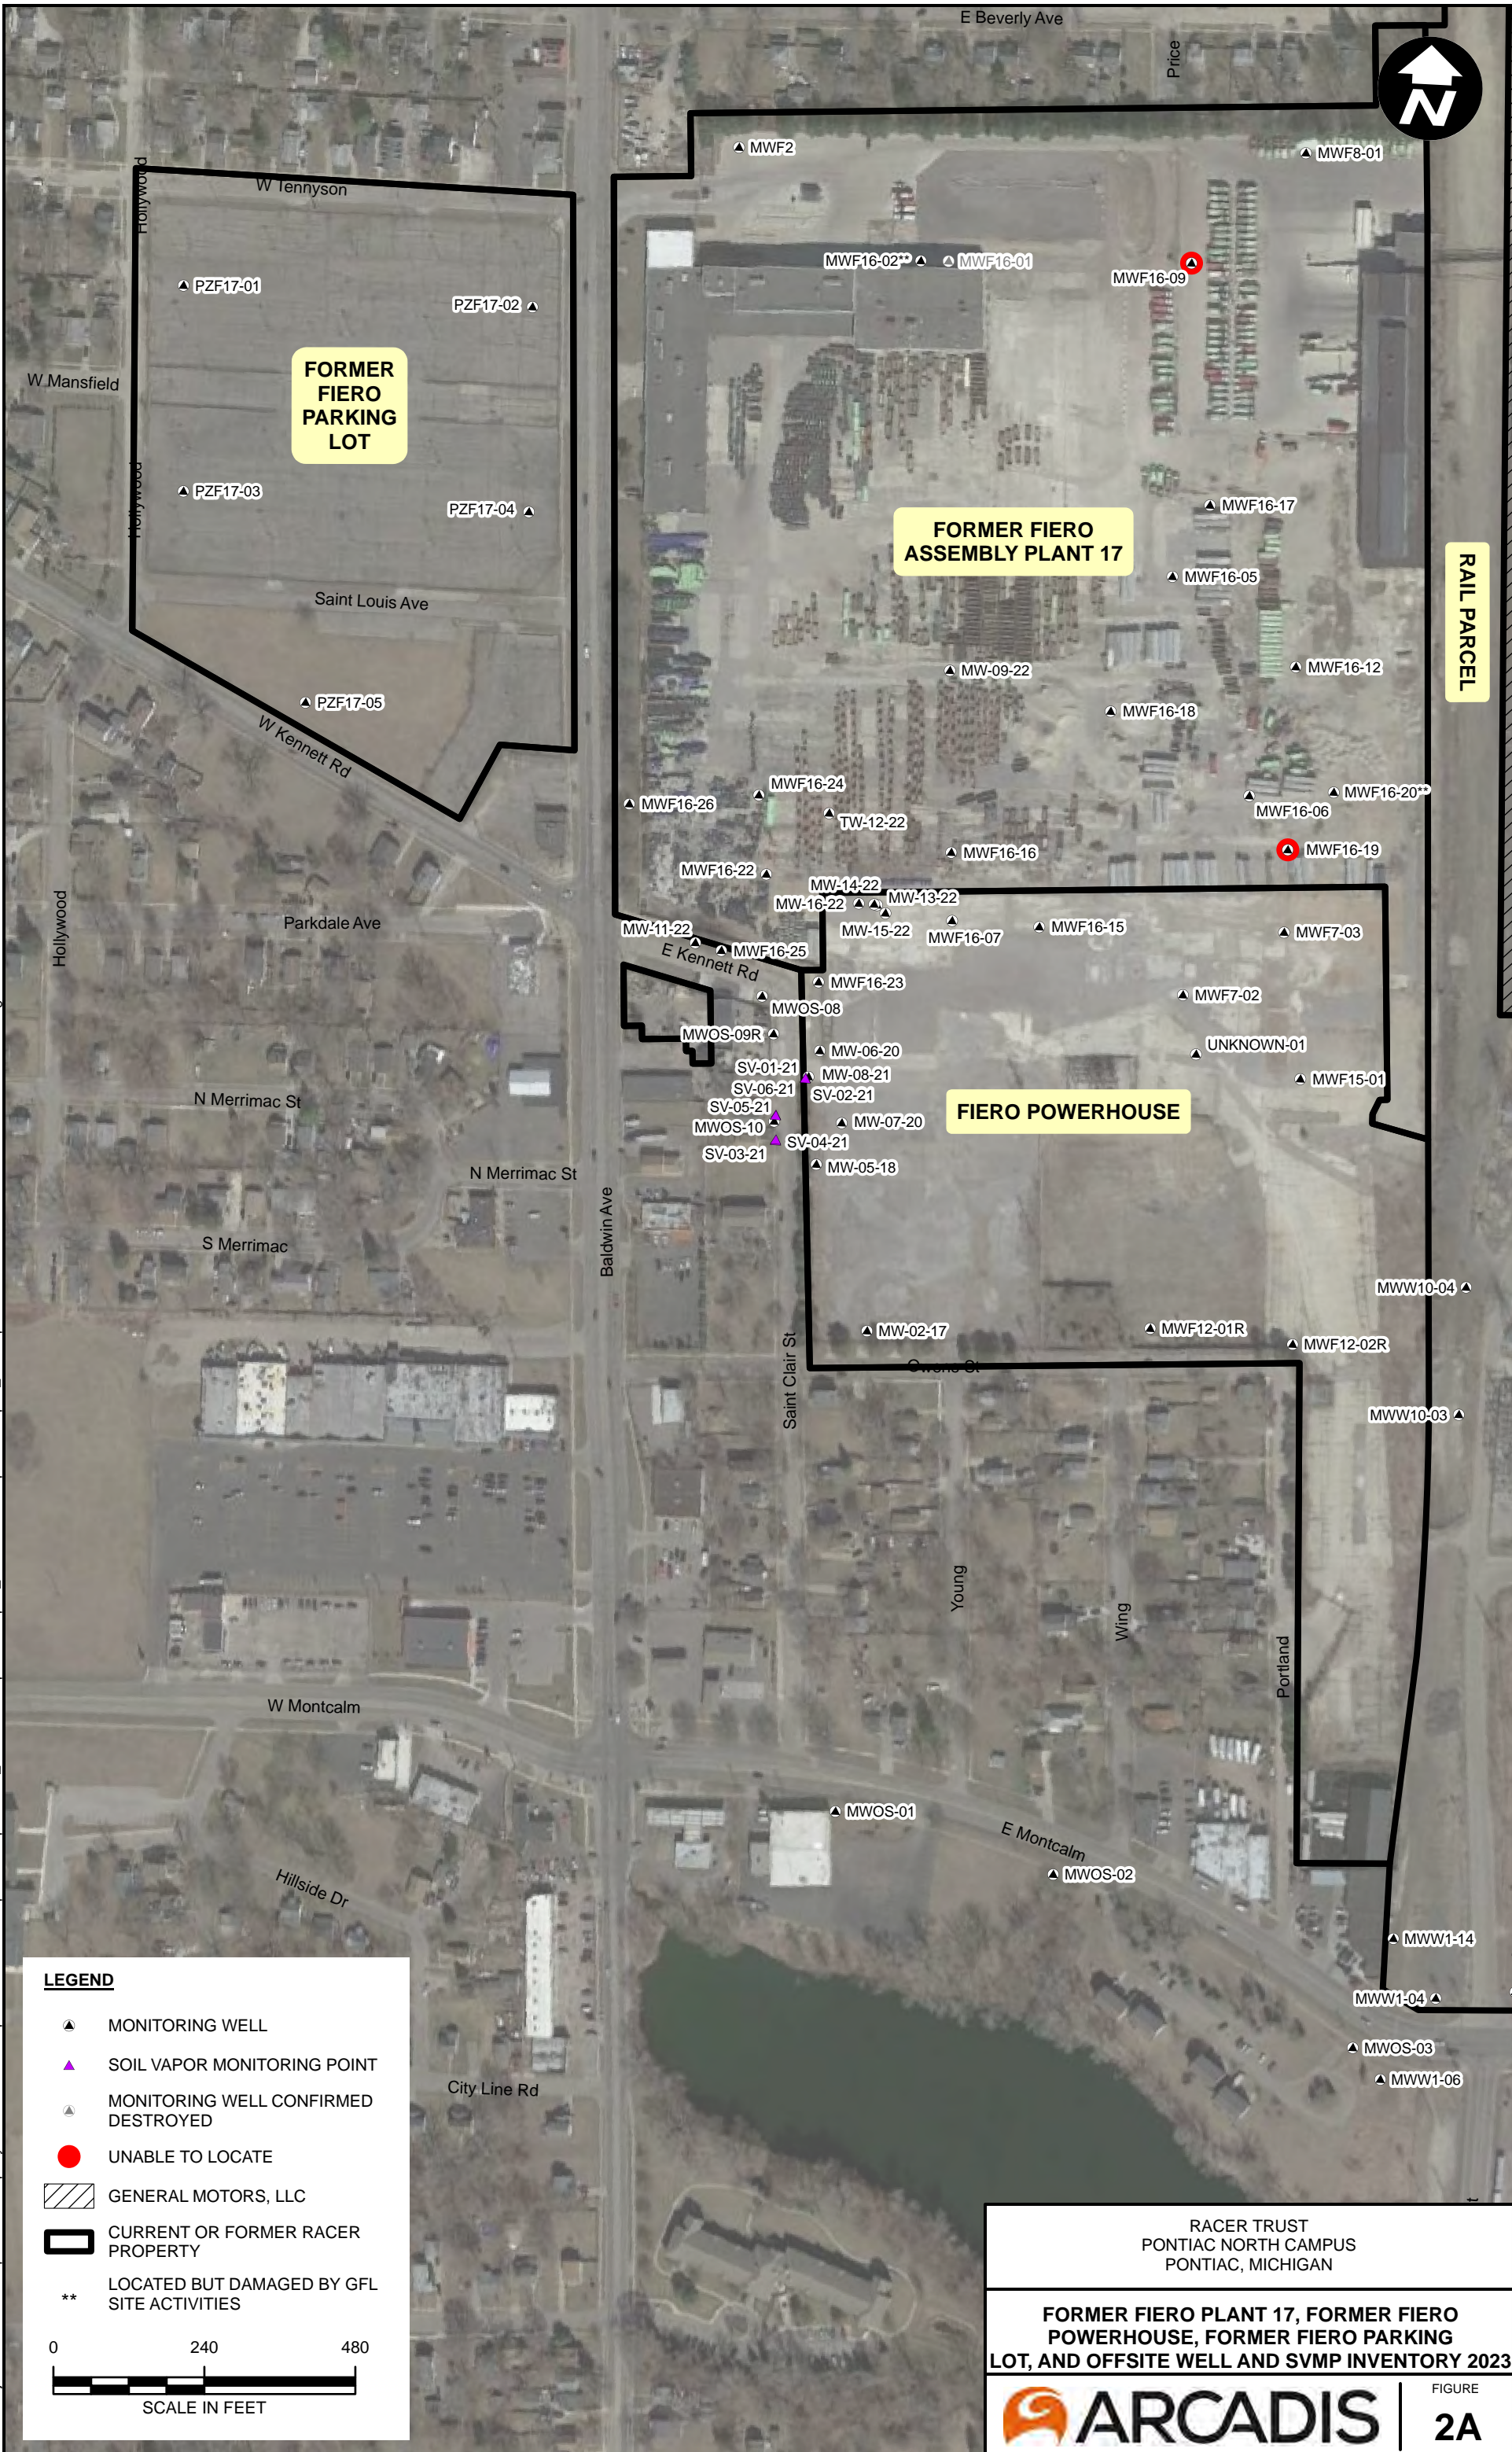
FORMER FIERO PLANT 17, FORMER FIERO POWERHOUSE, FORMER FIERO PARKING LOT, AND OFFSITE WELL AND SVMP INVENTORY 2023

RACER PNC Property	Wells and SVMPs Located on Property	Comments
Former Fiero Assembly (Table 1 and Figure 2A)	17/20 wells located (7/7 wells used for annual groundwater monitoring were located) (Note: in the prior 2022 Annual Report text the number of wells that were recorded under Fiero Assembly was incorrect and this has been corrected)	MWF16-02 and MWF16-20 were located in 2023 but have been damaged by GFL construction activities. MWF16-19 was likely covered by GFL construction materials at the time of inspection. MWF16-09 was located in 2022 but could not be located during 2023 inspection
Former Fiero Parking Lots (Table 2 and Figure 2A)	5/5 wells located (5/5 wells used for annual groundwater gauging were located)	All gauging wells in good condition.
Former Fiero Powerhouse (Table 3 and Figure 2A)	18/18 wells located (7/7 wells used for annual groundwater monitoring were located)	Wells in good condition except for some missing locks and in a condition where the lids can no longer be bolted.

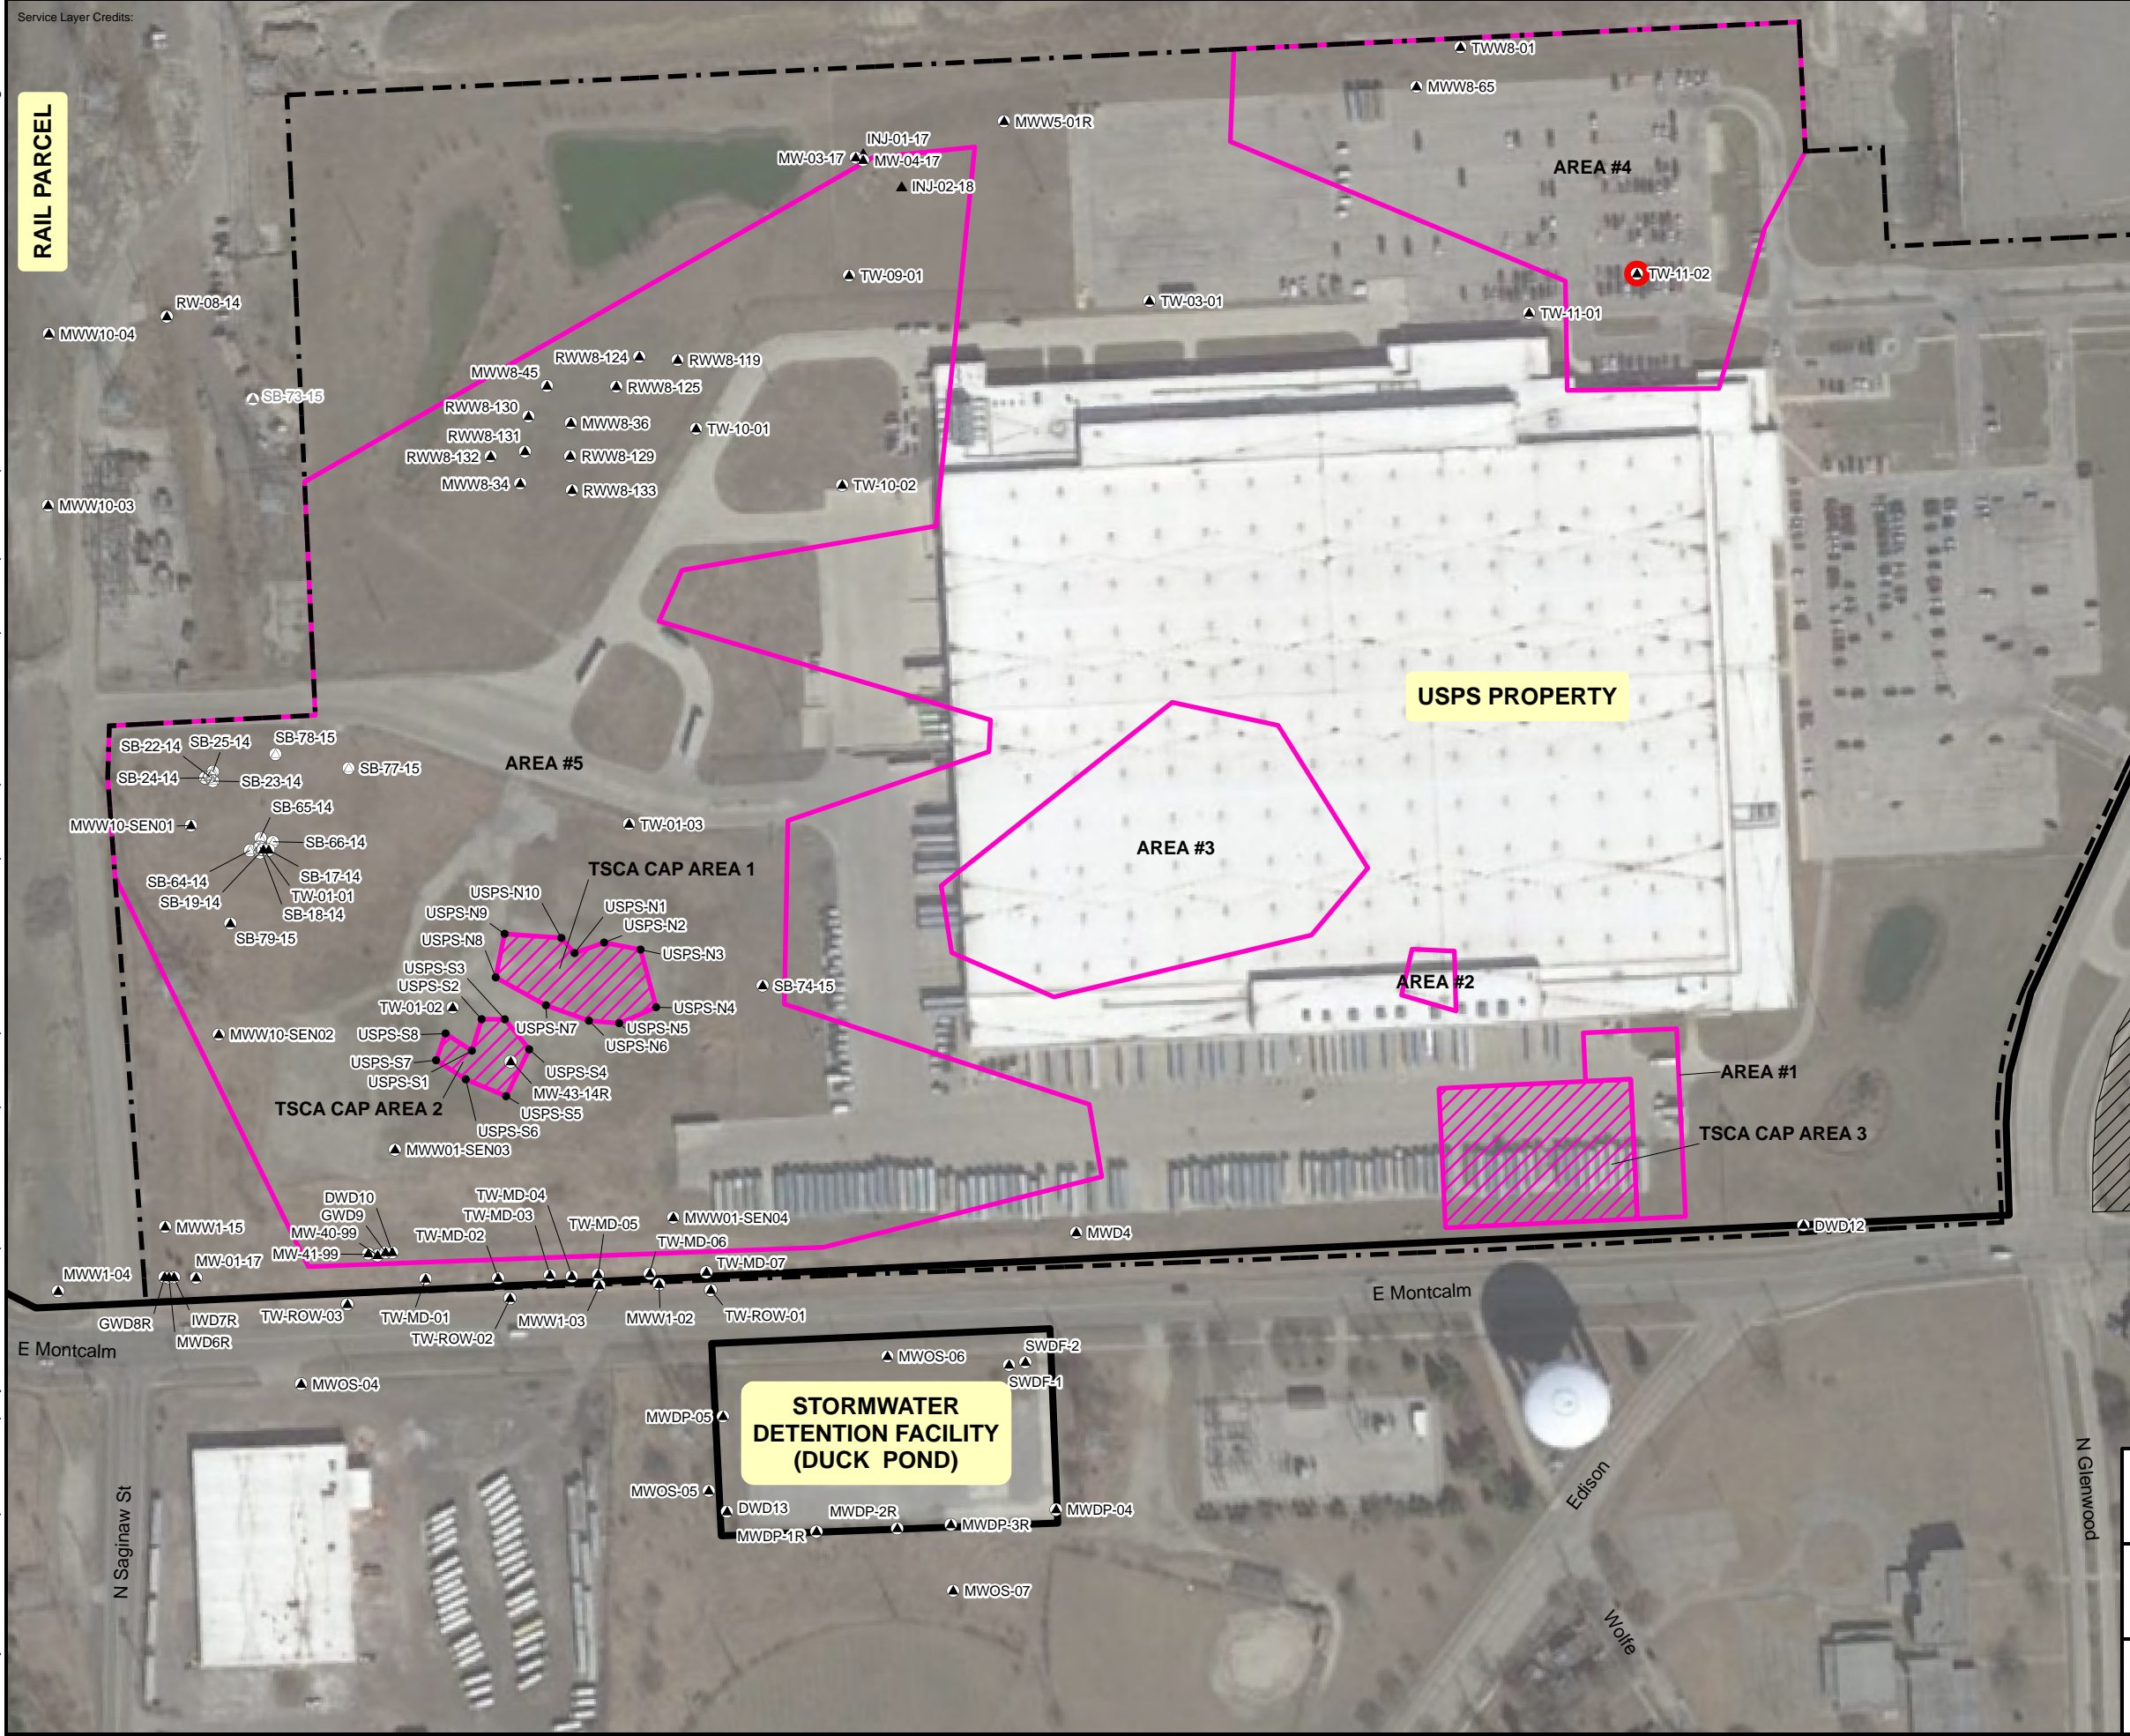
**RESTRICTION AREAS AND
 USPS WELL INVENTORY 2023**

RACER PNC Property	Wells and SVMPs Located on Property	Comments
USPS (Table 4 and Figure 2B)	68/69 wells located (33/34 wells used for annual groundwater monitoring were located)	TW-11-02 was not located but was likely under parked vehicles; some wells had missing bolts or lid will not close.
Former Plant 14S (Plants 5 and 23) (Table 5 and Figure 2C)	3/3 wells located (3/3 wells used for annual groundwater monitoring were located)	MWM2-22 was labeled incorrectly and did not have a lid. The well was properly labeled at a later date.
Former Plant 25 (Table 6 and Figure 2D)	10/47 wells located (5/6 wells used for annual groundwater monitoring were located)	Majority of wells are covered with soil, gravel, and debris piles and therefore could not be located. MWM4-06R was not located during the annual inspection but was found before the inspection and was gauged during the annual gauging event in 2023.

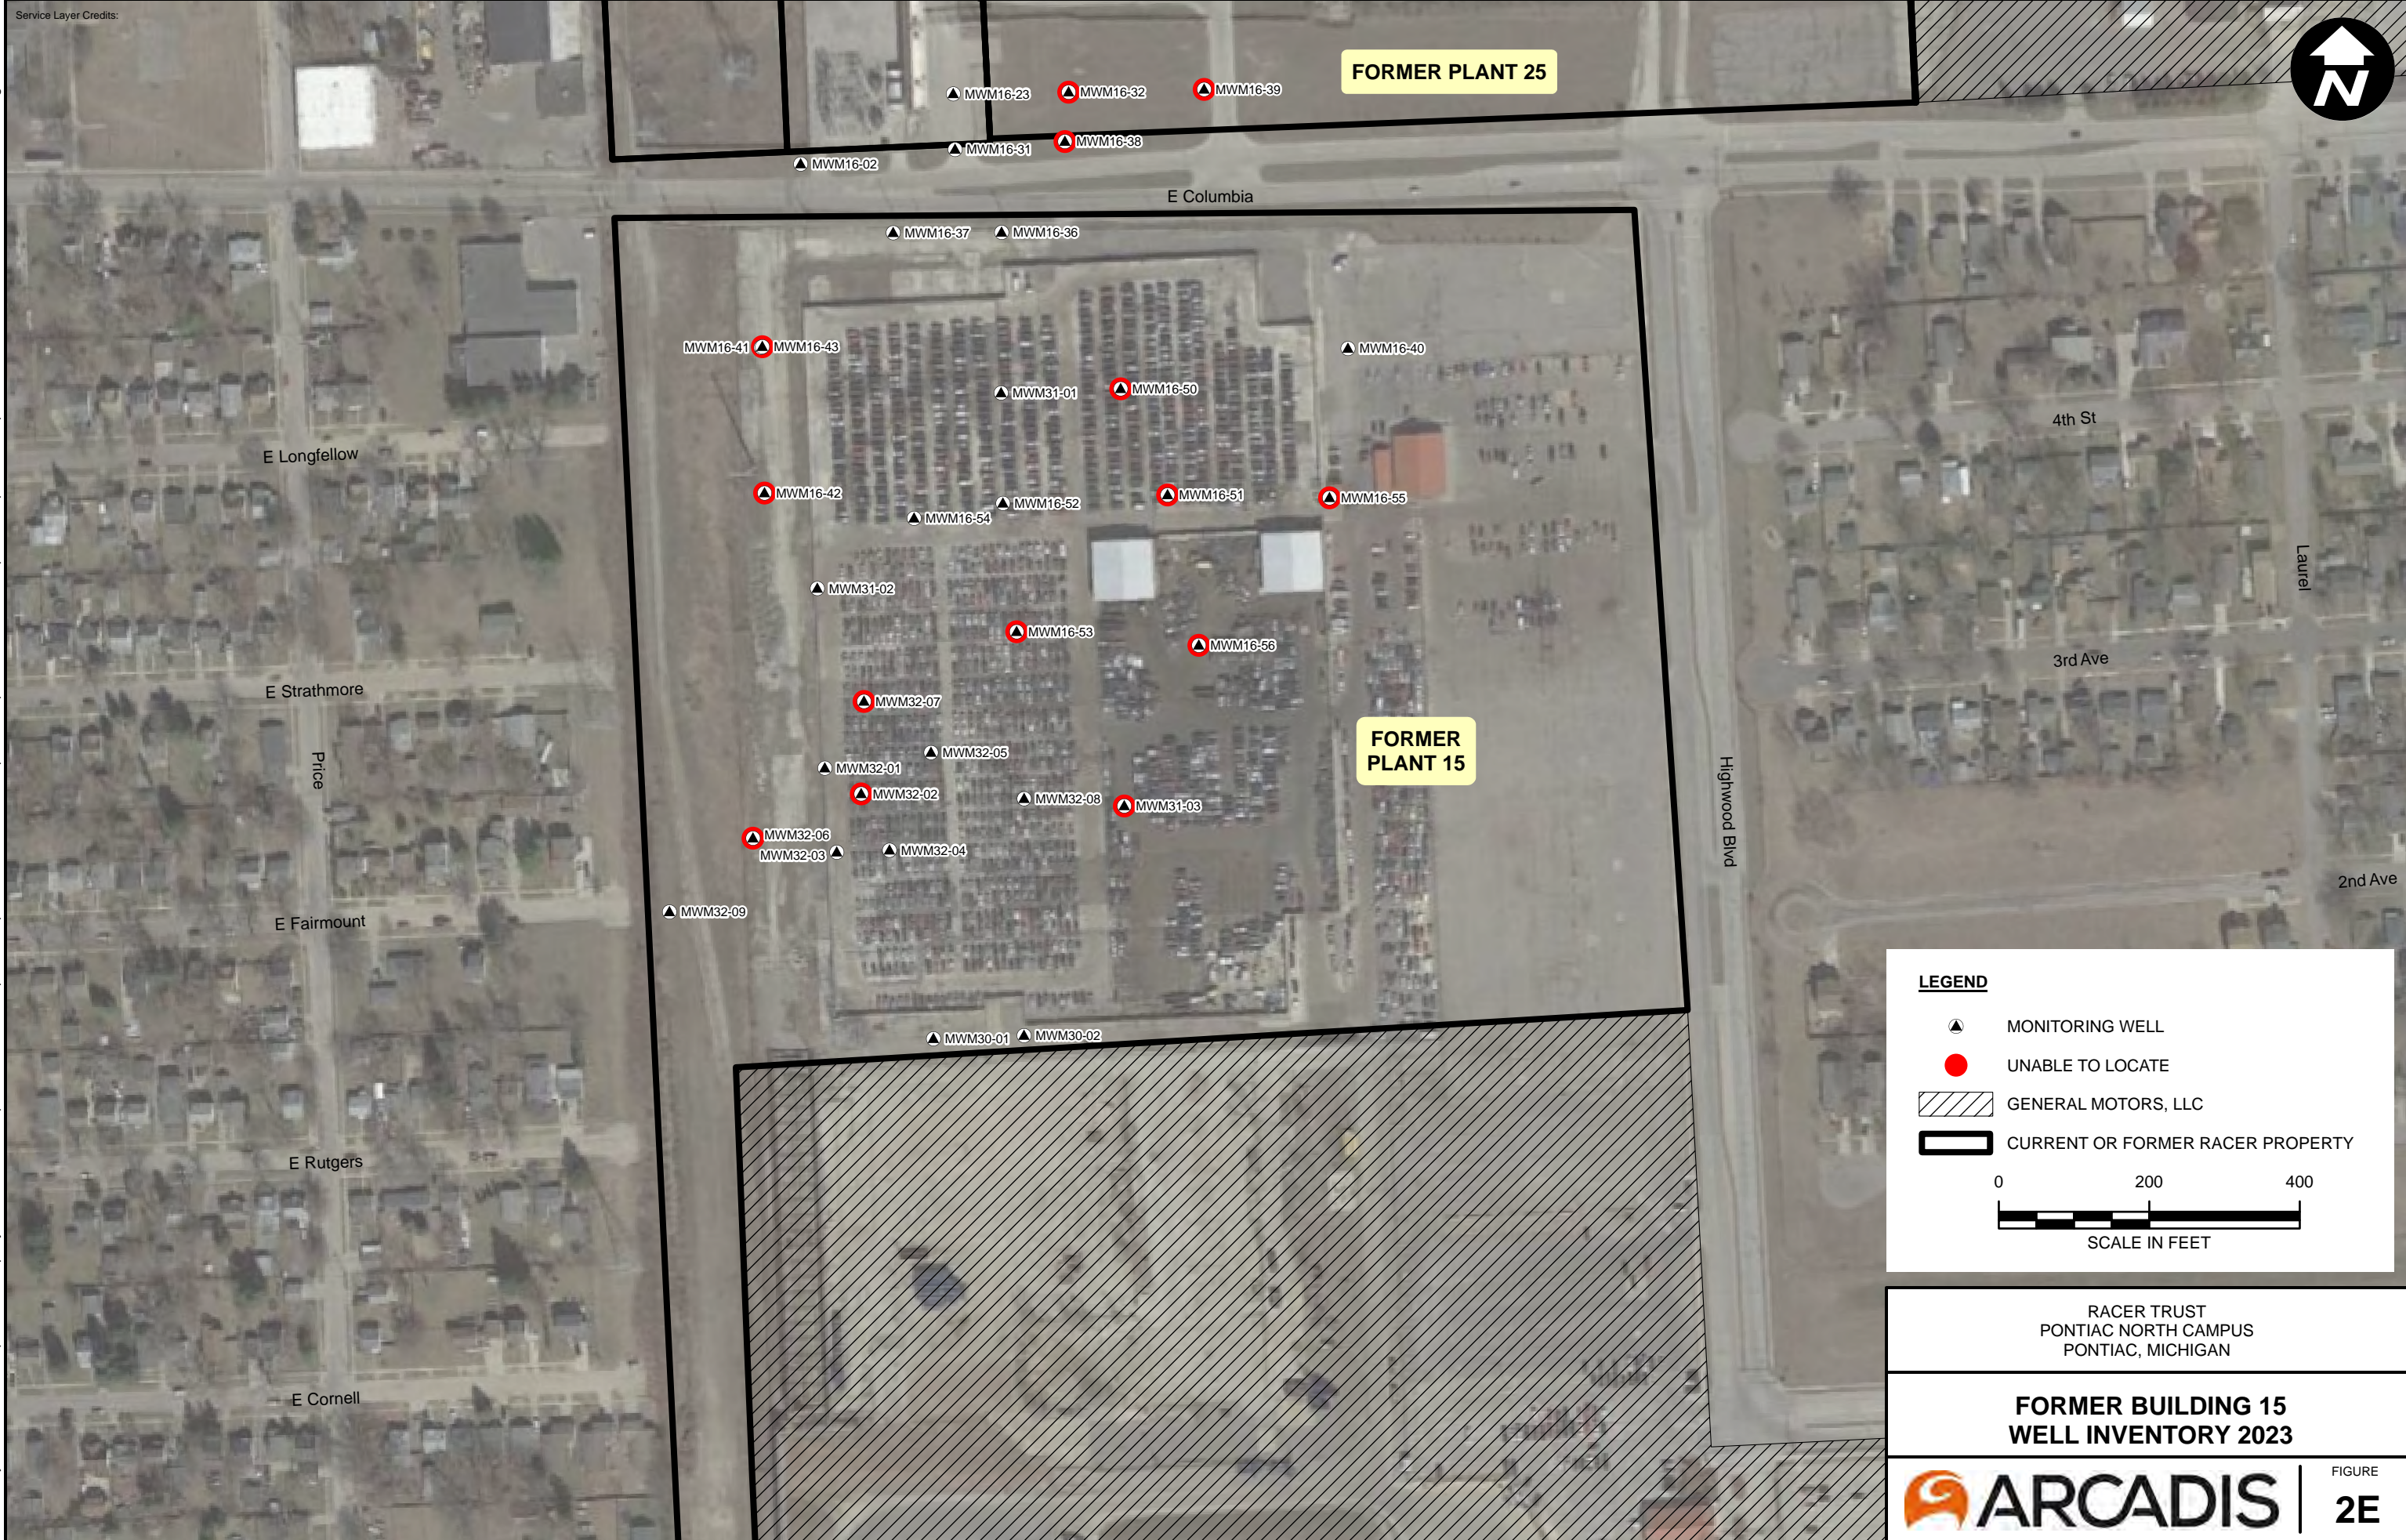
**FORMER BUILDING 15
WELL INVENTORY 2023**

Former Plant 15 (Table 7 and Figure 2E)	16/27 wells located (3/3 wells used for annual groundwater monitoring were located)	Many wells are apparently covered with scrap cars; some missing lids or in a condition where the lids can no longer be bolted.
Rail Parcels (Table 8 and Figures 2A, 2C, and 2D)	5/7 wells located (2/3 wells used for annual groundwater monitoring were located)	SB-73-15 has been confirmed destroyed and MWM4-05 could not be accessed as in a locked property but was previously accessed and gauged during the annual gauging event in 2023.
Duck Pond (Table 9 and Figure 2F)	8/8 wells located (3/3 wells used for annual groundwater monitoring were located)	All wells in good condition; some are missing bolts.
Offsite (Table 10 and Figures 2A, 2D, 2E, and 2F)	11/12 wells located (11/11 wells used for annual groundwater monitoring were located) 6/6 SVMP's located	All wells in good condition some are missing bolts. PZOS-02 could not be located as construction activities near the well prevented accessing the location.

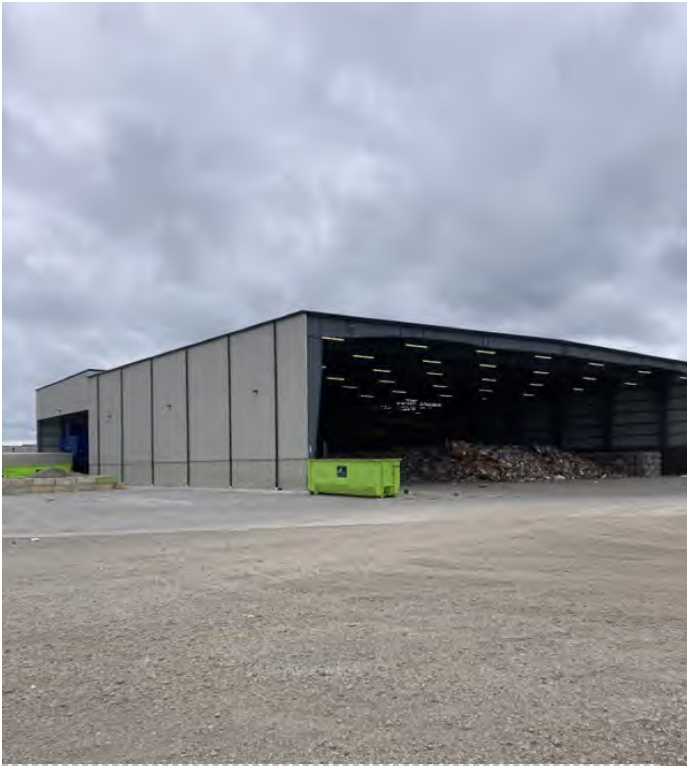
Building addition to existing assembly plant that was constructed last year in use located in northern portion of property

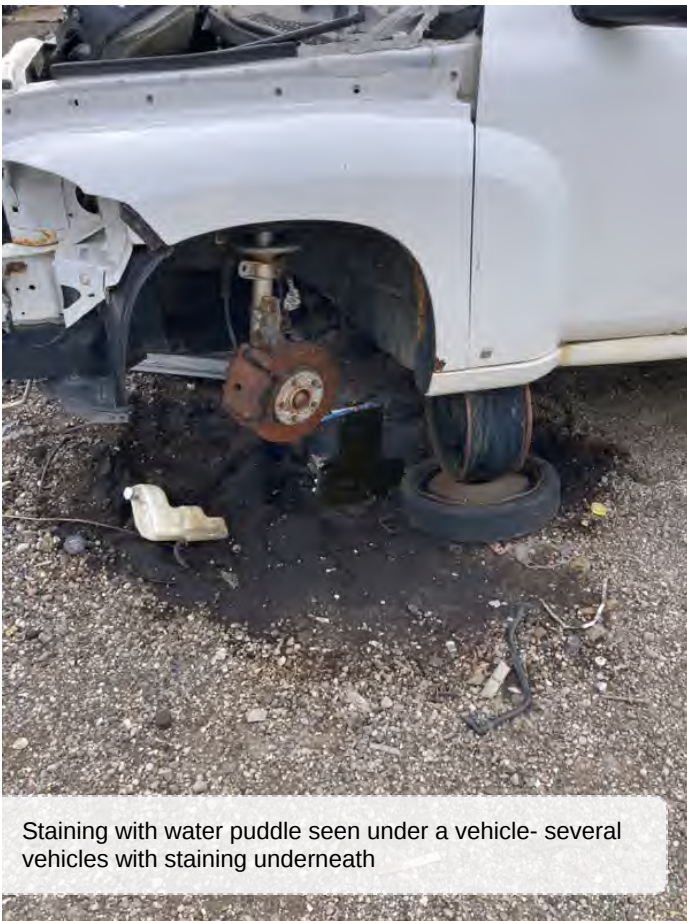
Staining with water puddle seen under a vehicle- several vehicles with staining underneath

Name of the IC	Annual DRC inspection- U pull and save auto parts
Characterize restricted activities and uses	Other Restrictions
Characterize other restriction(s)	No water wells observed at property; no evidence of excavation or soil relocation; no evidence of subsurface utility installation; no new buildings have been constructed; property is being used for non residential purposes.
Do site use and activities comply with other restrictions	Yes
Other comments or notes about the IC?	Staining observed beneath most vehicles stored at property

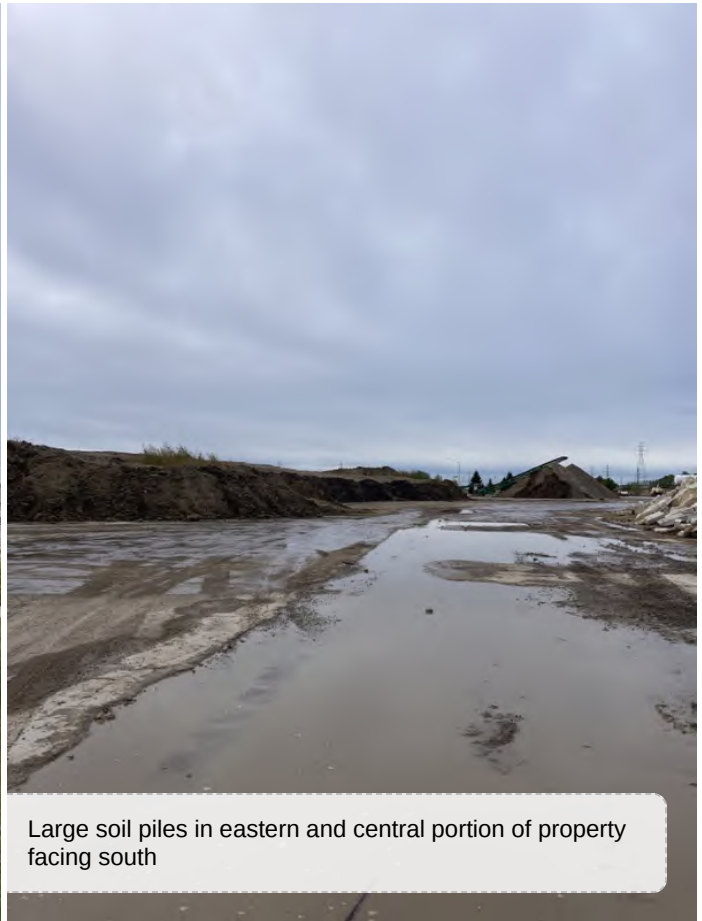
Large soil piles in eastern and central portion of property facing south

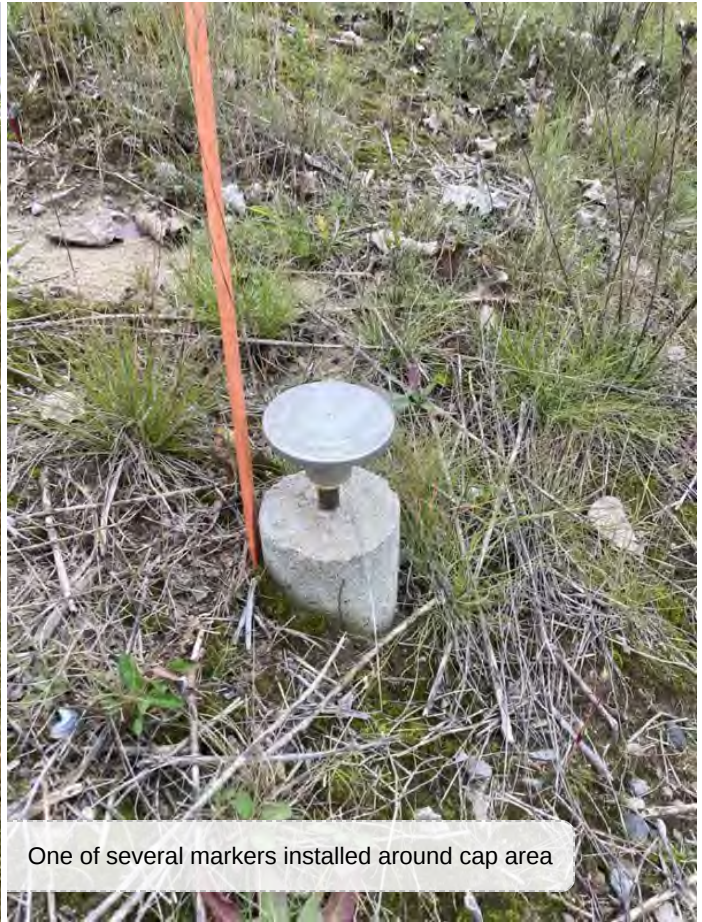
- Area #1/West TSCA Cap
 - The six stakes to define cap boundaries are in place and in good condition, but may want to re-paint orange for better visibility

One of several markers installed around cap area

- Cap was free of tall vegetation and larger trees as clearing occurred in September 2022
 - Cap area is free of debris and trash
 - In summary, no current conditions warrant corrective measures, with the exception of the replacement and re-painting stakes orange for better marker visibility

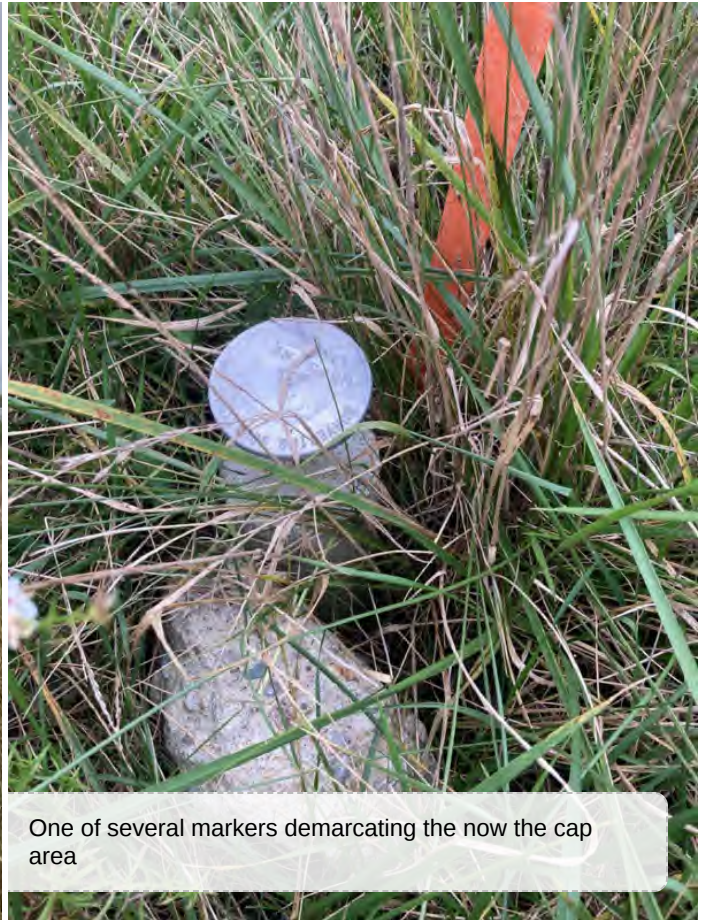
- Grass is in good condition
 - No evidence of erosion or visible indication of demarcation barrier
 - Cap is free of larger trees, but tall reeds and vegetation observed along with ponding water in areas

One of several markers demarcating the now the cap area

- Cap area is free of debris and trash
 - In summary, no current conditions warrant corrective measures, with the exception of cutting vegetation and re-painting stakes orange for better visibility

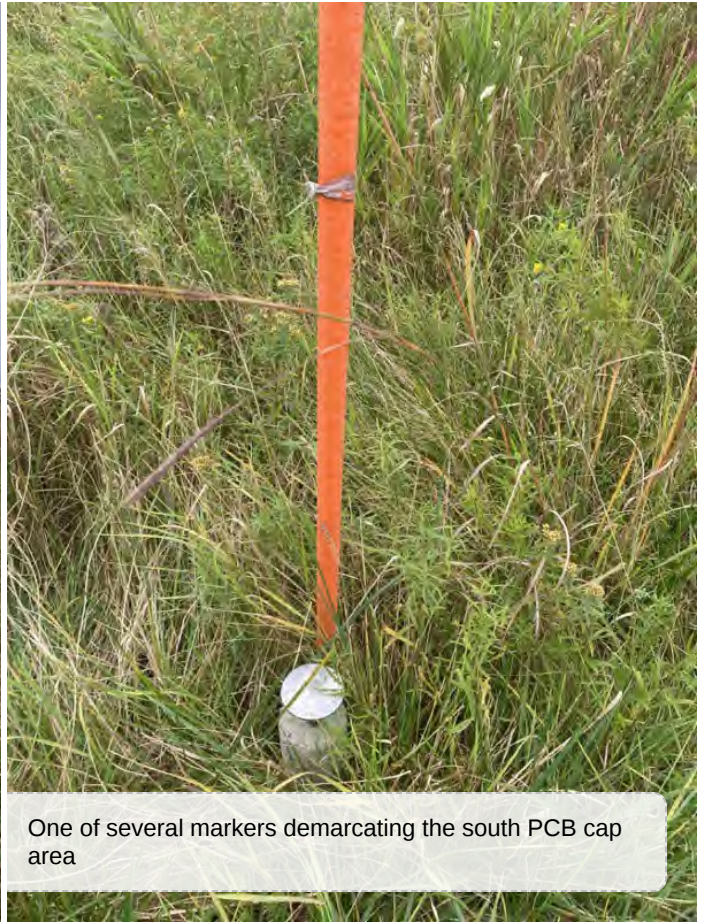
- All eight of the permanent monuments to identify limits and elevations are intact and legible; however, tall reeds and vegetation observed made some of the markers hard to locate

One of several markers demarcating the south PCB cap area

- Cap area is free of debris and trash
 - In summary, no current conditions warrant corrective measures, with the exception of mowing vegetation and re-painting stakes orange for better visibility

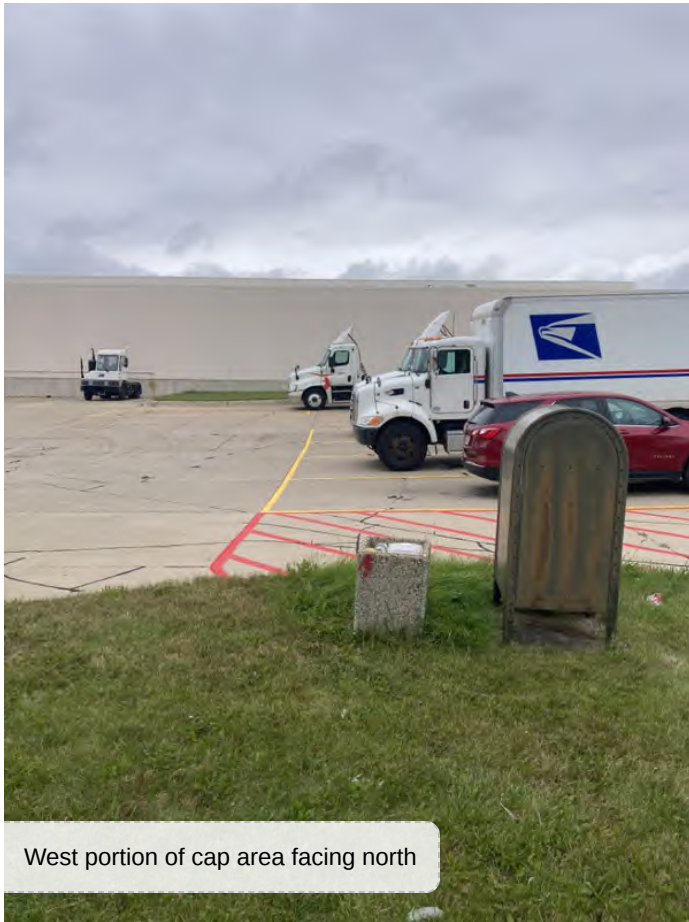
- Paved surfaces are intact and in good condition
 - Grass is in good condition where present
 - No evidence of erosion
 - Cap is free of larger trees
 - Cap area is mostly free of debris and trash

West portion of cap area facing north

- In summary, no current conditions warrant corrective measures

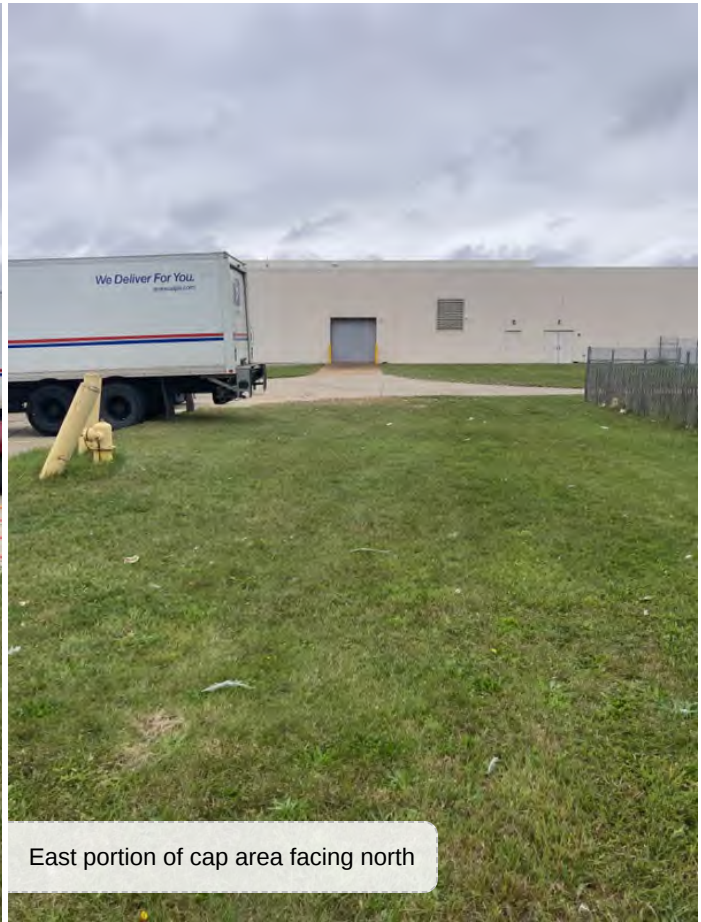
East portion of cap area facing north
