RE: Windiate Park/Dixieland Subdivision Landfill, Pengelly Road Site, Genesee County, Michigan  
(Site ID No. 25000689)

FILE: 15388/72201 - Soil Cover Inspection Report

## WINDIATE PARK SOIL COVER MAINTENANCE CHECKLIST

Inspection Date: May 17, 2019

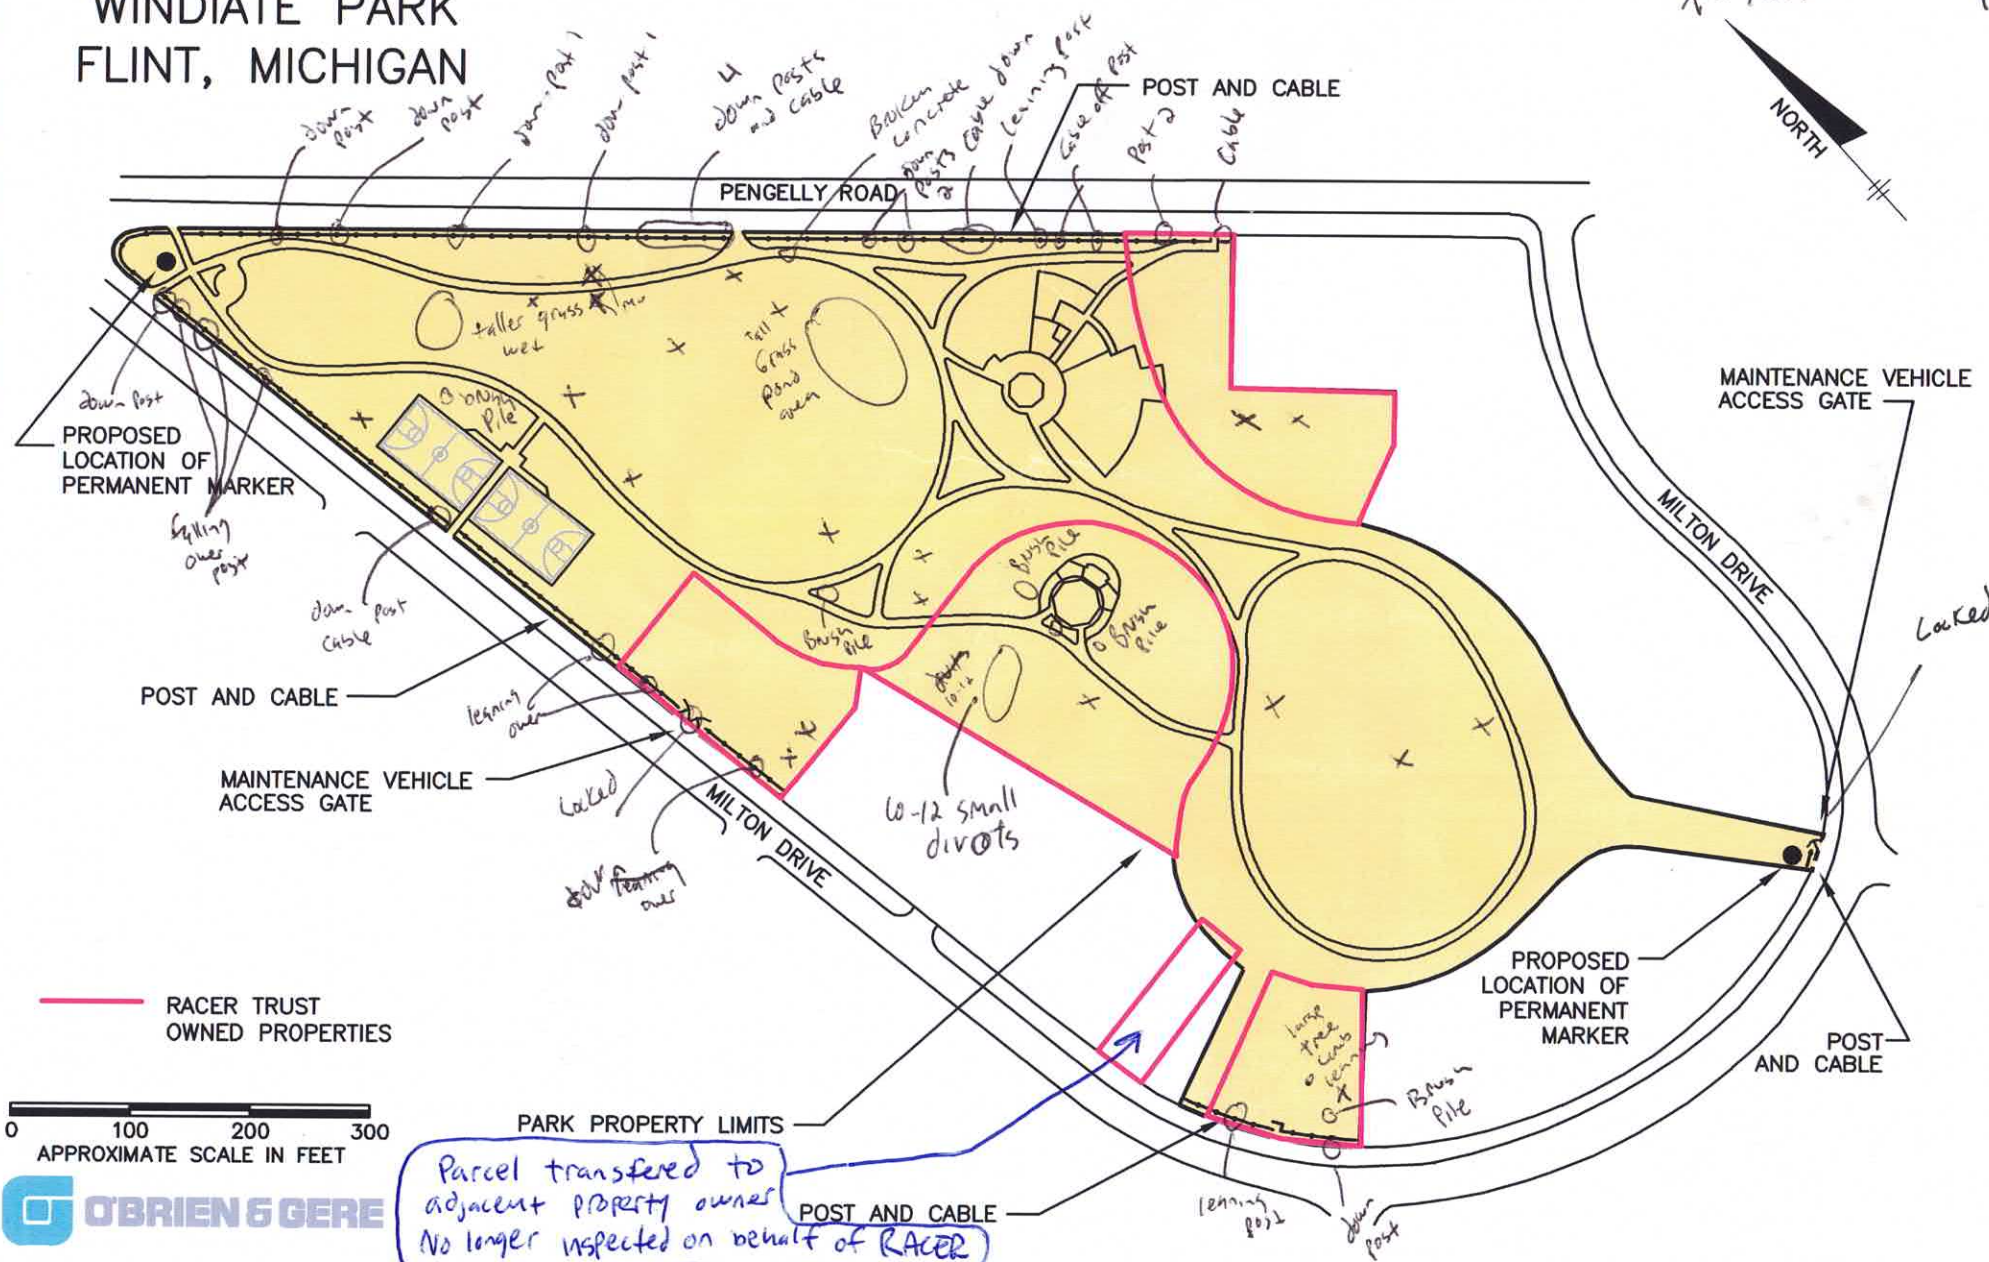
INSPECTION DATE: 5/17/19

During the inspection the soil cover was observed to be in good condition and no soil cover repairs are necessary at this time. Also, it should be noted that it has been a very wet April and May and on the City of Flint owned parcel, an area was observed where water has ponded after rain events. Please refer to the attached inspection sheet and map for further details.

| Inspected Item: | Comments: |
|---|---|
| <i>SOIL COVER</i> | Acceptable. No maintenance required at this time. One area was observed with standing water, tall grass and tall woody plants. One area on the west side was observed with shallow divots due to a vehicle on grass. |
| <i>GRASS/VEGETATIVE LAYER</i> | Acceptable. No maintenance required at this time. One area was observed with standing water, tall grass and tall woody plants. |
| <i>POST &amp; CABLE / VEHICLE GATES</i> | Acceptable. Twenty-three damaged posts were observed during the site inspection (either partially down or completely down). Four sections of down cable were observed. The south and west maintenance vehicle access gates were locked. |
| <i>OTHER OBSERVATIONS</i> | A number of mole mounds and/or trails were observed. Unable to determine if the mounds are from recent activity or from older activity. Six small piles of brush were observed and one large tree limb was down. |

Grass has been recently mowed

$X$  - mole activity

Add additional soil to area where water has ponded.
