Re: Ley Creek PCB Dredgings Site (Registry # 7-34-044)
NYSDEC Order on Consent Index # D-7-0008-97-06
2008 Annual OM&M Inspection Report

September 2008 OM&M Inspection Report

Re: Ley Creek PCB Dredgings Site
September 2008 OM&M Inspection

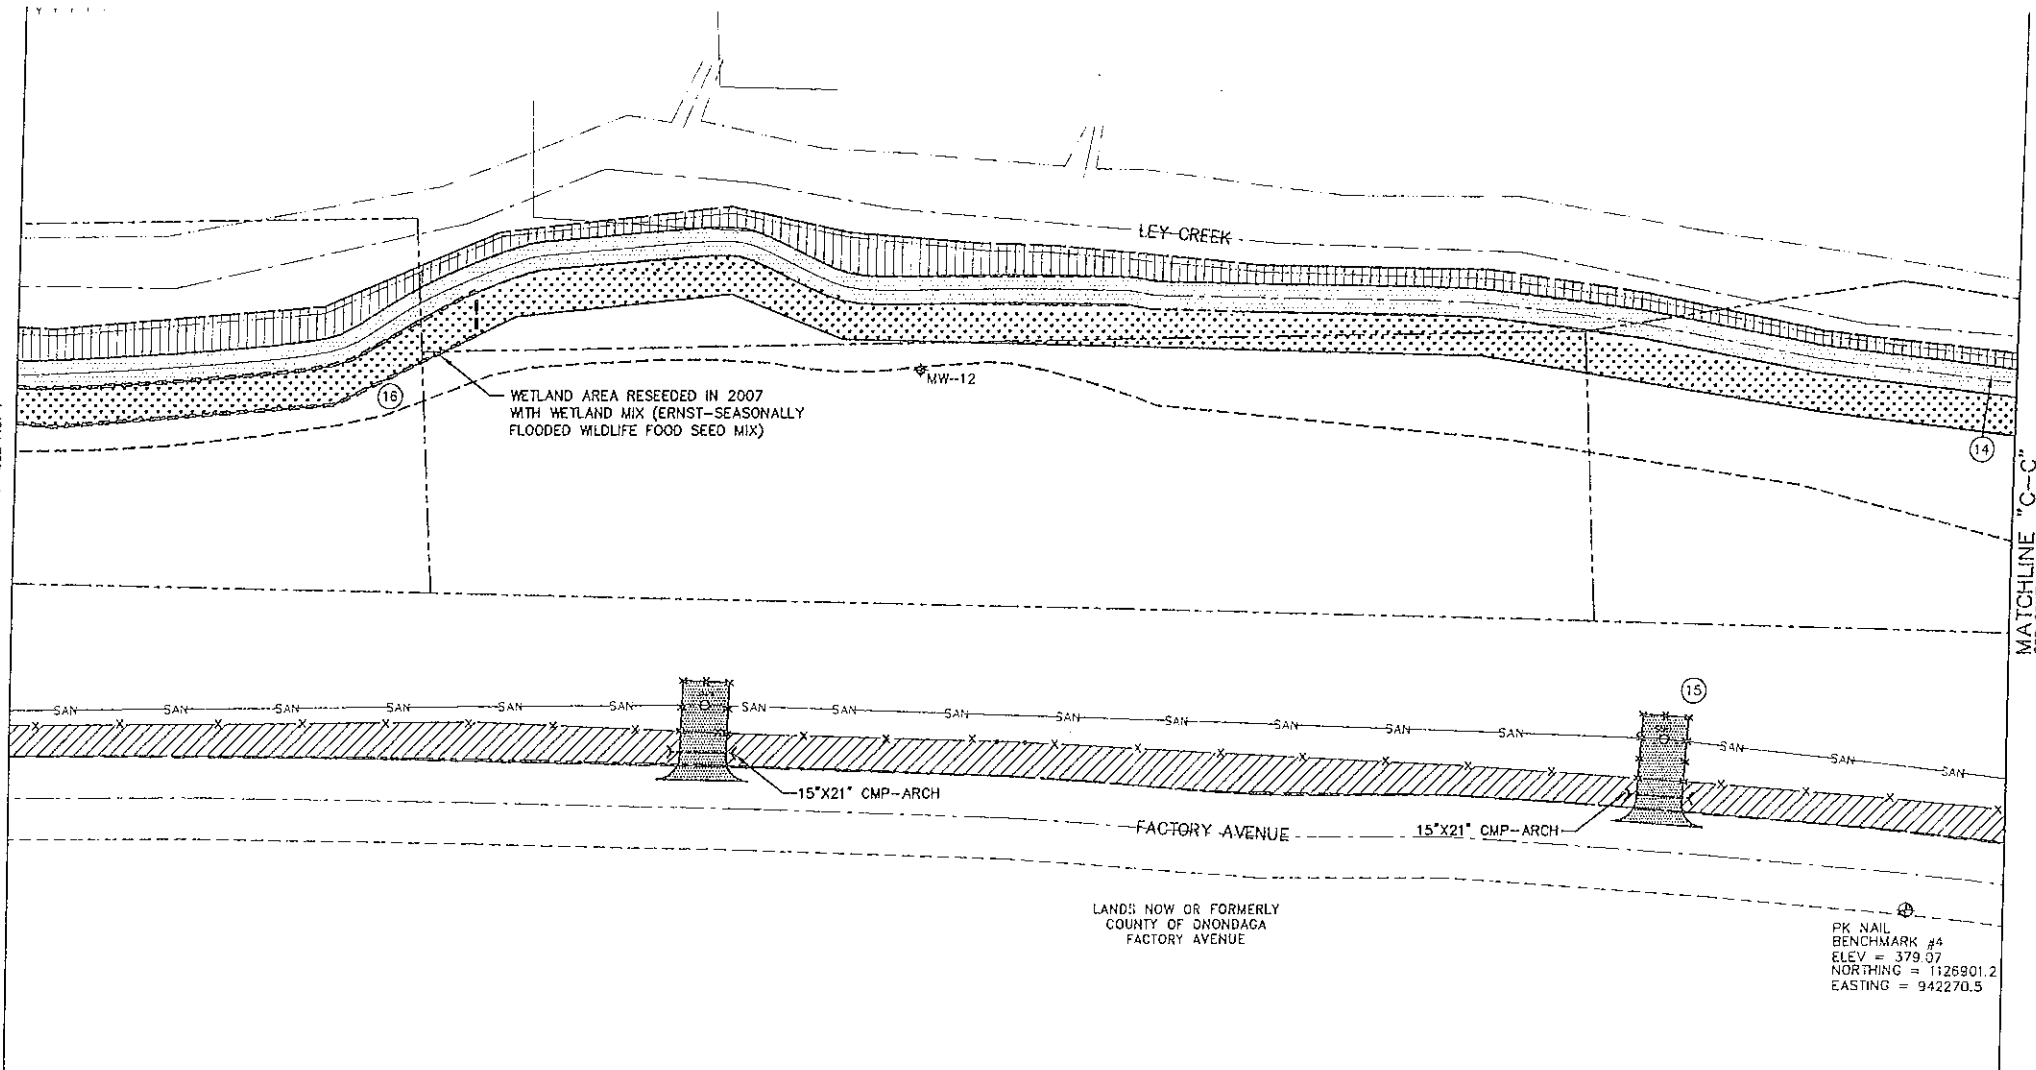
FIGURE 2

- A number of animal burrows in the vegetative cover (Example: Figure 4 and Photograph 7)
- High grass along the service road (Figures 2 and 5 and Photographs 1 and 14)
- Bent monitoring well sign (OBG-2) (Figure 5 and Photograph 5)

- Tree growing in the security fence (Figure 2 and Photograph 15)
- Catch basins plugged (CB-3 and CB-4) (Figure 3 and 5 and Photograph 10)

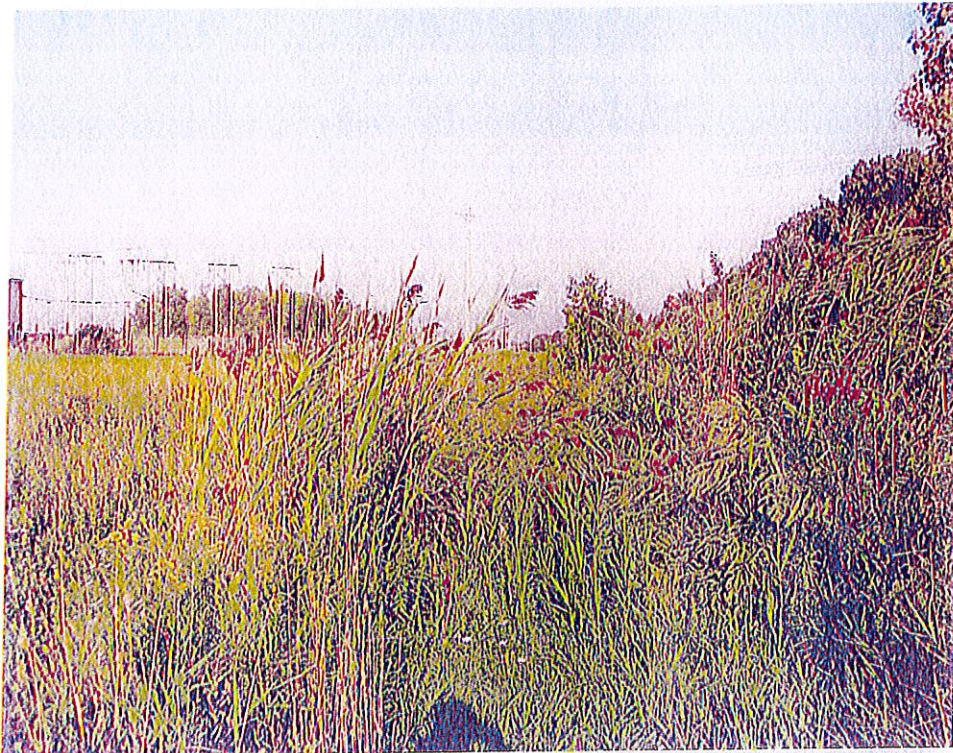
Photograph 1: View of East end of Service Road looking West.

High grass was observed along the service road (O'Brien & Gere 2009).	Grass will be mowed as part of routine spring maintenance activities.	To be performed in spring 2009.
The sign for monitoring well OBG-2 was observed to be bent (O'Brien & Gere 2009).	The sign will be repaired concurrent with routine spring maintenance activities.	To be performed in spring 2009.
A tree was observed to be growing in the security fence (O'Brien & Gere 2009).	The tree will be cut down concurrent with routine spring maintenance activities.	To be performed in spring 2009.

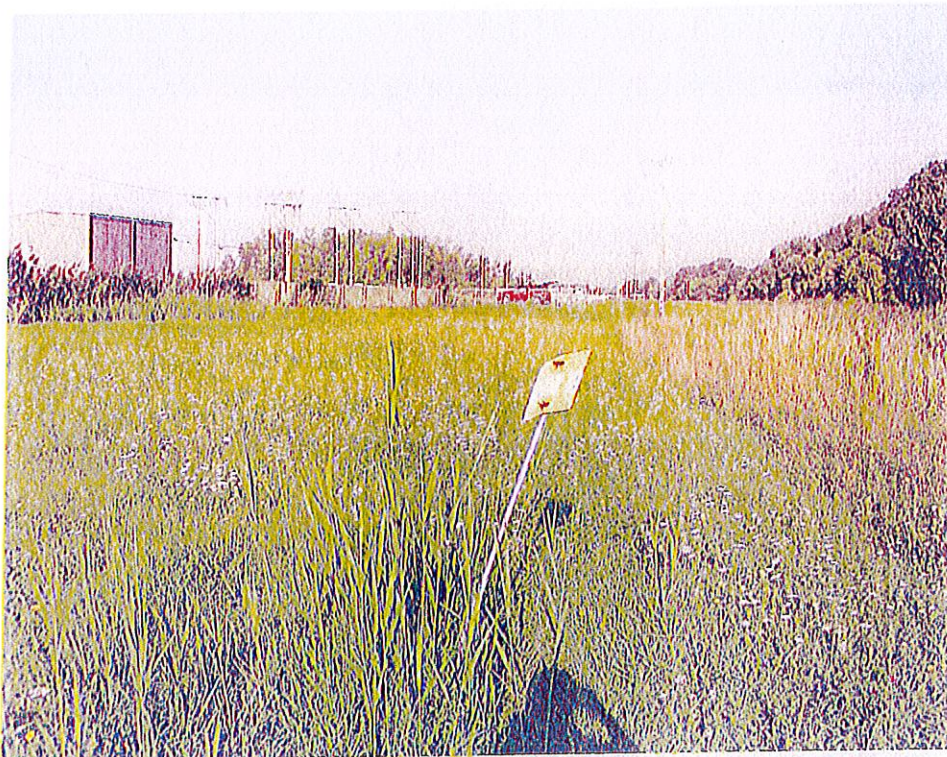
Photograph 5: Looking West from Monitoring Well OBG-2.

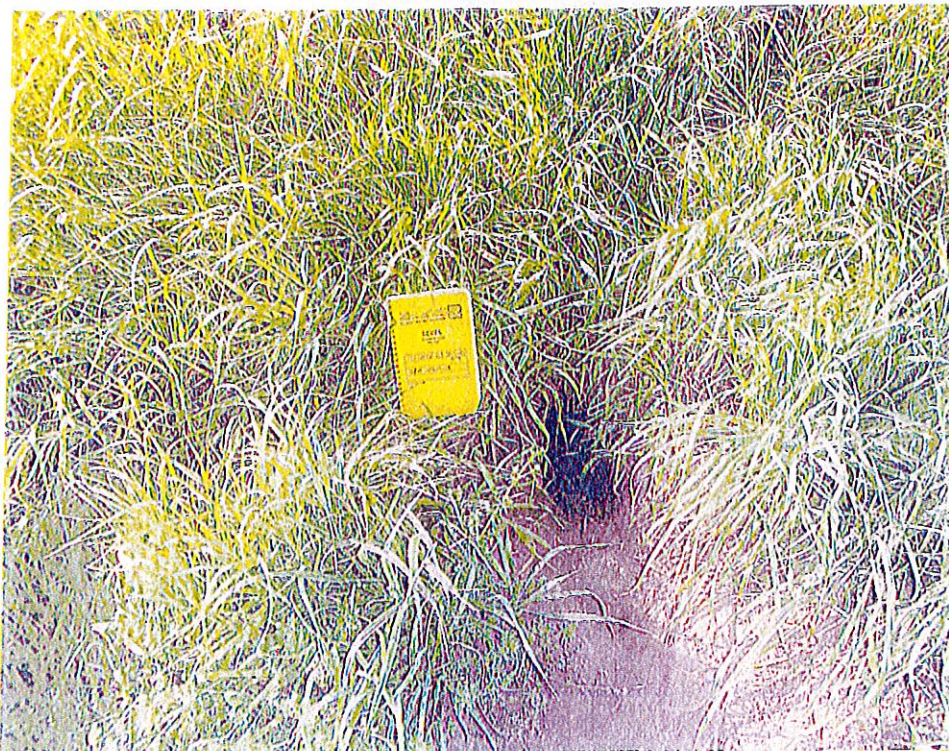
Item	Task	Response		Comments
		Yes	No	
Vegetative Cover	Visually inspect surface conditions.			
	1. Areas of settlement?		X	
	2. Areas of erosion?		X	
	3. Areas where geotextile visible due to erosion?		X	
	4. Areas of slope instability?		X	
	5. Lack or thinning vegetation?		X	
	6. Presence of burrowing animals?	X		Observed 7 holes between CB-3 & CB-4. Photograph 7.
	7. Areas of damage?		X	
	8. Drainage problems?		X	
	9. Mowing required?	X		Photographs 1, 9 and 14.
Access Road	Visually inspect conditions.			
	1. Areas of settlement?		X

Photograph 7: Animal burrow east of OBG-21D.

Issue	Recommended Action	Status
Conduct an assessment of actions to control burrowing animals at the site (e.g., removal of burrowing animals). Where needed, topsoil should be placed in holes and seed and fertilizer applied (USEPA 2007).	A New York State licensed trapper will trap burrowing animals from the Site in the areas noted in the September 2008 OM&M inspection report.	To be performed in spring 2009.
Replace grates in catch basins with trash racks to minimize clogging (USEPA 2007).	Evaluation of engineering controls being conducted to minimize clogging at CB-1, CB-2, and CB-3. CB-5/004 receives minimal flow and CB-4/003 does not generally clog with debris.	Evaluated in August 2007. Installation of recommended trash racks to be performed in spring 2009.
Soil covering MW-12 and MW-13 due to burrowing animal (O'Brien & Gere 2007).	A New York State licensed trapper will trap burrowing animals from areas. Material covering and around the monitoring wells will be placed back in the burrow and additional topsoil and seed placed, if necessary. If excess material is generated, it will be properly characterized and disposed.	Material replacement and seeding completed in September 2007. Trapping to be performed in spring 2009.

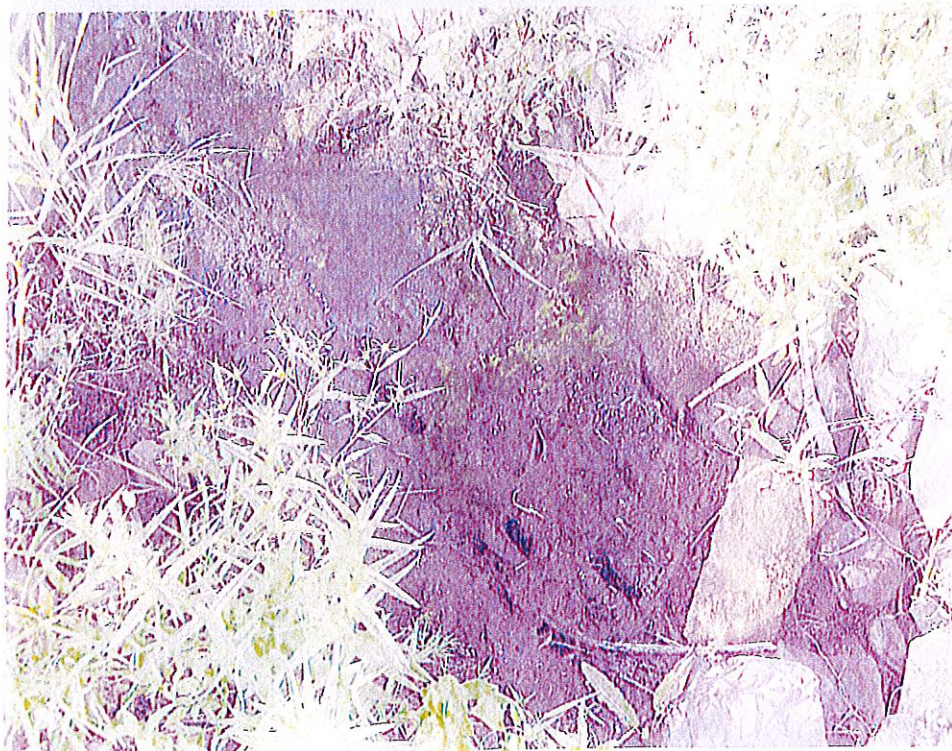
Item	Task	Response		Comments
		Yes	No	
Access Road	2. Areas of erosion?		X	
	3. Areas rutted or potholes present?		X	
	4. Areas of damage?		X	
Surface Water Drainage	Visually inspect ditches, catch basins, etc.			
	1. Accumulation of debris?	X		CB-3 & CB-4 were plugged. Photograph 10.
	2. Excessive scouring?		X	
	3. Areas of damage?		X	
Ground Water Wells	Visually inspect conditions.			
	1. Casings secure and locked?	X		
	2. Areas of damage?	X		Sign for OBG-2. Photograph 5.
Sanitary sewer access paths	Visually inspect conditions.			
	1. Cracks in asphalt?		X	
	2. Manhole covers in place?	X

Photograph 10: View of CB-3.

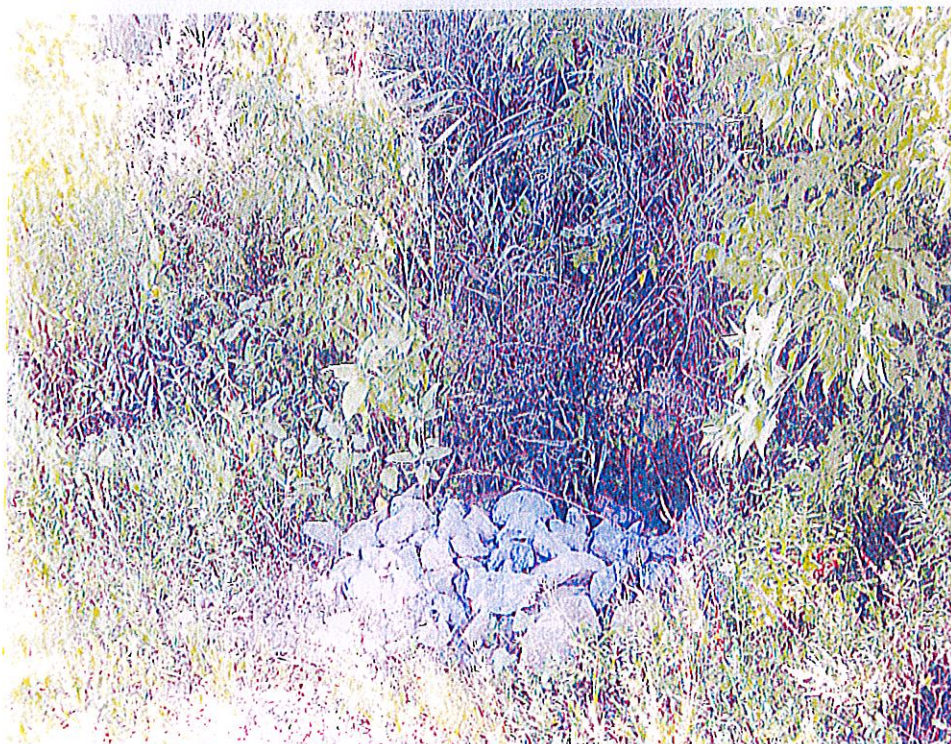
Photograph 12: Rip-rap repair at bank erosion location near the outfall from CB-3.

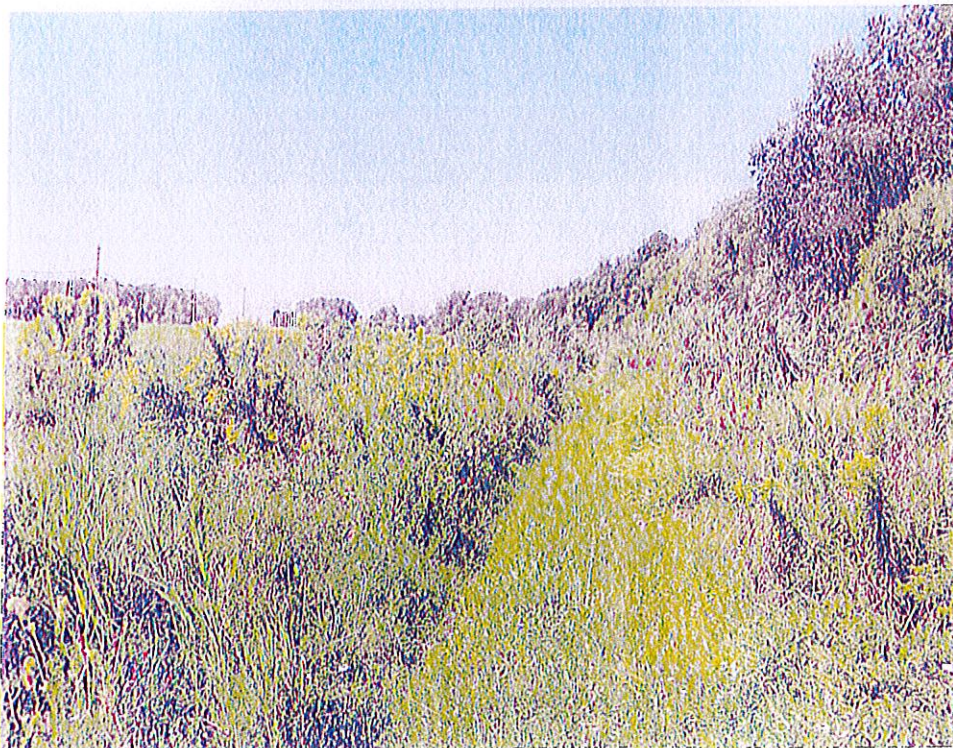
Photograph 14: View along access road looking West from CB-2 outfall.

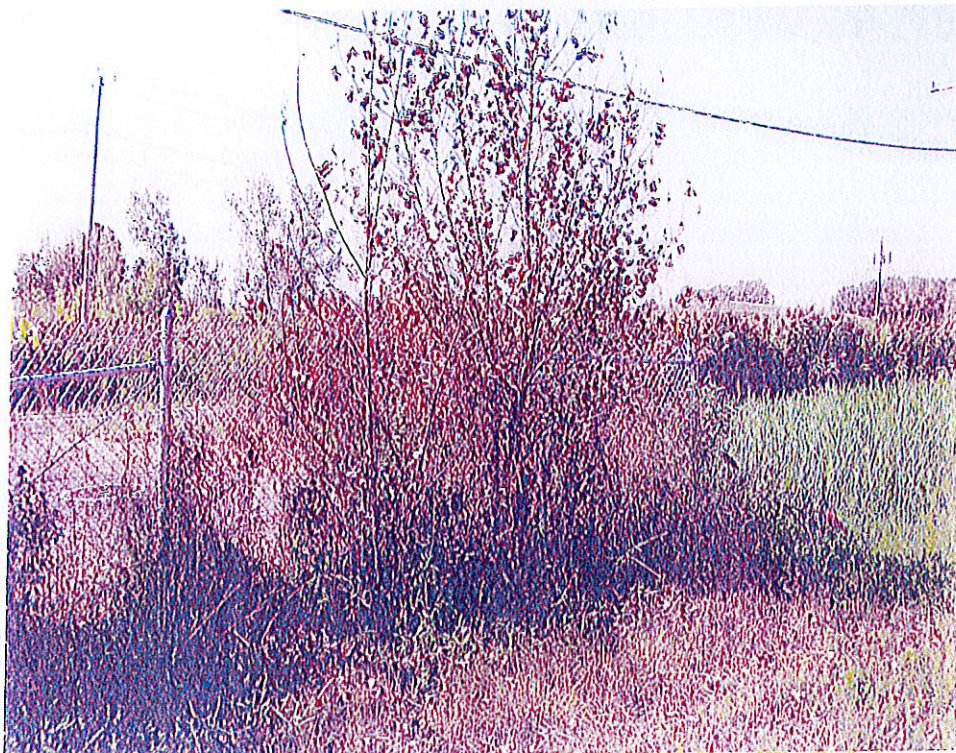
Date Performed: September 5, 2008			Weather: Sunny 75 F	
Site Name: Ley Creek PCB Dredgings Site			Inspector Name: Edwin B. Rahn	
Site Location: Syracuse, New York			Inspector Signature: <i>Edwin B. Rahn</i>	
Item	Task	Response		Comments
		Yes	No	
Sanitary sewer access paths	3. Debris accumulating in access paths?		X	
Physical Site Security	Visually inspect fences and gates			
	1. Signs intact?	X		
	2. Fence breached?		X	
	3. Access gates locked?	X		
	4. Areas of damage?		X	
Note any additional comments.				
Observation of burrowing animal holes seems to be increasing.				
Area seeded in 2007 has vegetation established. Photograph 16.				
The 15-foot width of wetland and the 5-foot width of buffer south of the service road looks well established.				
Tree growing in the security fence. Photograph 15.

Photograph 15: Tree in fence west of CB-2.
