RE: *Quarterly Status Report –July 2019 – September 2019*  
*Coldwater Road Landfill*  
*1245 East Coldwater Road, Flint, MI*  
*MID 005 356 860*  
FILE: 15388/72202/Docs

**3RD QUARTER 2019  
BURROW LOCATION  
MAP**

# COLDWATER RD LANDFILL | ANIMAL BURROW PHOTO LOG

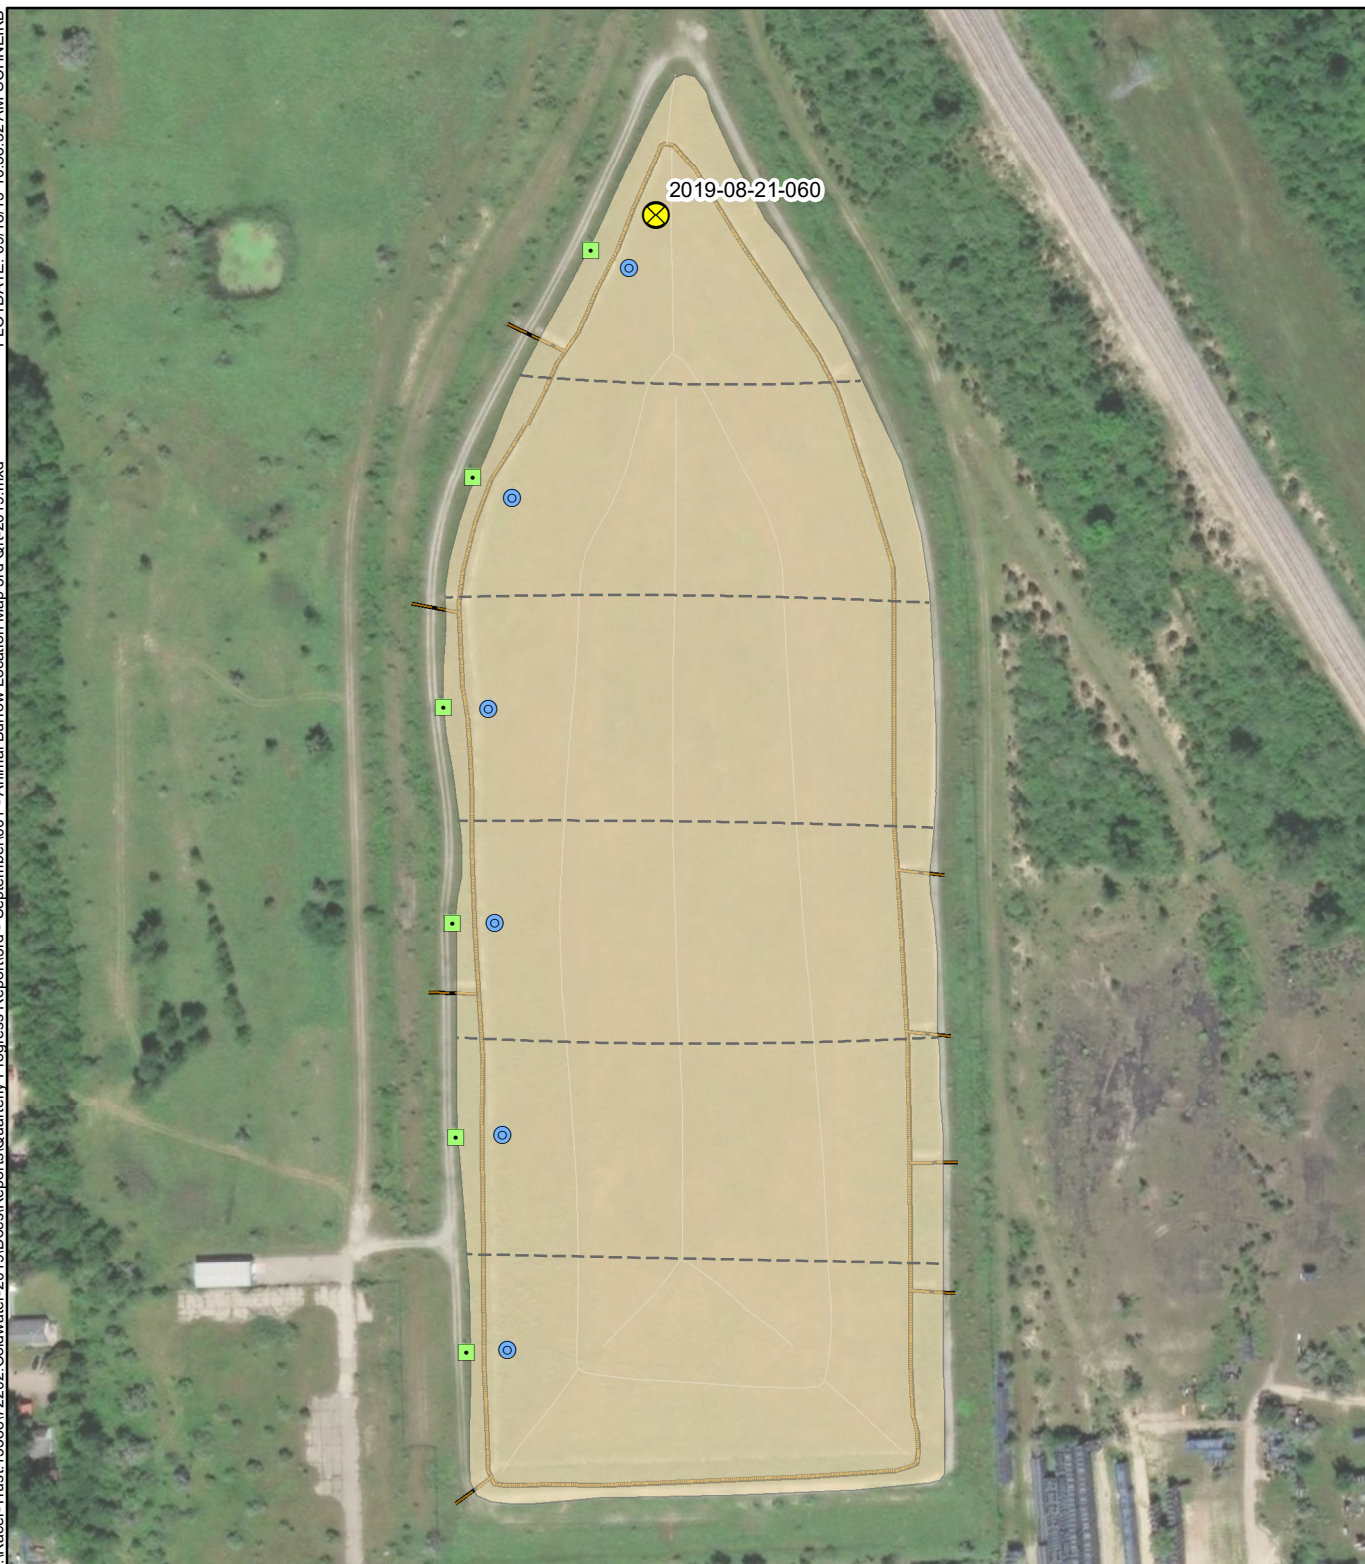
- » Observed one potentially active animal burrows on August 19, 2019 and set trap. The animal burrow found to not be active and was closed out on August 21, 2019. See attached photo log and figure for further details.

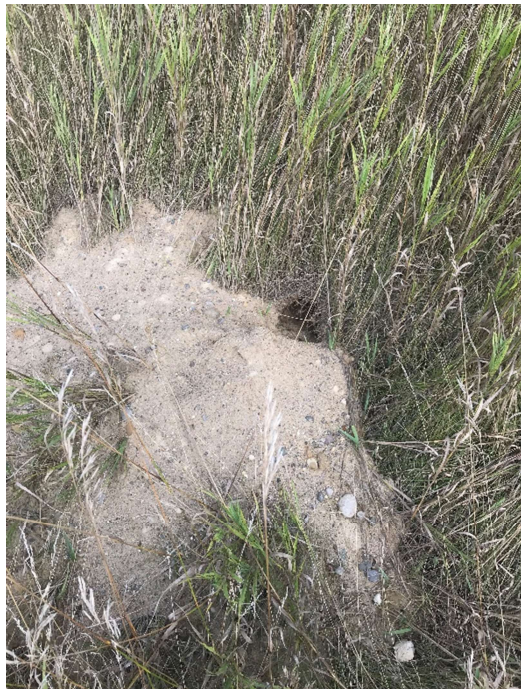
8/19/19	8/21/19			
NOTES:				
ID: 2019-08-21-060				
PRE repair photo.				
Trap set for two days.				
No activity.				
No signs of liner damage.				
LOCATION:		APPROX. LENGTH:	APPROX. DEPTH:	APPROX. DIAMETER:
Cell A1 – Top of slope		1.5 feet	3 inches	4 inches
DATE FOUND:	DATE CLOSED:
