**Landfill Inspection Report  
Coldwater Road Landfill  
Flint, Michigan  
MID 005 356 860**

**RACER Trust  
Ypsilanti, Michigan**

February 2012

RE: 2011 Annual Landfill Inspection Report Coldwater Road Landfill  
Flint, Michigan  
FILE: 14774/47850 #5

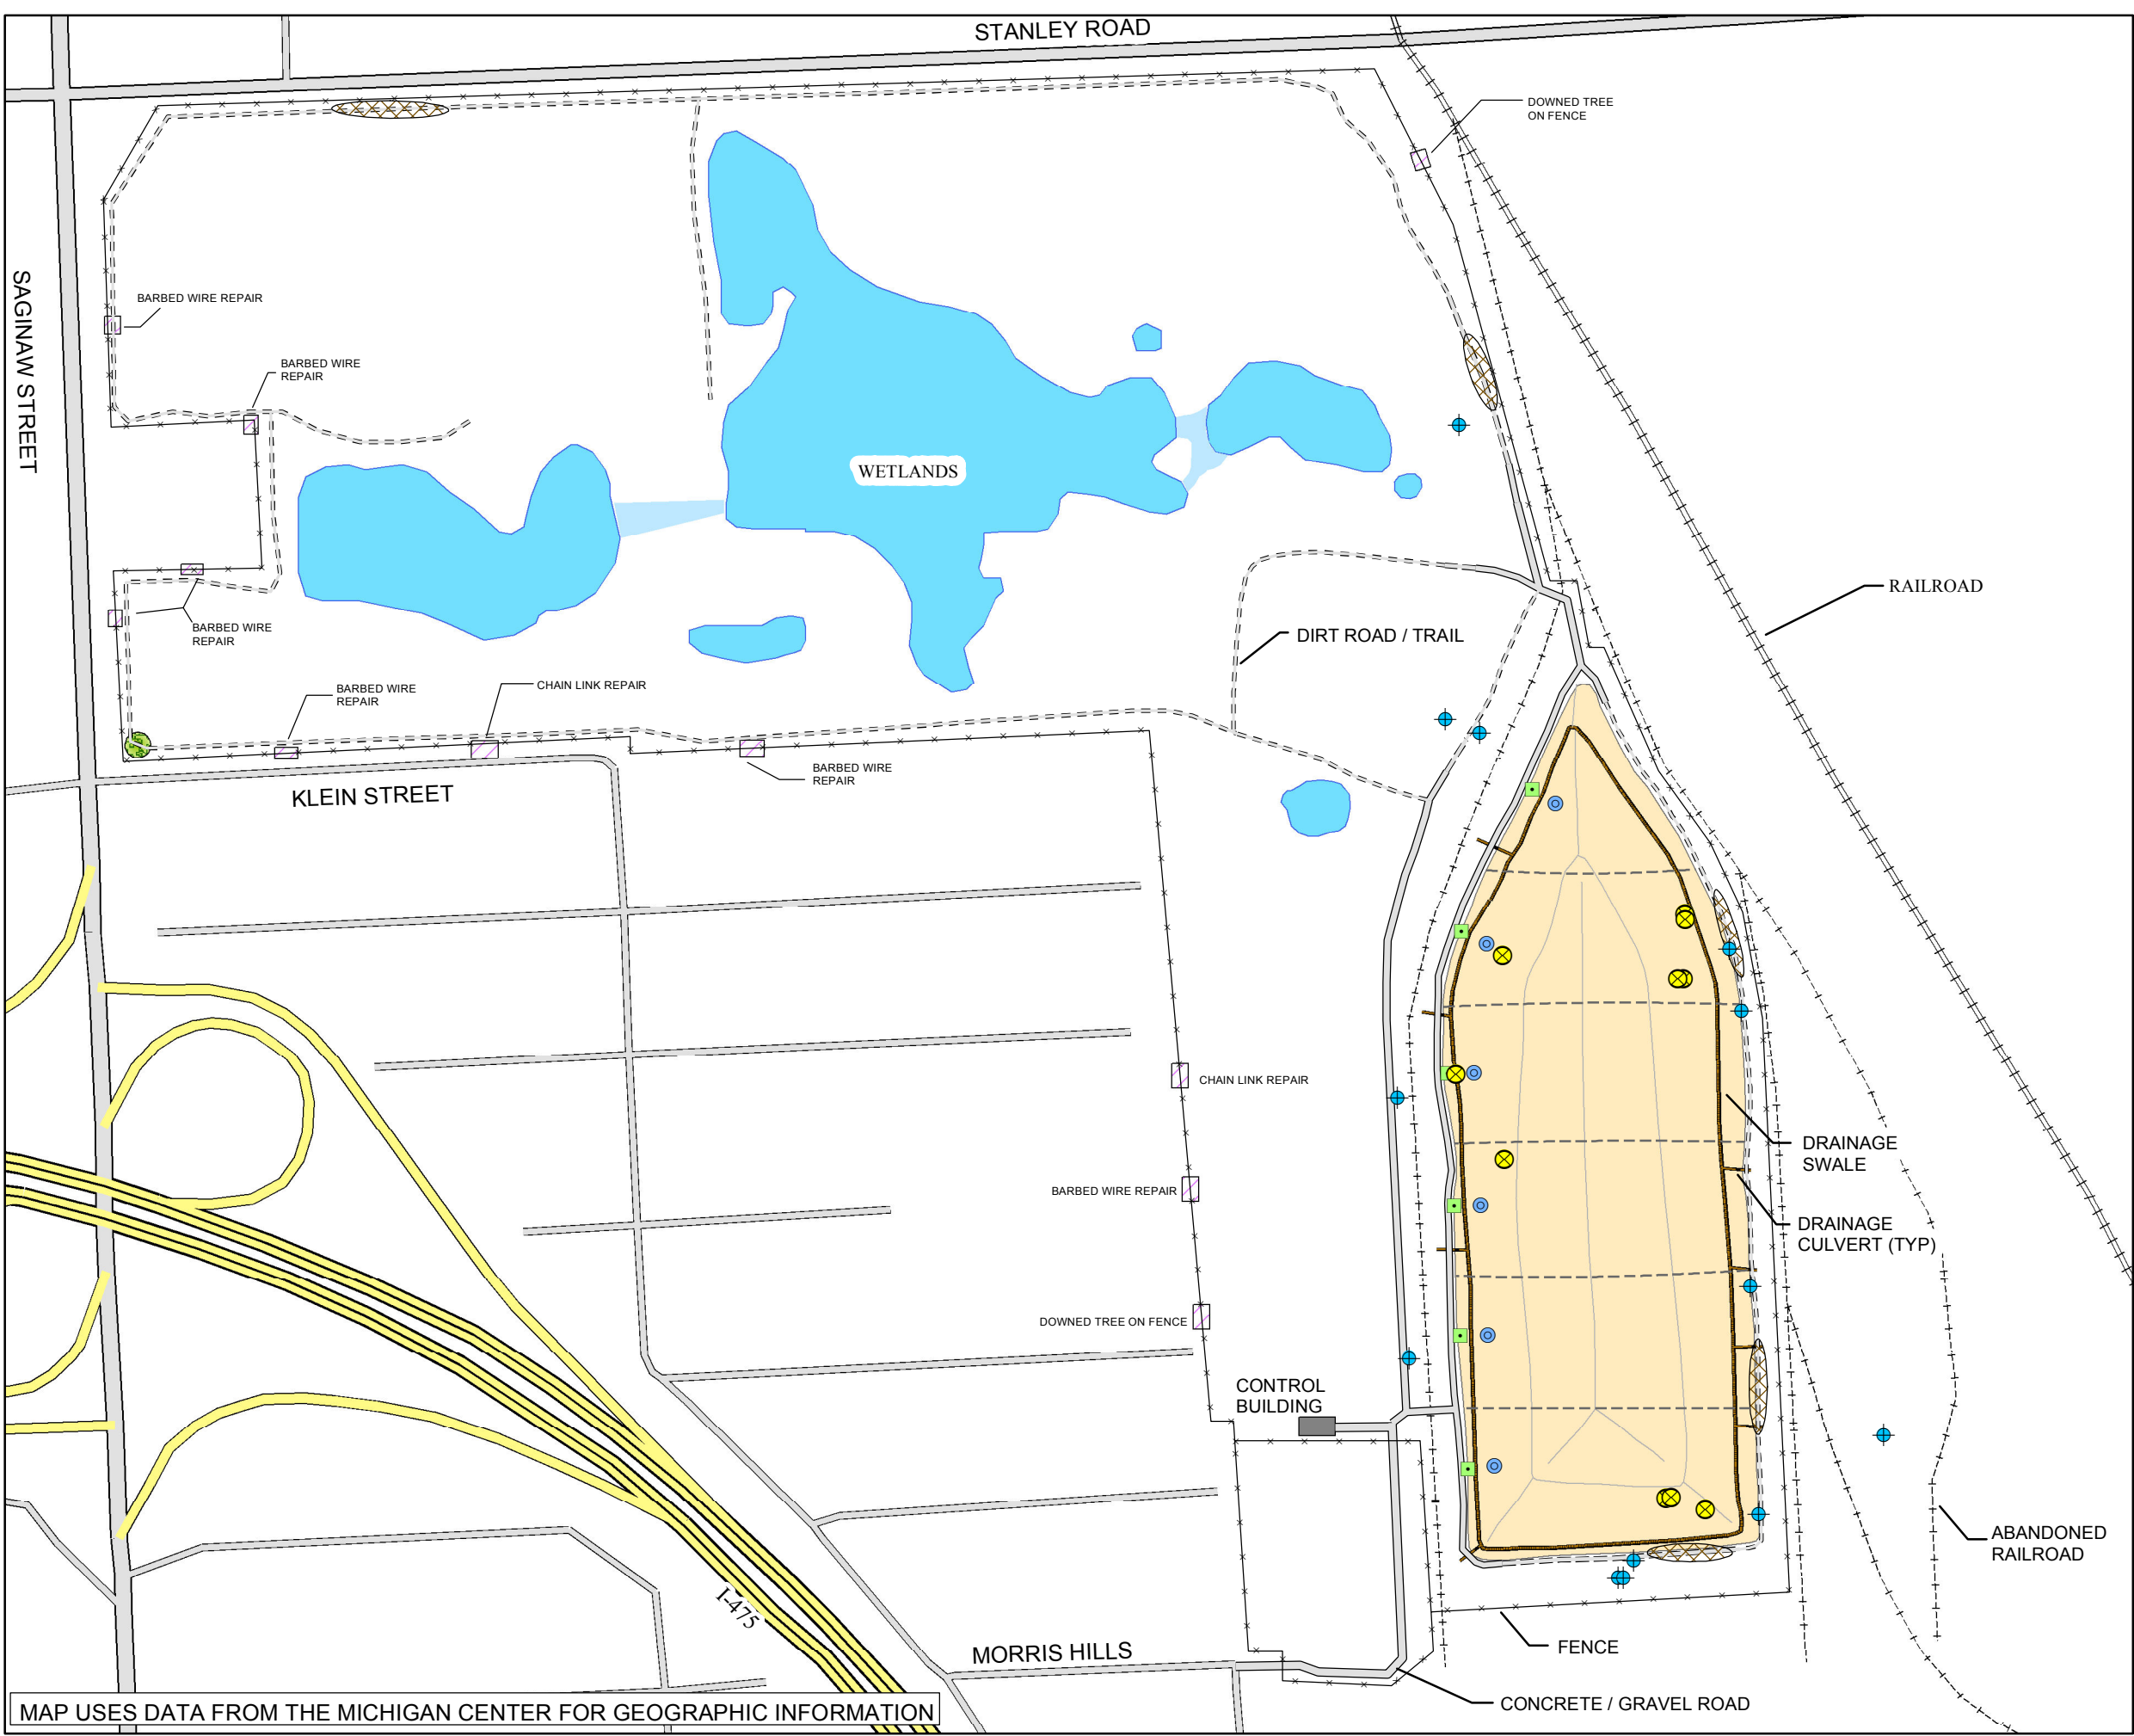
FIGURE 3

Ten animal burrows were identified during the quarterly inspections. Additional animal burrows were also identified and closed throughout the year. Animal burrows were photographically documented (before and after repair), and the approximate size and configuration of the burrows were documented and included as an attachment to the Quarterly Status Reports for the site.

The landfill access and perimeter roads were inspected for sufficient gravel and proper drainage during the quarterly inspections. During the December 23, 2011 inspection shallow ruts in the road were observed along the north perimeter road, north landfill access road, and east landfill access road (Figure 3). The shallow ruts will continue to be monitored and addressed if necessary. No other problems to the access roads were observed during 2011.

Damage to the site perimeter fence and/or the barbwire was noted at a number of locations during the quarterly inspections. During the March 31, 2011 inspection, two openings and five sections of downed or missing barbwire were observed along the west perimeter fence. During the September 29, 2011 inspection one previous repaired hole was reopened and a section of downed barbwire was observed along the west perimeter fence. A tree limb was also located lying on the fence along the north perimeter fence during the September 29, 2011 inspection.

Downed barbwire was observed at two areas along the northwest perimeter fence during the December 23, 2011 site inspection. During the quarterly inspections, or shortly thereafter, the holes in the perimeter fence and down barbwire were repaired by the addition of new materials. Fallen tree limbs were cut down and removed from the fence.

The perimeter of the landfill and berm, drainage trenches at the base of the landfill, the Remaining Materials Area (RMA, Figure 2), and the wetland area were inspected for potential drainage problems. During the March 31, 2011 inspection the soil around the new southwest manhole had settled 6 to 8 inches. The area was leveled using fill material on June 16, 2011. No other drainage issues were observed during the quarterly inspections.
