RE: *Quarterly Status Report –July 2016 – September 2016*  
*Coldwater Road Landfill*  
*1245 East Coldwater Road, Flint, MI*  
*MID 005 356 860*  
FILE: 15388/62658/Docs

# COLDWATER RD LANDFILL | ANIMAL BURROW PHOTO LOG

**3RD QUARTER 2016  
 BURROW LOCATION  
 MAP**

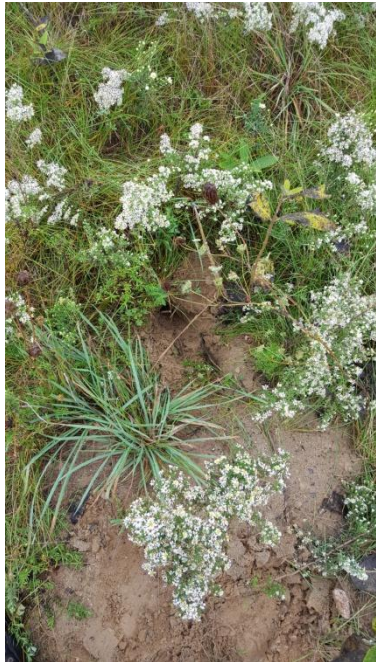
LOCATION:		APPROX. LENGTH:	APPROX. DEPTH:	APPROX. DIAMETER:
Cell C1 – middle of slope		1.5 ft	1 ft	6 inch
DATE FOUND:	DATE CLOSED:

9/26/16	9/30/16			
NOTES:				
ID: 2016-09-30-056				
PRE repair photo of burrow.				
Trap set up for 5 days.				
No activity.				
No signs of liner damage.

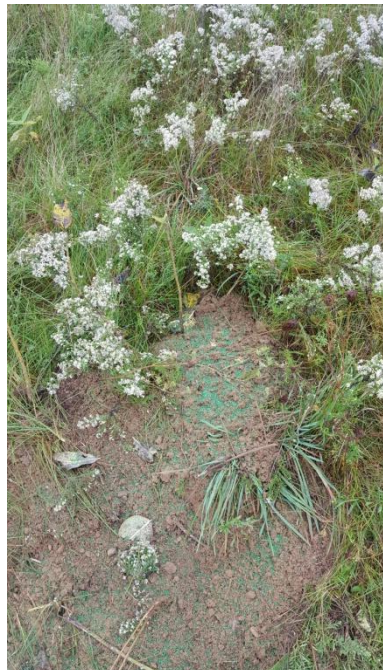
LOCATION:		APPROX. LENGTH:	APPROX. DEPTH:	APPROX. DIAMETER:
Cell C1 – middle of slope		1.5 ft	1 ft	6 inch
DATE FOUND:	DATE CLOSED:

9/26/16	9/30/16			
NOTES:				
ID: 2016-09-30-056				
POST repair photo.				
Filled in burrow.
