Re: Ley Creek PCB Dredgings Site (Registry # 7-34-044)
NYSDEC Order on Consent Index # D-7-0008-97-06
2005 Annual OM&M Inspection Report

Re: Ley Creek PCB Dredgings Site
2005 OM&M Wetland Evaluation

LEY CREEK PCB DREDGINGS SITE
SYRACUSE, NEW YORK
SITE REMEDIATION PROJECT

OM&M PARTIAL
SITE PLAN
WETLAND
EVALUATION

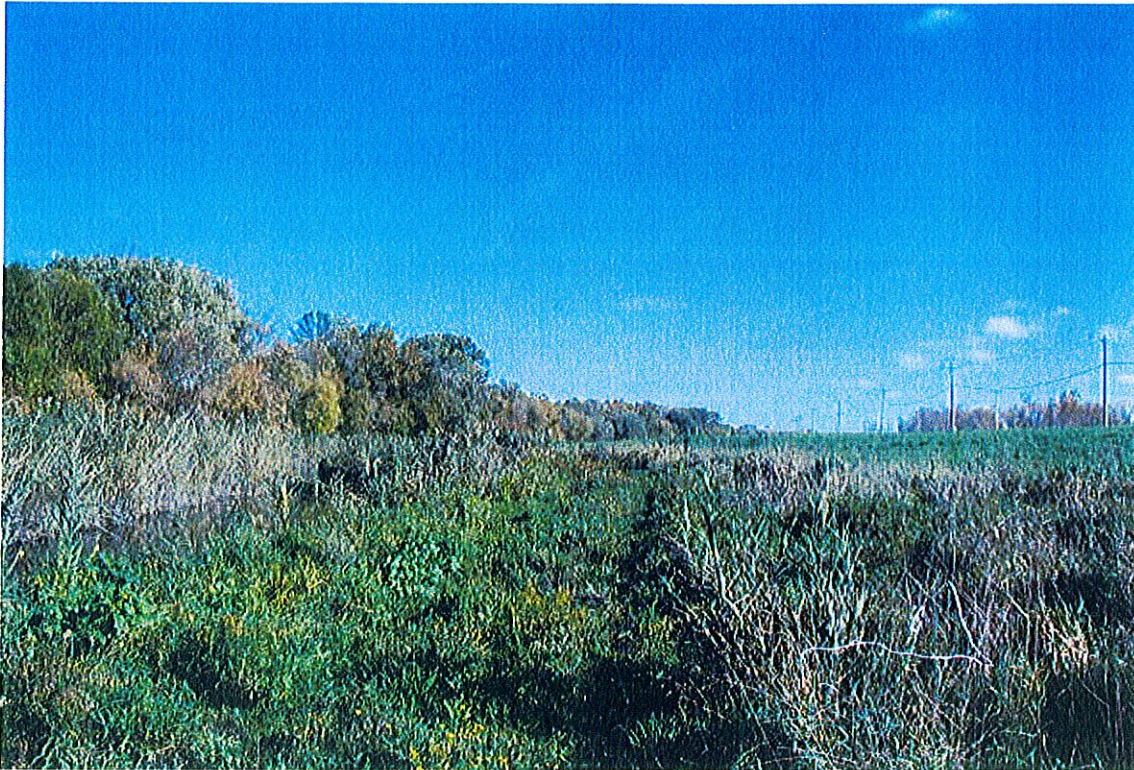
Species	Wetland Indicator Status	Percent cover
<i>Phalaris arundinacea</i>	FACW+	30
<i>Lathyrus sylvestris</i>	NI	60
<i>Phragmites australis</i>	FACW	5
<i>Fraxinus pennsylvanica</i>	FACW	5
Total ground cover (%)		100
% desirable ground cover		35 ^a
% ground cover hydrophytic (FAC, FACW and OBL)		40 ^b

Photo 1: Looking east at area of restored wetland evaluation Plot #1.
Date photo taken: 10/21/2005

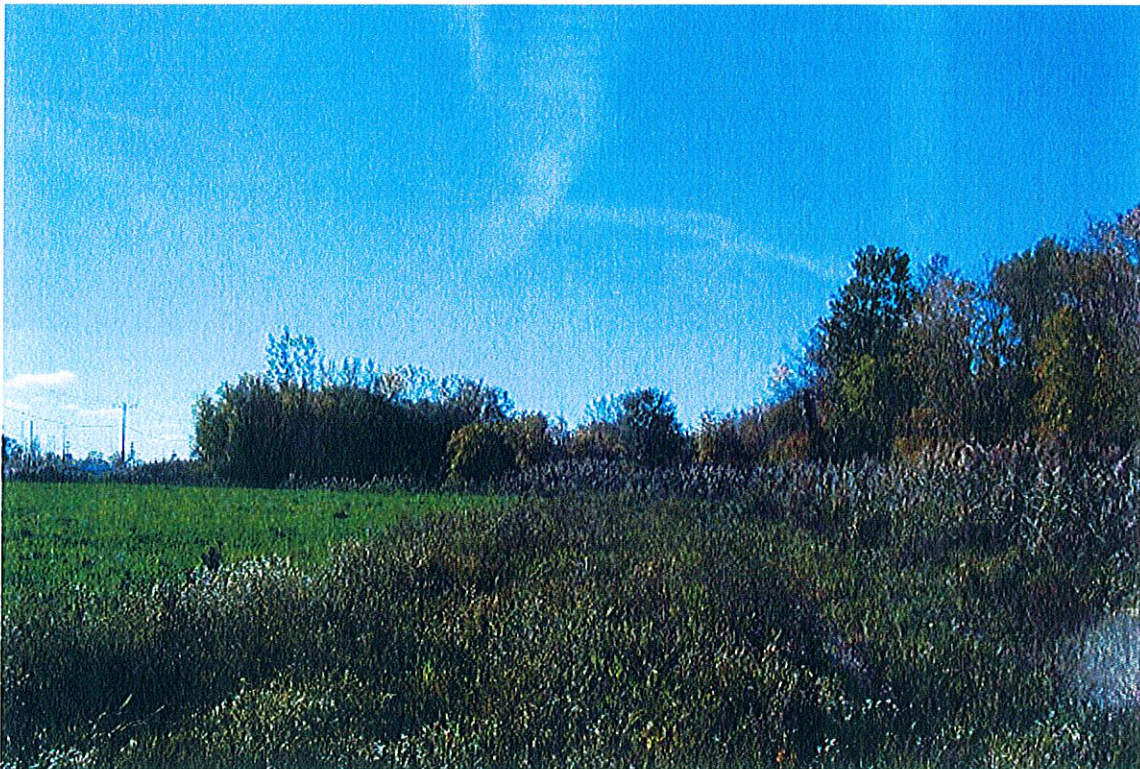
Species	Wetland Indicator Status	Percent cover
<i>Phalaris arundinacea</i>	FACW+	45
<i>Aster vimineus</i>	FAC	45
<i>Plantago major</i>	FACU	5
<i>Trifolium repense</i>	FACU-	1
Total ground cover (%)		96
% desirable ground cover		90 ^a
% ground cover hydrophytic (FAC, FACW and OBL)		90 ^b

Photo 2: Looking west at area of restored wetland evaluation Plot #2.
Date photo taken: 10/21/2005

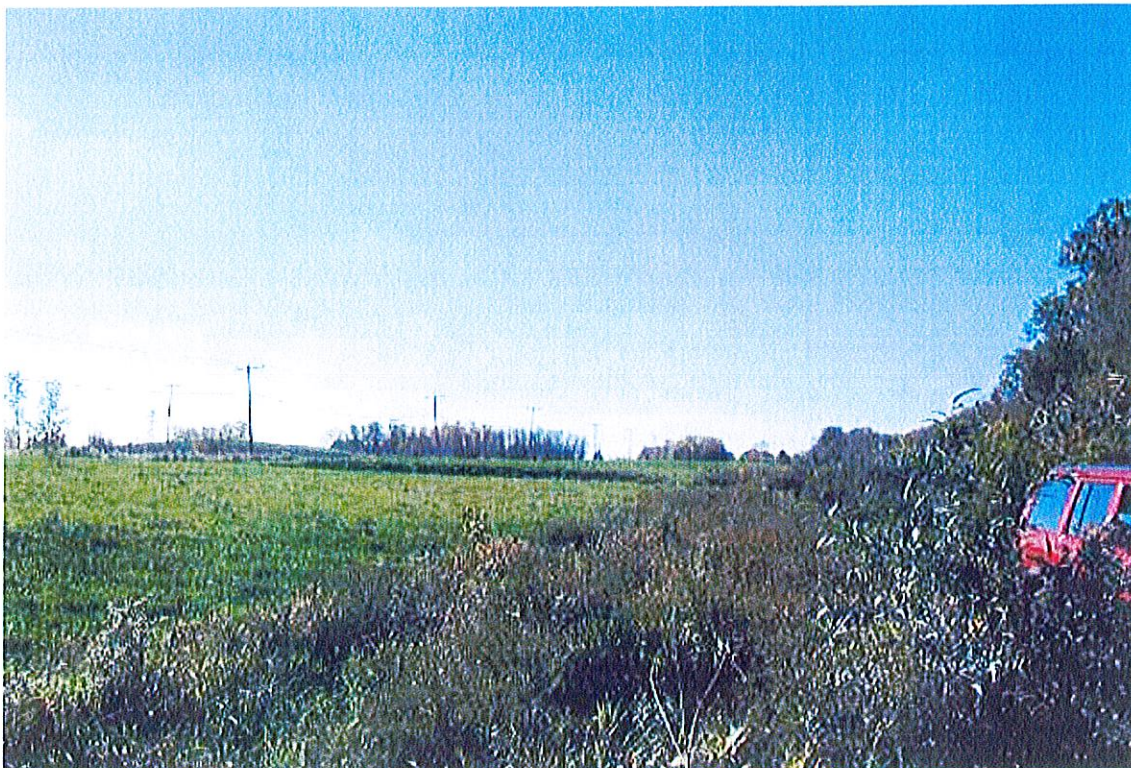
Photo 3: Looking west at area of restored wetland evaluation Plot #3.
Date photo taken: 10/21/2005

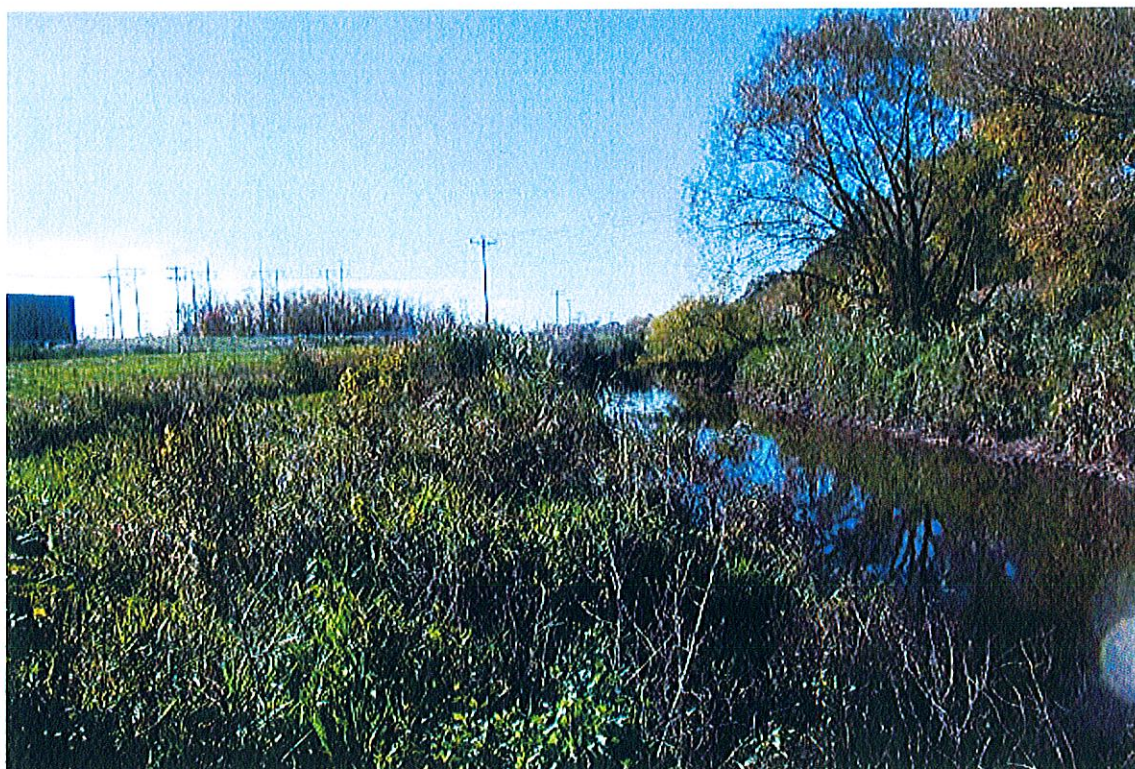
Photo 4: Looking northwest at area of restored wetland evaluation Plot #4.
Date photo taken: 10/21/2005

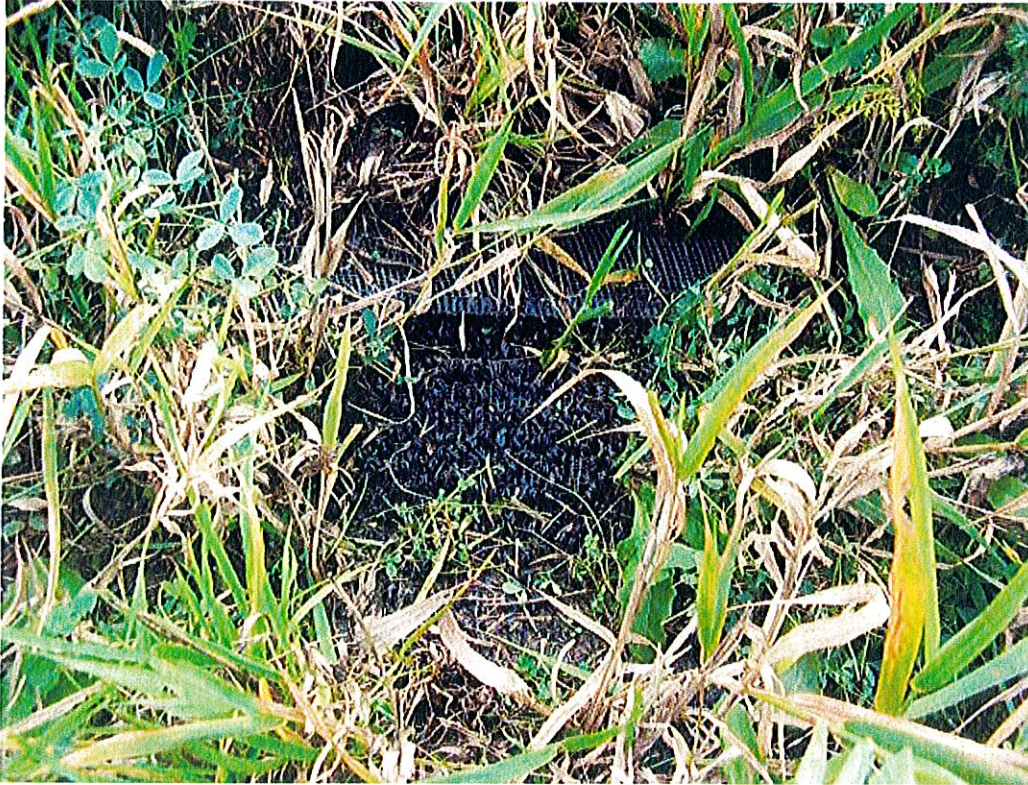
Item	Task	Response		Comments
		Yes	No	
Vegetative Cover	Visually inspect surface conditions.			
	1. Areas of settlement?		X	
	2. Areas of erosion?	X		Refer to Figures 3 and 5 and Photograph 1.
	3. Areas where geotextile visible due to erosion?		X	
	4. Areas of slope instability?		X	
	5. Lack or thinning vegetation?		X	
	6. Presence of burrowing animals?	X		Refer to Photograph 4-Figure 5 and Photograph 8-Figure 4.
	7. Areas of damage?		X	
	8. Drainage problems?		X	
	9. Mowing required?	X		Mowing required around catch basins (Photograph 12-Figure 3 and Photograph 13-Figure 1)
Access Road	Visually inspect conditions.			
	1. Areas of settlement?		X

Photograph 1: Exposed erosion fabric in CB-5/Outfall 004 spillway.

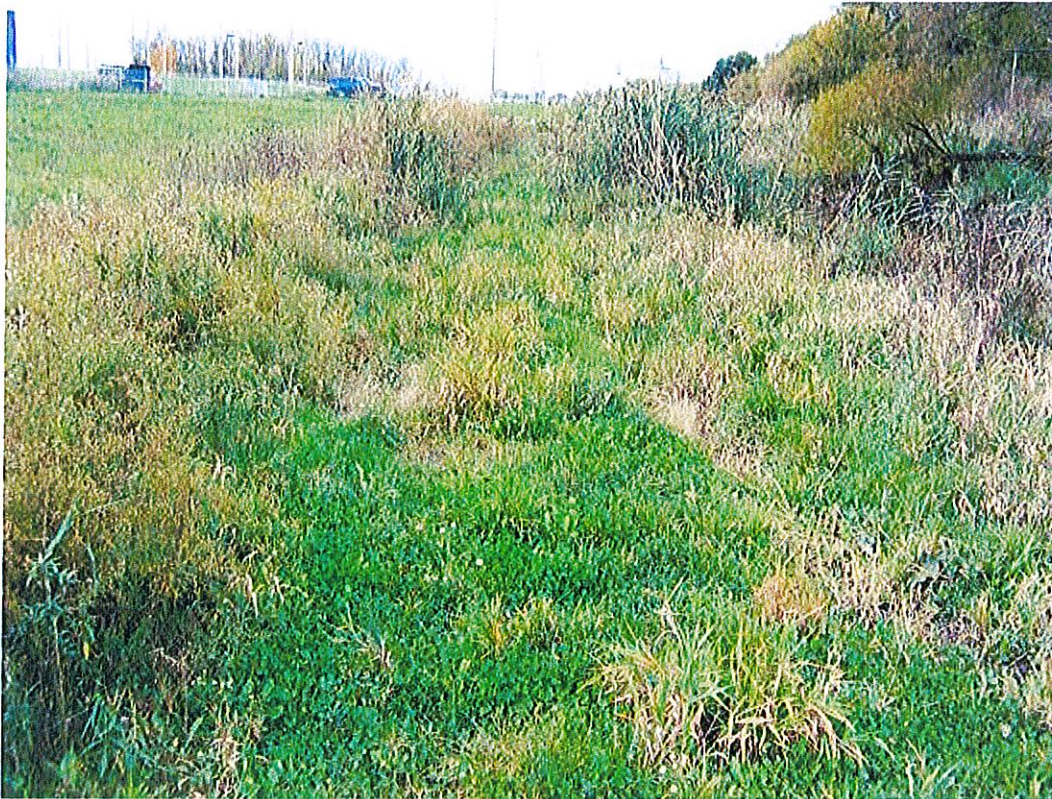
Photograph 3: Vegetation in access road between CB-5 and CB-4 near turnaround area.

- Remove vegetation from the stone access road and the stone access road turnaround
- Remove trees from fence line
- Unclog and replace grates in catch basins with trash racks to minimize clogging
- Place topsoil and seed over scoured areas
- Remove excessive vegetation around catch basins
- Repair pavement depression with like asphalt.

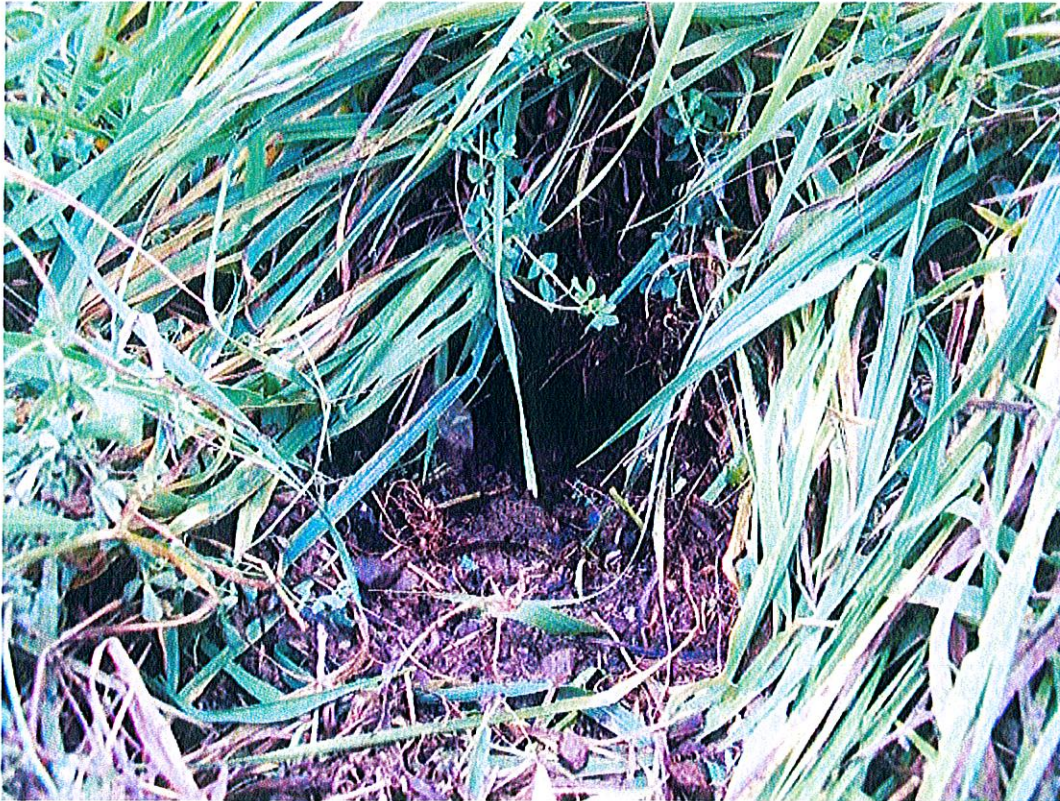
Photograph 4: Burrowing animal hole

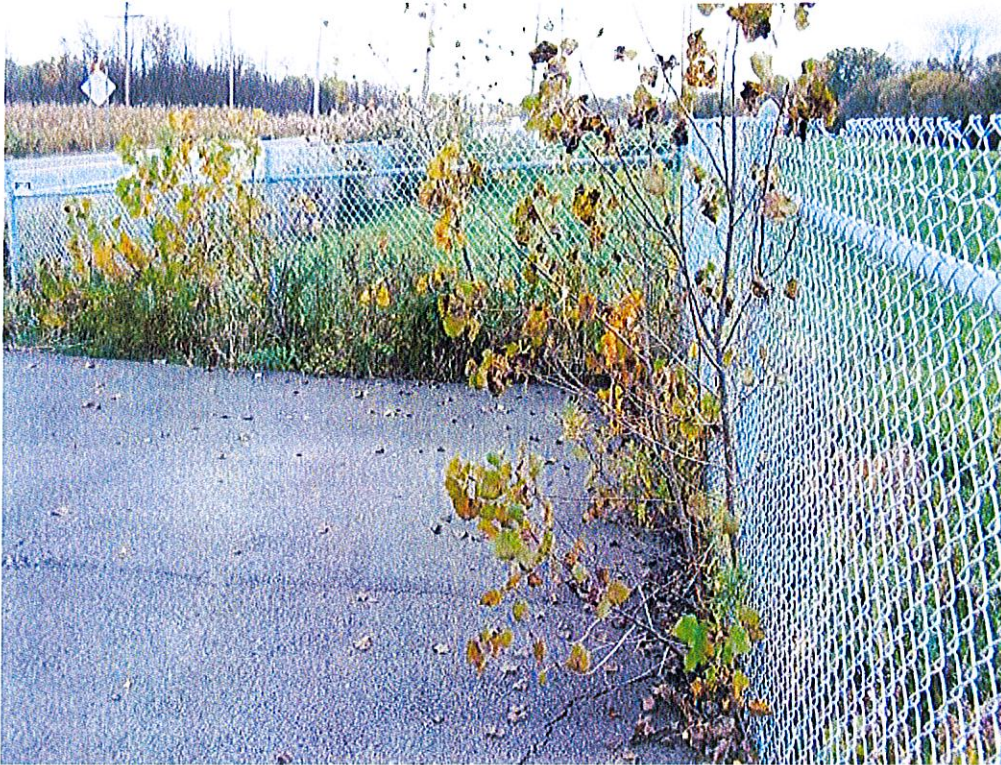
- Vegetation through pavement/cracks in asphalt (Photographs 9 and 11 - Figure 3)
- A significant amount of vegetation within the stone access road throughout the Site and the stone access road turnaround at the eastern end of the Site (Photograph 3-Figure 5)
- Tree establishment along the fence line (Photograph 5-Figure 4 and Photograph 10-Figure 3).

Tree establishment needs to be removed along fenceline.

Photograph 5: Tree establishment.

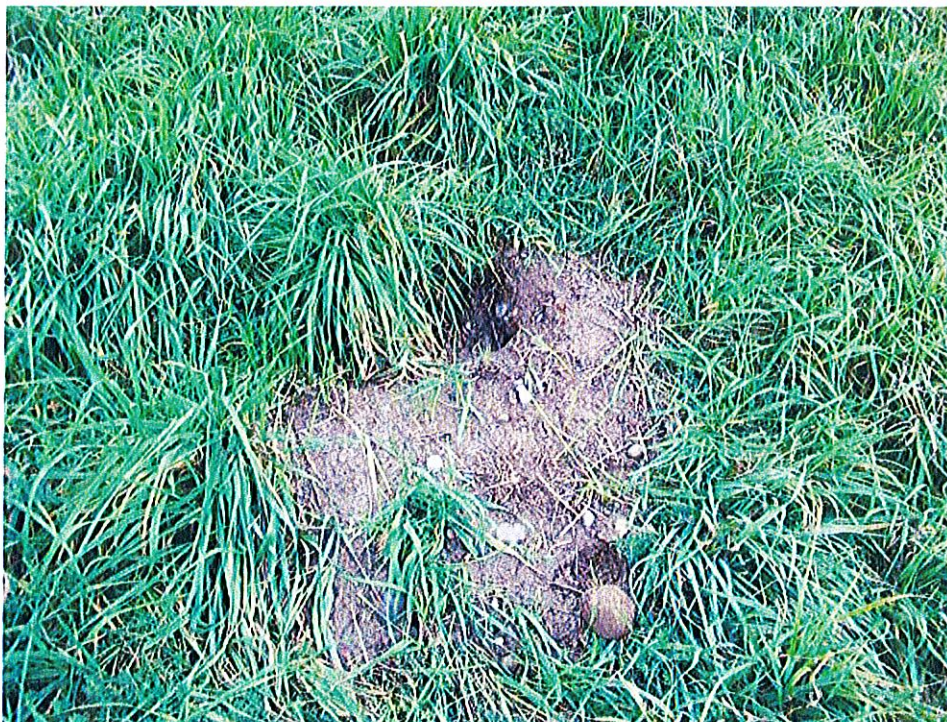
Photograph 8: Burrowing animal hole.

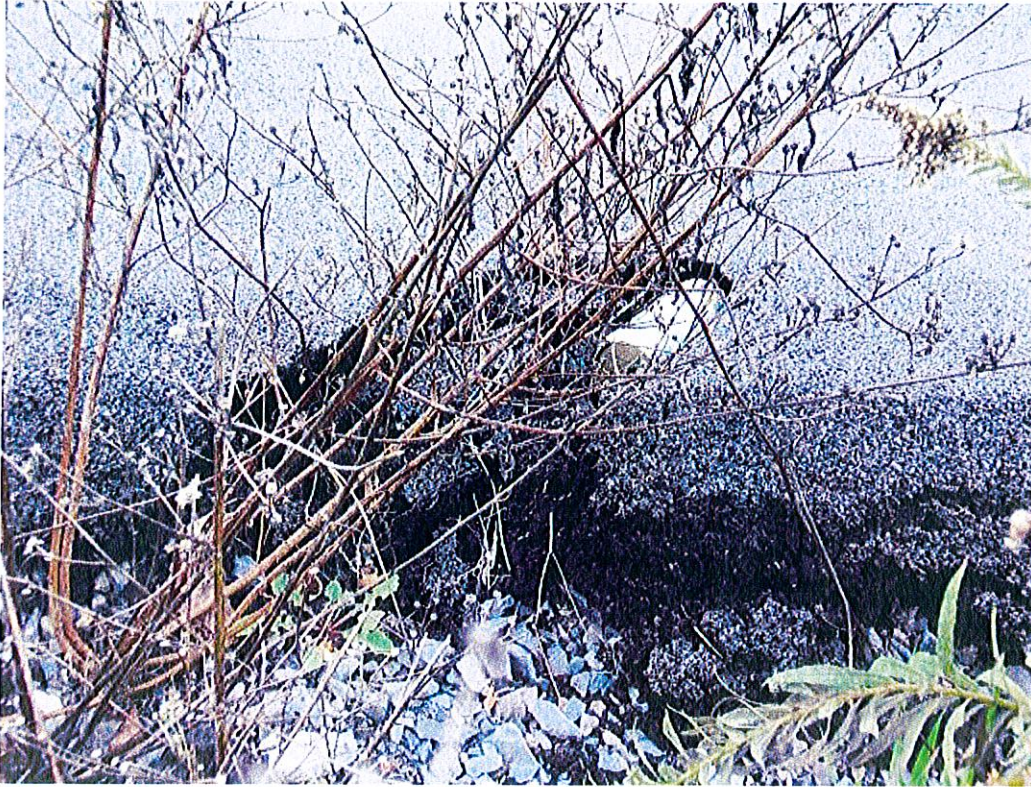
2. Areas of damage?		X	
Sanitary sewer access paths	Visually inspect conditions.			
	1. Cracks in asphalt?	X		Plant growth through asphalt. Refer to Figure 3 and Photographs 9 and 11.

Photograph 9: Pavement depression/erosion with debris.

- Repair the area of rutting of the stone access road by placement of additional crushed stone, and improve drainage of the stone access road by constructing small drainage channels to convey ponded water from the stone access road to Ley Creek. This could be performed by removal of less than 1 foot of vegetative cover material with subsequent replacement of crushed stone.
- Delineate wetland area with signage to discourage mowing of this area
- Repair the damaged site security fence
- Place topsoil over exposed erosion control fabric with subsequent seeding/fertilization and placement of erosion control fabric
- Remove burrowing animal(s) from the Site; place topsoil in the hole; and apply seed and fertilizer
- Remove vegetation from asphalt and repair cracks

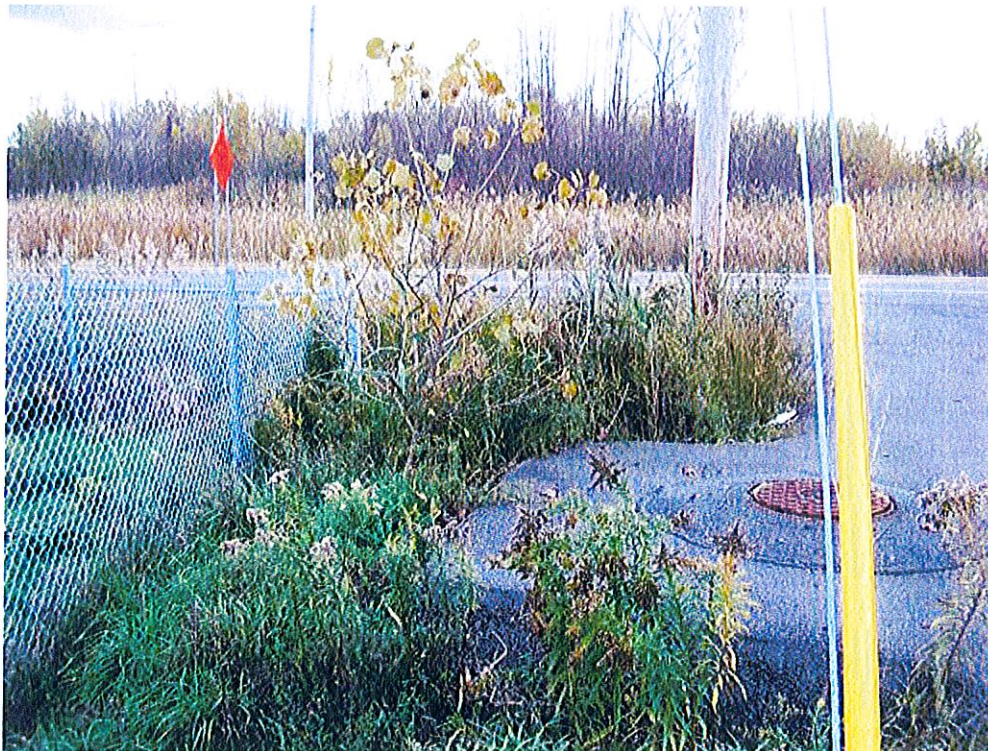
Photograph 10: Tree establishment.

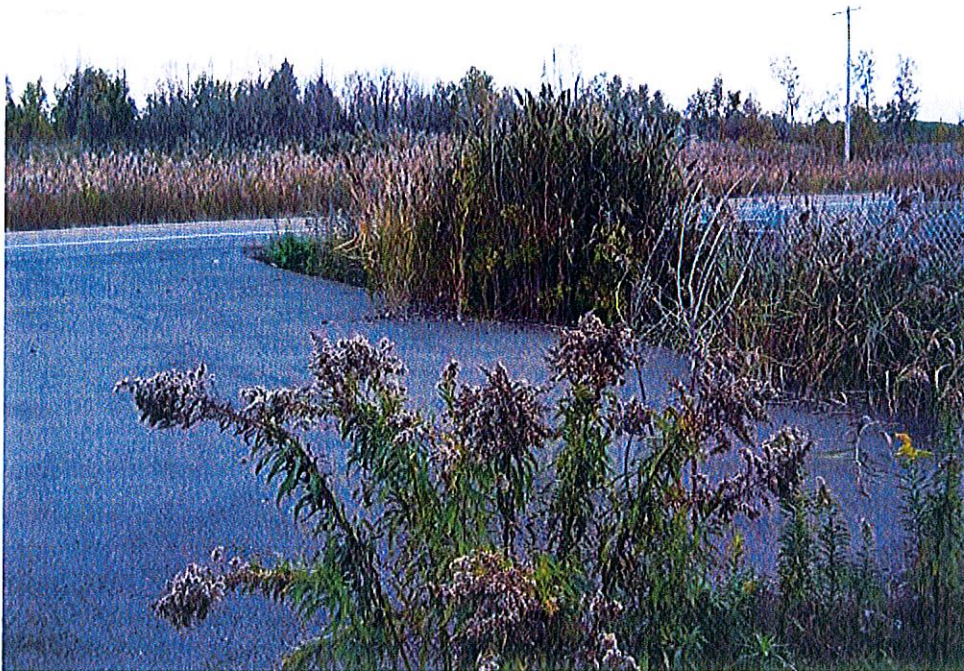
Photograph 11: Vegetation through asphalt.

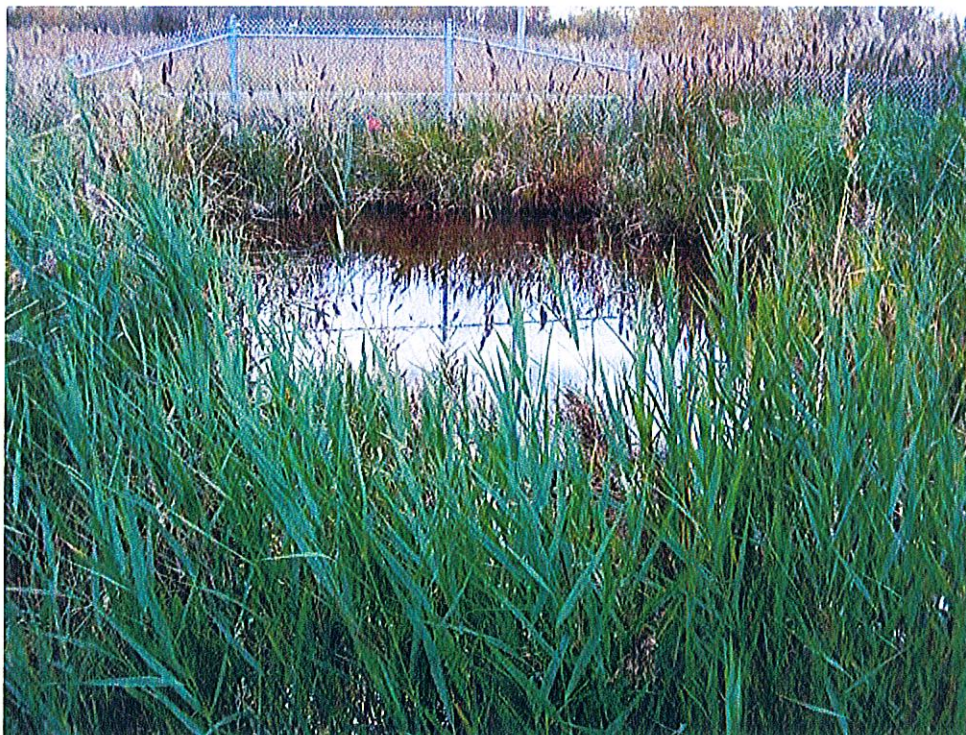
4. Areas of damage?		X	
Surface Water Drainage	Visually inspect ditches, catch basins, etc.			
	1. Accumulation of debris?	X		Refer to Photograph 12-Figure 3 and Photograph 13-Figure 1.

Photograph 12: Blocked catch basin grate at CB-2.

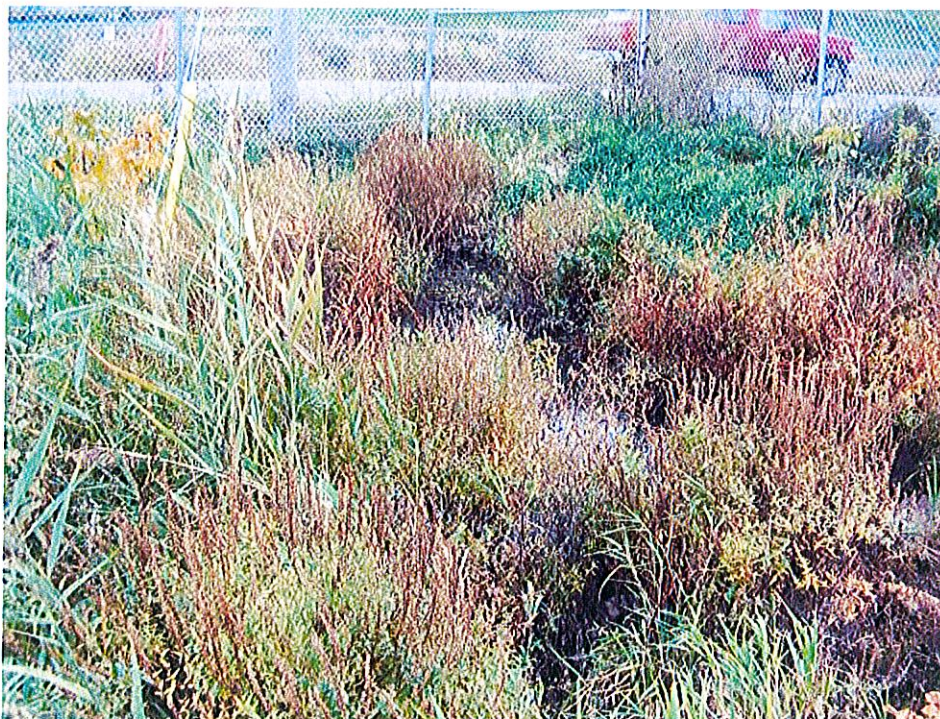
Photograph 13: Blocked catch basin at CB-1.

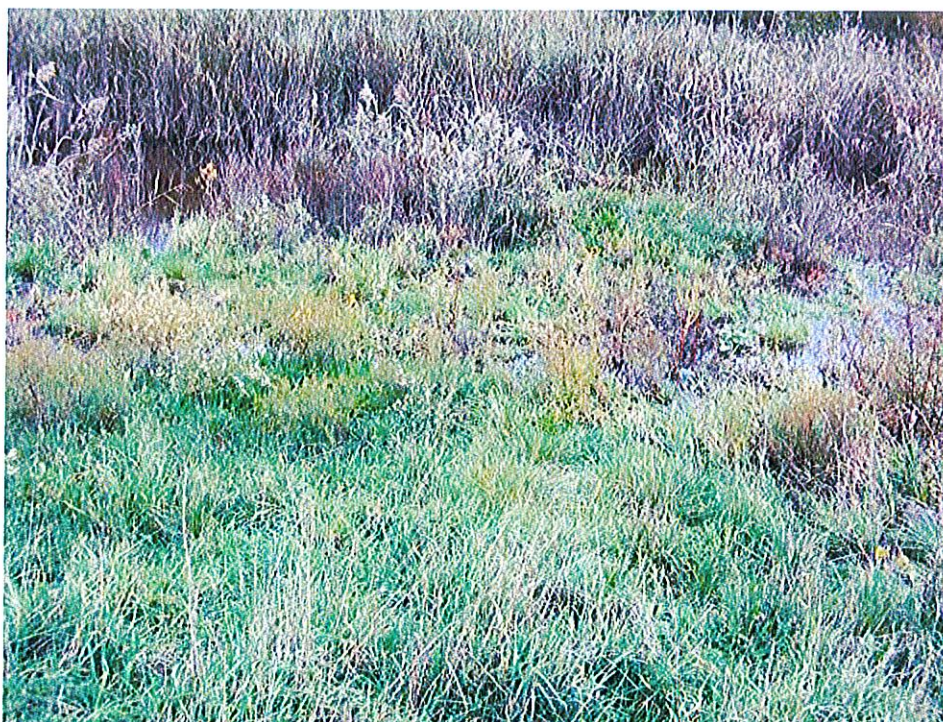
2. Excessive scouring?	X		Refer to Photograph 14-Figure 1
	3. Areas of damage?		X	
Ground Water Wells	Visually inspect conditions.			
	1. Casings secure and locked?	X

Photograph 14: Scour at CB-1 spillway into Ley Creek.

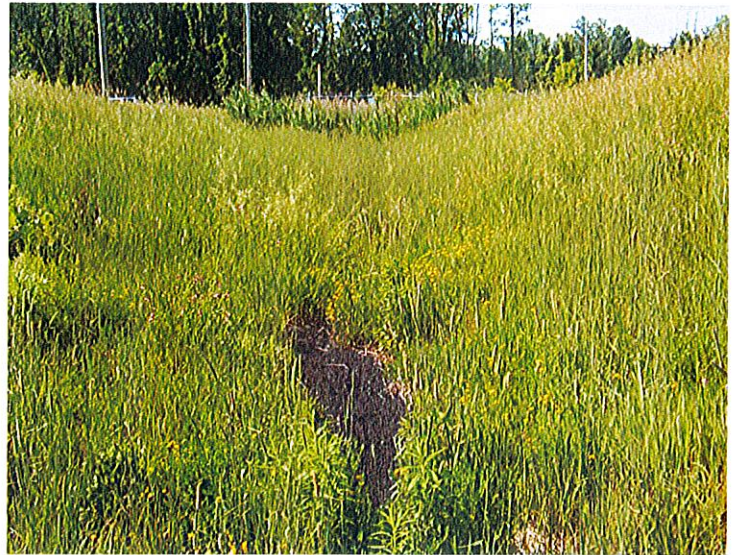
- Exposed Erosion Control Fabric: (Photograph 6, Figure 3) Topsoil has eroded away resulting in the exposure of erosion control fabric
- Presence of burrowing animals: (Photograph 8, Figure 2). A burrowing animal hole was observed near MW-12
- Vegetation through pavement/cracks in asphalt: (Photograph 11, Figure 3) Vegetation was observed growing through pavement
- Vegetation within stone access road: A significant amount of vegetation was observed within the stone access road throughout the Site and the stone access road turnaround at the eastern end of the Site
- Tree establishment: (Photograph 10 and 11, Figure 1 and Figure 3) Trees were observed along the fence line.

Item	Task	Response		Comments
		Yes	No	
Vegetative Cover	Visually inspect surface conditions.			
	1. Areas of settlement?		X	
	2. Areas of erosion?	X		Refer to Figure 3 and Photograph 6.
	3. Areas where geotextile visible due to erosion?		X	
	4. Areas of slope instability?		X	
	5. Lack or thinning vegetation?		X	
	6. Presence of burrowing animals?	X		Refer to Figure 2 and Photograph 8.
	7. Areas of damage?		X	
	8. Drainage problems?		X	
	9. Mowing required?	X		
Access Road	Visually inspect conditions.			
	1. Areas of settlement?		X

Photograph 6 - CB-3 overflow with exposed erosion control fabric.

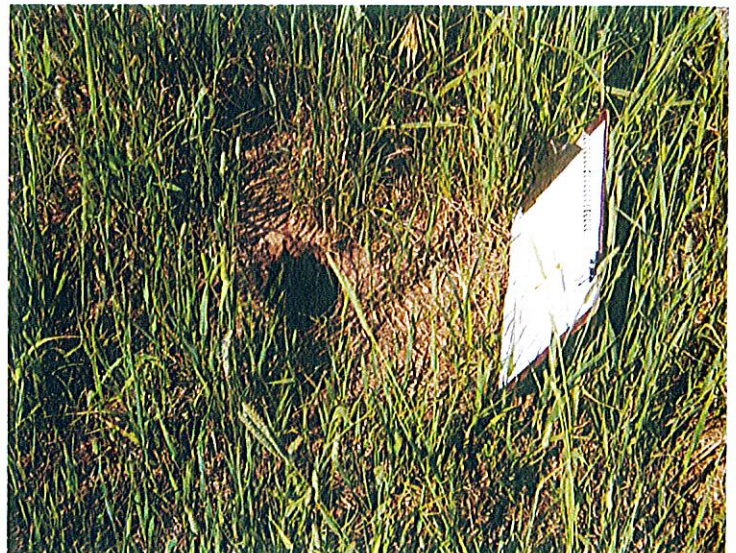
Photograph 8 - Burrowing animal hole near MW-12

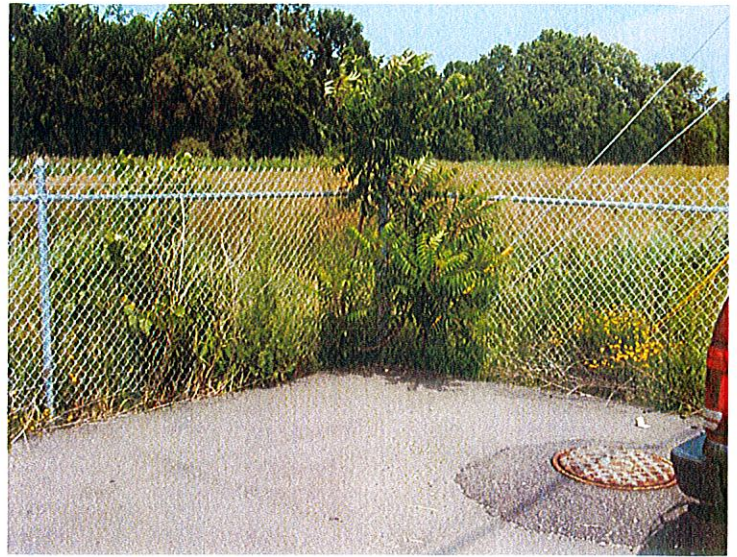
Photograph 10 - Tree growing along fence line at CB-1

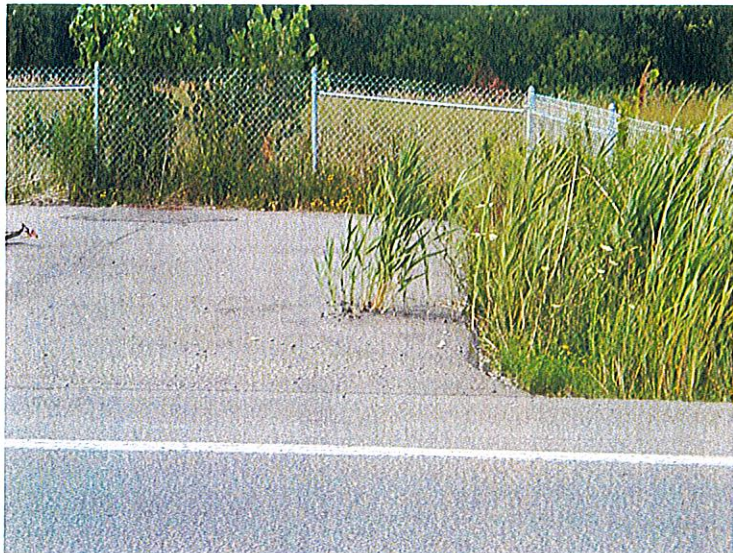
Date Performed: June 21, 2005			Weather: Sunny 75 F	
Site Name: Ley Creek PCB Dredgings Site			Inspector Name: Edwin B. Rahn	
Site Location: Syracuse, New York			Inspector Signature: <i>Edwin B. Rahn</i>	
Item	Task	Response		Comments
		Yes	No	
Access Road	2. Areas of erosion?		X	
	3. Areas rutted or potholes present?	X		Refer to Figure 2 for location of rutting.
	4. Areas of damage?		X	
Surface Water Drainage	Visually inspect ditches, catch basins, etc.			
	1. Accumulation of debris?		X	
	2. Excessive scouring?		X	
	3. Areas of damage?		X	
Ground Water Wells	Visually inspect conditions.			
	1. Casings secure and locked?	X		
	2. Areas of damage?		X	
Sanitary sewer access paths	Visually inspect conditions.			
	1. Cracks in asphalt?	X		Plant growth through asphalt. Refer to Figures 1 and 3 and Photographs 10 and 11.
	2. Manhole covers in place?	X

Photograph 11 - Vegetation in pavement and trees along fenceline

- Remove vegetation from asphalt and repair cracks
- Remove vegetation from the stone access road and the stone access road turnaround
