## **APPENDIX I**

### **Test Pit Location Summary and Photo Logs**

## Leeds Site Investigation; TP-02 (Photo Log)

**Project** Former Leeds Manufacturing Plant; Northern Parcel  
**Location** Kansas City, Missouri

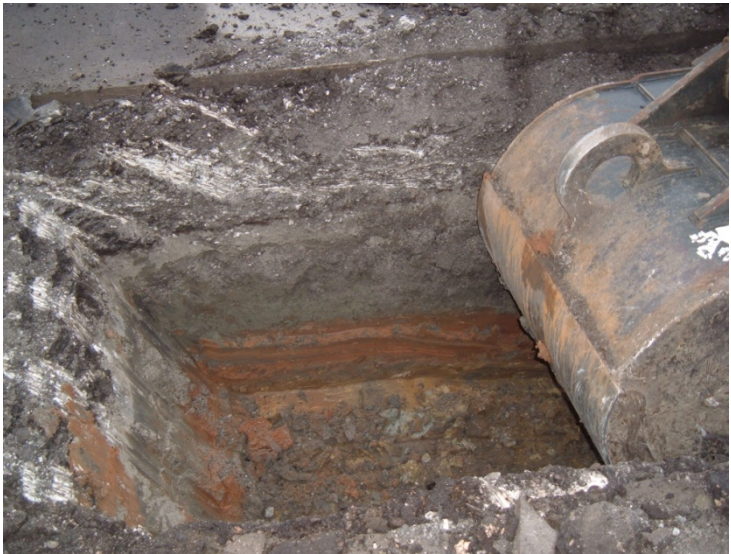
| Photo No. | Date | |
|---|---|---|
| 3 | 4/05/12 | |

| Photo No. | Date | |
|---|---|---|
| <b>Description</b><br>Fill in sidewall. Orange coloring is oxidized clay, not orange paint. | | |

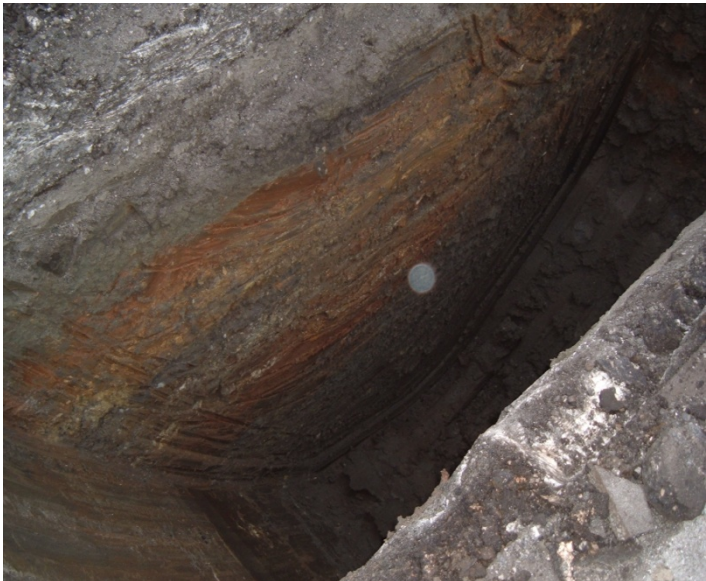
| Photo No. | Date | |
|---|---|---|
| 4 | 4/05/12 | |

| Photo No. | Date | |
|---|---|---|
| <b>Description</b><br>Fill over natural soil in sidewall of test pit. Natural soil at approx. 9 ft. bgs (dark brown). No debris in test pit. | | |

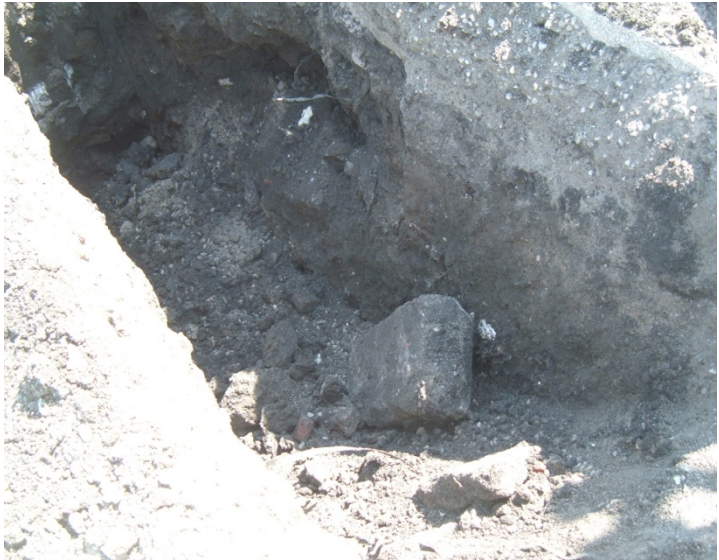
| Photo No. | Date | |
|---|---|---|
| <b>Description</b><br>Miscellaneous fill and concrete debris in test pit. | | <p>The photograph shows a test pit with a dark, muddy interior. The pit is filled with miscellaneous fill and concrete debris, including large chunks of concrete and smaller pieces of debris. The pit is dug into the ground, and the surrounding area is light-colored soil.</p> |

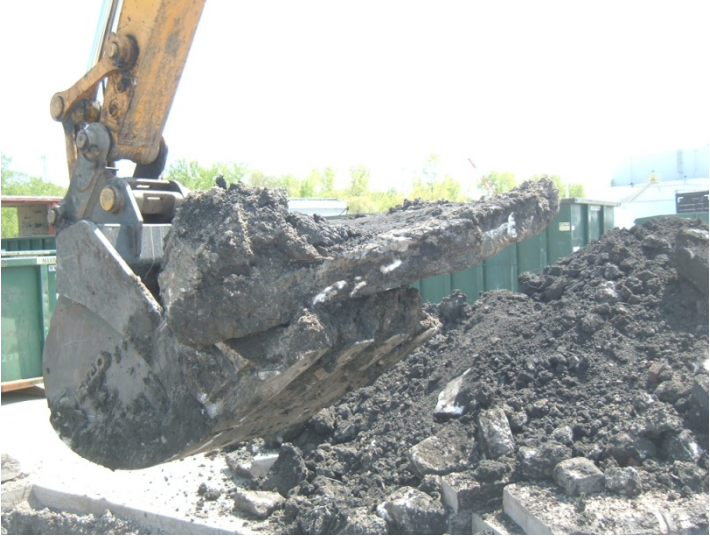
| Photo No. | Date | |
|---|---|---|
| 3 | 4/09/12 | |

| Photo No. | Date | |
|---|---|---|
| <b>Description</b><br>Large concrete debris from test pit. | | |

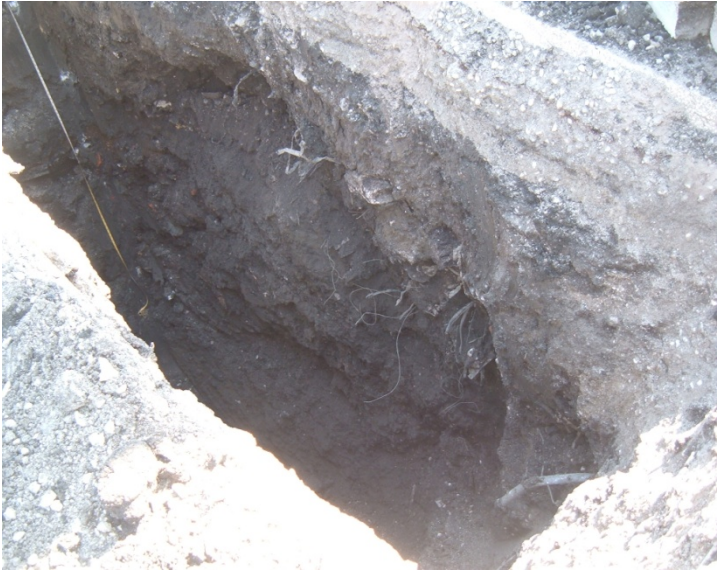
| Photo No. | Date | |
|---|---|---|
| 4 | 4/09/12 | |

| Photo No. | Date | |
|---|---|---|
| <b>Description</b><br>Test pit sidewall showing minor amounts of wire debris intermixed with fill material. | | |

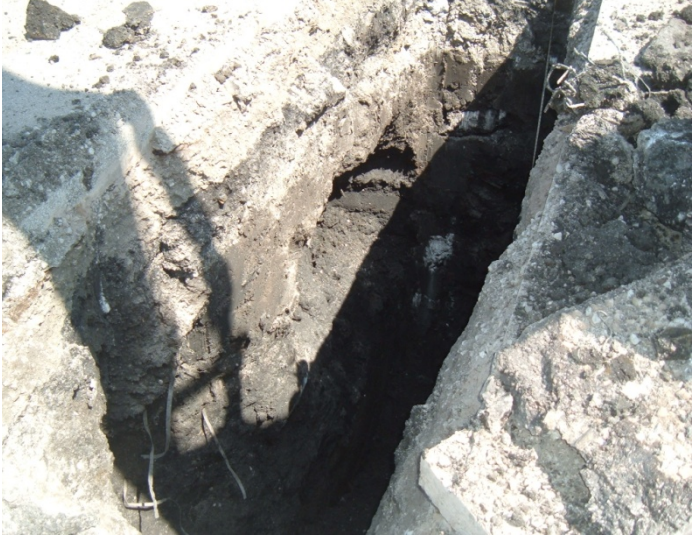
| Photo No. | Date | |
|---|---|---|
| 5 | 4/09/12 | |

| Photo No. | Date | |
|---|---|---|
| <b>Description</b><br>Miscellaneous fill in sidewall. Natural soil observed at approx. 12 ft. bgs. | | |

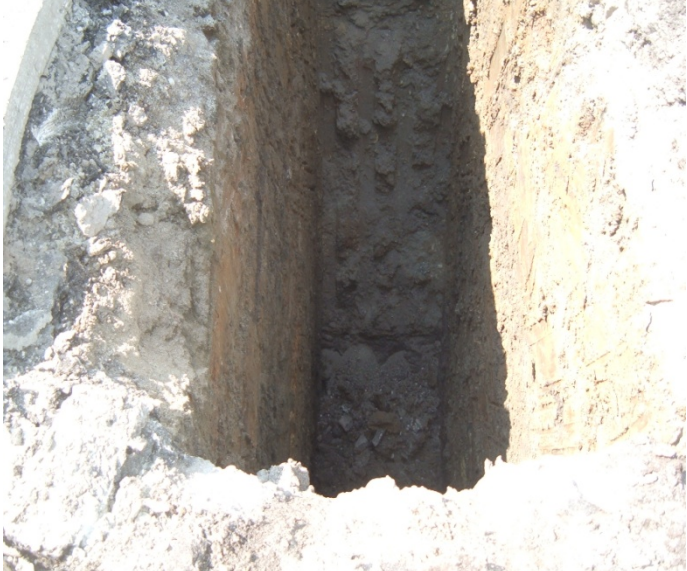
| Photo No. | Date | |
|---|---|---|
| 3 | 4/05/12 | |

| Photo No. | Date | |
|---|---|---|
| <b>Description</b><br>Test pit sidewalls showing no debris. | | |

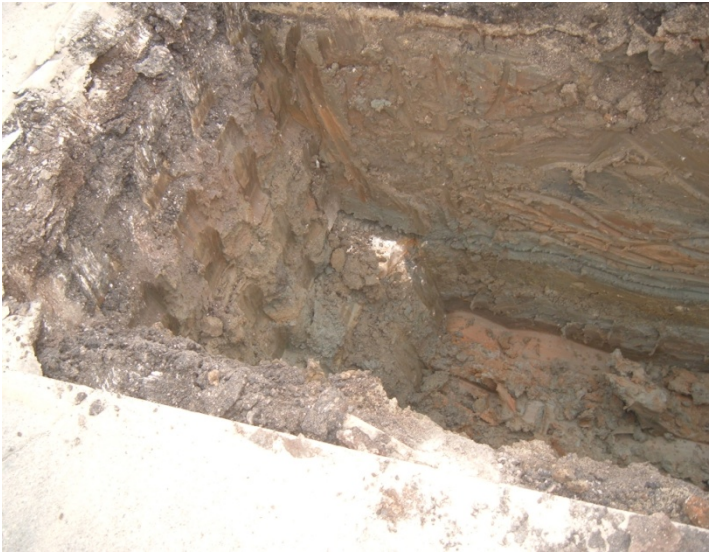
| Photo No. | Date | |
|---|---|---|
| 2 | 4/04/12 | |

| Photo No. | Date | |
|---|---|---|
| <b>Description</b><br>Fill material in test pit sidewall. Orange coloring is oxidized clay, not orange paint. | | |

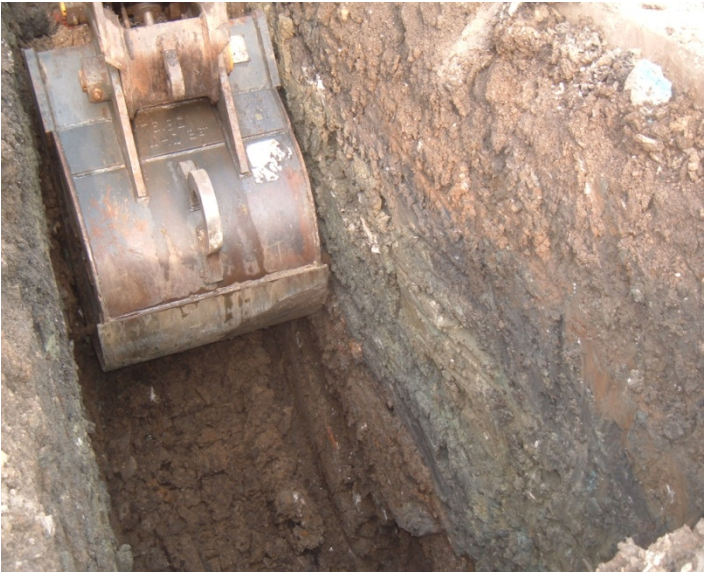
| Photo No. | Date | |
|---|---|---|
| <b>Description</b><br>Upper fill relatively debris free. Cinders and some paint debris. | | A photograph showing a large, rusted metal drum remnant lying horizontally in a deep, narrow pit. The surrounding soil is dark brown and appears to be a mix of cinders and debris. The drum has some white markings on its side. |

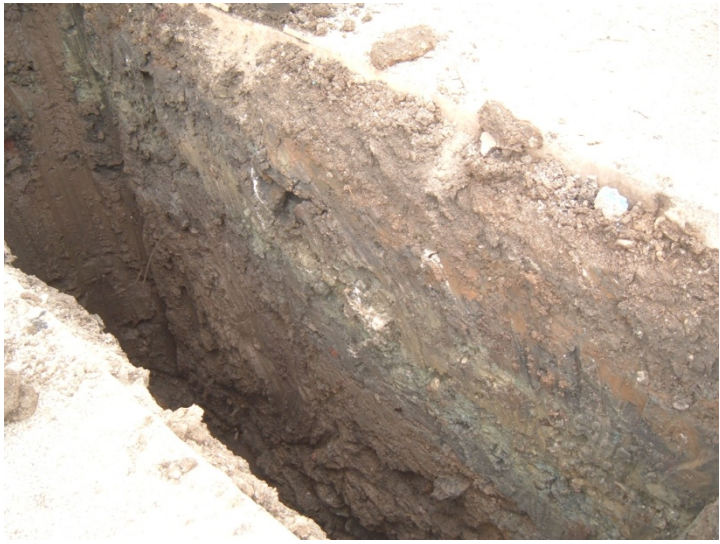
| Photo No. | Date | |
|---|---|---|
| 3 | 4/04/12 | |

| Photo No. | Date | |
|---|---|---|
| <b>Description</b><br>Gray green fill layer observed sloping downward from east to west in upper portion of test pit. | | |

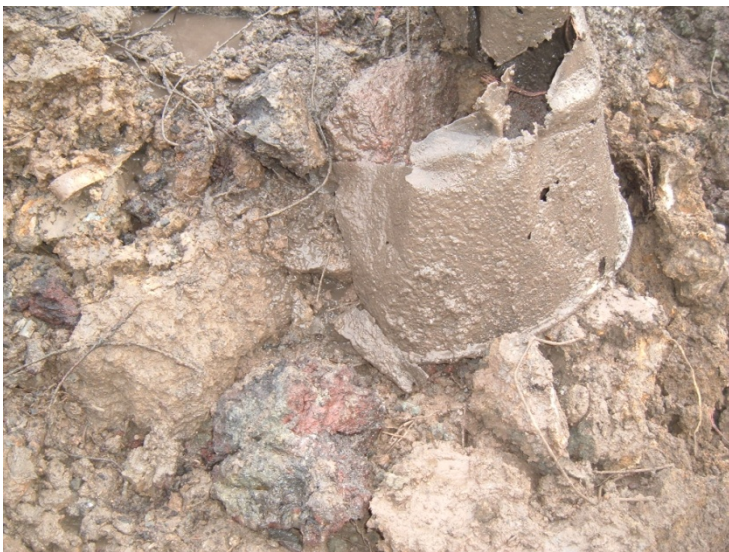
| Photo No. | Date | |
|---|---|---|
| 6 | 4/04/12 | |

| Photo No. | Date | |
|---|---|---|
| <b>Description</b><br>Drum remnants from approx. 15 ft. bgs. 2 drum remnants observed. | | |

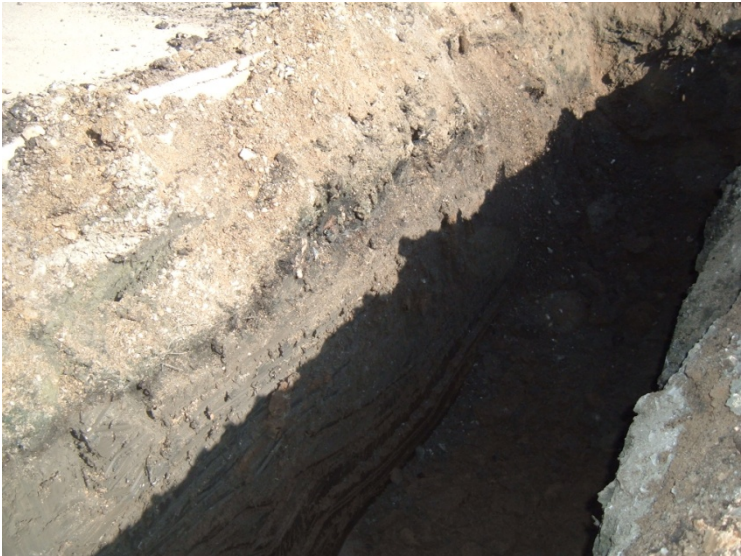
| Photo No. | Date | |
|---|---|---|
| 2 | 4/06/12 | |

| Photo No. | Date | |
|---|---|---|
| <b>Description</b><br>Fill with cinders, brick and concrete pieces. | | |

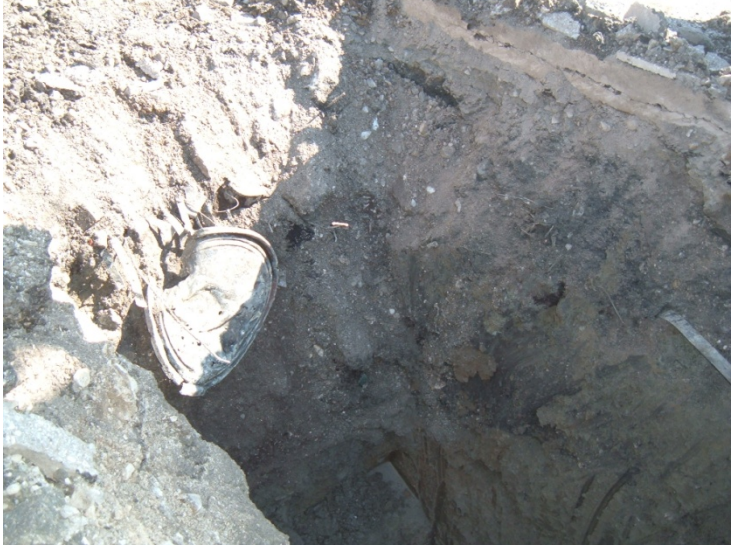
| Photo No. | Date | |
|---|---|---|
| 3 | 4/06/12 | |

| Photo No. | Date | |
|---|---|---|
| <b>Description</b><br>2 drum remnants encountered at north end of pit approx. 3 ft. bgs. | | |

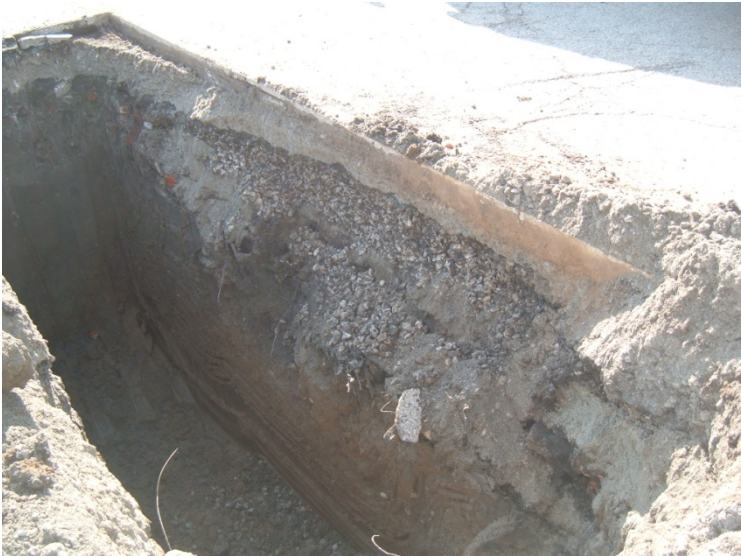
| Photo No. | Date | |
|---|---|---|
| 2 | 4/09/12 | |

| Photo No. | Date | |
|---|---|---|
| <b>Description</b><br>Test pit sidewall, debris in fill encountered in upper 3 feet of test pit. | | |

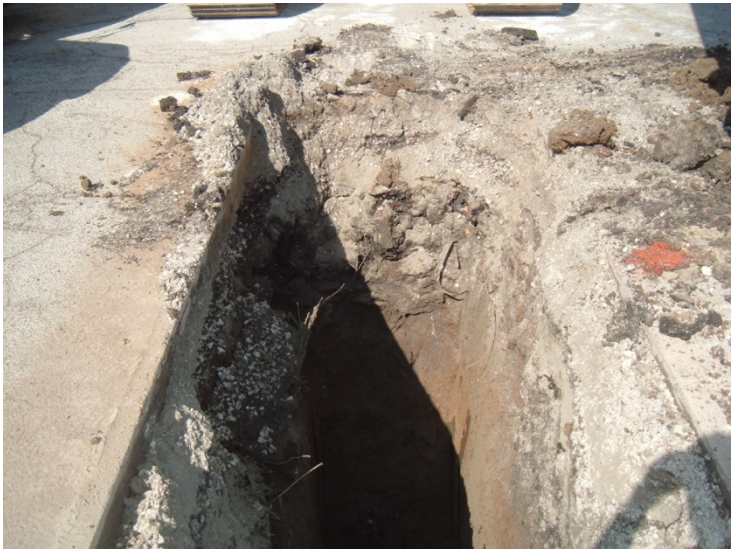
| Photo No. | Date | |
|---|---|---|
| 3 | 4/09/12 | |

| Photo No. | Date | |
|---|---|---|
| <b>Description</b><br>Area of fill where drum remnant was encountered at shallow depth (~3 ft. bgs.) | | |

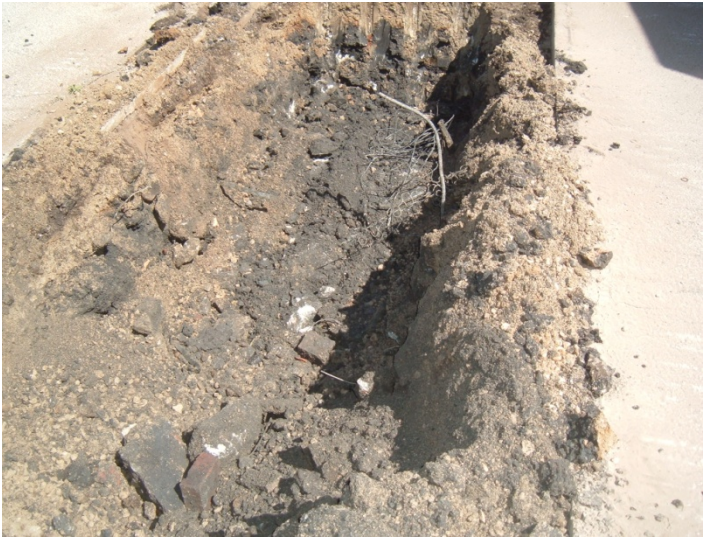
| Photo No. | Date | |
|---|---|---|
| <b>Description</b><br>Shallow debris in fill. | | <p>The photograph shows a cross-section of the ground surface, revealing a layer of dark, loose soil and debris (fill) overlying a more solid, light-colored material. The debris includes small rocks, twigs, and organic matter.</p> |

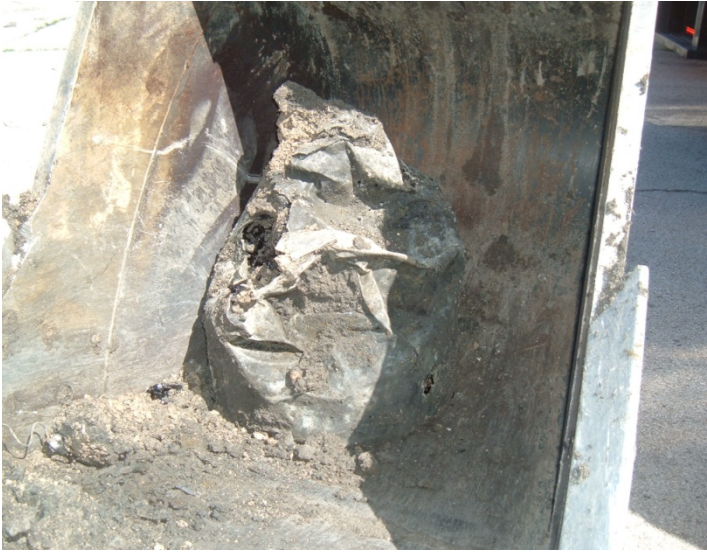
| Photo No. | Date | |
|---|---|---|
| 4 | 4/06/12 | |

| Photo No. | Date | |
|---|---|---|
| <b>Description</b><br>Drum remnant encountered at approx. 5 ft. bgs. | | |

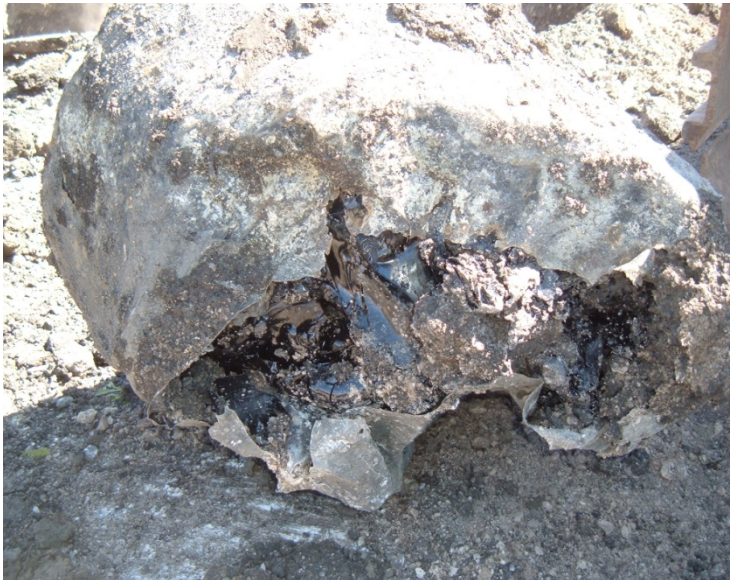
| Photo No. | Date | |
|---|---|---|
| 5 | 4/06/12 | |

| Photo No. | Date | |
|---|---|---|
| <b>Description</b><br>Dry, hardened black material in drum | | |

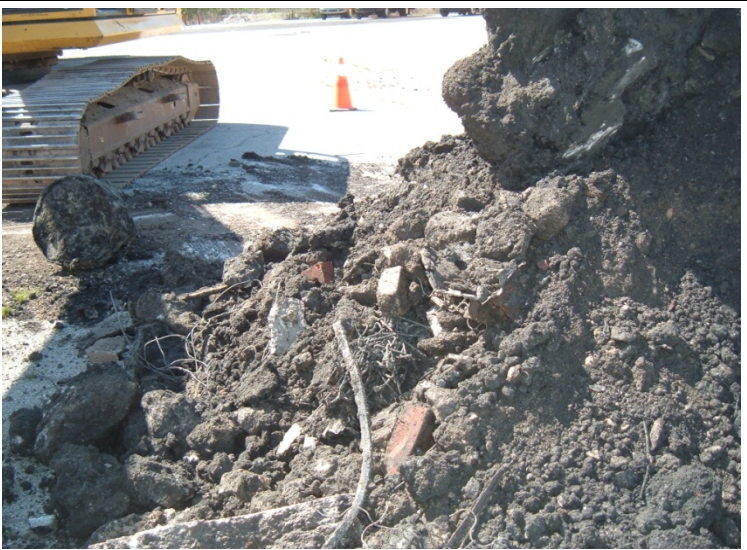
| Photo No. | Date | |
|---|---|---|
| 6 | 4/06/12 | |

| Photo No. | Date | |
|---|---|---|
| <b>Description</b><br>Miscellaneous debris in fill. | | |

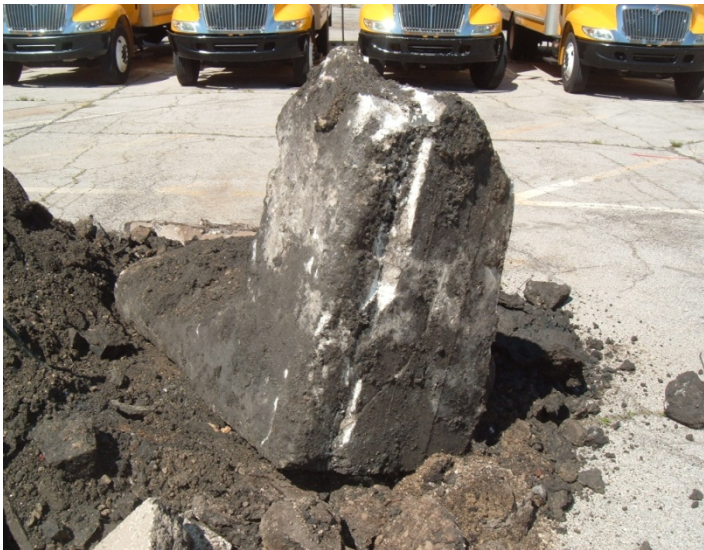
| Photo No. | Date | |
|---|---|---|
| 7 | 4/06/12 | |

| Photo No. | Date | |
|---|---|---|
| <b>Description</b><br>Large concrete debris in fill. | | |

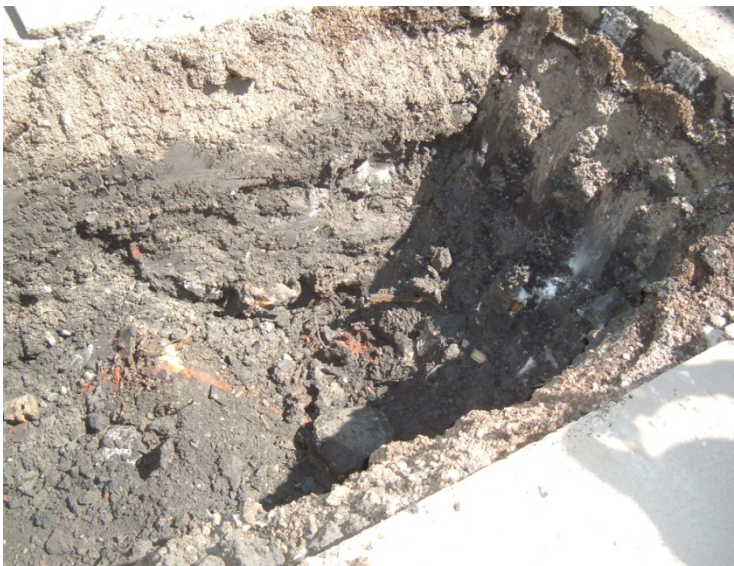
| Photo No. | Date | |
|---|---|---|
| 2 | 4/06/12 | |

| Photo No. | Date | |
|---|---|---|
| <b>Description</b><br>Miscellaneous fill with cinders, brick, metal, wood, wire. | | |

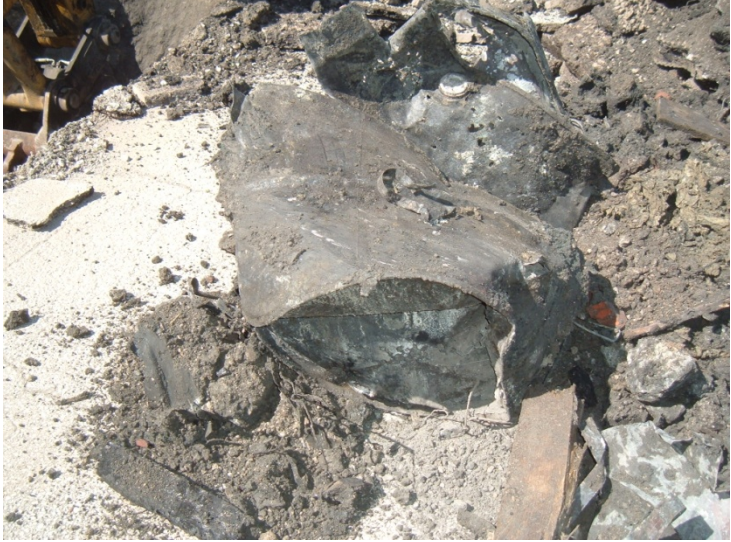
| Photo No. | Date | |
|---|---|---|
| 3 | 4/06/12 | |

| Photo No. | Date | |
|---|---|---|
| <b>Description</b><br>2 drum remnants encountered in upper 4 ft. of fill. | | |

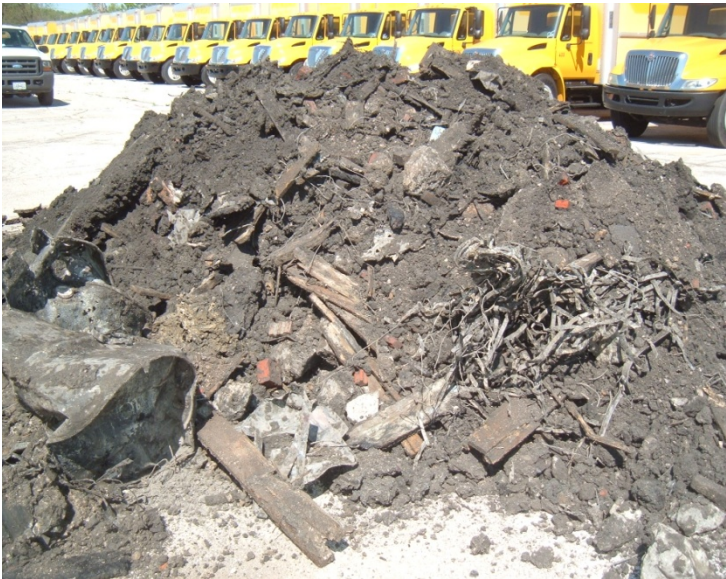
| Photo No. | Date | |
|---|---|---|
| 4 | 4/06/12 | |

| Photo No. | Date | |
|---|---|---|
| <b>Description</b><br>Debris from fill in upper 8 ft. of test pit. | | |

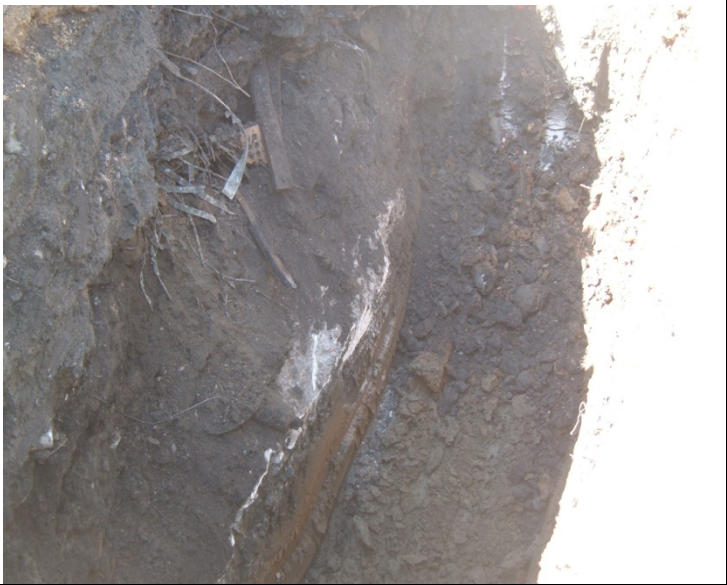
| Photo No. | Date | |
|---|---|---|
| 5 | 4/06/12 | |

| Photo No. | Date | |
|---|---|---|
| <b>Description</b><br>Fill with debris over natural soil. Concrete piece (white/gray) demarks bottom of fill. | | |

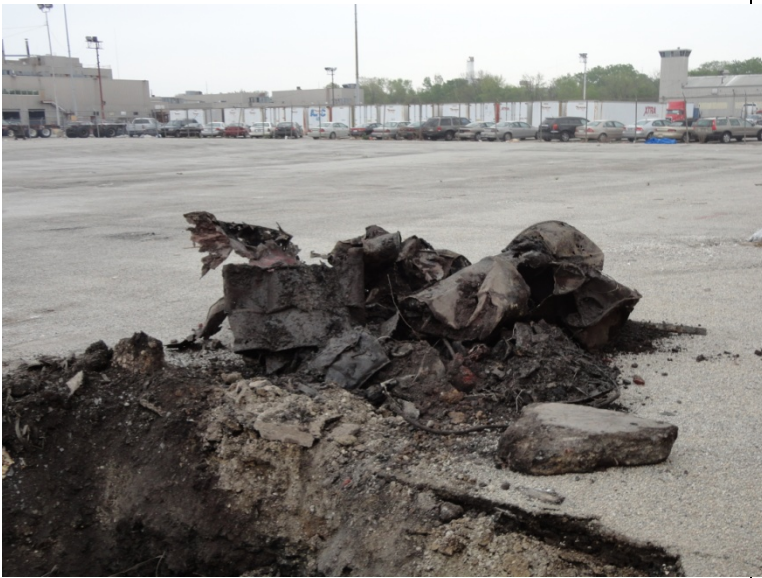
| Photo No. | Date | |
|---|---|--|
| 2 | 4/03/12 | |

| Photo No. | Date | |
|---|---|--|
| Description | Drum remnants | |

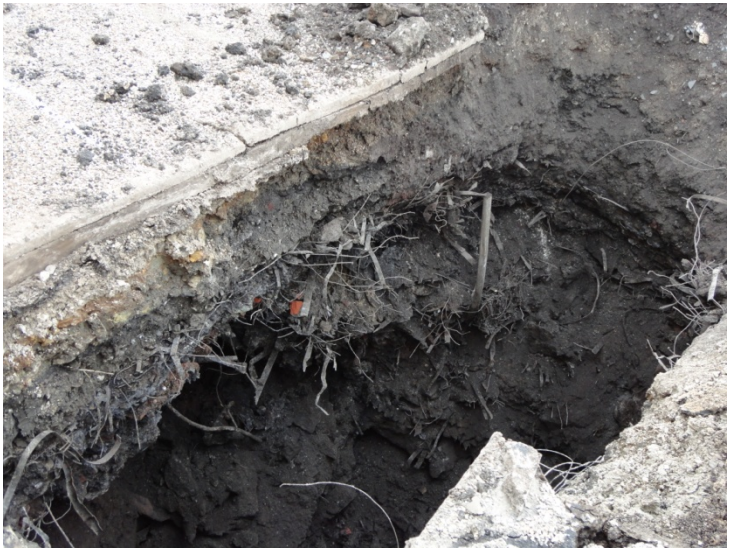
| Photo No. | Date | |
|---|---|---|
| 3 | 4/03/12 | |

| Photo No. | Date | |
|---|---|---|
| <b>Description</b><br>Miscellaneous metal debris beginning approximately 1 to 2 ft beneath pavement. | | |

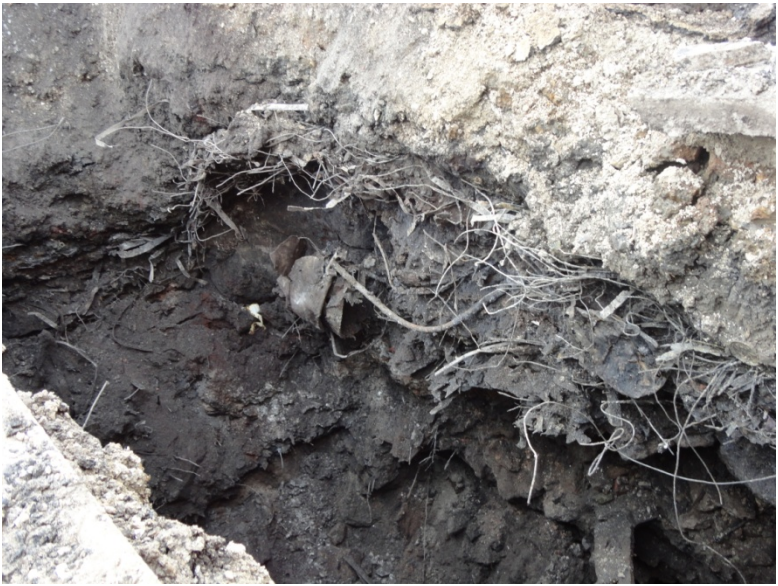
| Photo No. | Date | |
|---|---|---|
| 4 | 4/03/12 | |

| Photo No. | Date | |
|---|---|---|
| <b>Description</b><br>Debris in test pit | | |

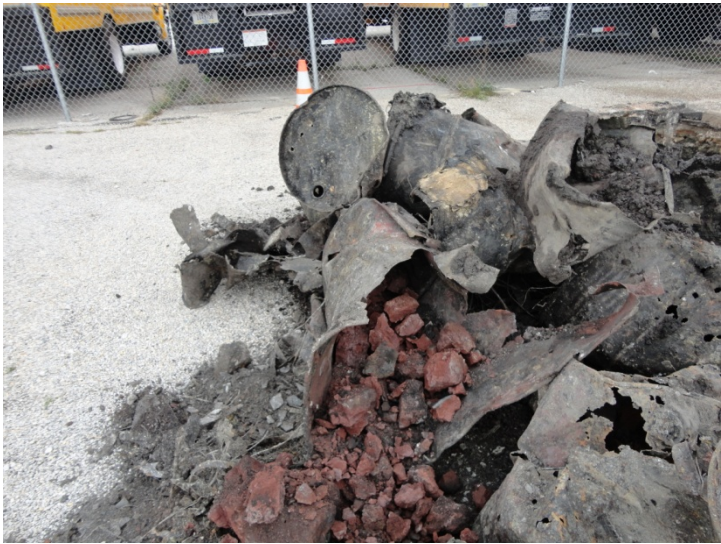
| Photo No. | Date | |
|---|---|---|
| 5 | 4/03/12 | |

| Photo No. | Date | |
|---|---|---|
| <b>Description</b><br>Paint debris from inside drum remnant. | | |

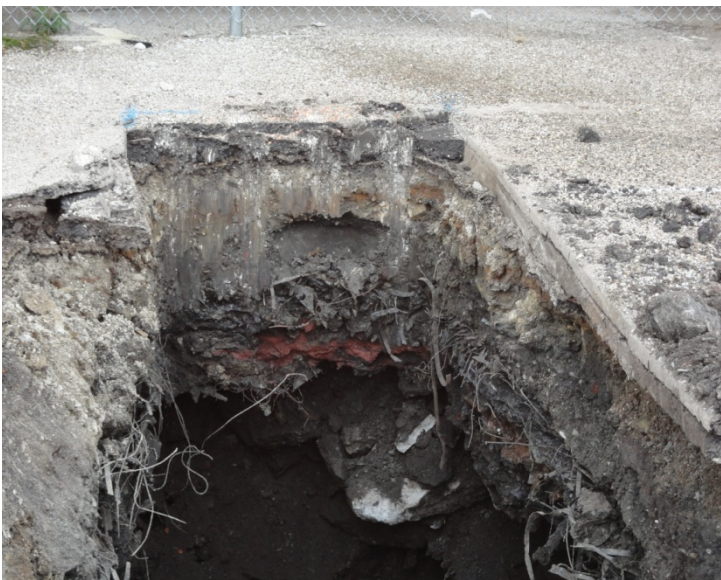
| Photo No. | Date | |
|---|---|---|
| 6 | 4/03/12 | |

| Photo No. | Date | |
|---|---|---|
| <b>Description</b><br>Red paint layer in test pit wall. | | |

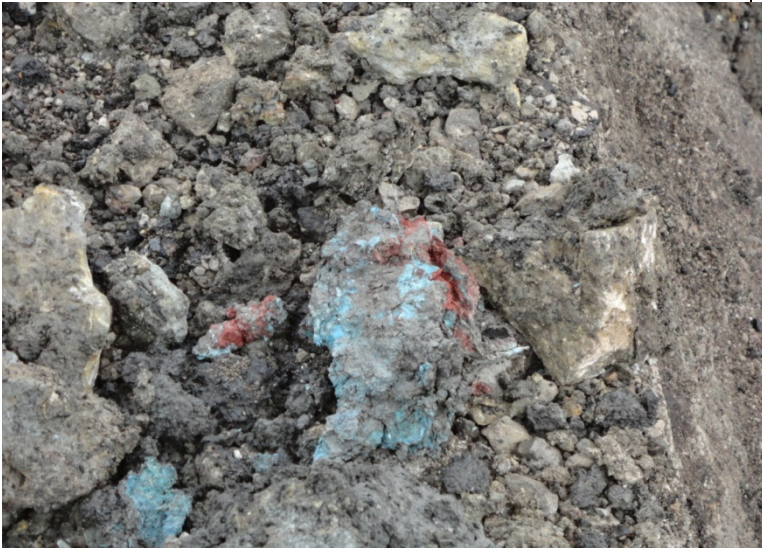
| Photo No. | Date | |
|---|---|---|
| 2 | 4/03/12 | |

| Photo No. | Date | |
|---|---|---|
| <b>Description</b><br>Paint debris | | |

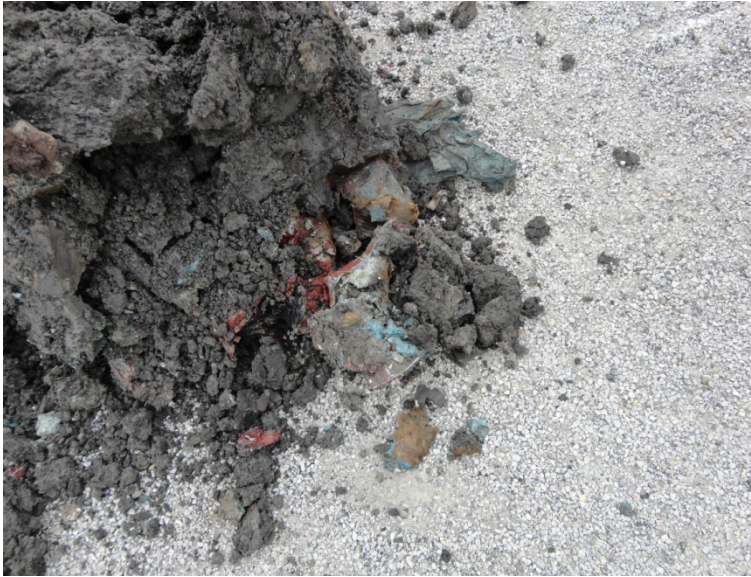
| Photo No. | Date | |
|---|---|---|
| 4 | 4/03/12 | |

| Photo No. | Date | |
|---|---|---|
| <b>Description</b><br>Paint debris in cardboard enclosure. Possible powder pigment that has solidified over the years. | | |

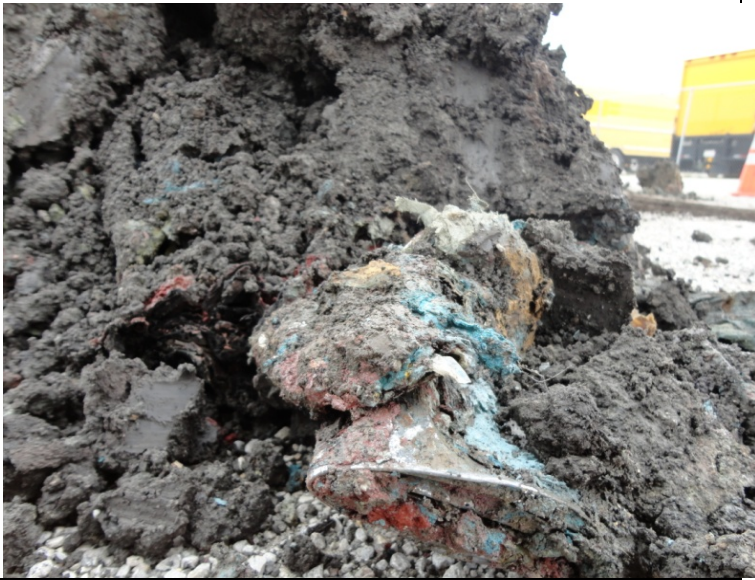
| Photo No. | Date | |
|---|---|---|
| 5 | 4/03/12 | |

| Photo No. | Date | |
|---|---|---|
| <b>Description</b><br>Paint can debris. | | |

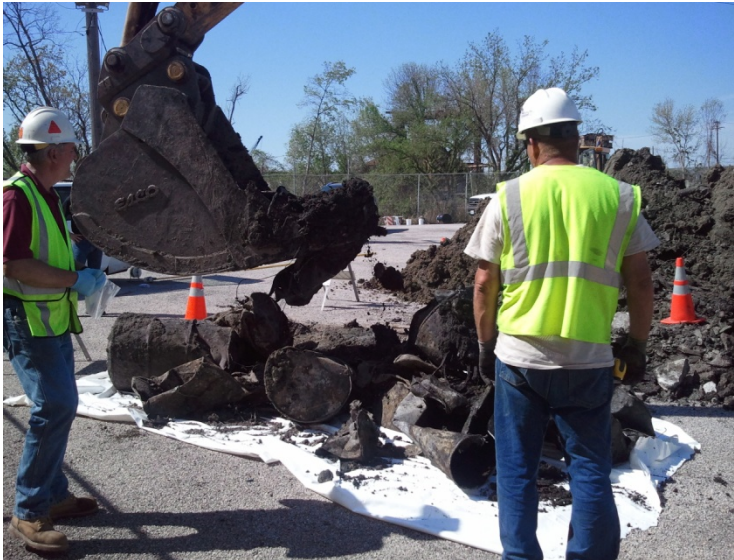
| Photo No. | Date | |
|---|---|---|
| 2 | 4/02/12 | |

| Photo No. | Date | |
|---|---|---|
| <b>Description</b><br>Drum remnants | | |

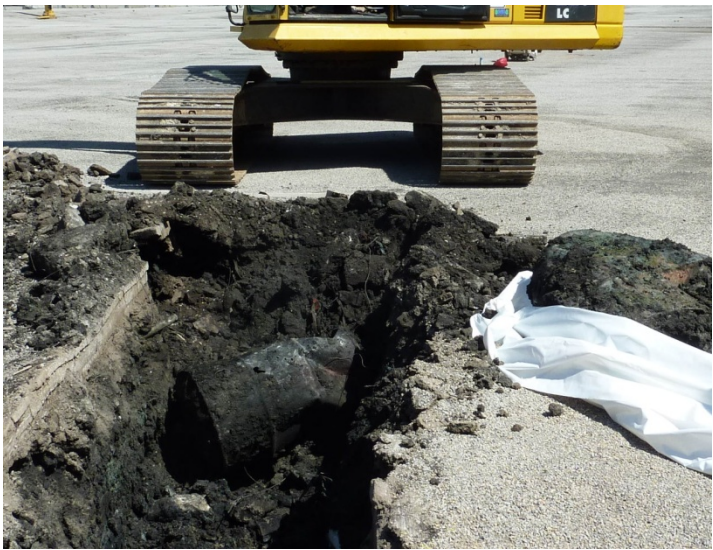
| Photo No. | Date | |
|---|---|---|
| 3 | 4/02/12 | |

| Photo No. | Date | |
|---|---|---|
| <b>Description</b><br>Drum encountered shallow in the test pit. | | |

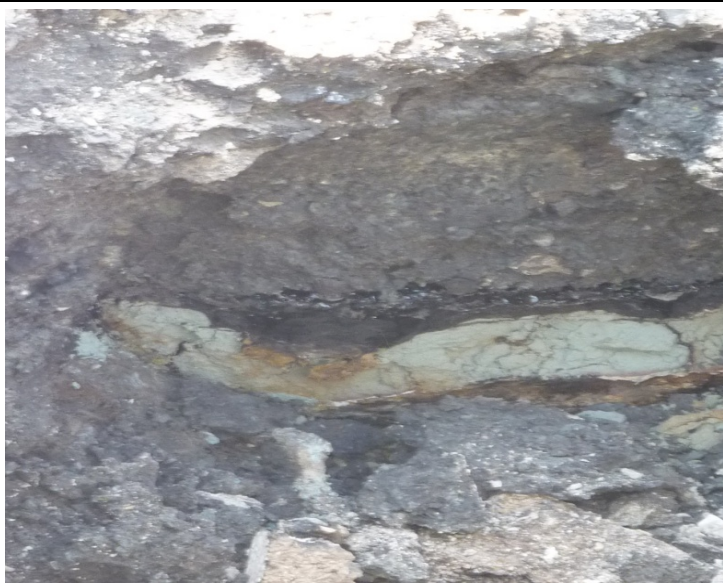
| Photo No. | Date | |
|---|---|---|
| 4 | 4/02/12 | |

| Photo No. | Date | |
|---|---|---|
| <b>Description</b><br>Paint layer in test pit sidewall | | |

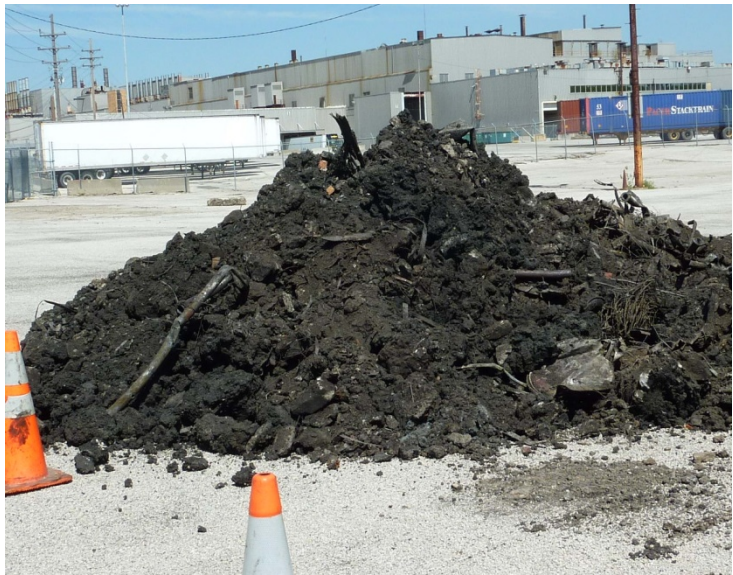
| Photo No. | Date | |
|---|---|---|
| 5 | 4/0212 | |

| Photo No. | Date | |
|---|---|---|
| <b>Description</b><br>TP-18<br>miscellaneous debris | | |

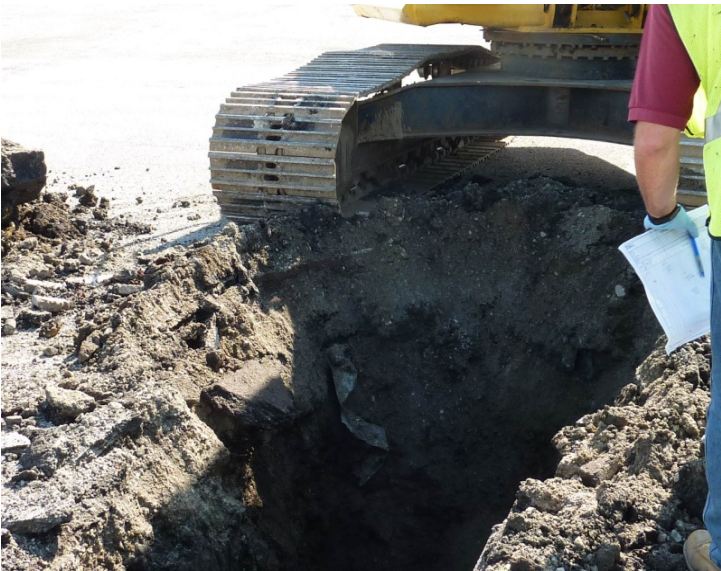
| Photo No. | Date | |
|---|---|---|
| <b>Description</b><br>Miscellaneous metal debris near surface, no drums. | | A photograph showing a close-up of a large, dark, irregularly shaped metal object, likely a drum or container, partially buried in a pile of dirt and debris. A person wearing a red shirt and a yellow safety vest is visible on the right side of the frame, holding a blue folder or clipboard. The background shows a sandy area and a yellow excavator bucket. |

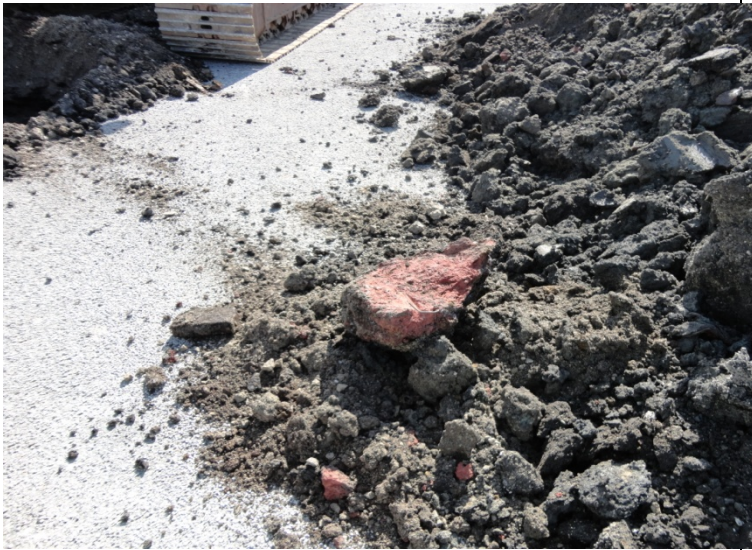
| Photo No. | Date | |
|---|---|---|
| 3 | 4/03/12 | |

| Photo No. | Date | |
|---|---|---|
| <b>Description</b><br>Paint pigment from test pit | | |

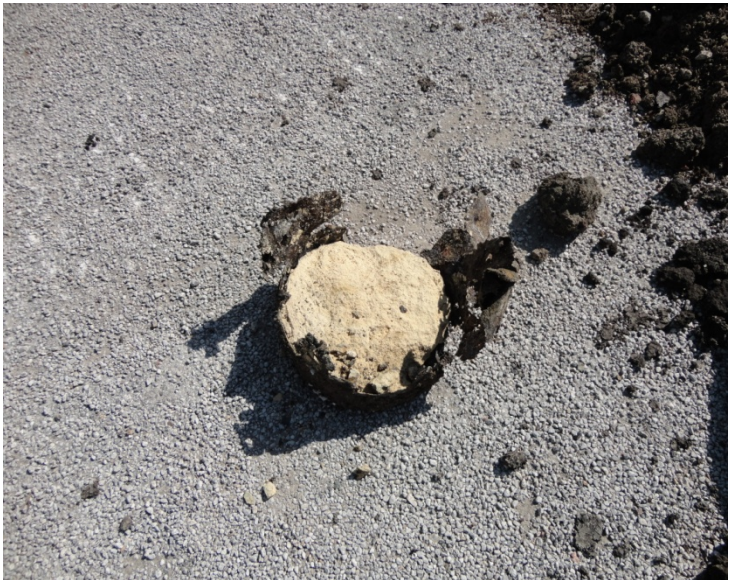
| Photo No. | Date | |
|---|---|---|
| 5 | 4/03/12 | |

| Photo No. | Date | |
|---|---|---|
| <b>Description</b><br>Remnants of paint can with solid paint residue in bottom. | | |

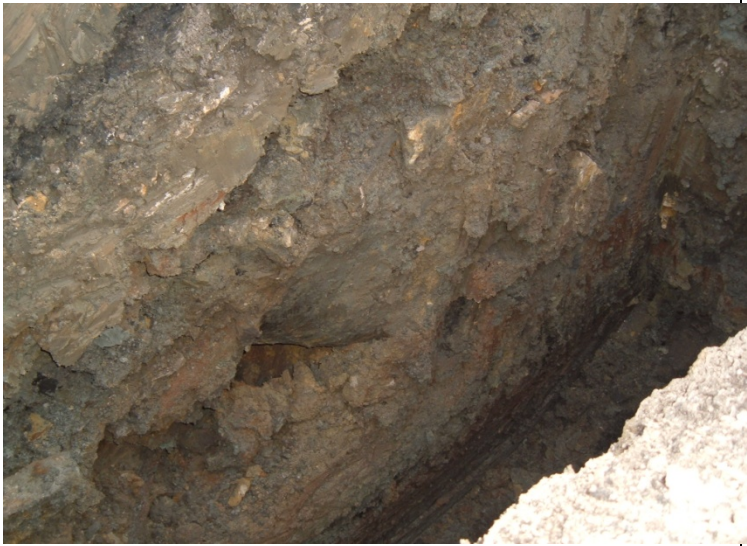
| Photo No. | Date | |
|---|---|---|
| 3 | 4/04/12 | |

| Photo No. | Date | |
|---|---|---|
| <b>Description</b><br>Paint debris in test pit sidewall (white, yellow and red/orange). | | |

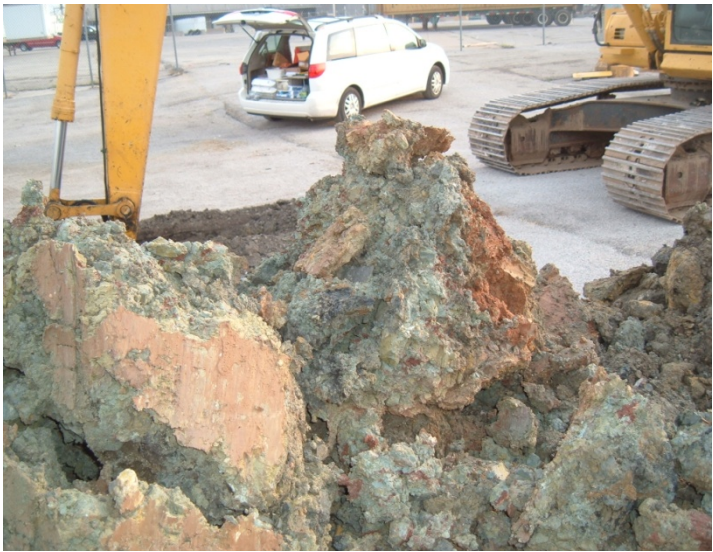
| Photo No. | Date | |
|---|---|---|
| 4 | 4/04/12 | |

| Photo No. | Date | |
|---|---|---|
| <b>Description</b><br>Close up of paint debris in spoil pile. | | |

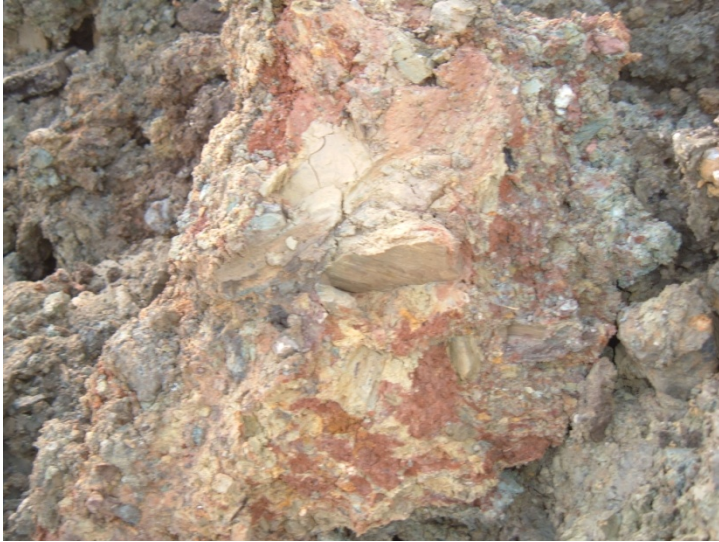
| Photo No. | Date | |
|---|---|---|
| 5 | 4/04/12 | |

| Photo No. | Date | |
|---|---|---|
| <b>Description</b><br>Paint debris | | |

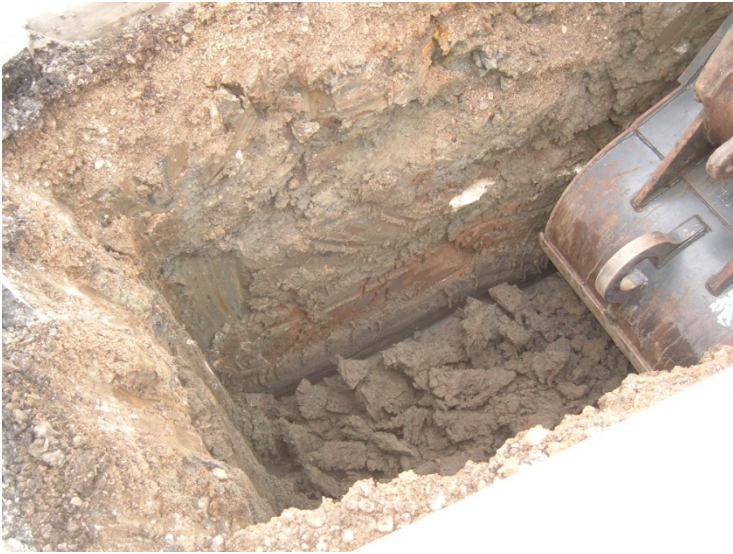
| Photo No. | Date | |
|---|---|---|
| <b>Description</b><br>Fill material in sidewall.<br>Orange coloring is oxidized clay, not orange paint. | | A photograph showing a cross-section of a trench or excavation. The sidewall is composed of brown, textured fill material. A large, dark, curved object, possibly a piece of machinery or a large pipe, is visible on the right side of the trench. The bottom of the trench is filled with loose, brown soil. |
