2010 ANNUAL REPORT – FINAL REPORT

**Landfill Inspection Report
REALM Coldwater Road Landfill
Flint, Michigan
MID 005 356 860**

**Motors Liquidation Company
Birmingham, Michigan**

February 2011

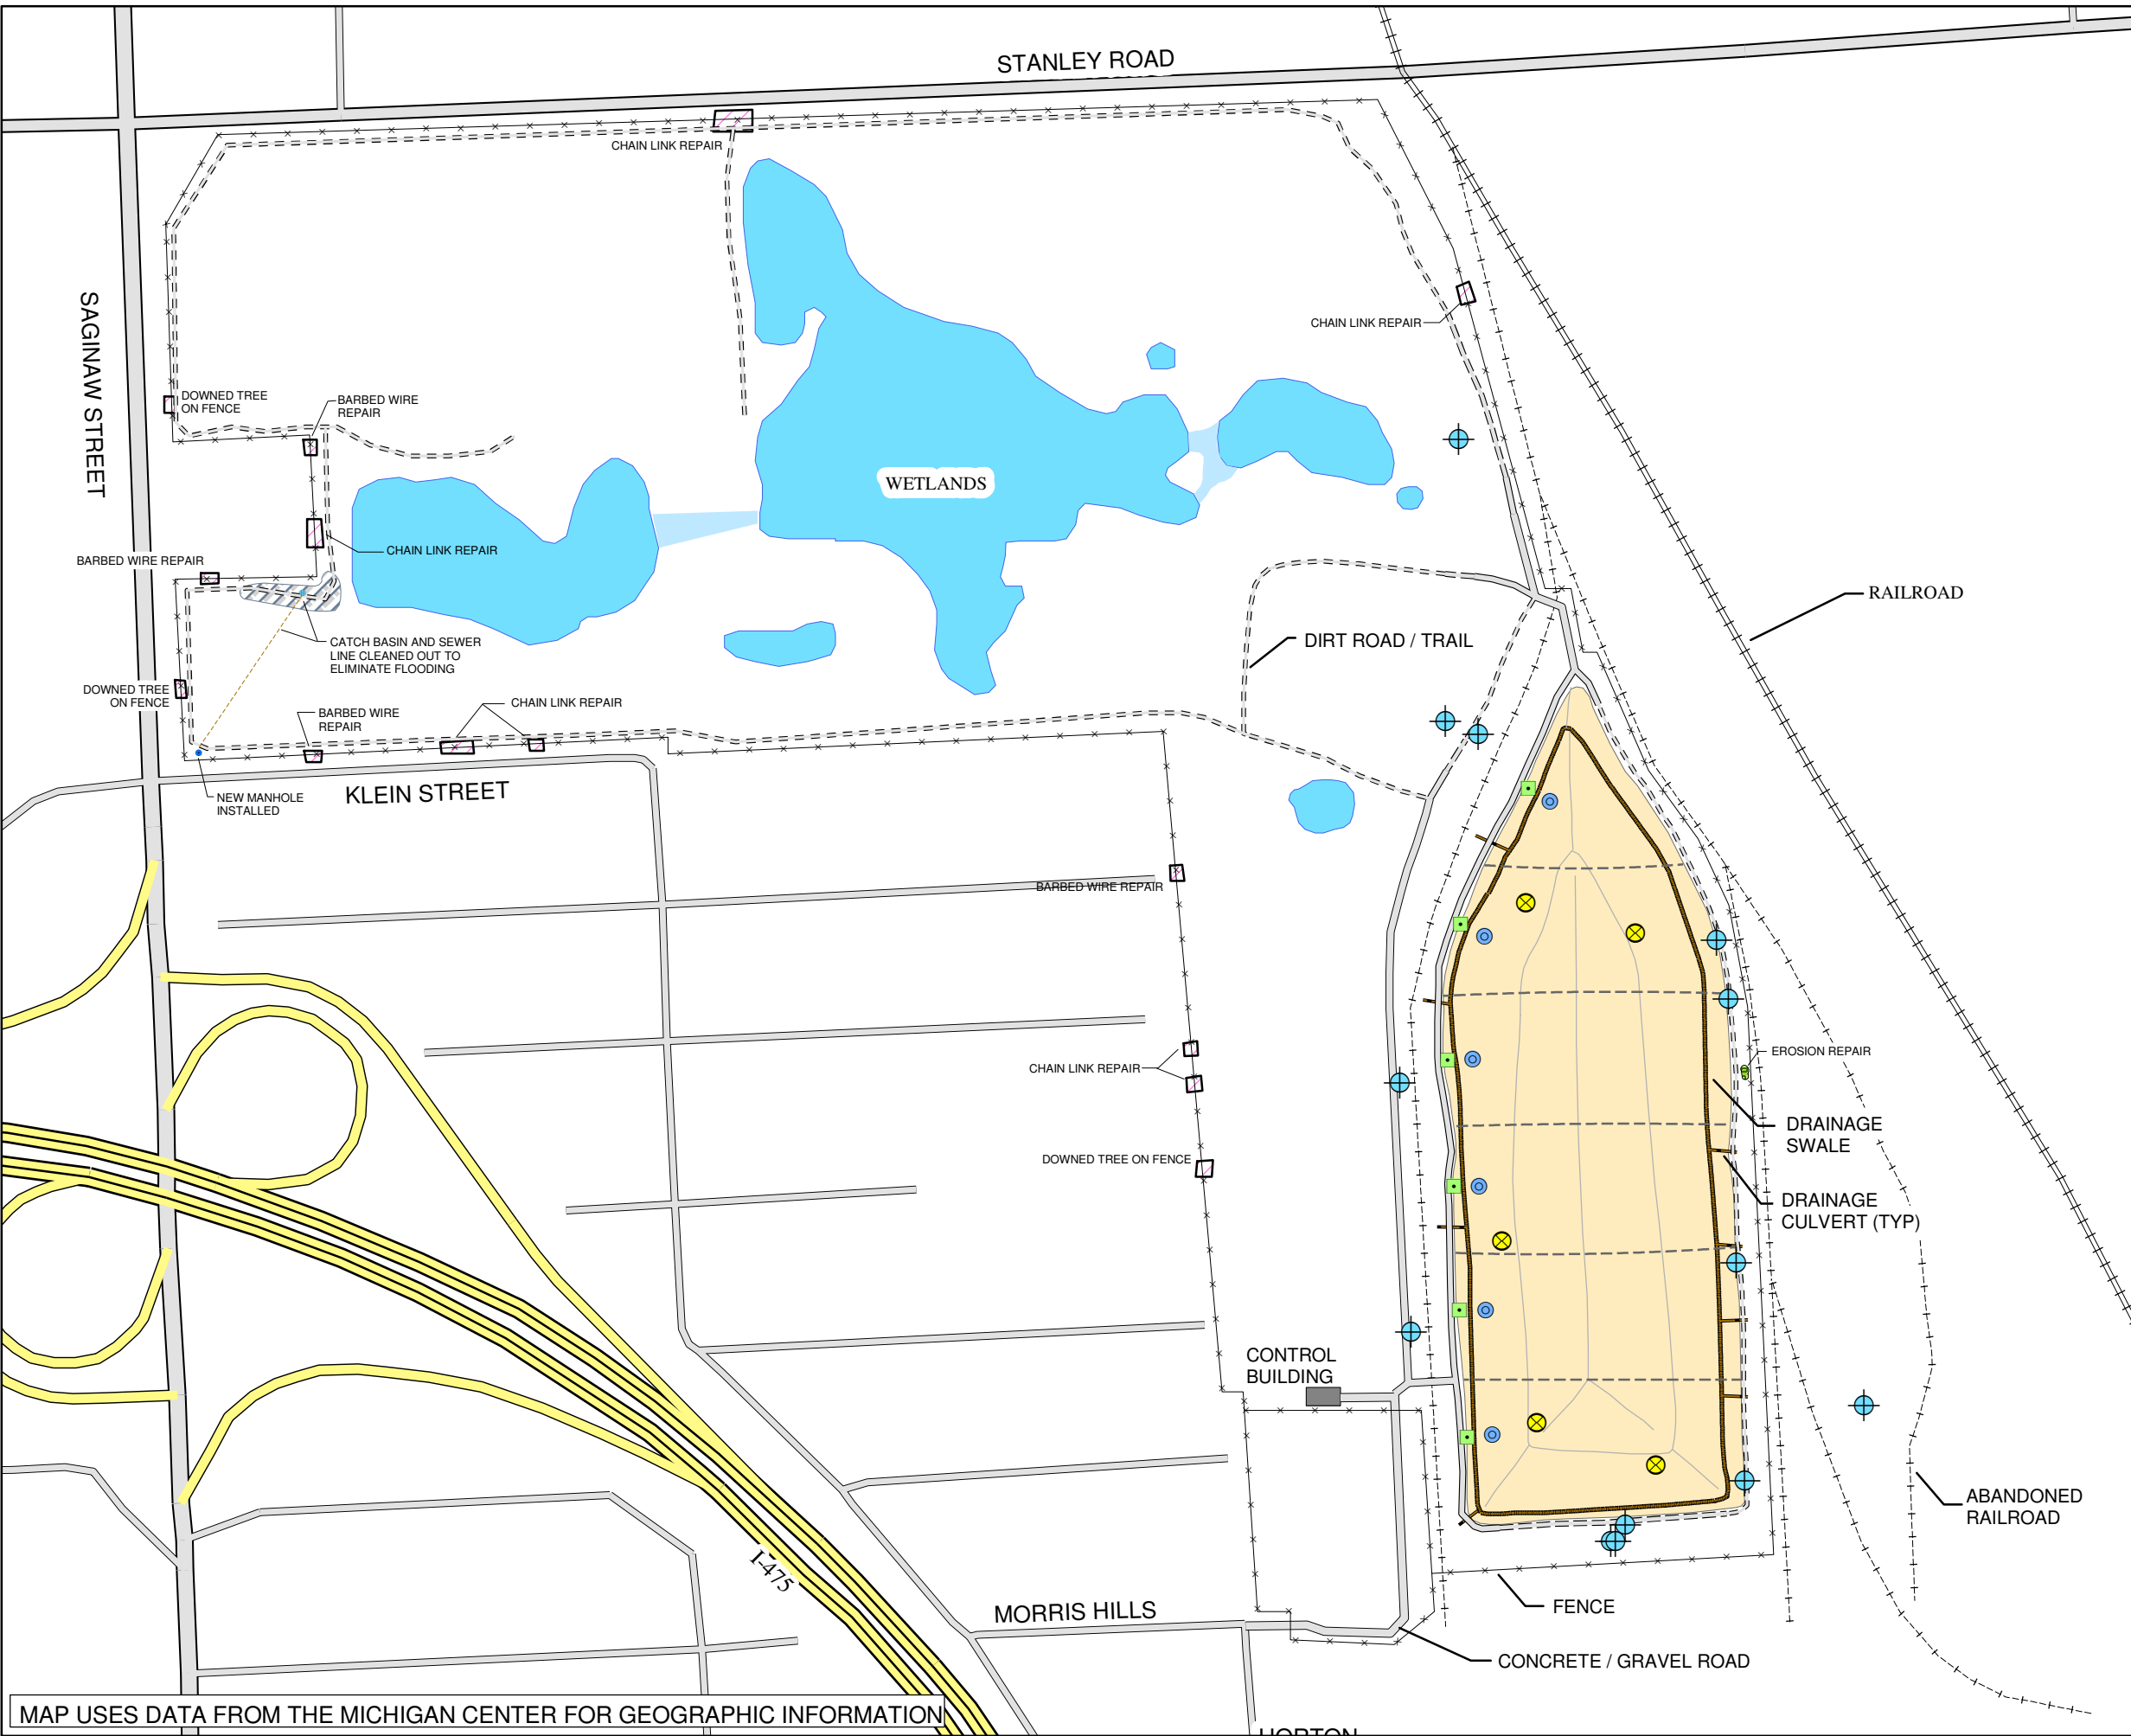
**2010
 INCIDENT LOCATION
 MAP**

Several hundred woody-stemmed plants were removed by the root from the landfill cap between March 2010 and December 2010. The locations where woody plants were removed are too numerous to show on Figure 3.

Five animal burrows were identified between March 2010 and December 2010. Traps were set at the opening of each animal burrow that appeared to be active. After five days without animal activity, the burrows were filled using methods approved by the Michigan Department of Environmental Quality (MDEQ). Animal burrow locations are noted on Figure 3. A log of burrow activity is maintained at the landfill. The log contains information on the date that a burrow is identified, response activities, and the date the burrow is closed.

Damage to the site perimeter fence and/or the barbwire was noted at a number of locations during the quarterly inspections. During the September 14, 2010 inspection, three openings were observed along the west perimeter fence. During the December 29, 2010 inspection three additional openings were observed along the west perimeter fence and one opening was observed along the northeastern perimeter fence. Downed barbwire was observed at four areas along the west perimeter fence, and three areas with tree limbs laying on the fence were also observed during the December 29, 2010 inspection. The holes in the perimeter fence were repaired by the addition of new materials and grading the soil. Tree limbs were or will be removed from the fence.

The perimeter of the landfill and berm, drainage trenches at the base of the landfill, the Remaining Materials Area (RMA, Figure 2), and the wetland area were inspected for potential drainage problems. During the May 17, 2010 inspection ponded water was present in the area of the catch basin located west of the wetland area, near Saginaw Street (northwest catch basin). The ponded water around the northwest catch basin was corrected during the third and fourth quarters by rotor rooting the vegetation in the storm sewer, allowing the storm water to drain properly. A new manhole was installed on the downstream end of the storm sewer to allow the completion of the rotor rooting activities during the fourth quarter. During the September 14, 2010 inspection an area of erosion was observed on the east side of the east landfill road across from Cell B. The area was filled in with fill soil on October 19, 2010.
