*RE: Quarterly Status Report –October 2011 – December 2011  
Coldwater Road Landfill  
1245 East Coldwater Road, Flint, MI  
MID 005 356 860 / Consent Order No. 64-05-92*

COLDWATER RD LANDFILL – ANIMAL BURROW PHOTO LOG

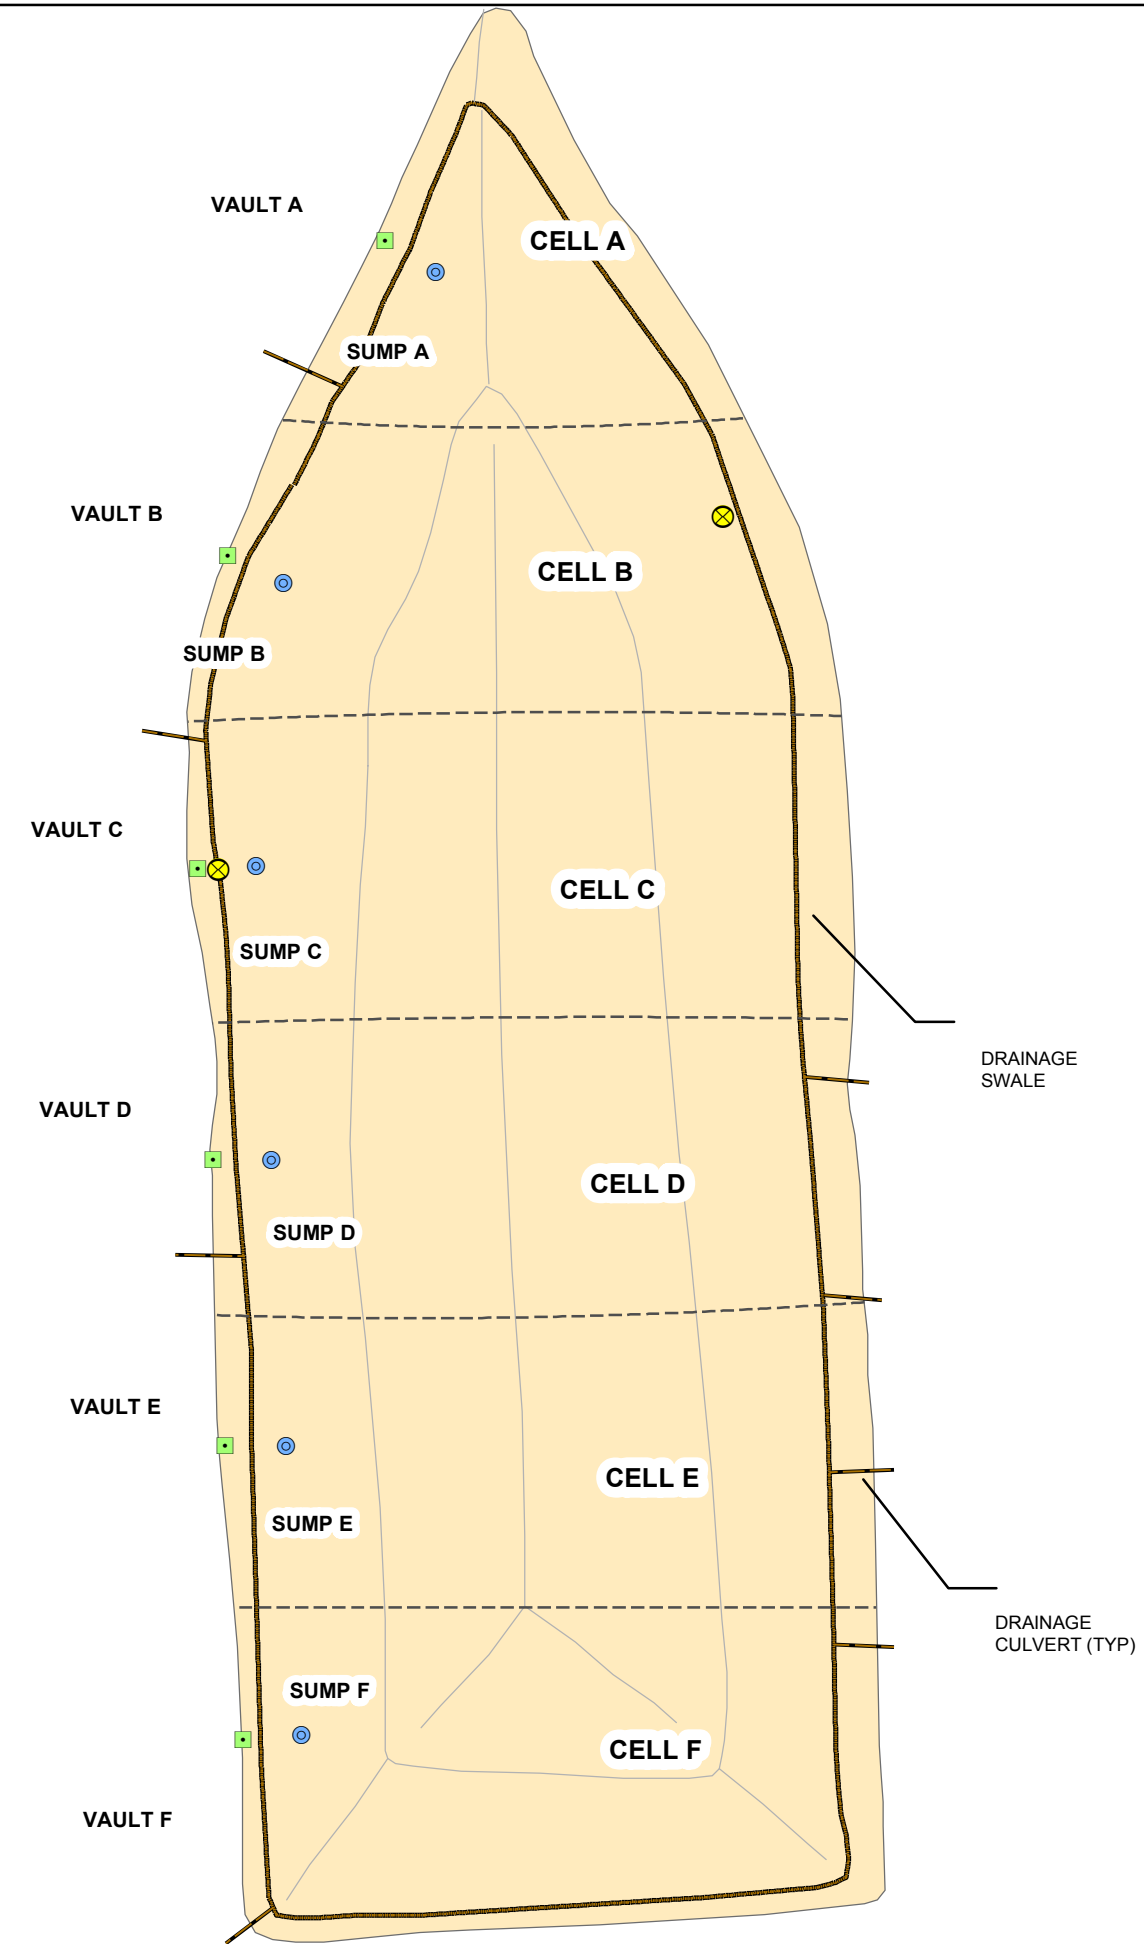
FIGURE 1

- » Filled in 2 inactive animal burrows. See attached figure for animal burrow locations and photo log for detailed information concerning animal burrow activities for this quarter.

**Animal Burrow Locations**

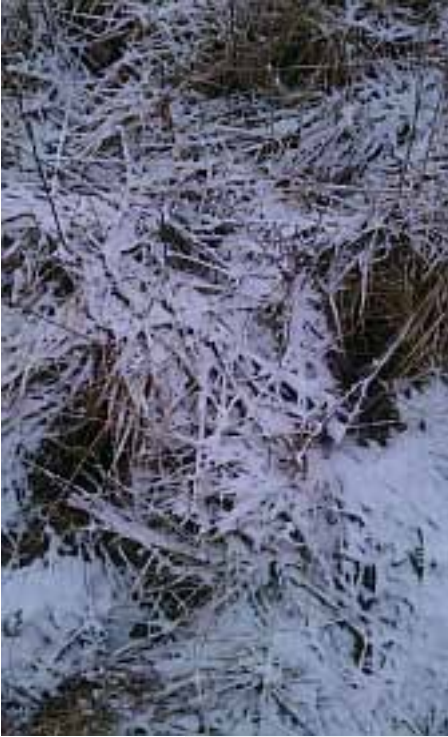
<b>LOCATION:</b> B3 - bottom of slope		<b>APPROX. LENGTH:</b> 1 foot	<b>APPROX. DEPTH:</b> 1 foot	<b>APPROX. DIAMETER:</b> 4 inches
<b>DATE FOUND:</b> 12/23/11	<b>DATE CLOSED:</b> 12/23/11

<b>NOTES:</b> PRE repair photo.  Entry and Exit. Burrows appeared inactive.  No signs of liner damage.				
<b>LOCATION:</b> B3 - bottom of slope		<b>APPROX. LENGTH:</b> 1 foot	<b>APPROX. DEPTH:</b> 1 foot	<b>APPROX. DIAMETER:</b> 4 inches
<b>DATE FOUND:</b> 12/23/11	<b>DATE CLOSED:</b> 12/23/11

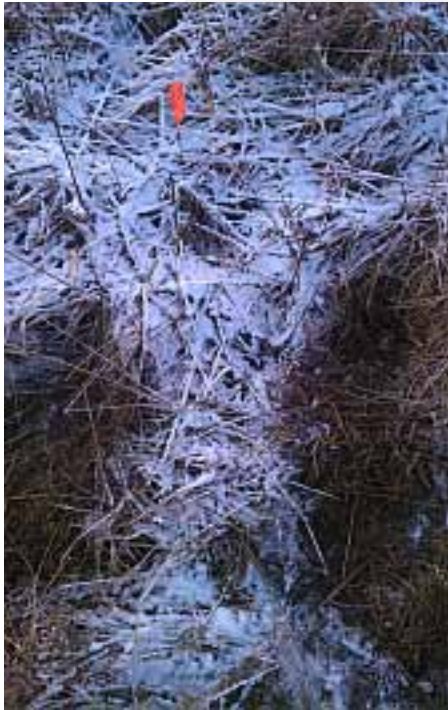
<b>NOTES:</b> POST repair photo. Filled in burrow.

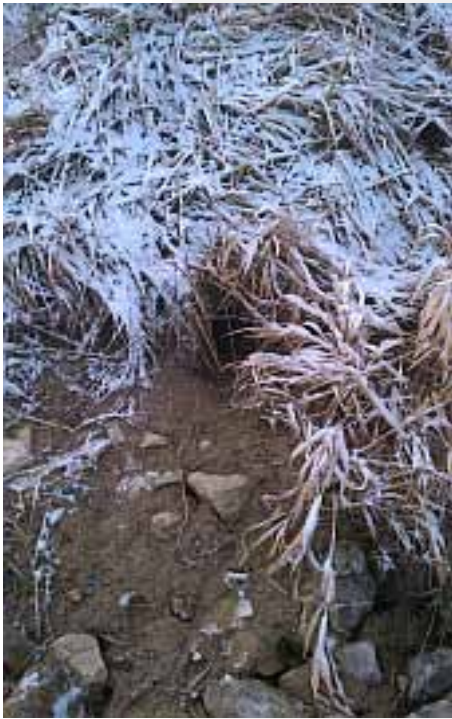
<b>LOCATION:</b> C1 – near culvert		<b>APPROX. LENGTH:</b> 2 feet	<b>APPROX. DEPTH:</b> 6 inches	<b>APPROX. DIAMETER:</b> 3 inches
<b>DATE FOUND:</b> 12/23/11	<b>DATE CLOSED:</b> 12/23/11

<b>NOTES:</b> PRE repair photo. Burrow appeared inactive. No signs of liner damage.				
<b>LOCATION:</b> C1 – near culvert		<b>APPROX. LENGTH:</b> 2 feet	<b>APPROX. DEPTH:</b> 6 inches	<b>APPROX. DIAMETER:</b> 3 inches
<b>DATE FOUND:</b> 12/23/11	<b>DATE CLOSED:</b> 12/23/11

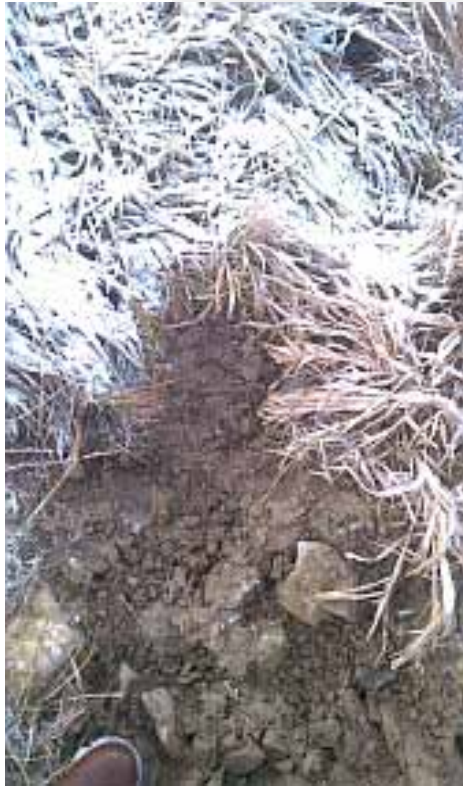
<b>NOTES:</b> POST repair photo. Filled in burrow.
