RE: *Quarterly Status Report – October 2023 – December 2023*
Coldwater Road Landfill
1245 East Coldwater Road, Flint, MI
MID 005 356 860
 FILE: 1088190/1940103462/Docs

**4TH QUARTER 2023
BURROW LOCATION MAP**

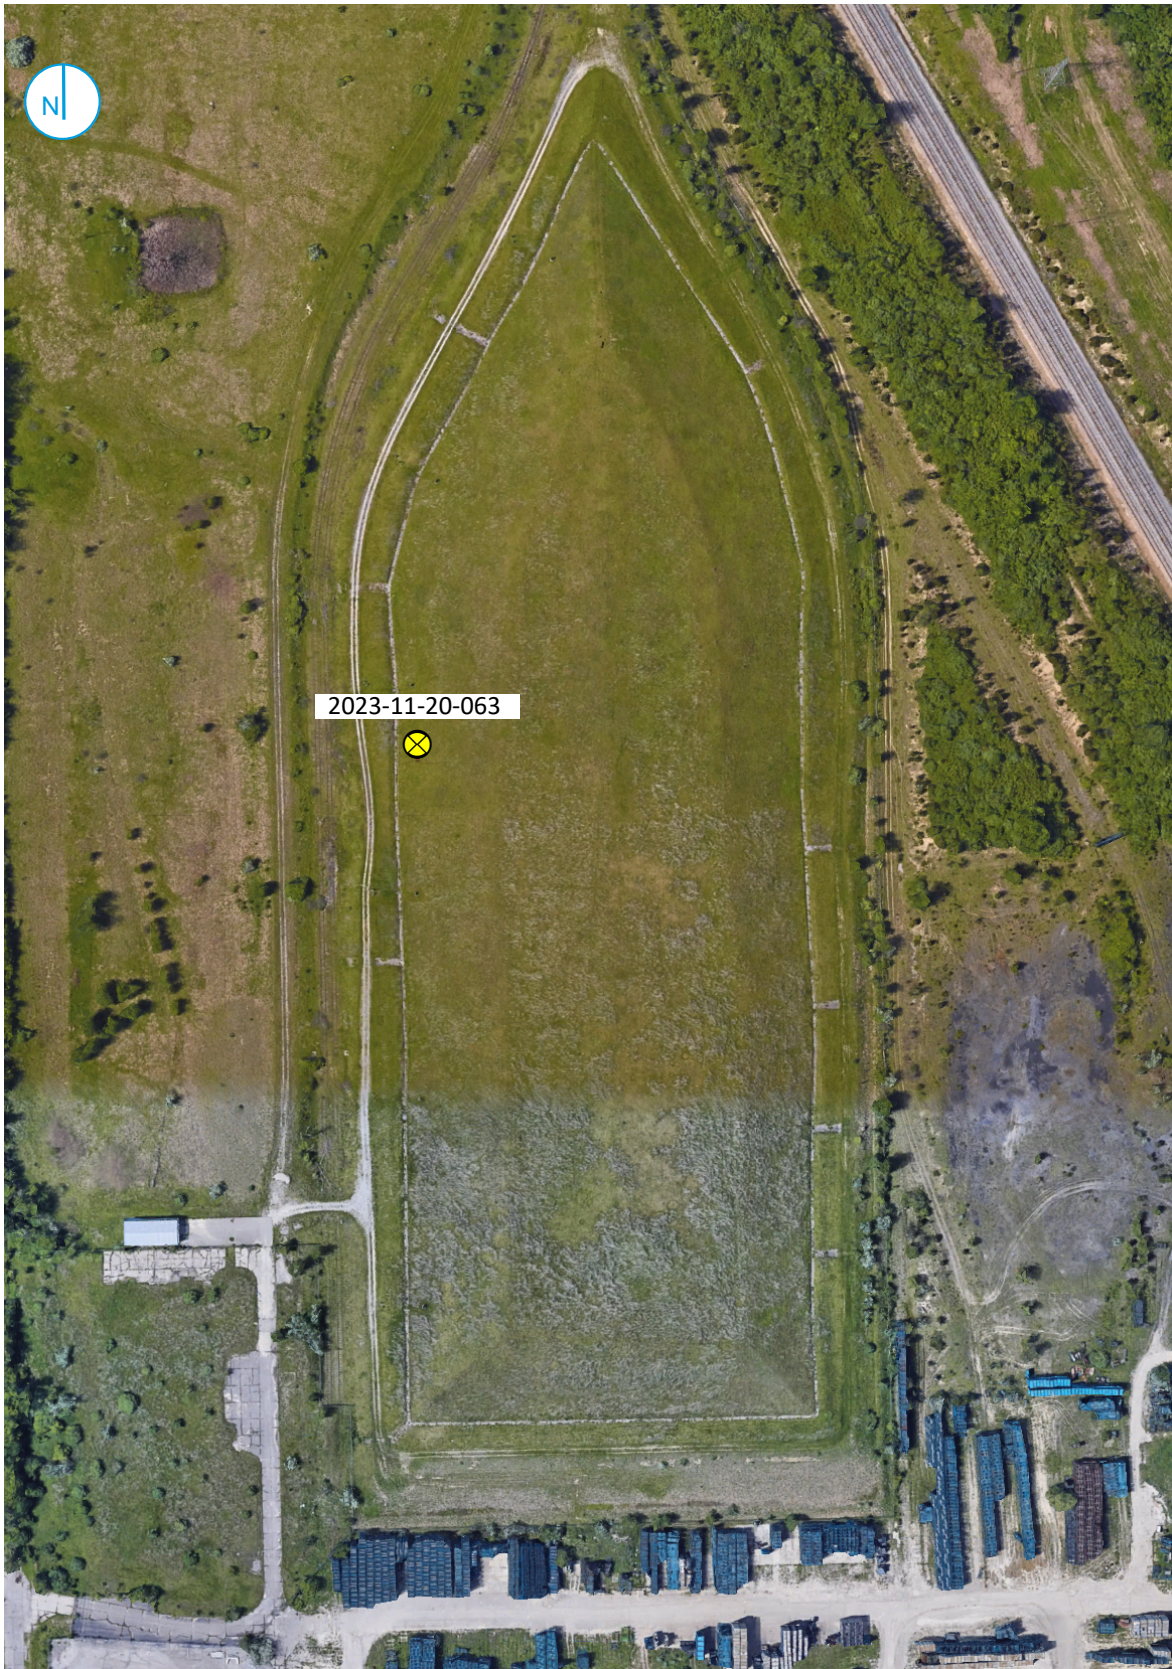
FIGURE 01

- » Observed one potentially active animal burrow on September 29, 2023, and a trap was set the same day. The animal burrow was found to be active; a raccoon was trapped, and the burrow was closed out on November 20, 2023. See attached photo log and figure for further detail.
- » Openings along the northeastern and western perimeter fence were repaired on October 4, 2023, and December 18, 2023.

ANIMAL BURROW LOCATION
