Landfill Inspection Report 2020

COLDWATER ROAD LANDFILL - MID 005 356 860 LANDFILL INSPECTION REPORT

Project name **RACER Trust Coldwater Road Landfill**
Project no. **15388/75178**
Recipient **Jacob Runge**
Document type **Annual Report**
Version **1**
Date **February 24, 2021**
Prepared by **Kevin Schneider**
Checked by **Clifford Yantz**
Approved by **Clifford Yantz**
Description **Landfill Inspection Annual Report**

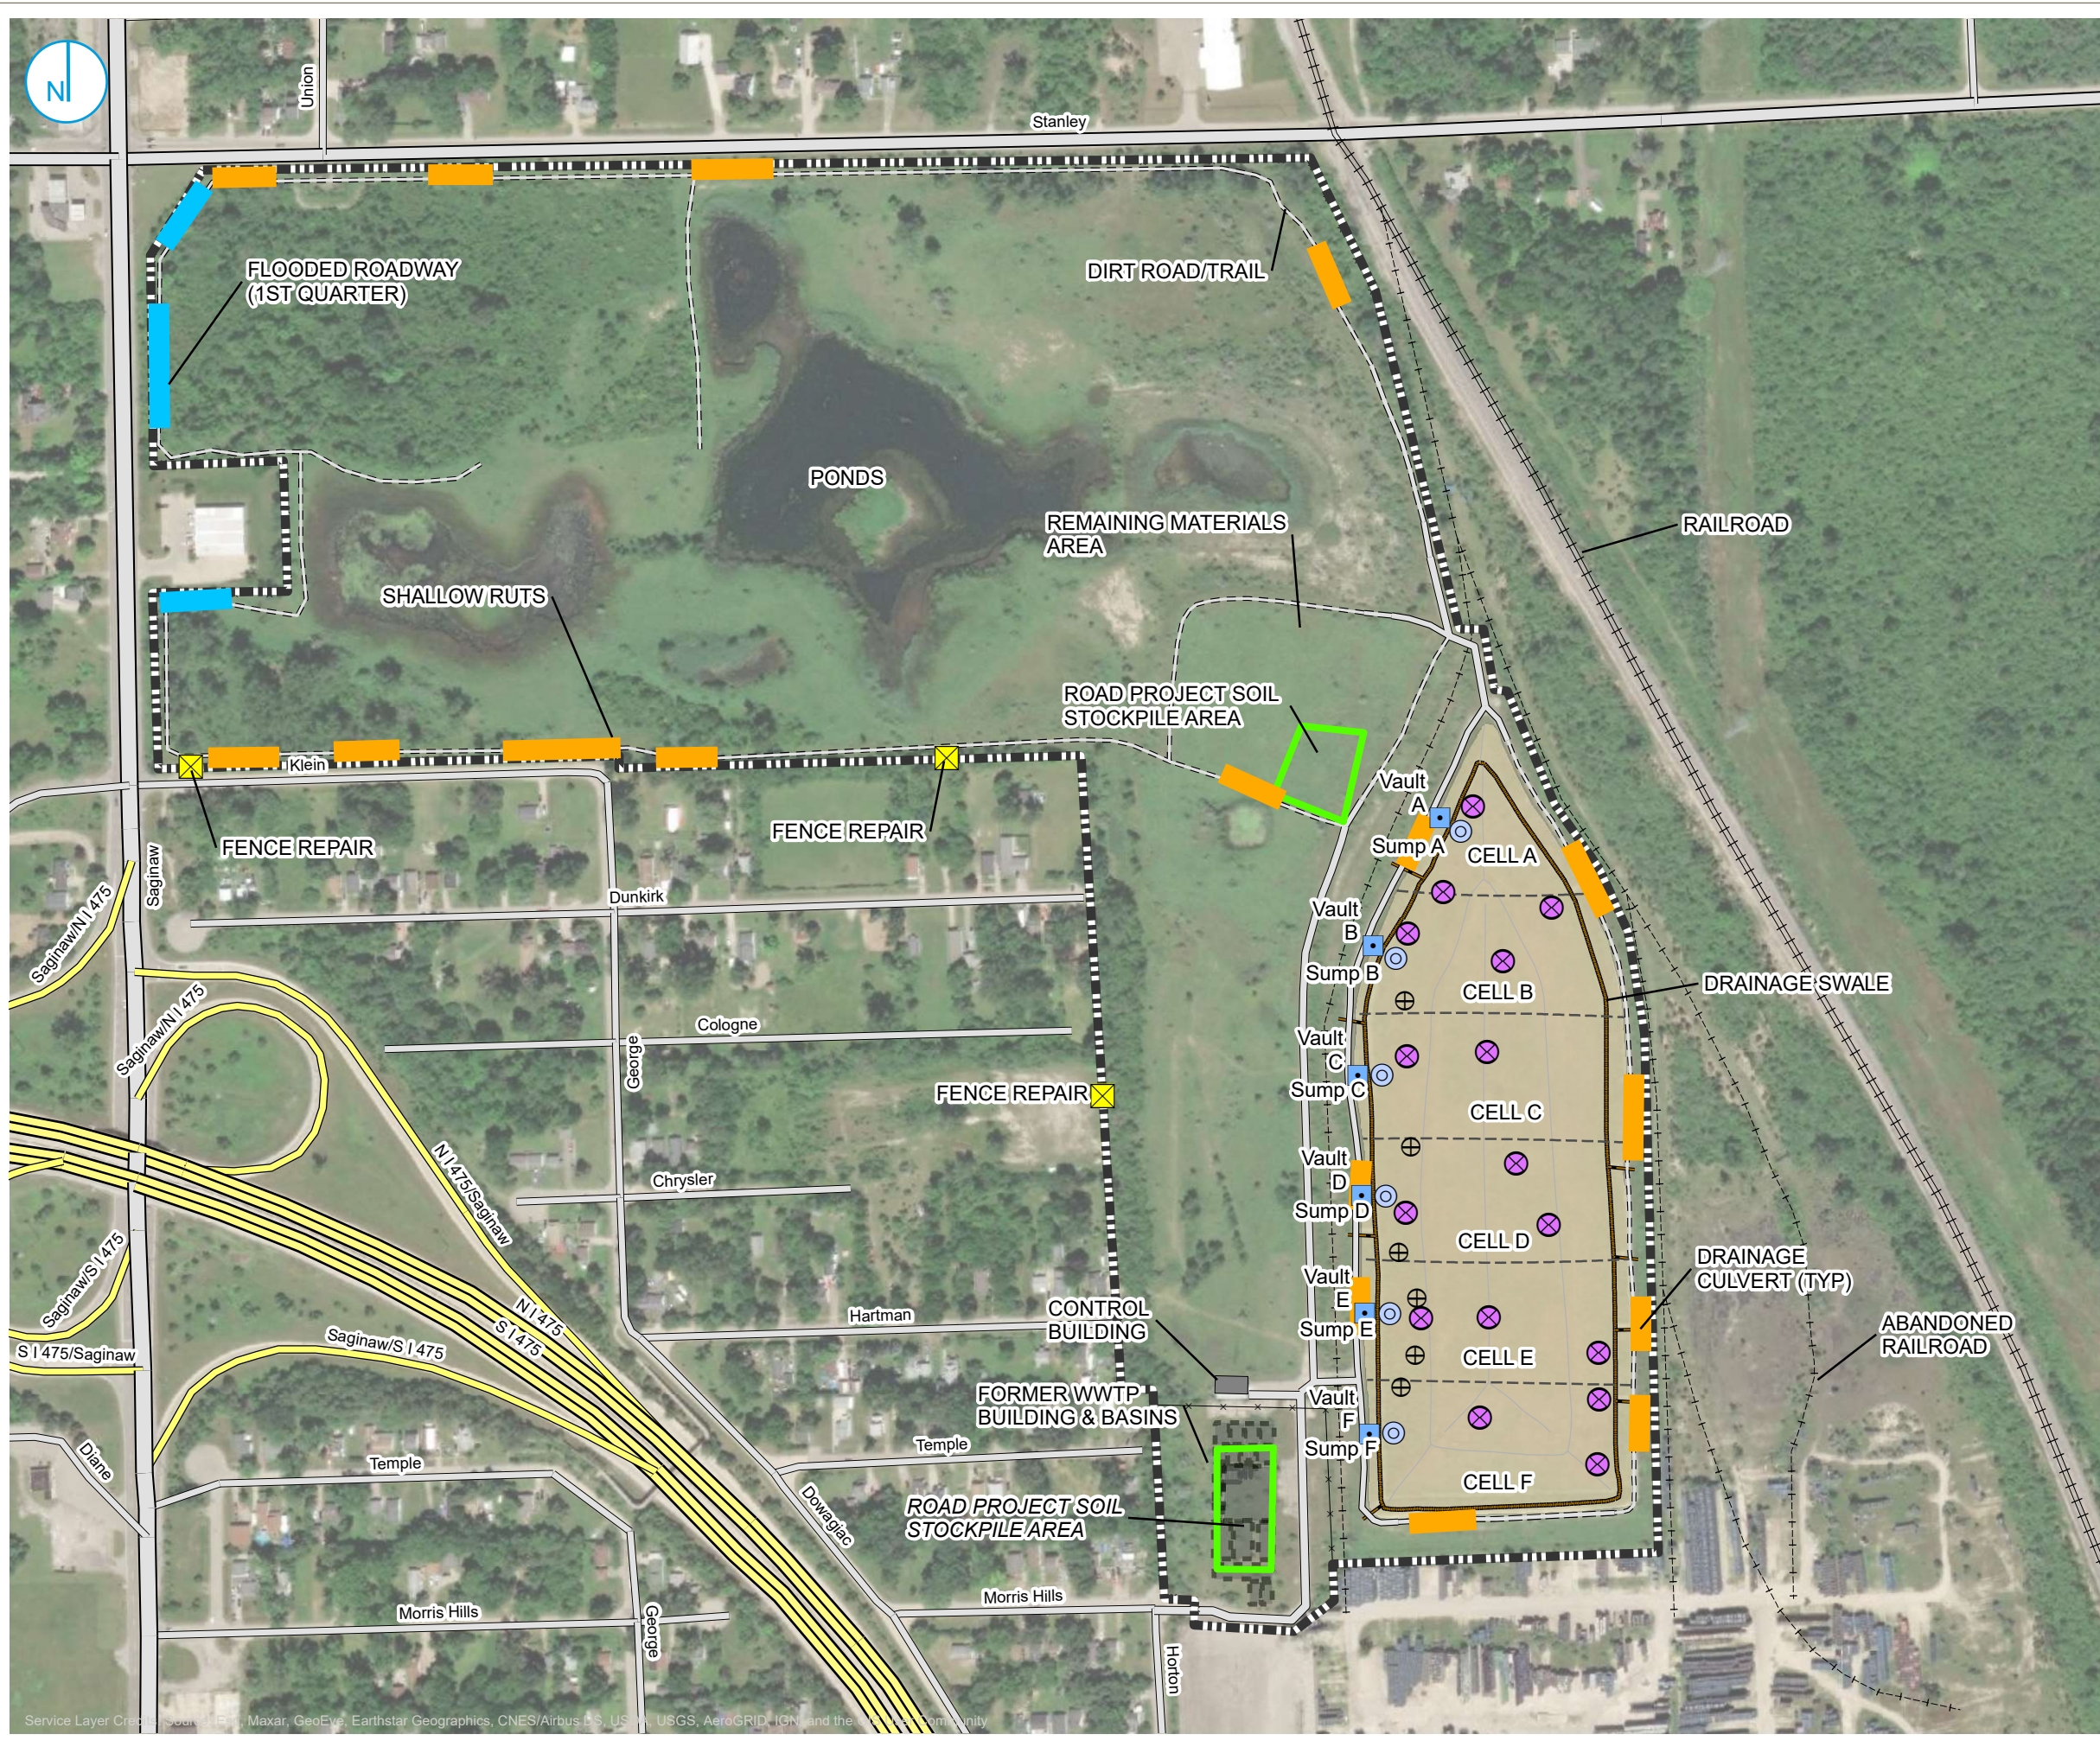
Figure 3: 2020 Incident Location Map

Mole activity was observed during the 1st through 4th quarter inspections at Cell B, Cell D, and Cell E (**Figure 3**). The mole activity was addressed by placing poisonous mole bait and setting traps where mole trails were observed. The mole activity will continue to be addressed during future landfill cap maintenance.

During the 1st quarter inspection, the access road west of the ponds had areas of ponded water. The wet sections of road were avoided until the road was dry.

During the 3rd quarter, and 4th quarter, one previously repaired hole along the west perimeter fence had been reopened. The hole was repaired during the site inspections. During the 4th quarter, two smaller holes (1 to 2 feet in length) were repaired during the site inspection along the northwestern arm of the perimeter fence ([Figure 3](#)).

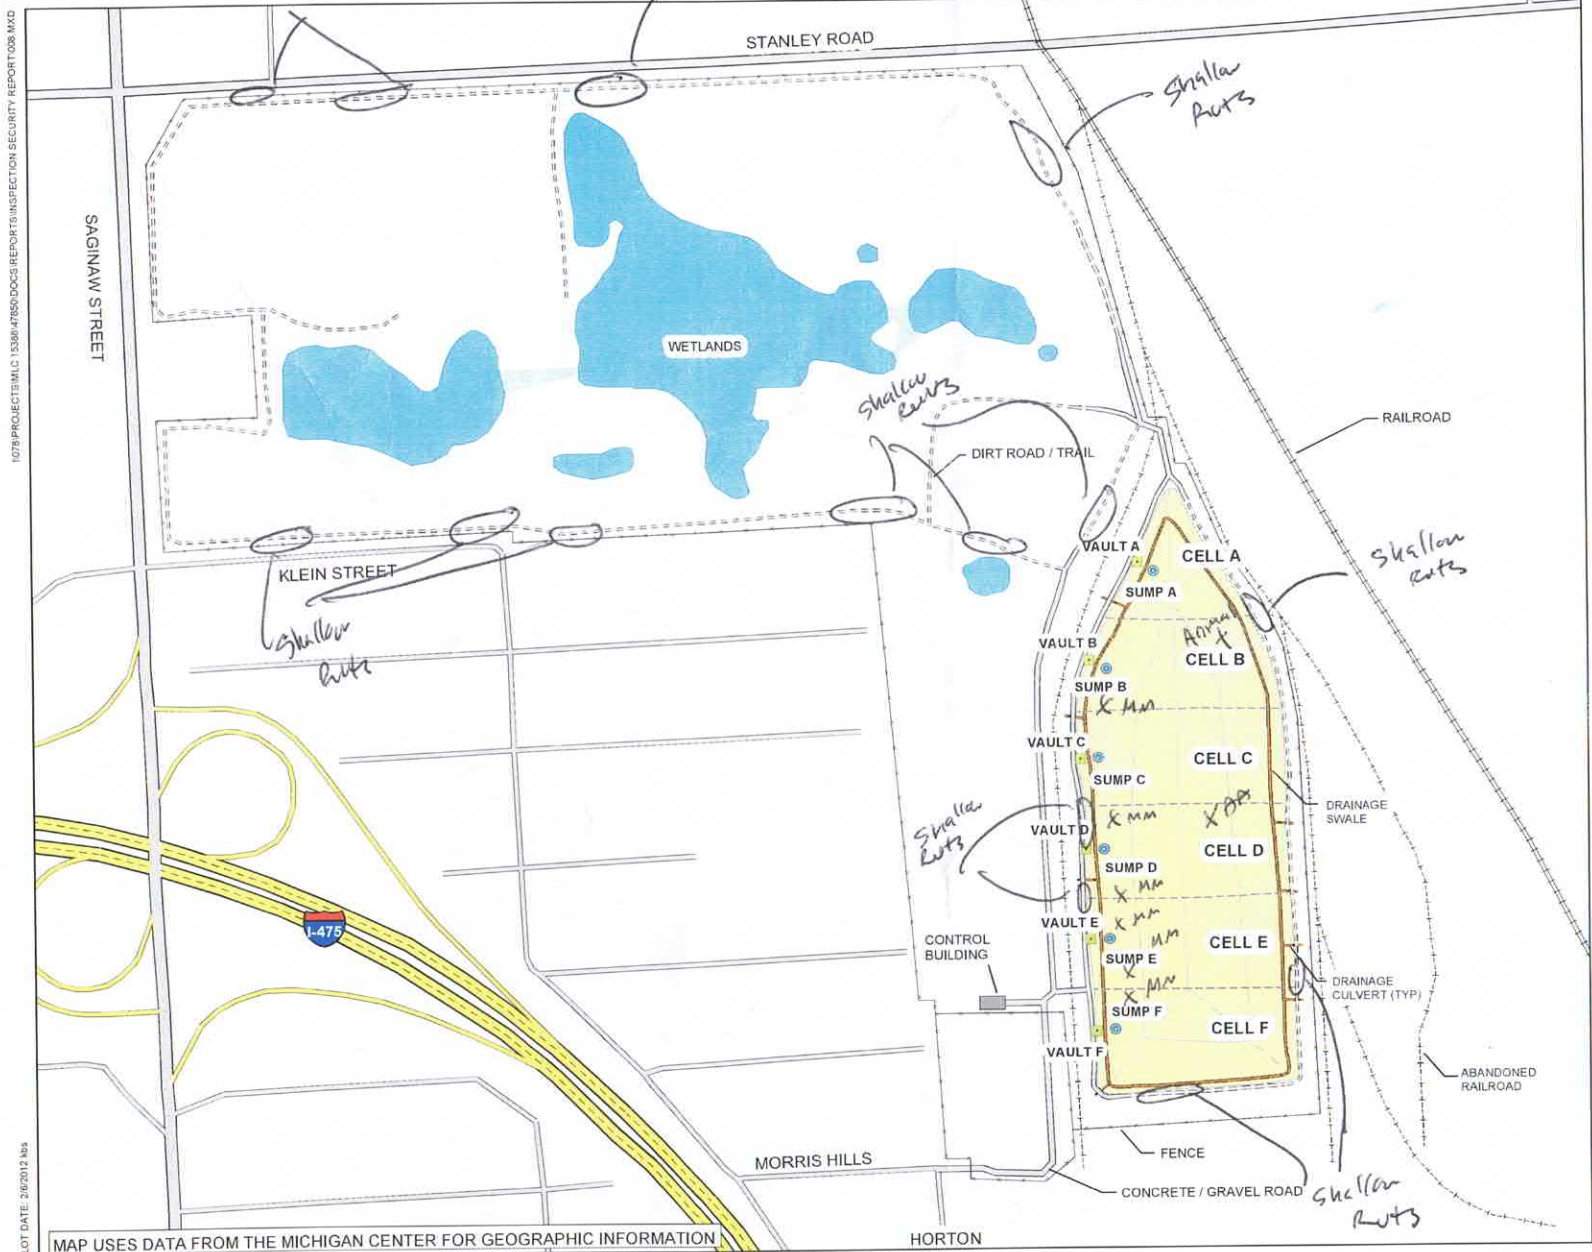
few evergreen trees pulled during inspection
few ^{small} divots in a few cells due to deer activity
landfill cap & vegetation in good condition
mole mounds were observed cells B, D, E

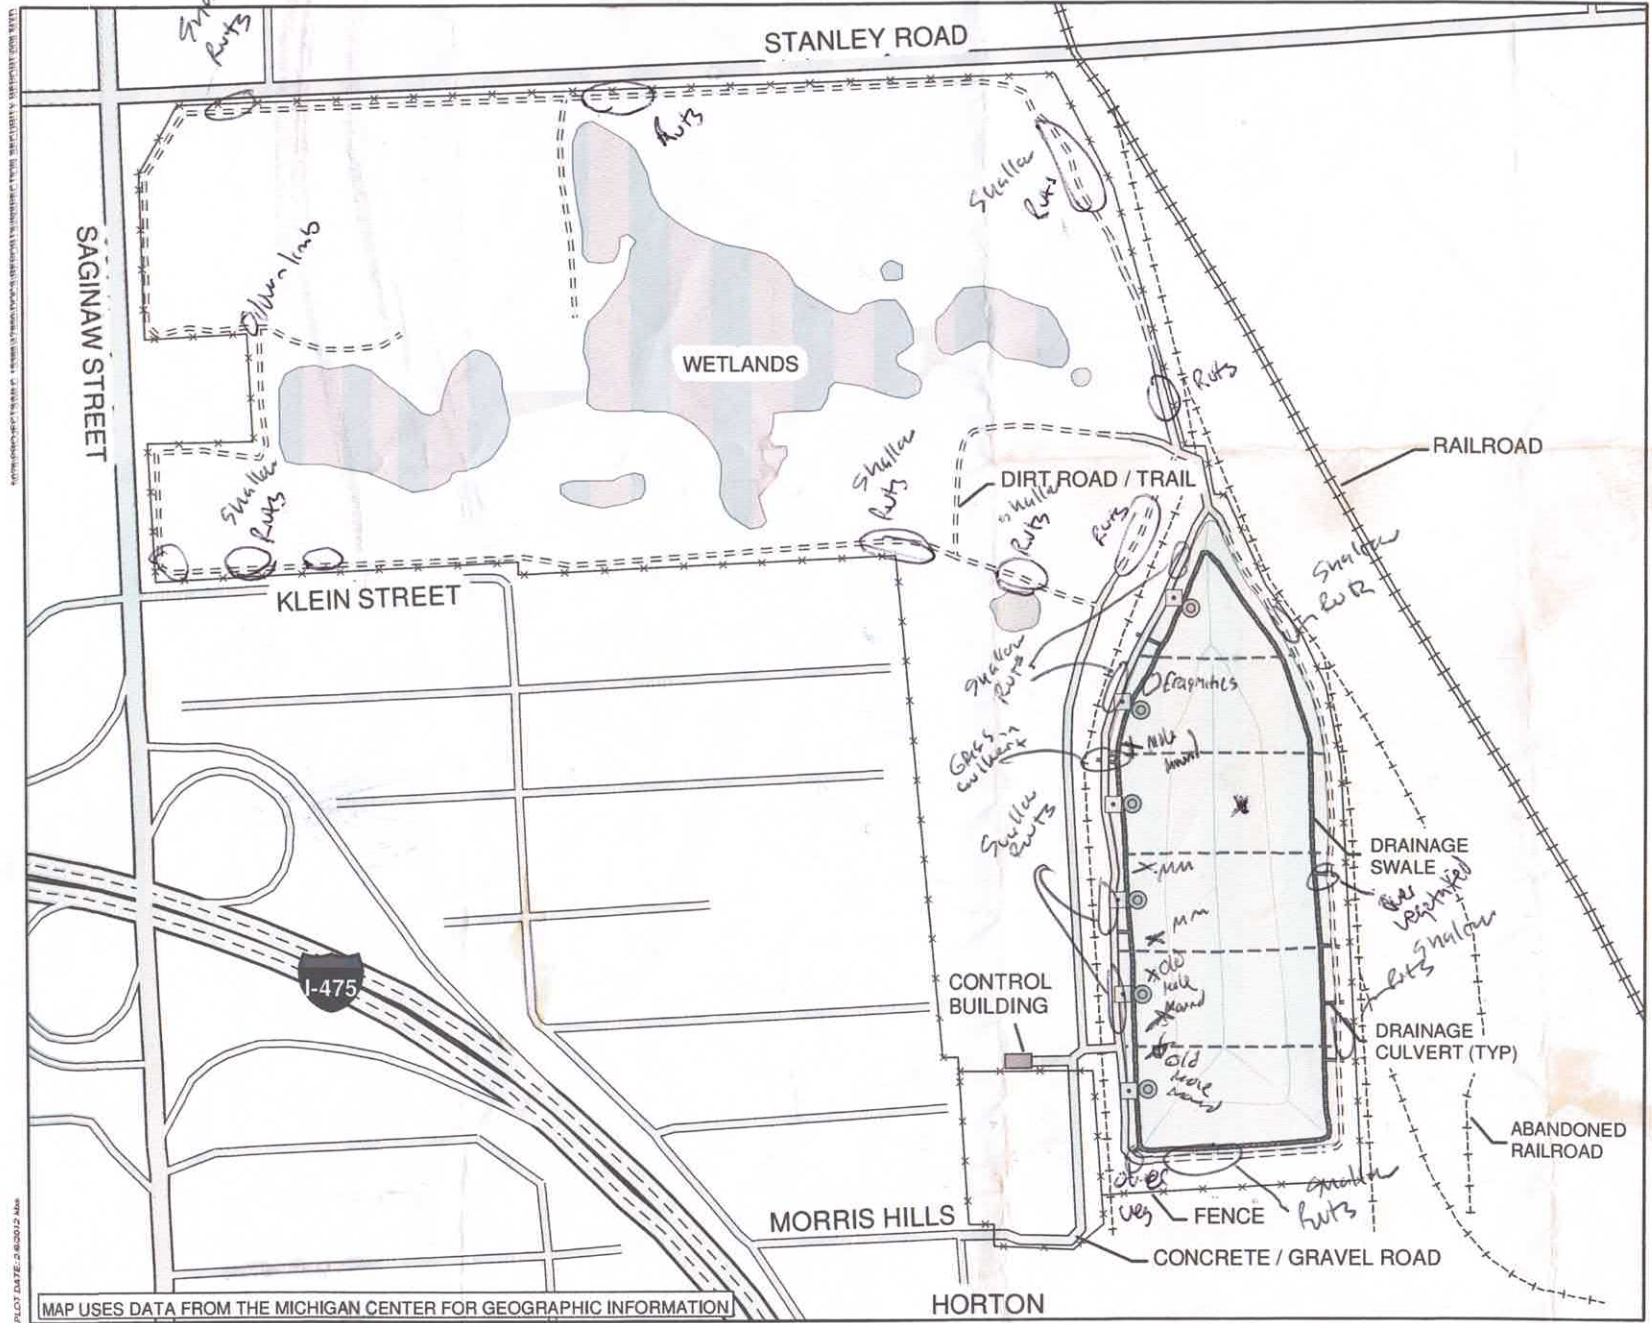
Tree pulling activity was conducted over entire landfill cap over the quarter. No large wood plants observed. Mole mounds were observed west side cells B, D, E, F

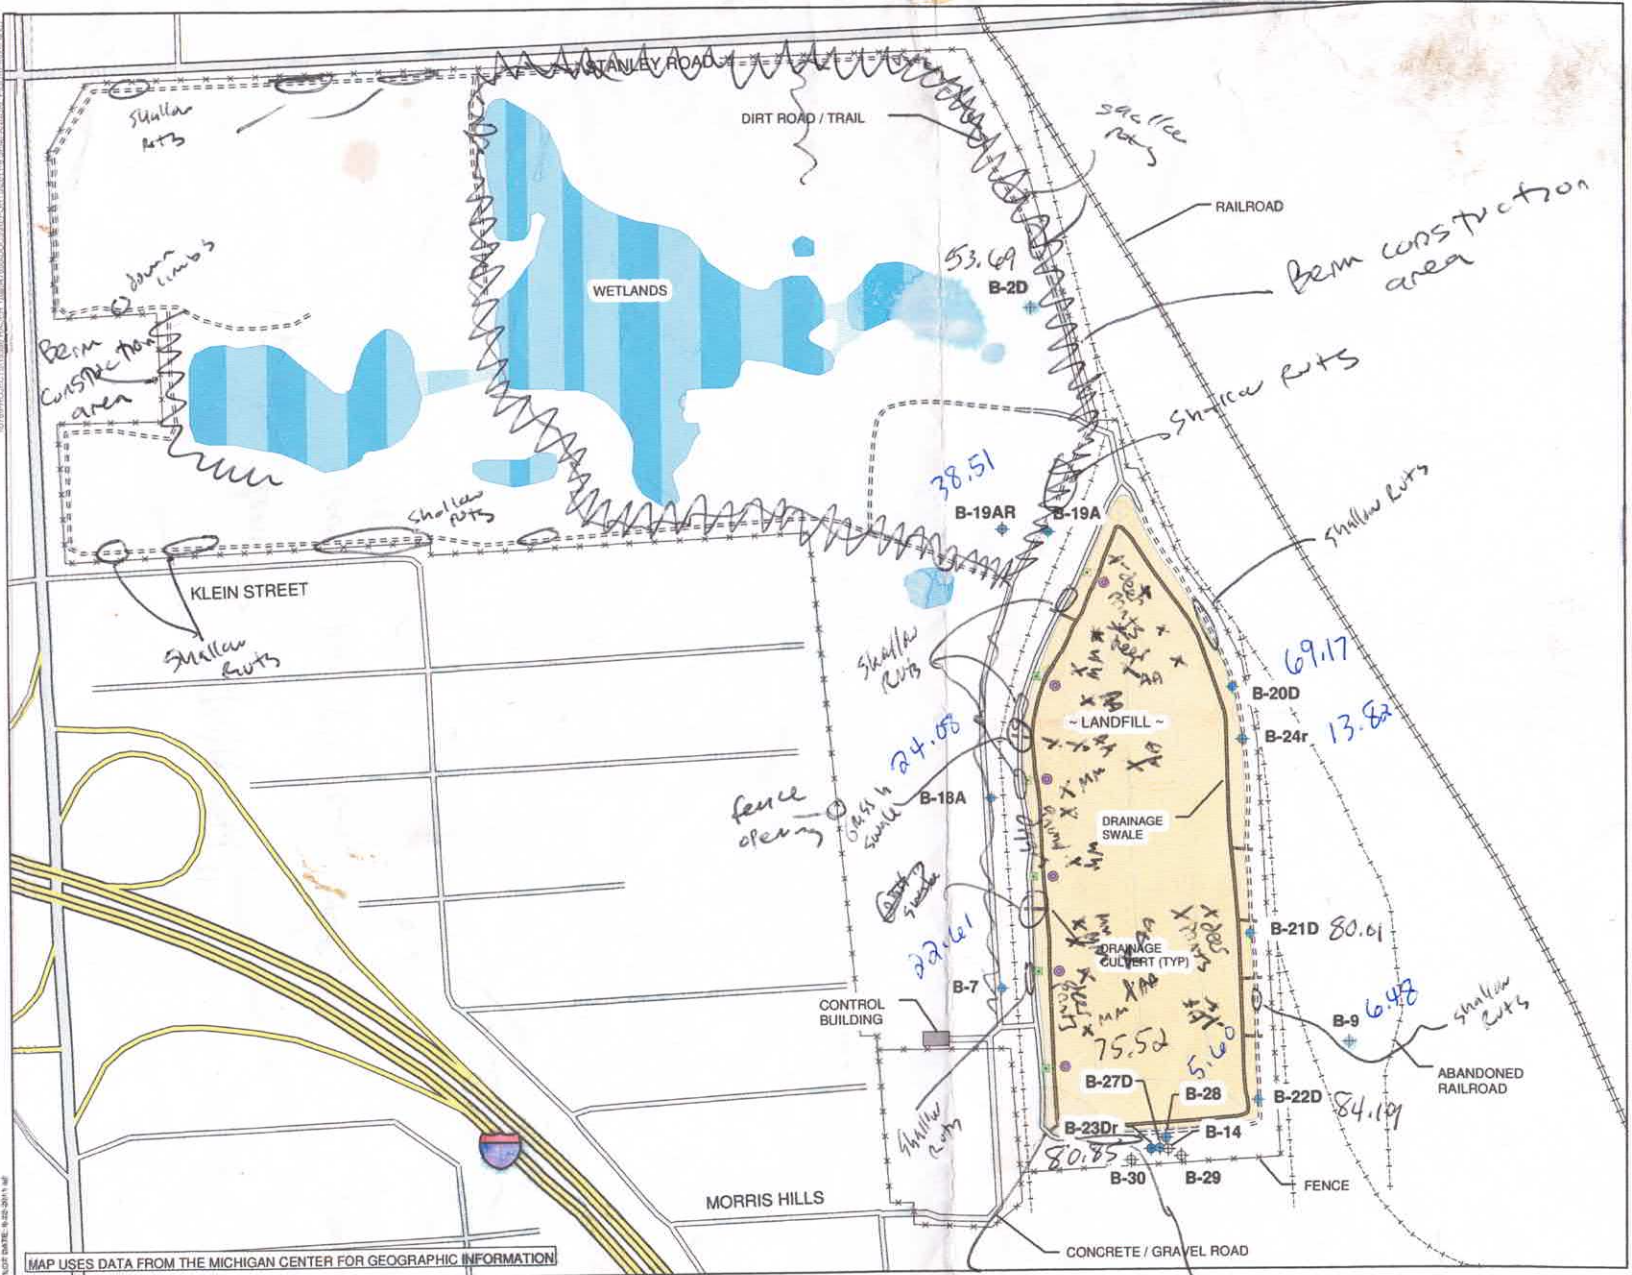
woody plants removed periodically during quarter
 animal activity observed @ cells A1, A2, B1, B2, B3, C1, C2, E1, E2, E4
 shallow deer prints and shallow digging by possible fox or coyote
 a fox has been seen onsite during quarter no repairs needed Packed out areas while on site

Area	Sufficient gravel present?	Proper drainage present?	If no, describe issue, and actions taken	Date Corrected
Roads located approx. west of landfill	Yes few shallow ruts	Yes	Road repairs will be made	
Roads located approx. east of landfill	Yes few shallow ruts	Yes	once berm construction is complete	
Roads located approx. north of wetlands	Yes few shallow ruts	Yes		
Roads located approx. south of wetlands	Yes few shallow ruts	Yes		
Roads located approx. west of wetlands	Yes few shallow ruts	Yes		
Roads located approx. east of wetlands	Yes few shallow ruts	Yes

Area	Any damage present?	Signs of unauthorized entry?	Broken or damaged locks on gates?	"Trespassing Prohibited" and "Private Property" Signs Missing?	If yes to any, describe issue, and actions taken	Date Corrected
Fences along north property line	No	No	No	No		
Fences along south property line	No	No	No	No		
Fences along west property line	Previous wire opened Yes	No	No	No	Previous opening open	Repaired while on site
Fences along east property line	No	No	No	No

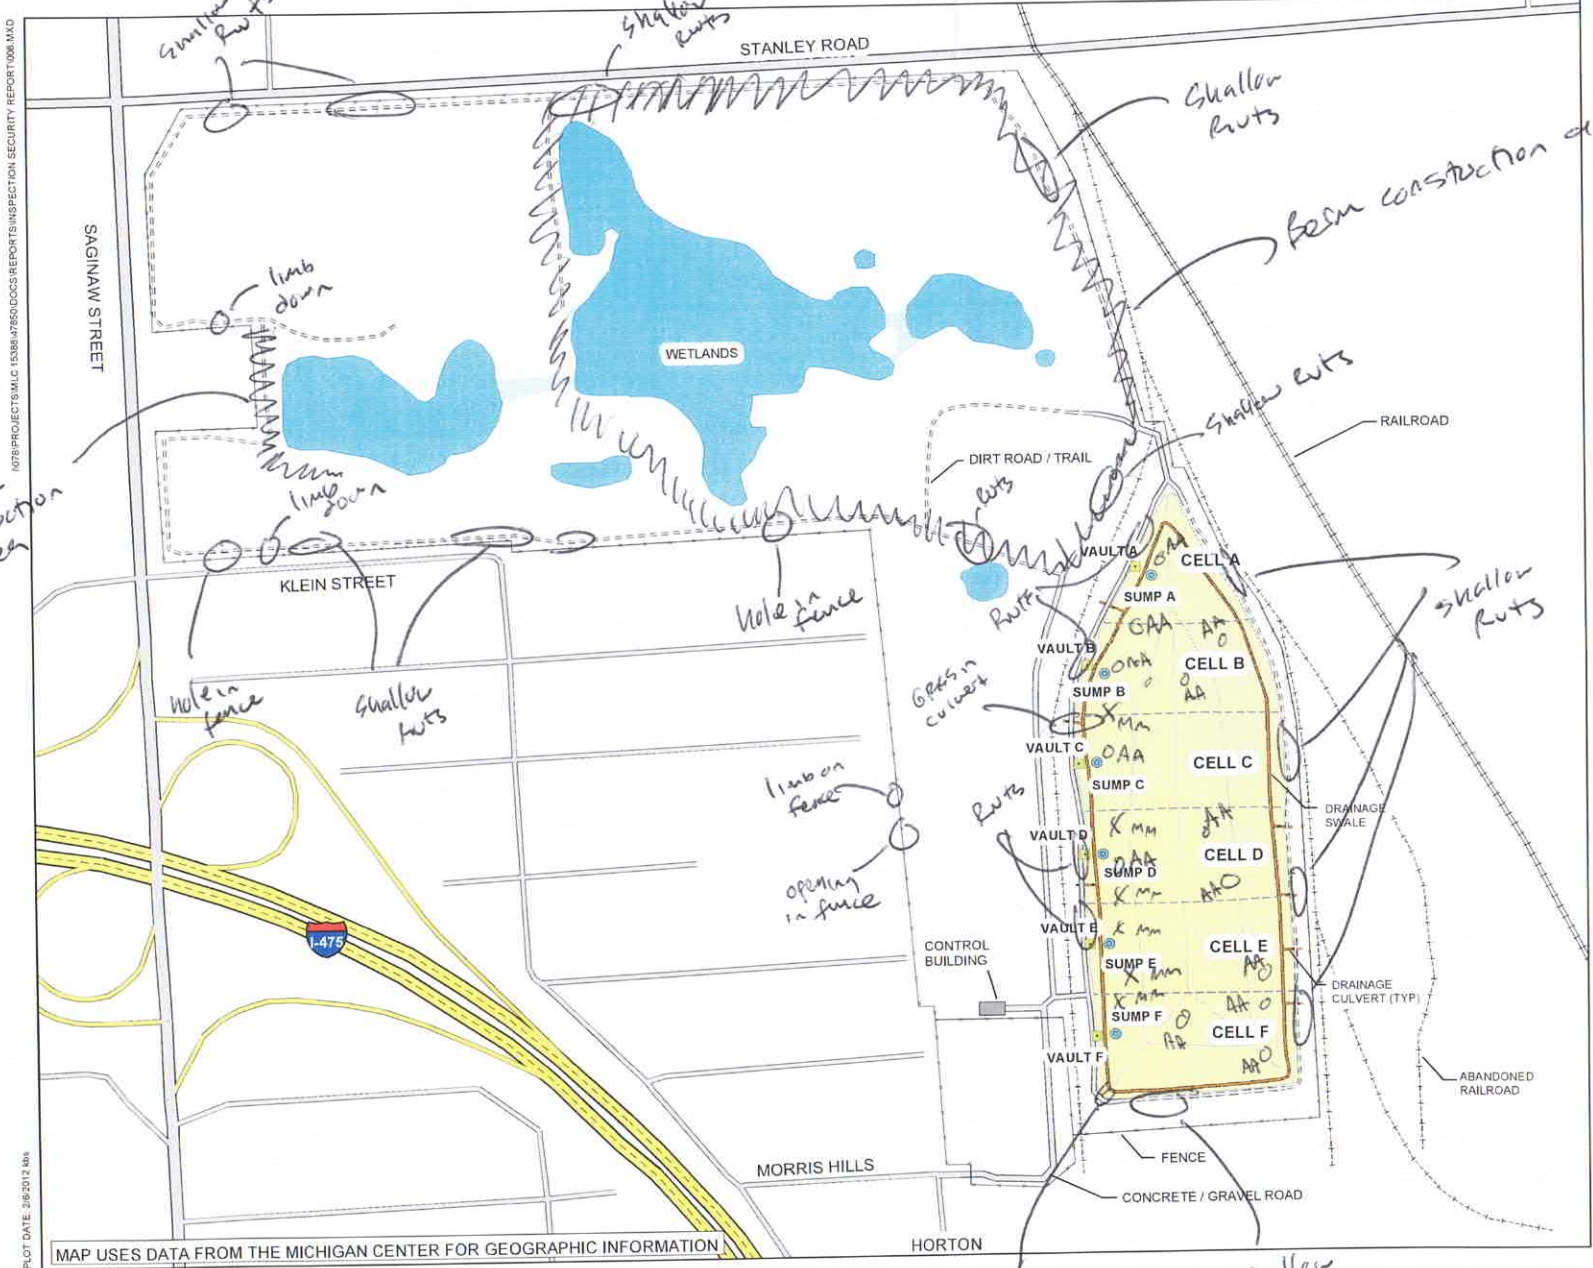
animal activity observed shallow digging/deer prints @ cells A1, B1, B3, C1, C2, C4
 D1, D3, E1, E4, F2, F3
 fox/coyote has been seen on site animal bones @ C4

Area	Sufficient gravel present?	Proper drainage present?	If no, describe issue, and actions taken	Date Corrected
Roads located approx. west of landfill	Yes few shallow Ruts in spots	Yes	Road Repairs will be made	
Roads located approx. east of landfill	Yes few shallow Ruts in spots		once beam construction is complete	
Roads located approx. north of wetlands	Yes shallow Ruts			
Roads located approx. south of wetlands				
Roads located approx. west of wetlands				
Roads located approx. east of wetlands

Area	Any damage present?	Signs of unauthorized entry?	Broken or damaged locks on gates?	"Trespassing Prohibited" and "Private Property" Signs Missing?	If yes to any, describe issue, and actions taken	Date Corrected
Fences along north property line	No	No	No	No	No	
Fences along south property line	No	No	No	No	No	
Fences along west property line	one hole that was repaired	two small holes	No	No	No	12/21/20 closed up during inspection
Fences along east property line	No	No	No	No	No
