RE: *Quarterly Status Report –April 2013 – June 2013*
Coldwater Road Landfill
1245 East Coldwater Road, Flint, MI
MID 005 356 860

**2ND QUARTER 2013
 BURROW LOCATION
 MAP**

COLDWATER RD LANDFILL – ANIMAL BURROW PHOTO LOG

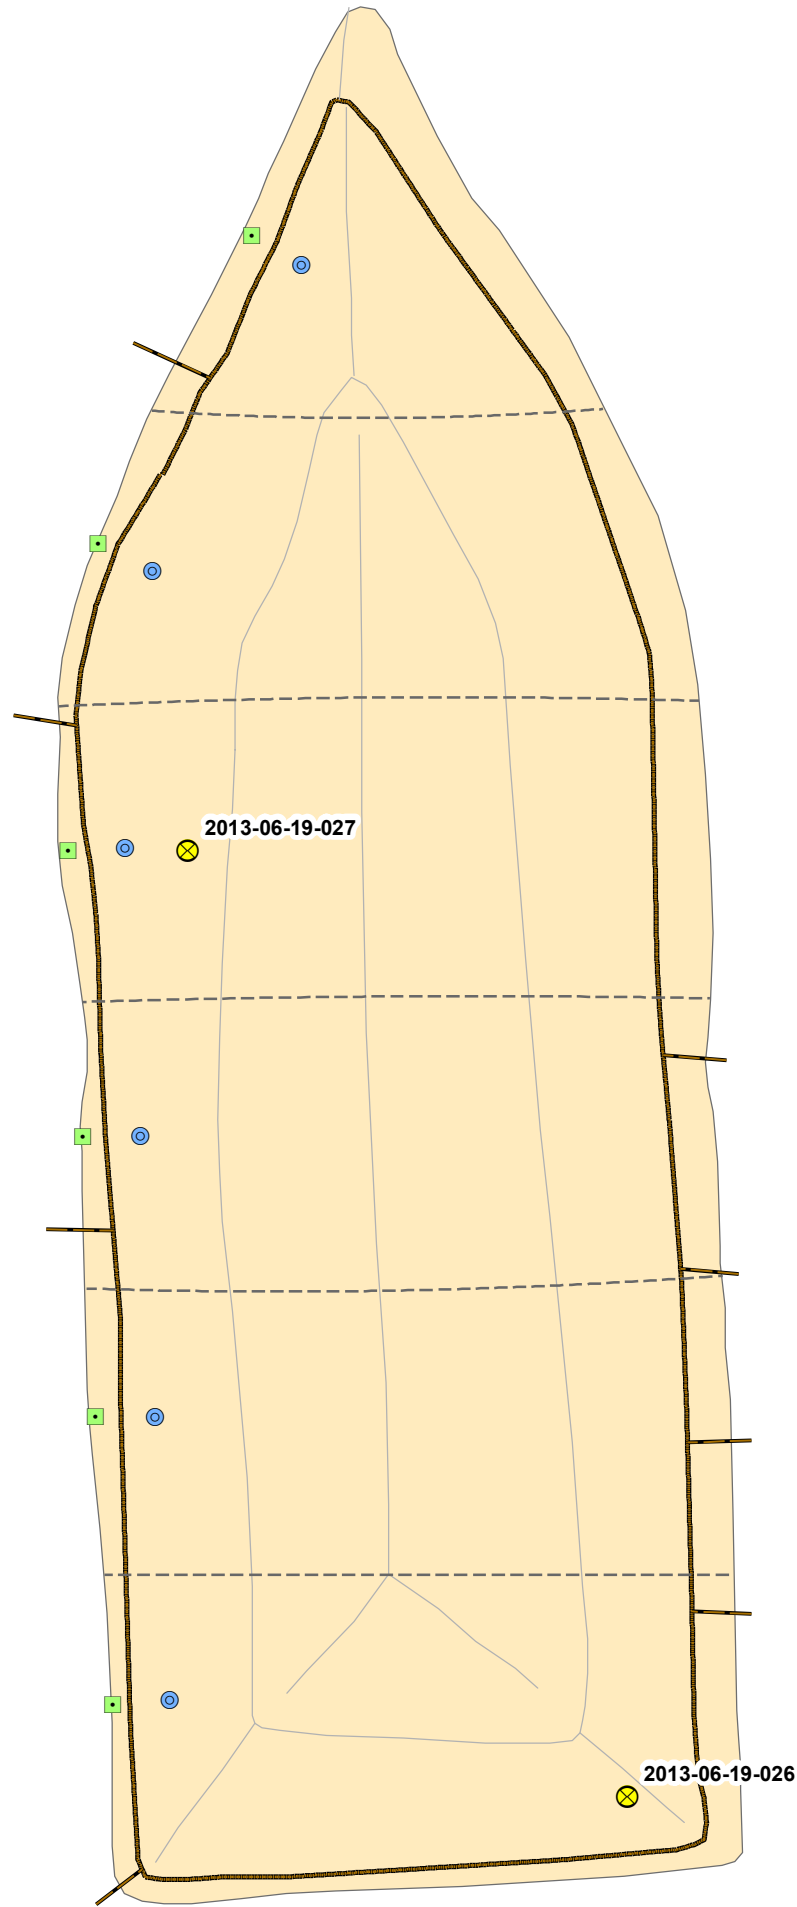
FIGURE 1

- » Observed 2 potentially active animal burrows on June 19, 2013, and set traps. See attached figure for animal burrow locations and photo log for detailed information concerning animal burrow activities for this quarter.

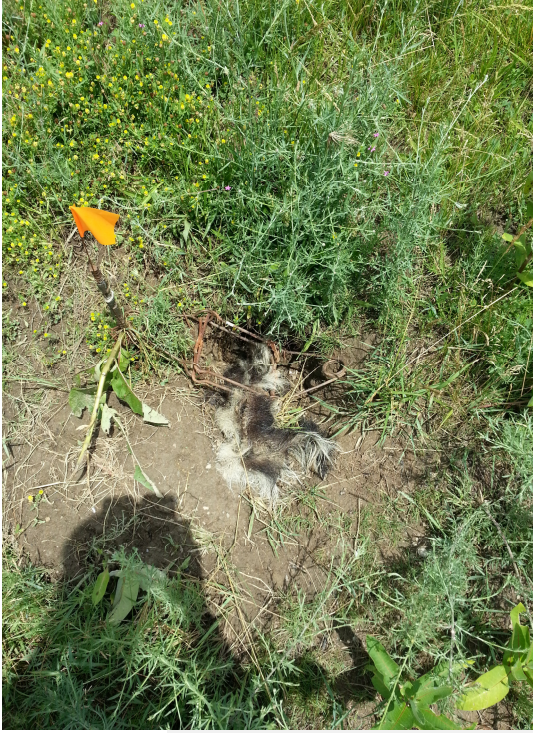
LOCATION:		APPROX. LENGTH:	APPROX. DEPTH:	APPROX. DIAMETER:
F4 – Middle Slope		2 ft	12 inch	6 inch
DATE FOUND: 6/19/13	DATE CLOSED: 6/28/13

NOTES: ID: 2013-06-19-026 PRE repair photo. Trap set up for a week. Trapped skunk. No signs of liner damage.				
LOCATION:		APPROX. LENGTH:	APPROX. DEPTH:	APPROX. DIAMETER:
F4 – Middle Slope		2 ft	12 inch	6 inch
DATE FOUND: 6/19/13	DATE CLOSED: 6/28/13
