Our ref: 11208058-LTR-29

**Response to Comments in the EGLE CAMM Inspection Report dated September 25, 2025**  
**RACER Trust Bay City Powertrain Industrial Land; MID 005 356 688;**  
**Waste Data System Number 393420**

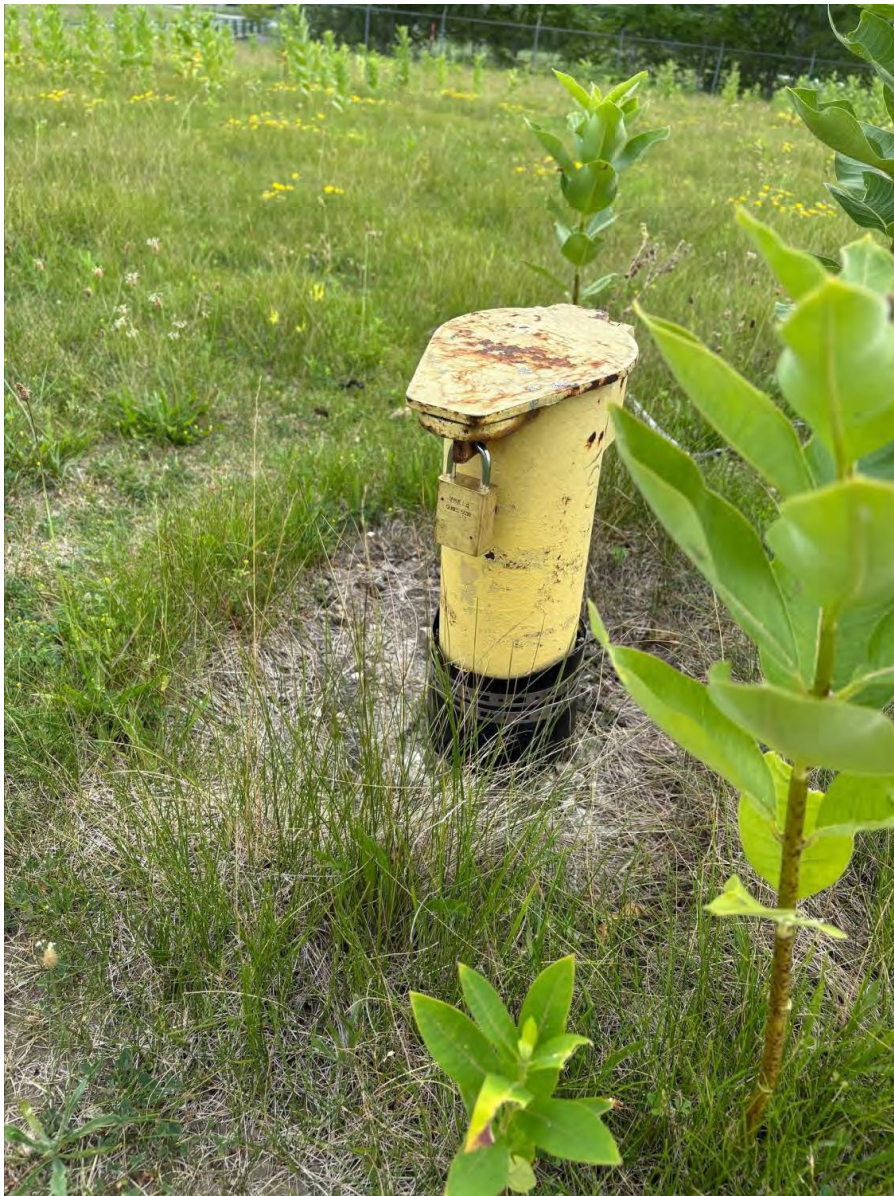
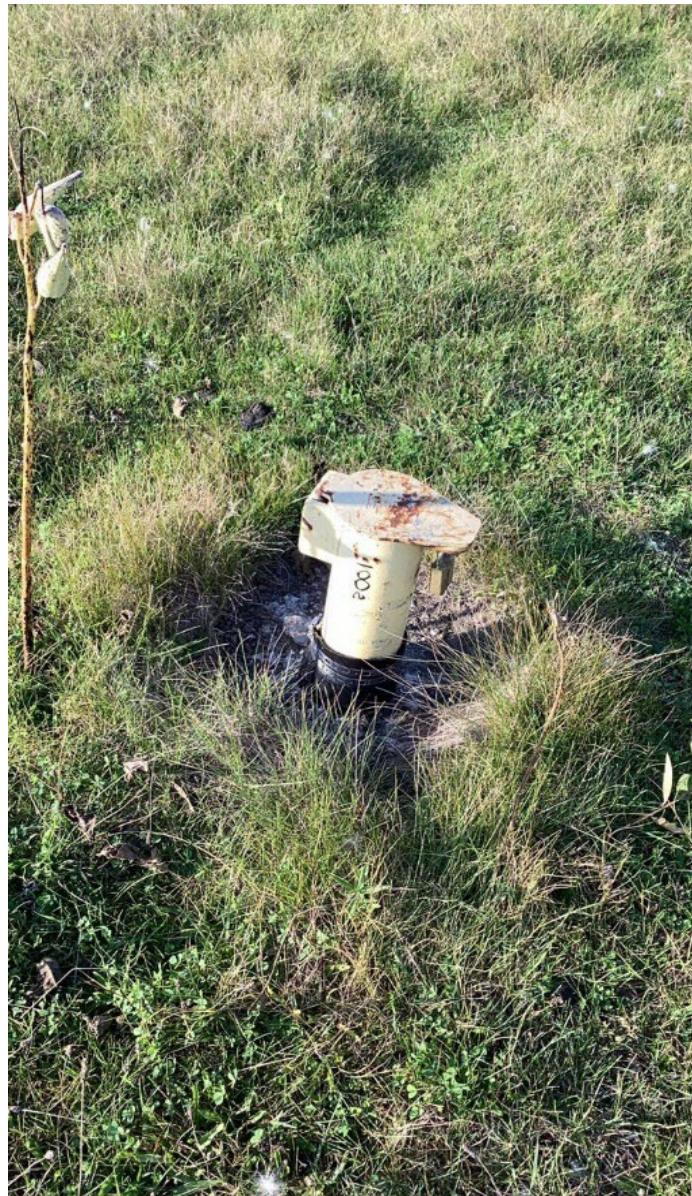
**EGLE Letter Comment 4:** *There were three unlabelled and uncapped monitoring wells that must be named and secured with adequate locks.*

2. Left: MW100S unmarked well (EGLE, July 11). Right: Marked well (GHD, Oct 4).

Between August and September 2025, GHD replaced/repaired locks, hinges, and labels on MW100S, MW1, and MW2, and on other deficient monitoring wells while completing the annual monitoring event. Pictures are provided in Attachment 1.

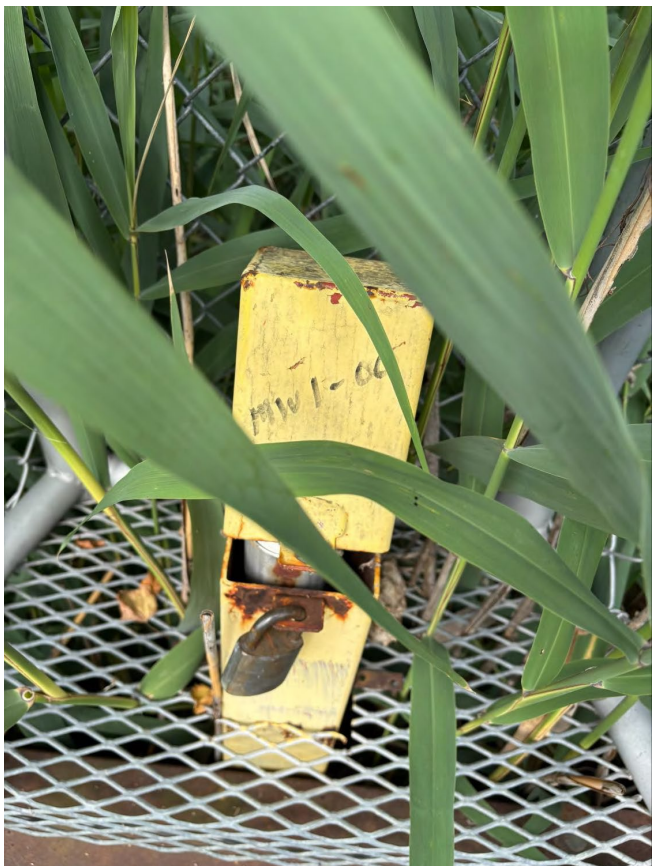
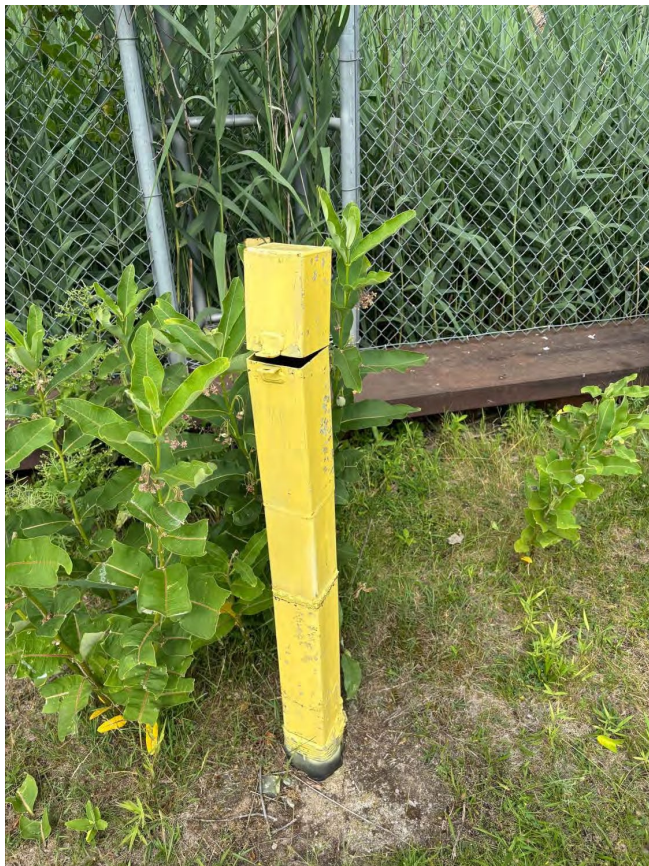
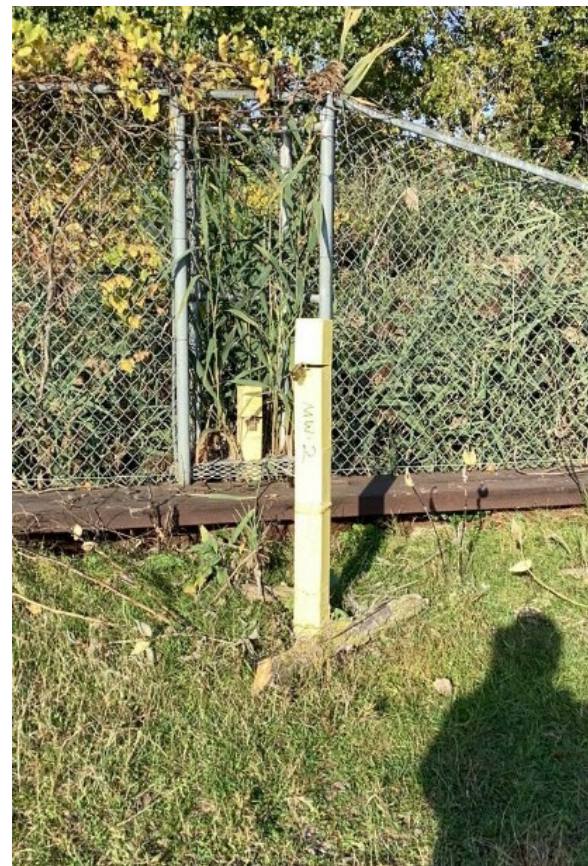
3. Left and Center: Unlocked and exposed wells MW1 and MW2 (EGLE, July 11). Right: Secured wells MW 1 and MW 2 (GHD, Oct 4).

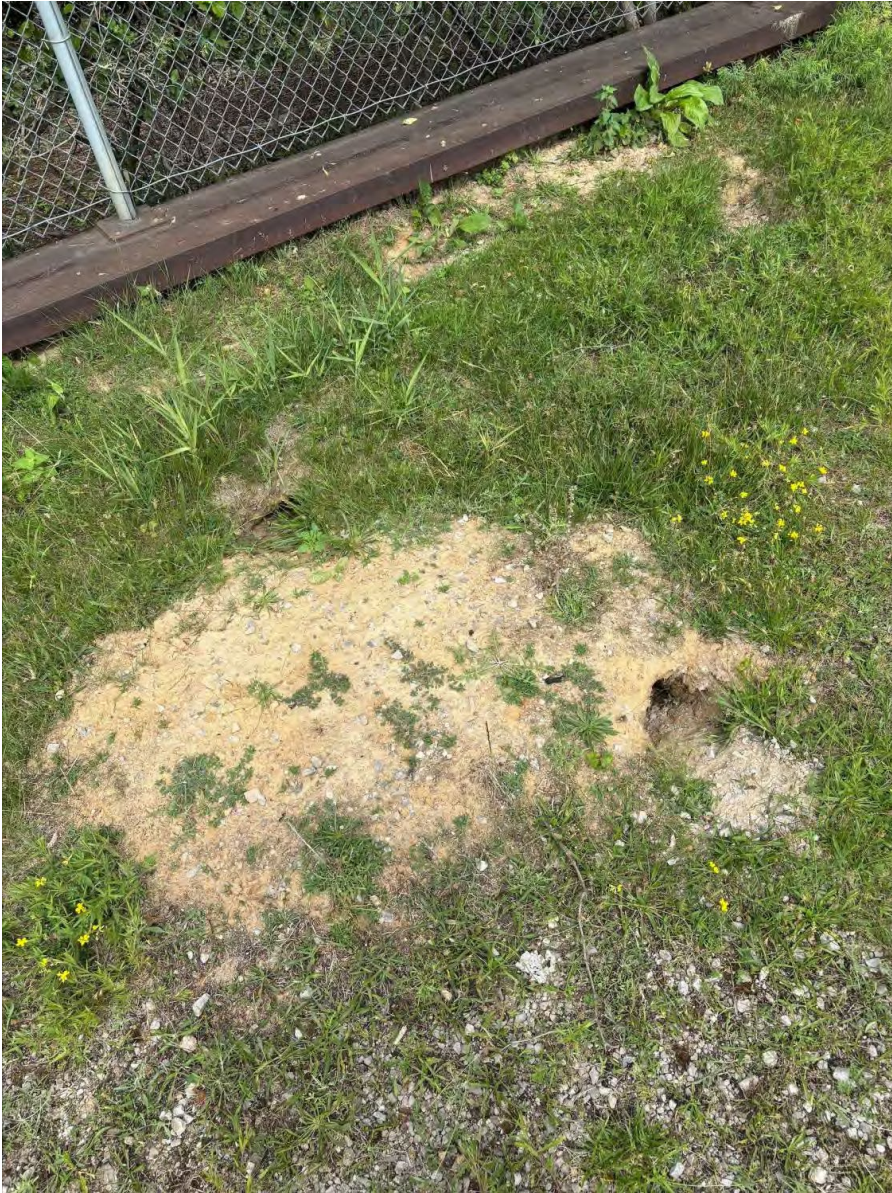
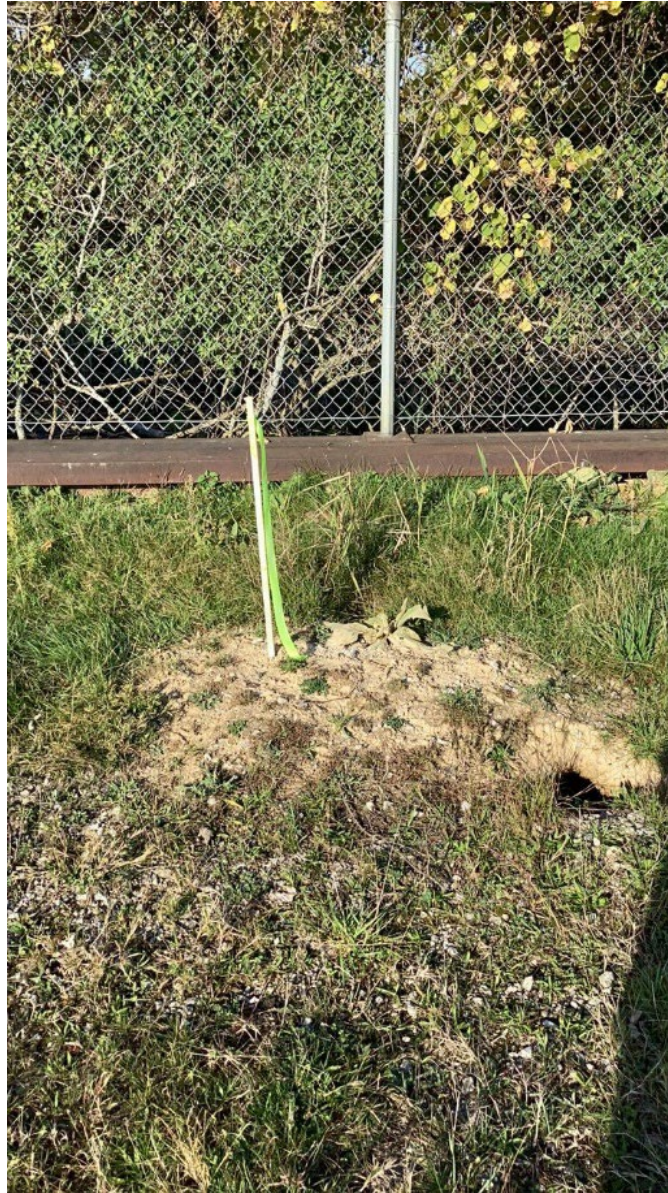
**EGLE Letter Comment 1:** *A number of animal burrows were found in the cap. RACER must fill the burrows and remove the occupants.*

4. Left: Groundhog burrow near outfall on cap (EGLE, July 11). Right: Same burrow marked and staked (GHD, Oct 4), to be filled following animal removal.

GHD has conducted a Site inspection and identified fifteen animal burrows, as identified on Figure 1. Example photographs of these staked locations are presented in Attachment 1. These locations were marked with stakes and flags on the Site. GHD is in the process of securing the professional services of a wildlife control company to remove groundhogs. The identified contractor for this work is Central Michigan Wildlife Services. Once it is confirmed that a groundhog is captured from a burrow GHD will fill the burrow and take a photograph to document the burrow has been addressed.

GHD will then look for future animal activity during Site inspections and if active animal burrows are observed, GHD will schedule the wildlife control company to come to the Site and remove the animal and GHD will fill in the burrow and photograph the filled burrow.

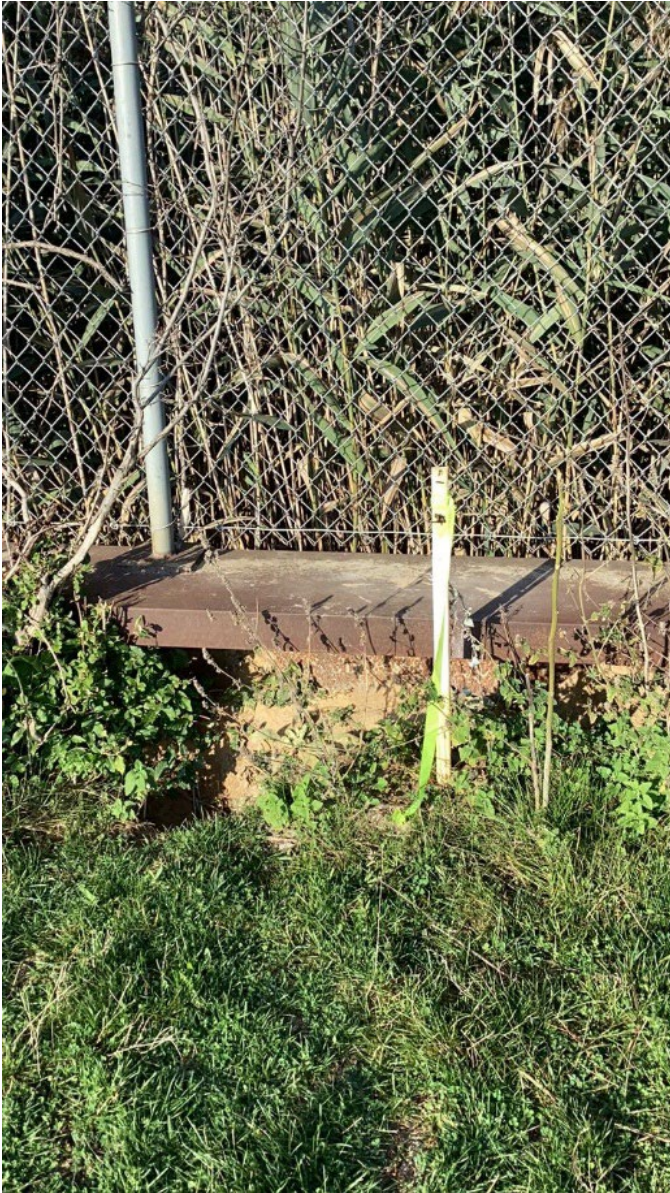
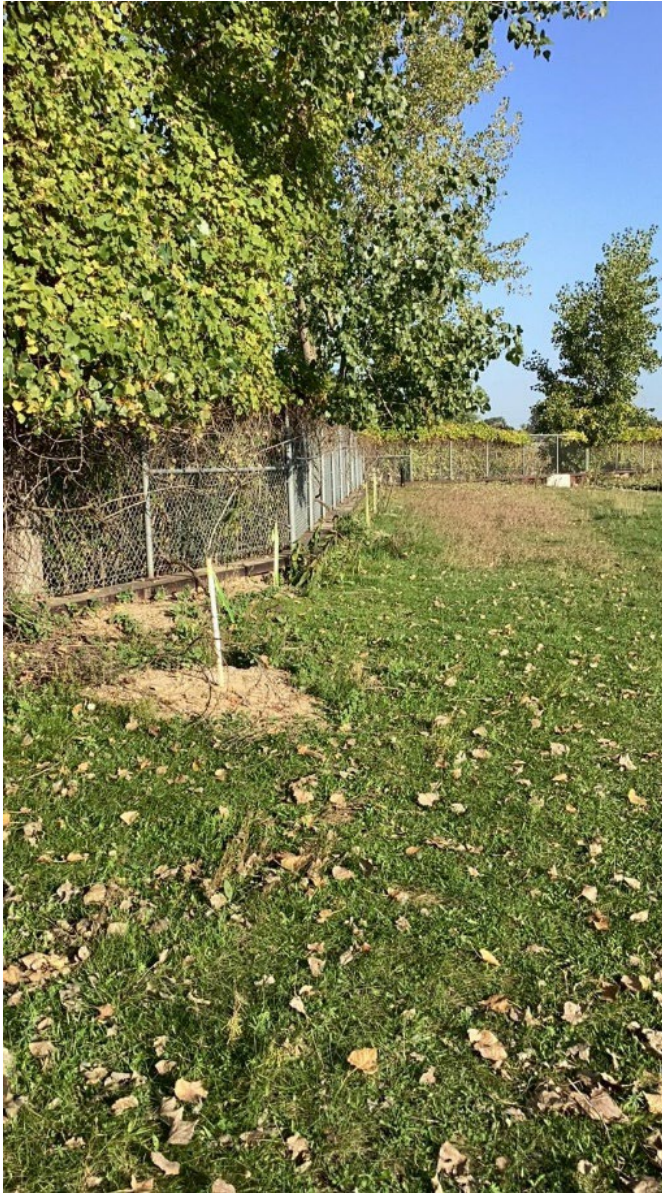
5. Additional example of one of the 15 burrows that have been marked and staked (GHD, Oct 4), to be filled following animal removal.

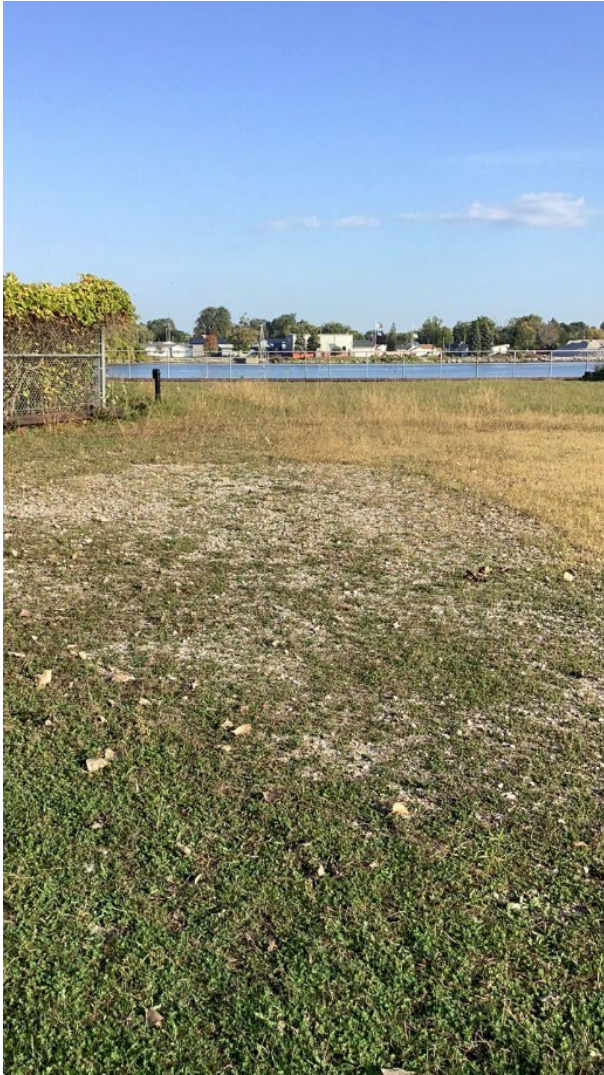
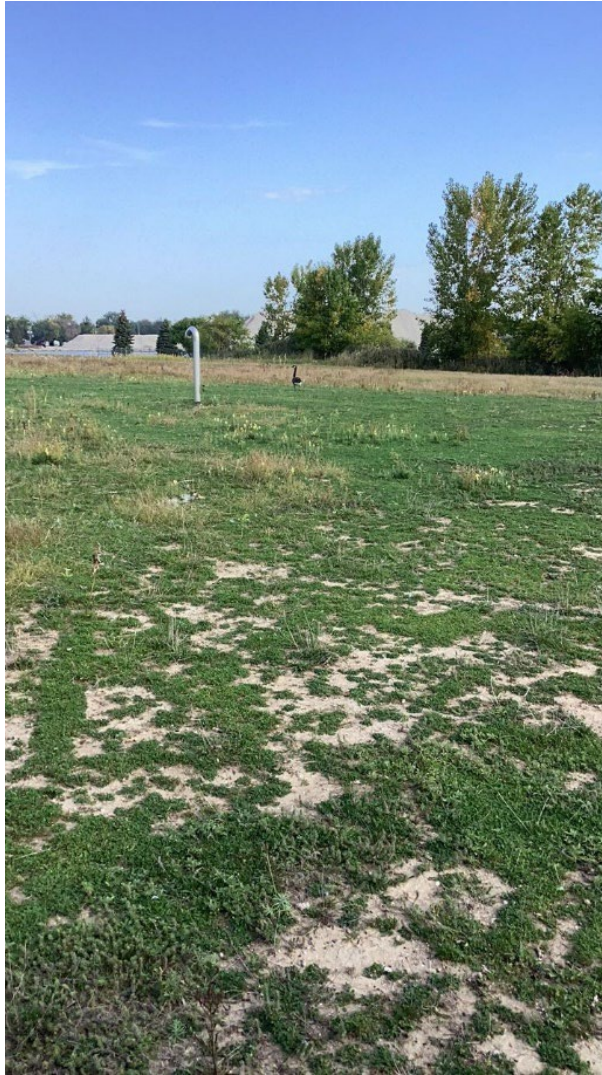
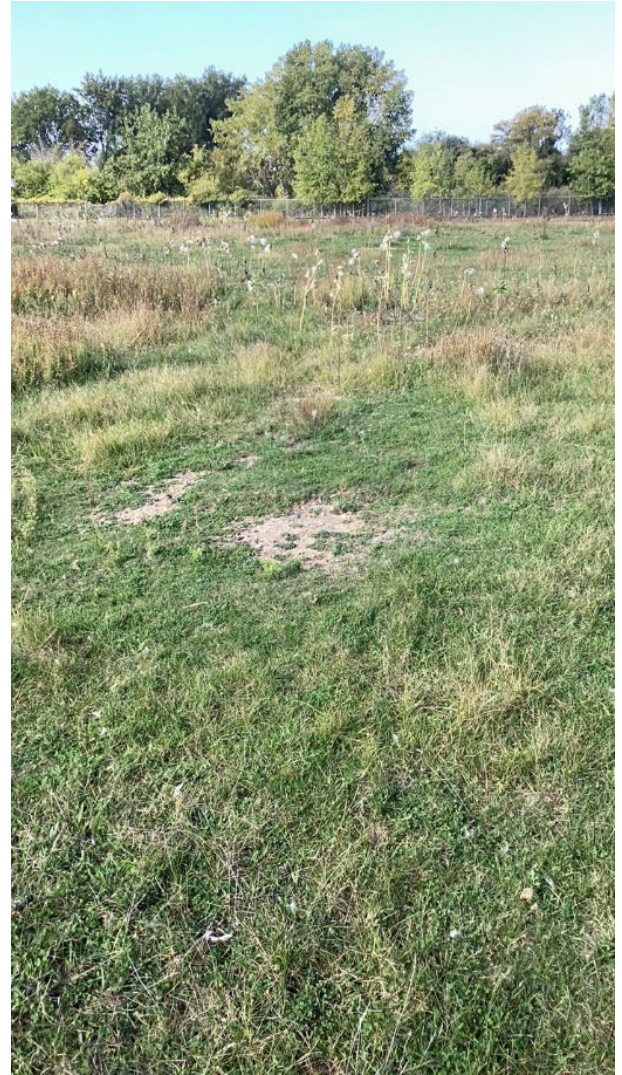
**EGLE Letter Comment 3:** *Several bare spots on the cap were observed. Recommendations and Follow up Actions: these areas must be reseeded and regraded as necessary to prevent further erosion.*

6. Bare spots filling in and showing no signs of erosion (GHD, Oct 4).

RACER and GHD conducted separate Site visits in October 2025 and identified that the bare spots have substantially filled in naturally, and that there are no signs of erosion; therefore no work is proposed for these areas. Pictures are provided in Attachment 1.

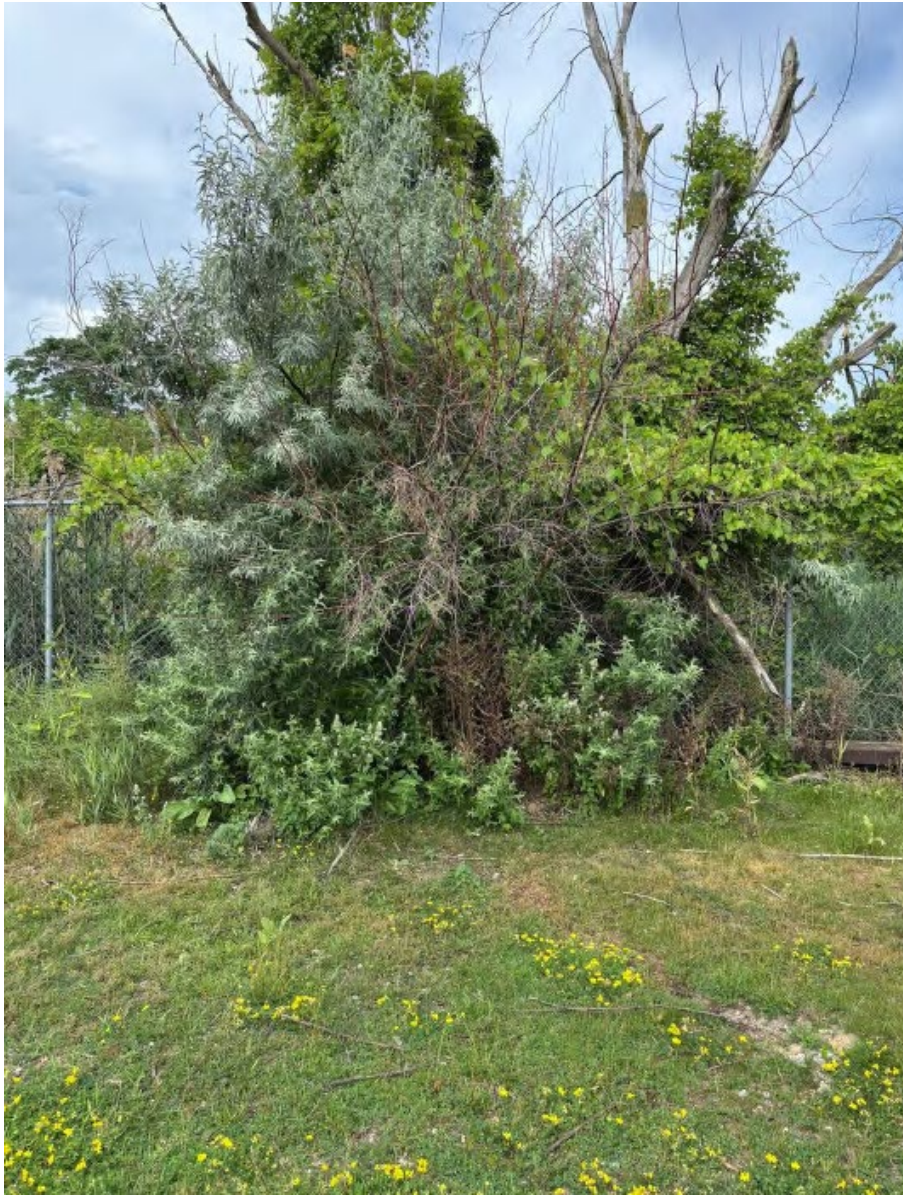
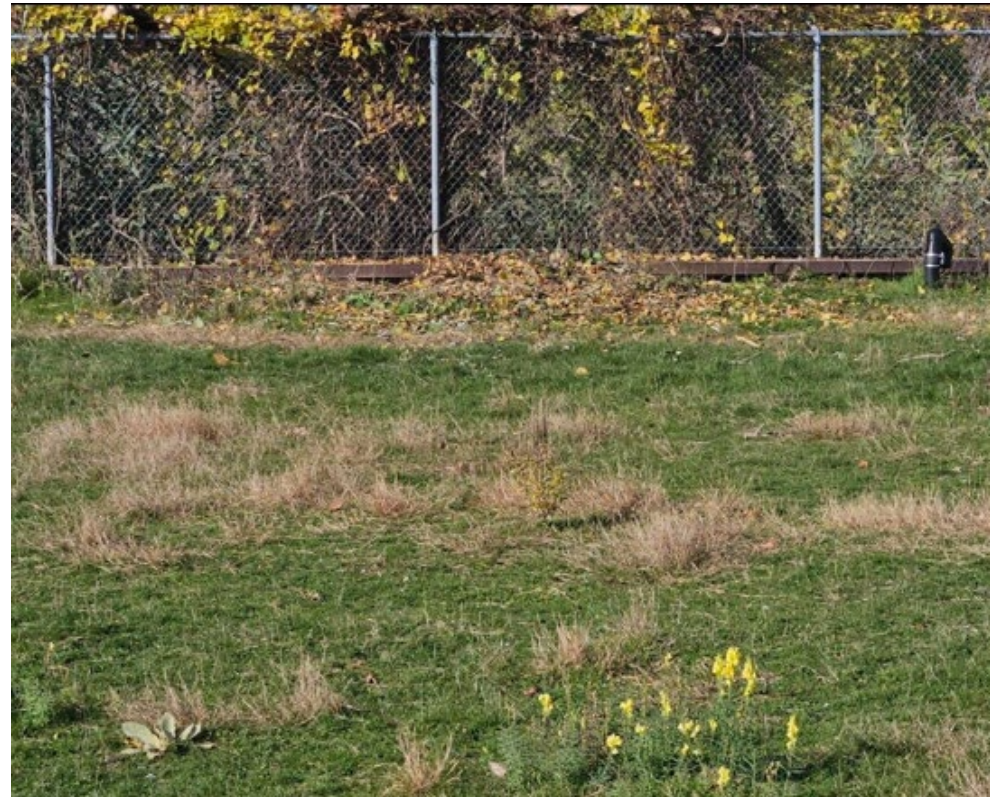
**EGLE Letter Comment 2:** *Several autumn olive (*Elaeagnus umbellata*) were found growing on the edge of the cap, inside the fence barrier. The root structures of these trees grow between one and seven metres underground. RACER must remove the trees. Following the removal the MMD recommends that a round of herbicide is applied to the remnants, as it is common for autumn olive to resprout from the root crown shortly after being cut down.*

7. Left and Center: Autumn Olive on west side (EGLE, July 11). Right: Same area showing tree removed (RACER, Oct 22).

In October 2025, the two trees identified in the EGLE Report were removed. During the next inspection, these areas will be inspected to determine the need for additional actions such as herbicide. Pictures are provided in Attachment 1.

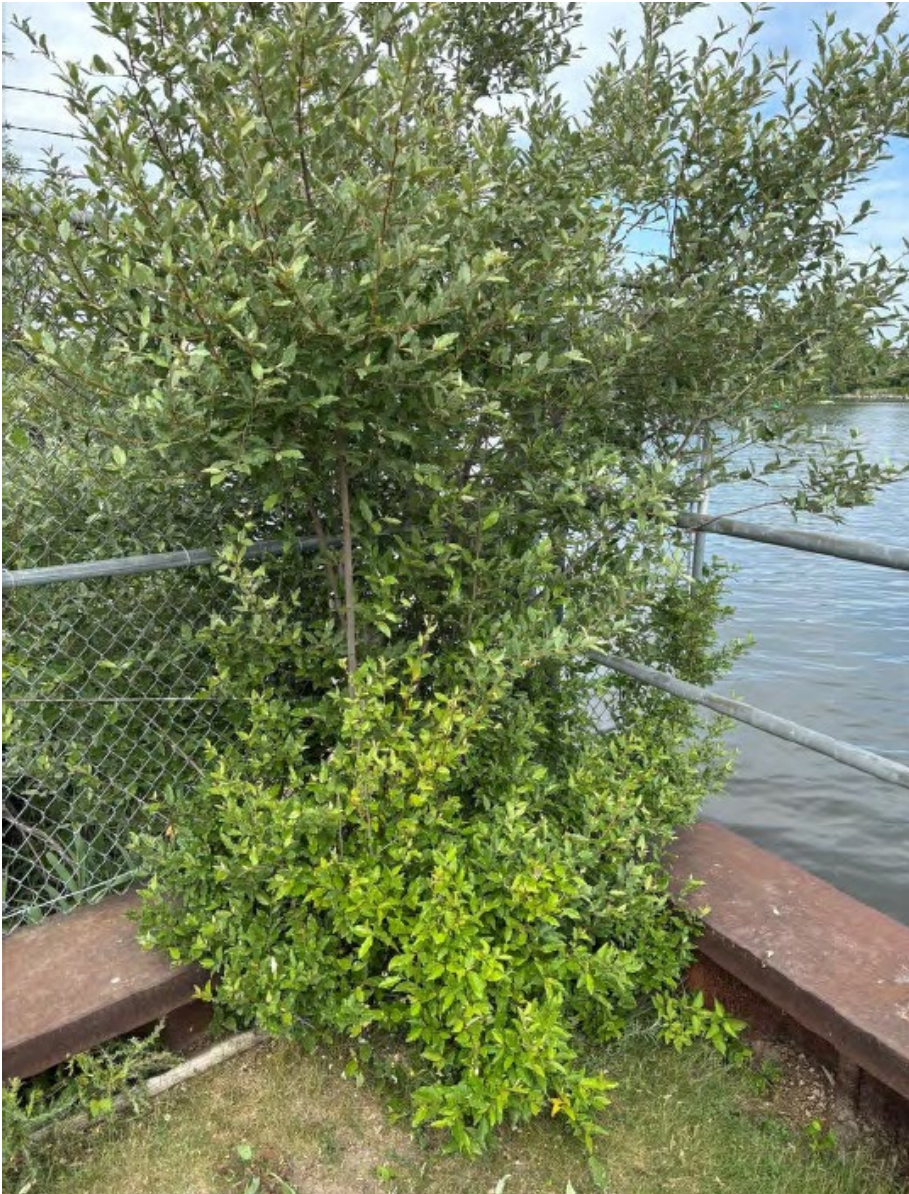
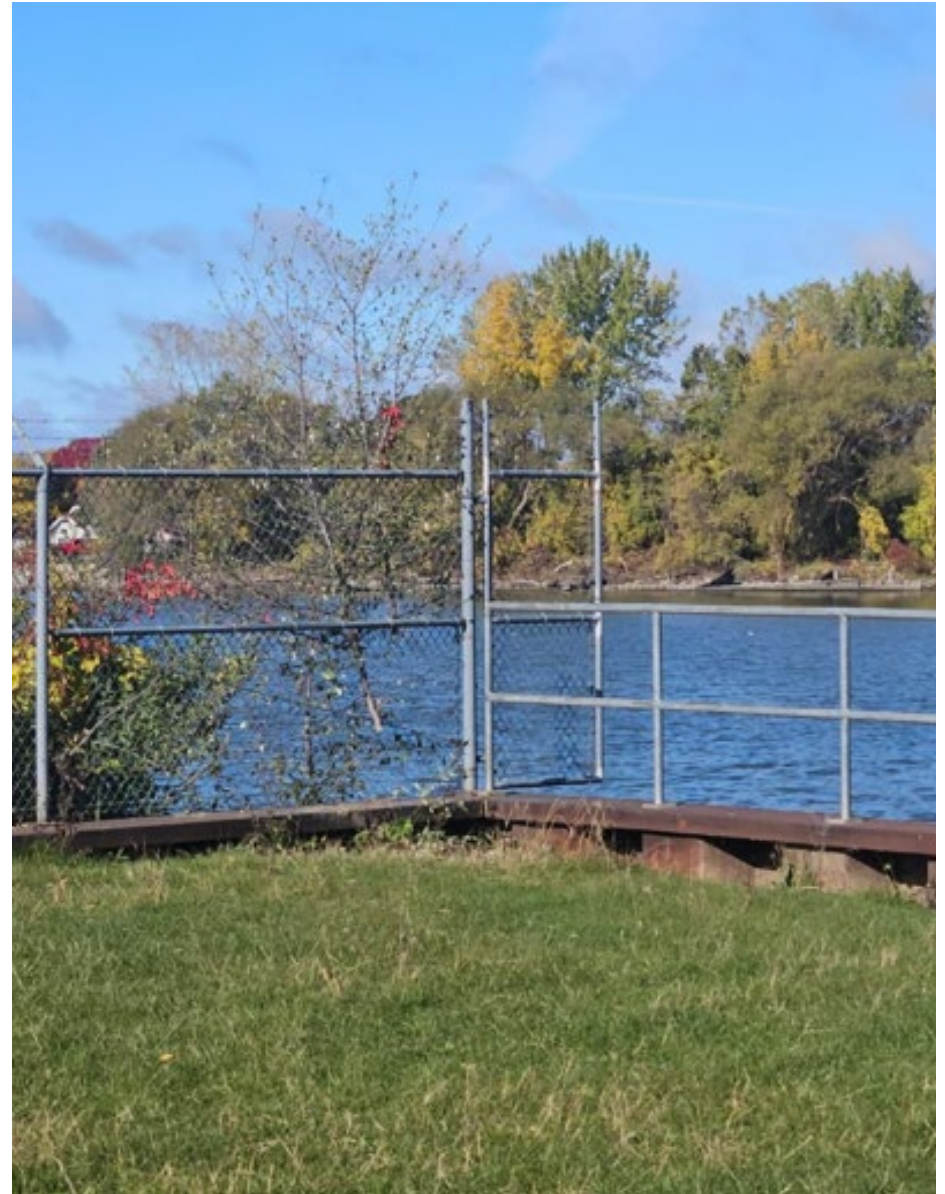
8. Left: Autum Ollive on northwest corner (EGLE, July 11). Right: Same area showing tree removed (RACER, Oct 22).

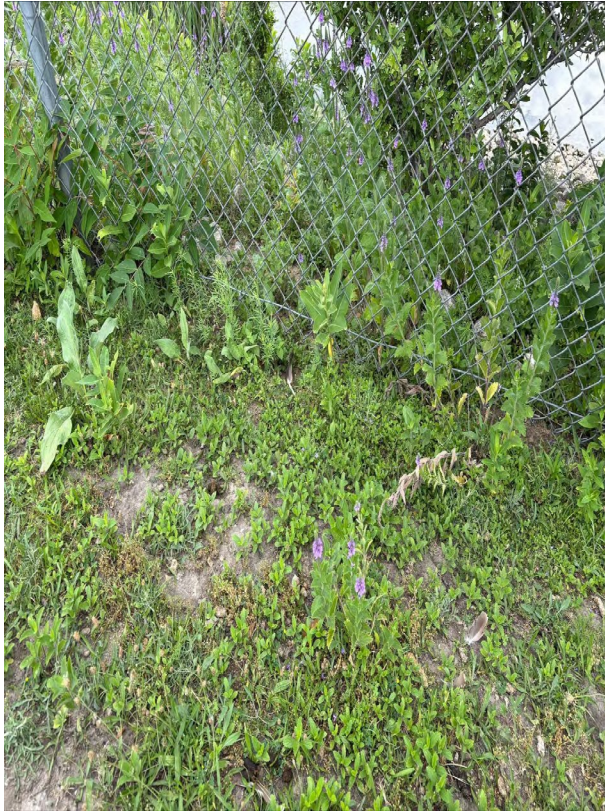
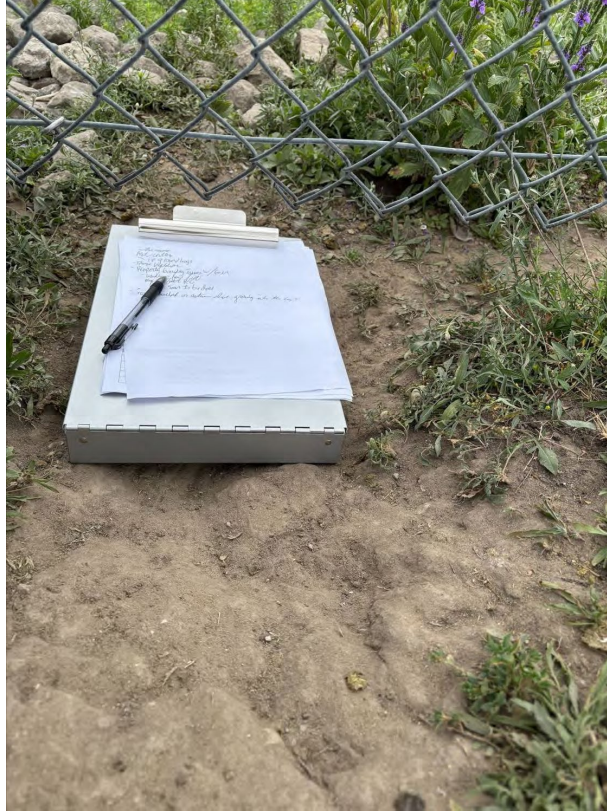
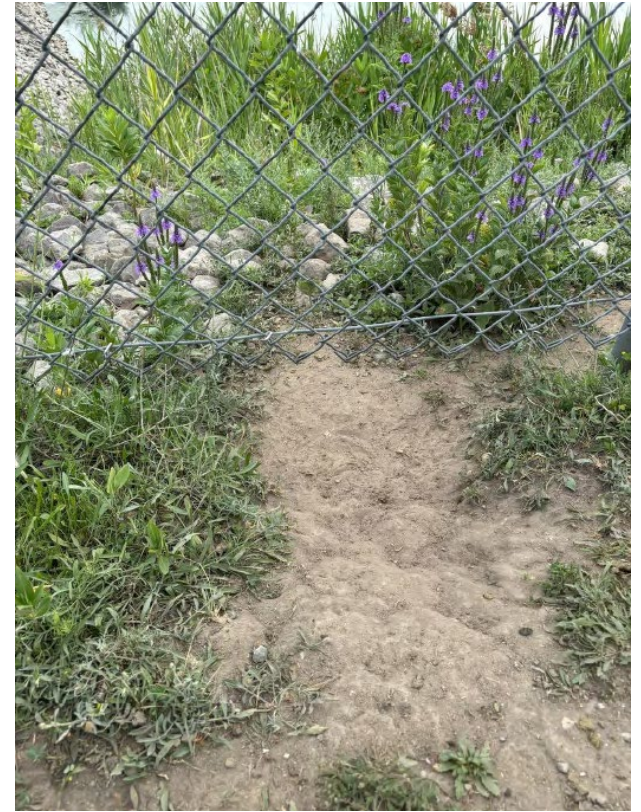
9. Exposed fencing with potential for animal traversal (EGLE, July 11). These locations will be filled in Spring 2026.
