RE: Comments on 2022 Cap Inspection Report – Letter Dated April 14, 2023
Coldwater Road Landfill
1245 East Coldwater Road, Flint, MI
MID 005 356 860
FILE: 1088190/1940103462/Corres

Date May 10, 2023

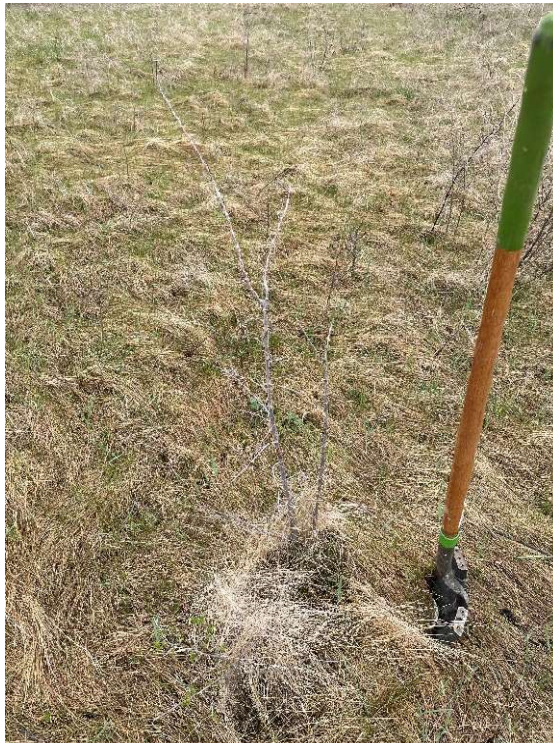
Location: Cell E

Inspection issue 2:
Small woody plant.

Picture taken prior to
corrective measure.

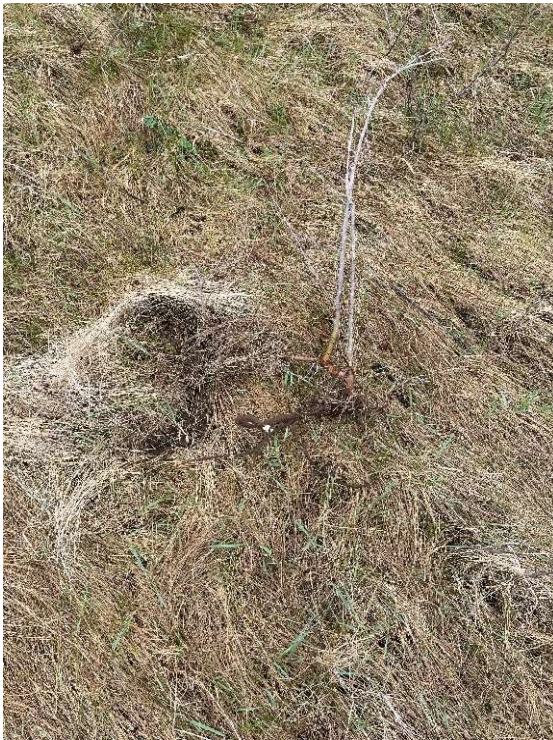
Location: Cell E

Inspection issue 2:
Small woody plant.

Picture taken post
corrective measure.
Woody plant was
removed by the root.

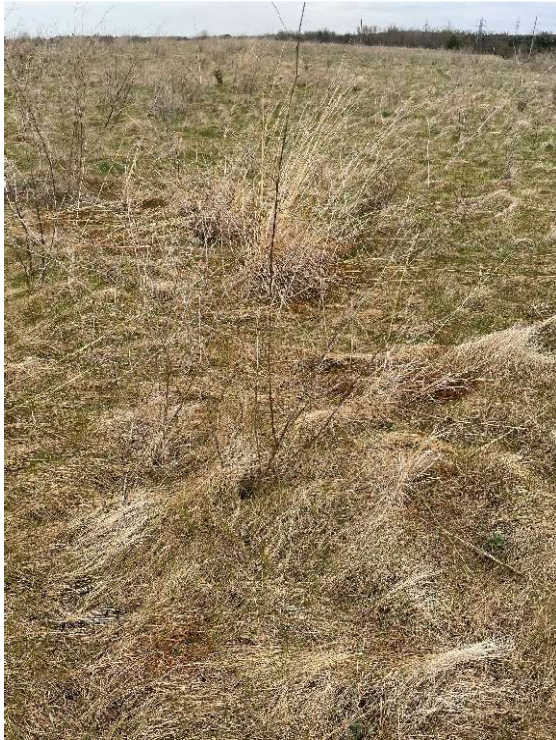
Location: Cell D

Inspection issue 3:
Small woody plants.

Picture taken prior to
corrective measure.

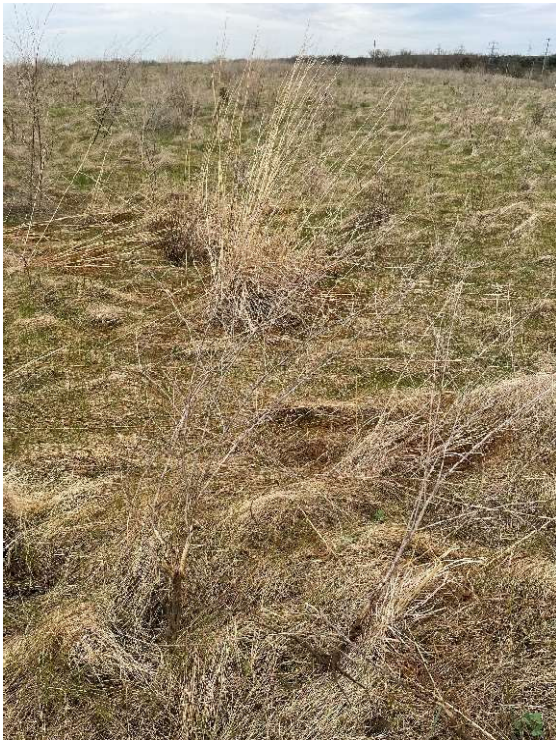
Location: Cell D

Inspection issue 3:
Small woody plants.

Appeared to have
shallow roots and
does not appear to
be a woody perennial
plant.

Picture taken post
corrective measure.
Plants were removed
by the root.

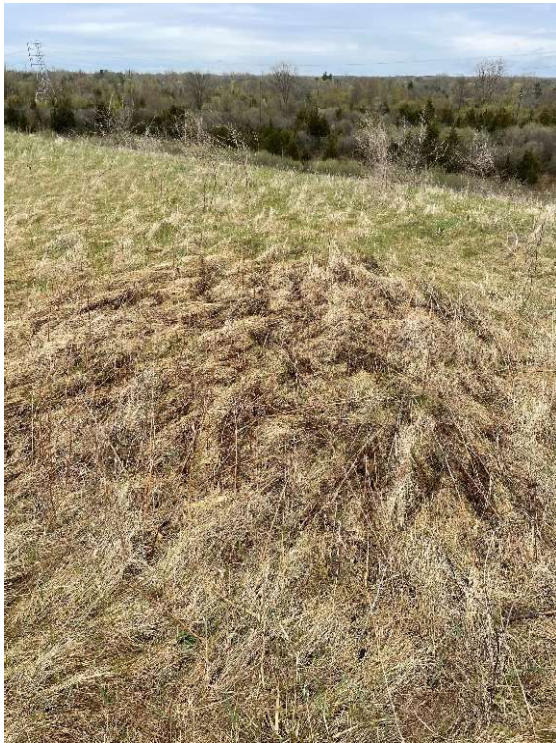
Location: Cell C

Inspection issue 5:
Overgrown
vegetation, possible
woody plants.

Picture taken prior to
corrective measure.
Plants were down
upon arrival and
decomposed.

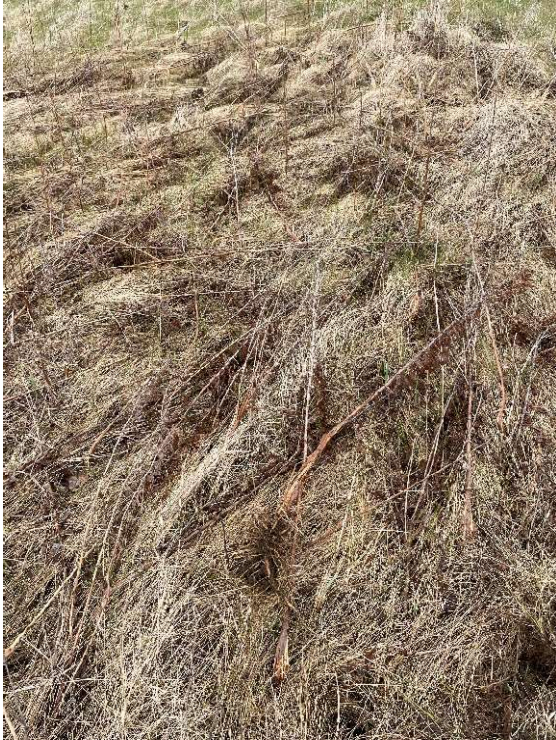
Location: Cell C

Inspection issue 5:
Overgrown
vegetation, possible
woody plants.

Appeared to have
shallow roots and
does not appear to
be a woody perennial
plant.

Picture taken post
corrective measure.

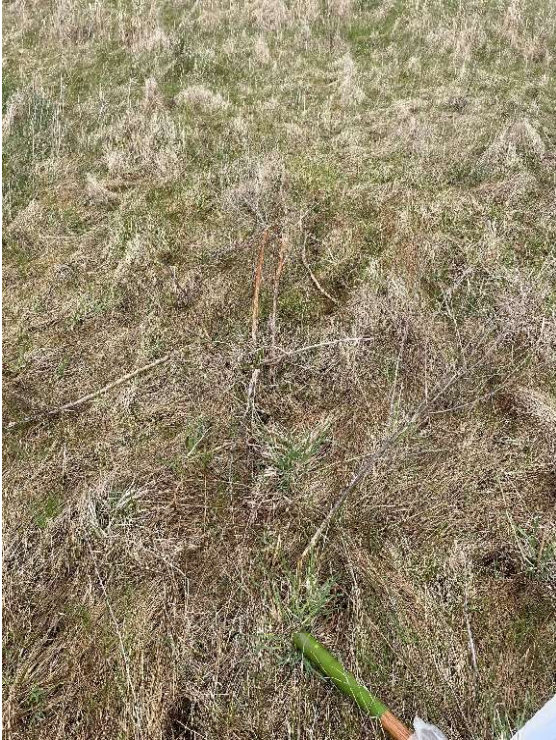
Location: Cell C

Inspection issue 6:
Small woody plants.

Picture taken prior to
corrective measure.
Plant was down on
arrival.

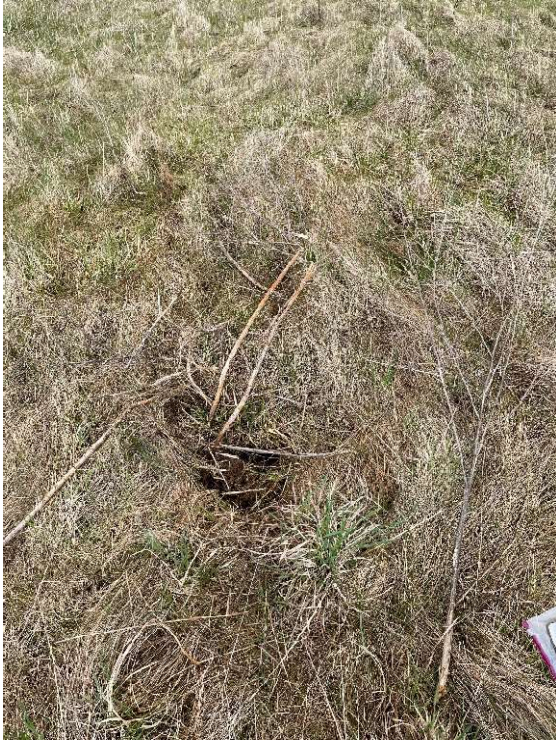
Location: Cell C

Inspection issue 6:
Small woody plants.

Appeared to have
shallow roots and
does not appear to
be a woody perennial
plant.

Picture taken post
corrective measure.

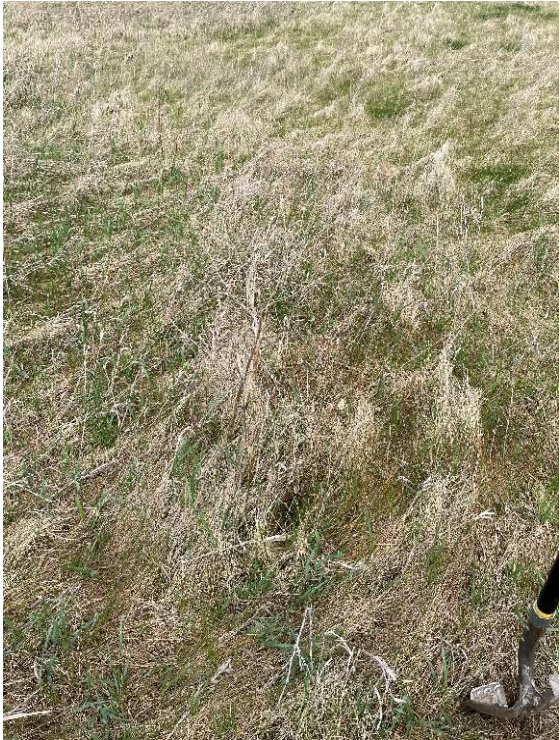
Location: Cell C

Inspection issue 7:
Small woody plant.
Plant was down on arrival.

Picture taken prior to corrective measure.

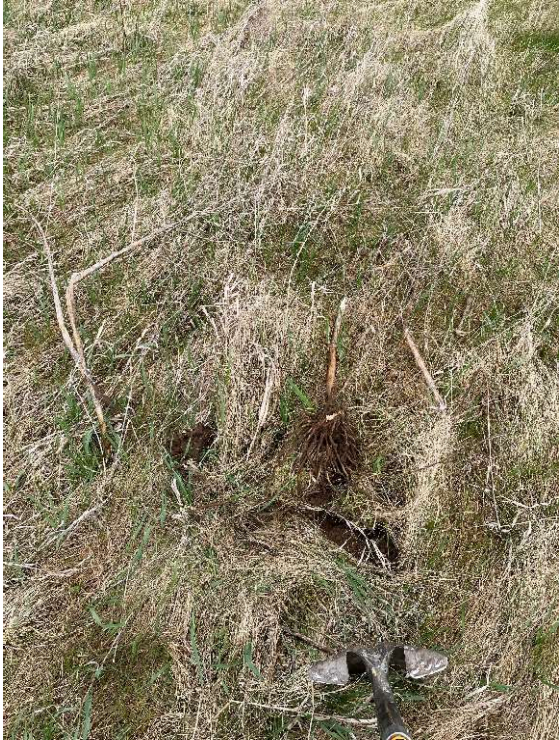
Location: Cell C

Inspection issue 7:
Small woody plant.

Appeared to have shallow roots and does not appear to be a woody perennial plant.

Picture taken post corrective measure.
