**Landfill Inspection Report 2023**

**February 2024**

# **COLDWATER ROAD LANDFILL - MID 005 356 860 LANDFILL INSPECTION REPORT**

Project name **RACER Trust Coldwater Road Landfill**  
Project no. **15388/1940103462**  
Recipient **Nicole Sanabria (EGLE) & Christina Hebert (EGLE)**  
Document type **Annual Report**  
Version **1**  
Date **February 28, 2024**  
Prepared by **Kevin Schneider**  
Checked by **Clifford Yantz**  
Approved by **Clifford Yantz**  
Description **Landfill Inspection Annual Report**

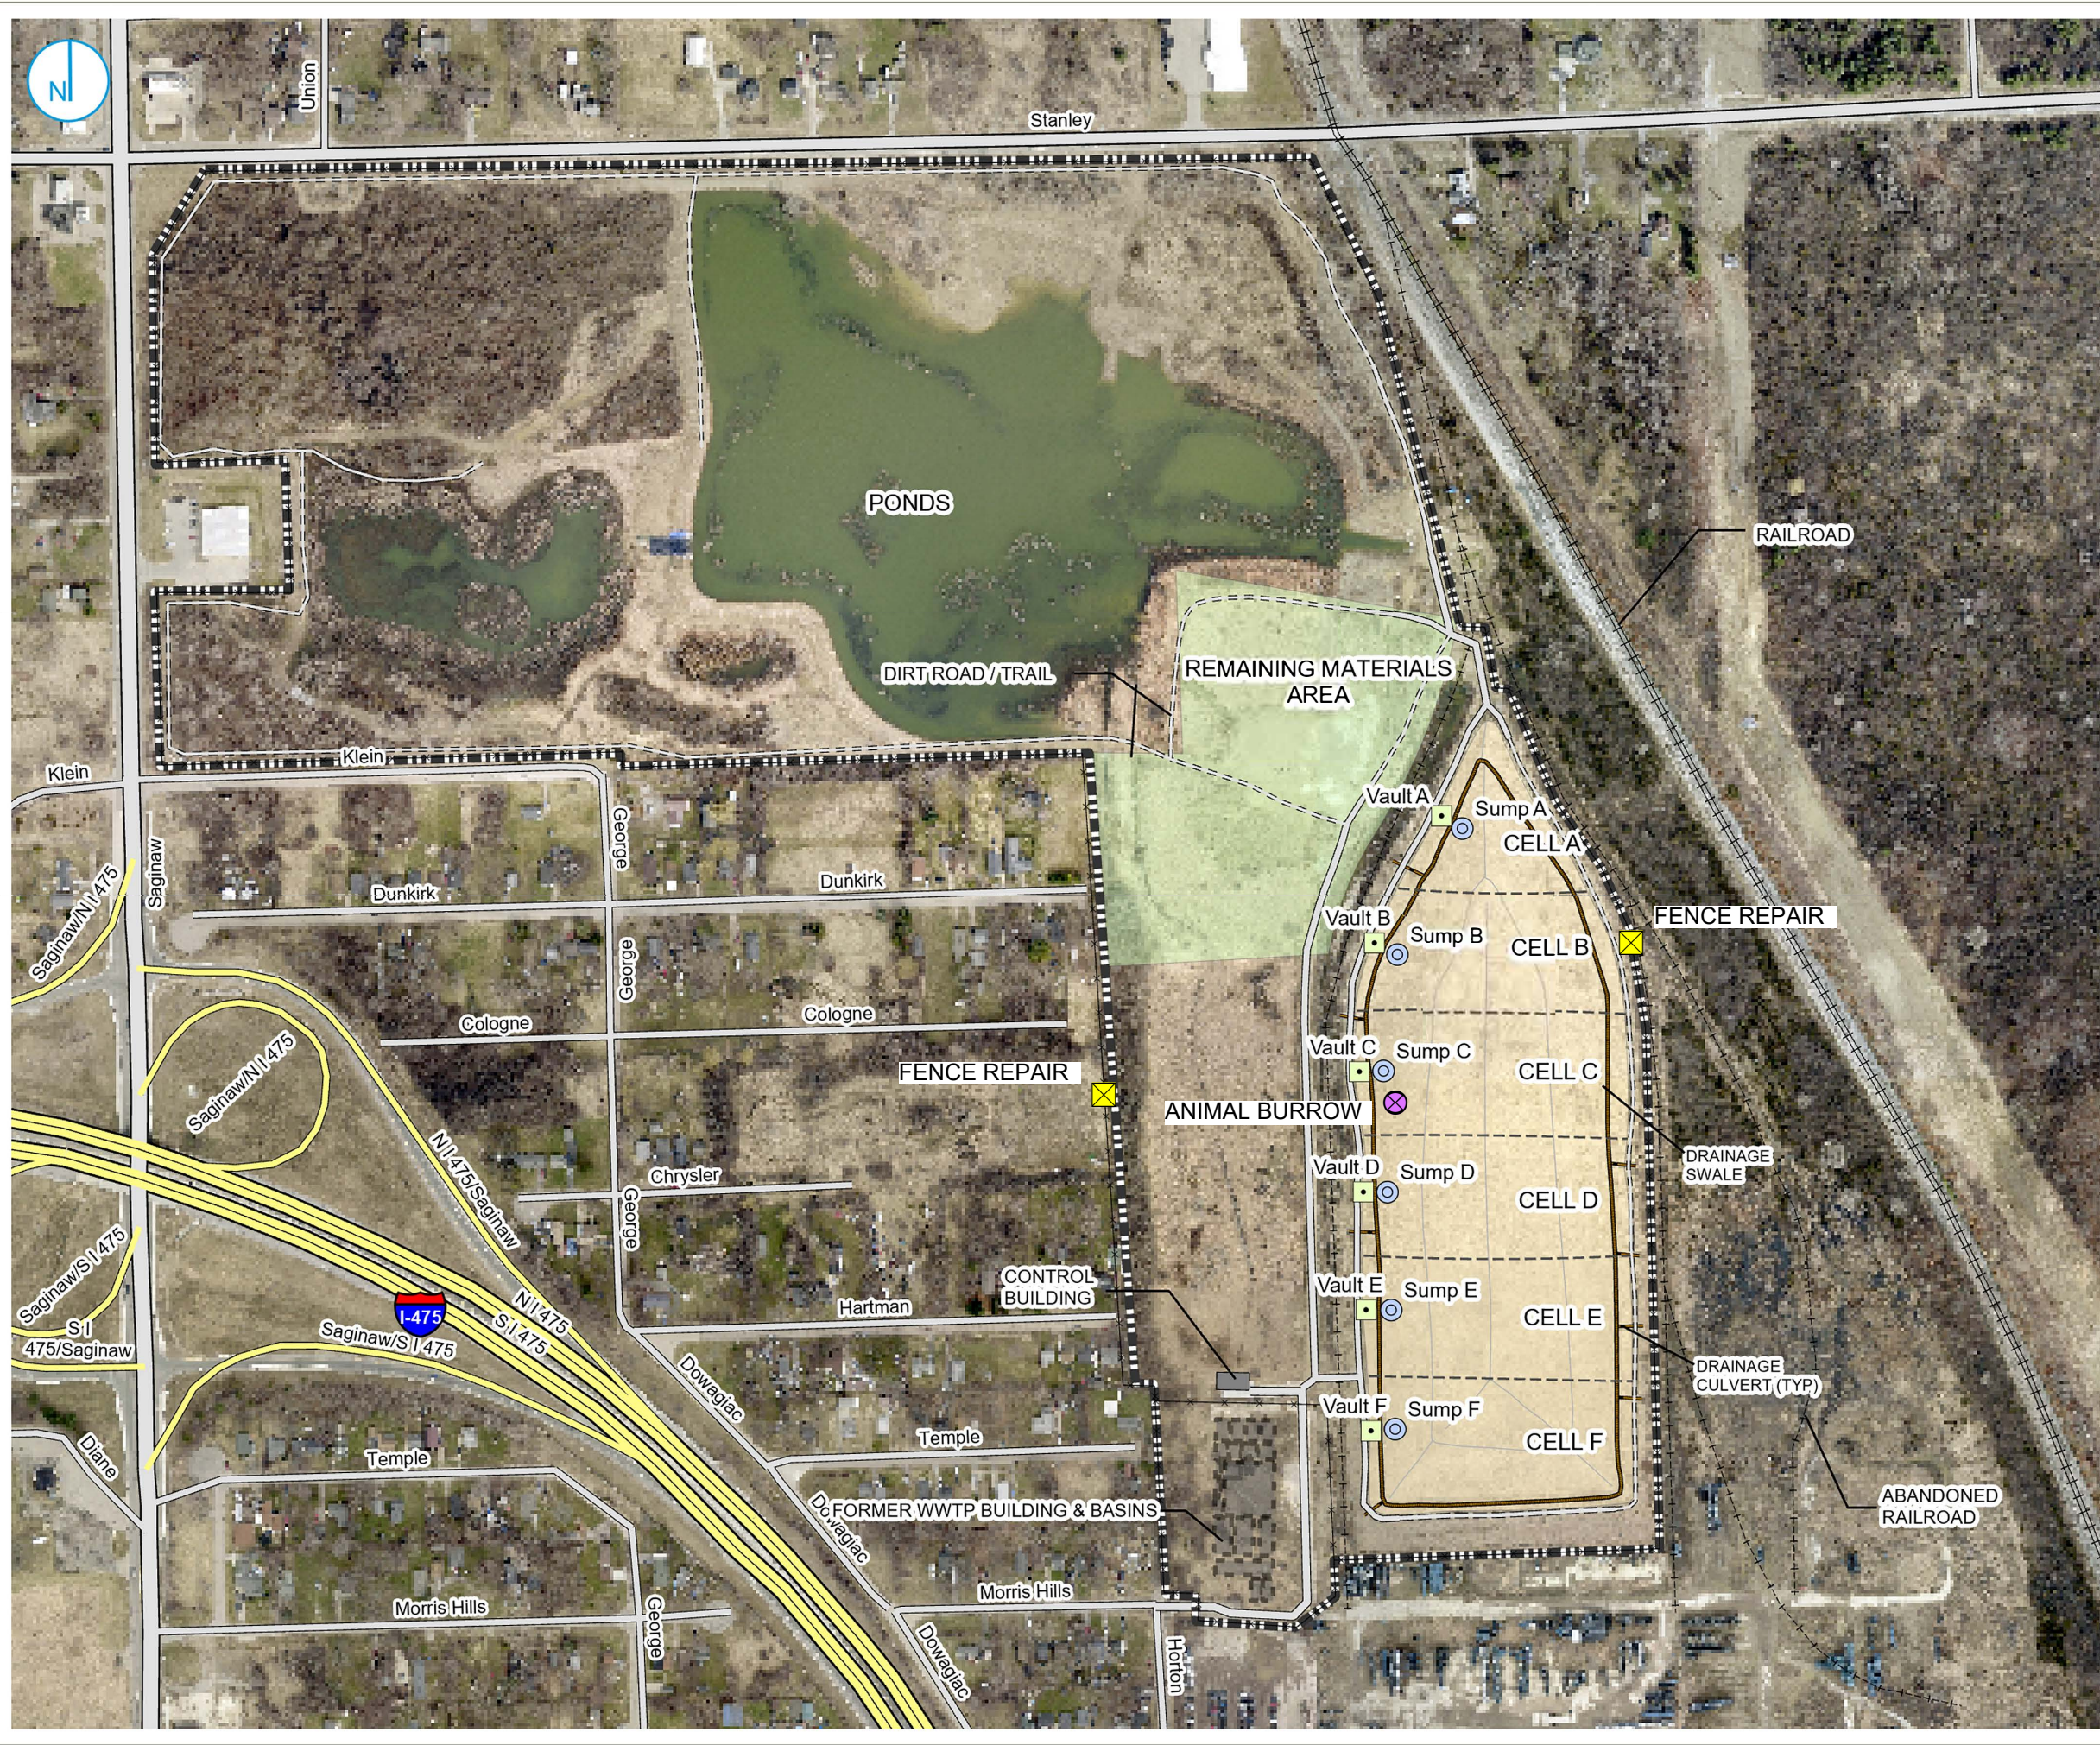
One potentially active animal burrow was observed on September 29, 2023 and a trap was set the same day. The animal burrow was found to be active, as an animal was trapped. The animal burrow was closed out on November 20, 2023. The burrow was filled using methods approved by EGLE, which included measuring the approximate length (4+ feet), depth (1 foot), and diameter (6 inches) and recording the location.

During the 1<sup>st</sup> quarter, 2<sup>nd</sup> quarter, and 3<sup>rd</sup> quarter, a hole in the fence west of the landfill cap north of Chrysler Street was repaired. A hole in the perimeter fence northeast of the landfill cap was observed during the 2<sup>nd</sup> quarter inspection and repaired during the 4<sup>th</sup> quarter 2023. See **Figure 2** for the location of the fence repairs completed during the entire year.

Once the burrow was filled in, the area was raked smooth and grass seed was spread. No signs of liner damage were observed during the inspection and repair of the animal burrow. A log of burrow activity throughout the year is maintained at the landfill. The log contains information on the date that a burrow was identified, response activities, and the date the burrow was filled and seeded. A photo log and figure containing the location of the burrow was also included in the 4<sup>th</sup> Quarter Status Report. The location of the animal burrow can be found on **Figure 2** in this report. Animal activity will continue to be addressed during future landfill cap maintenance.

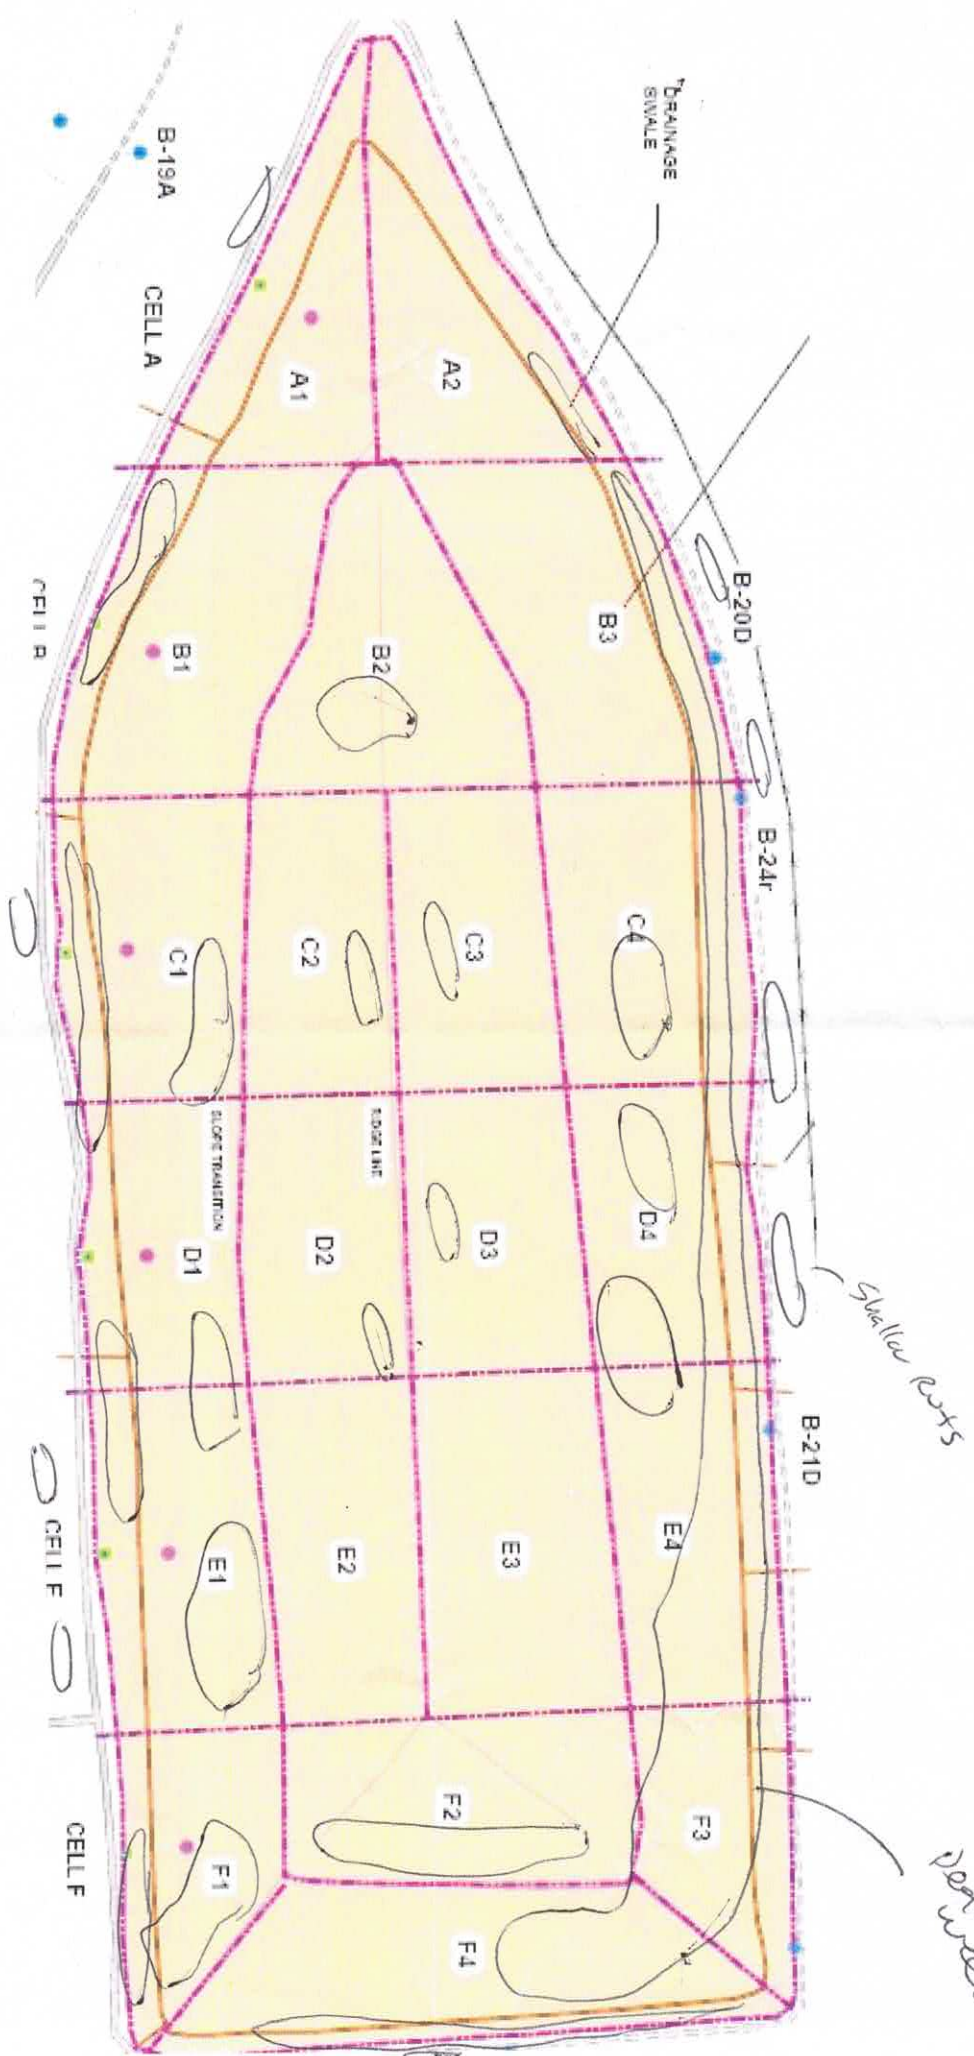
Dead tall weeds

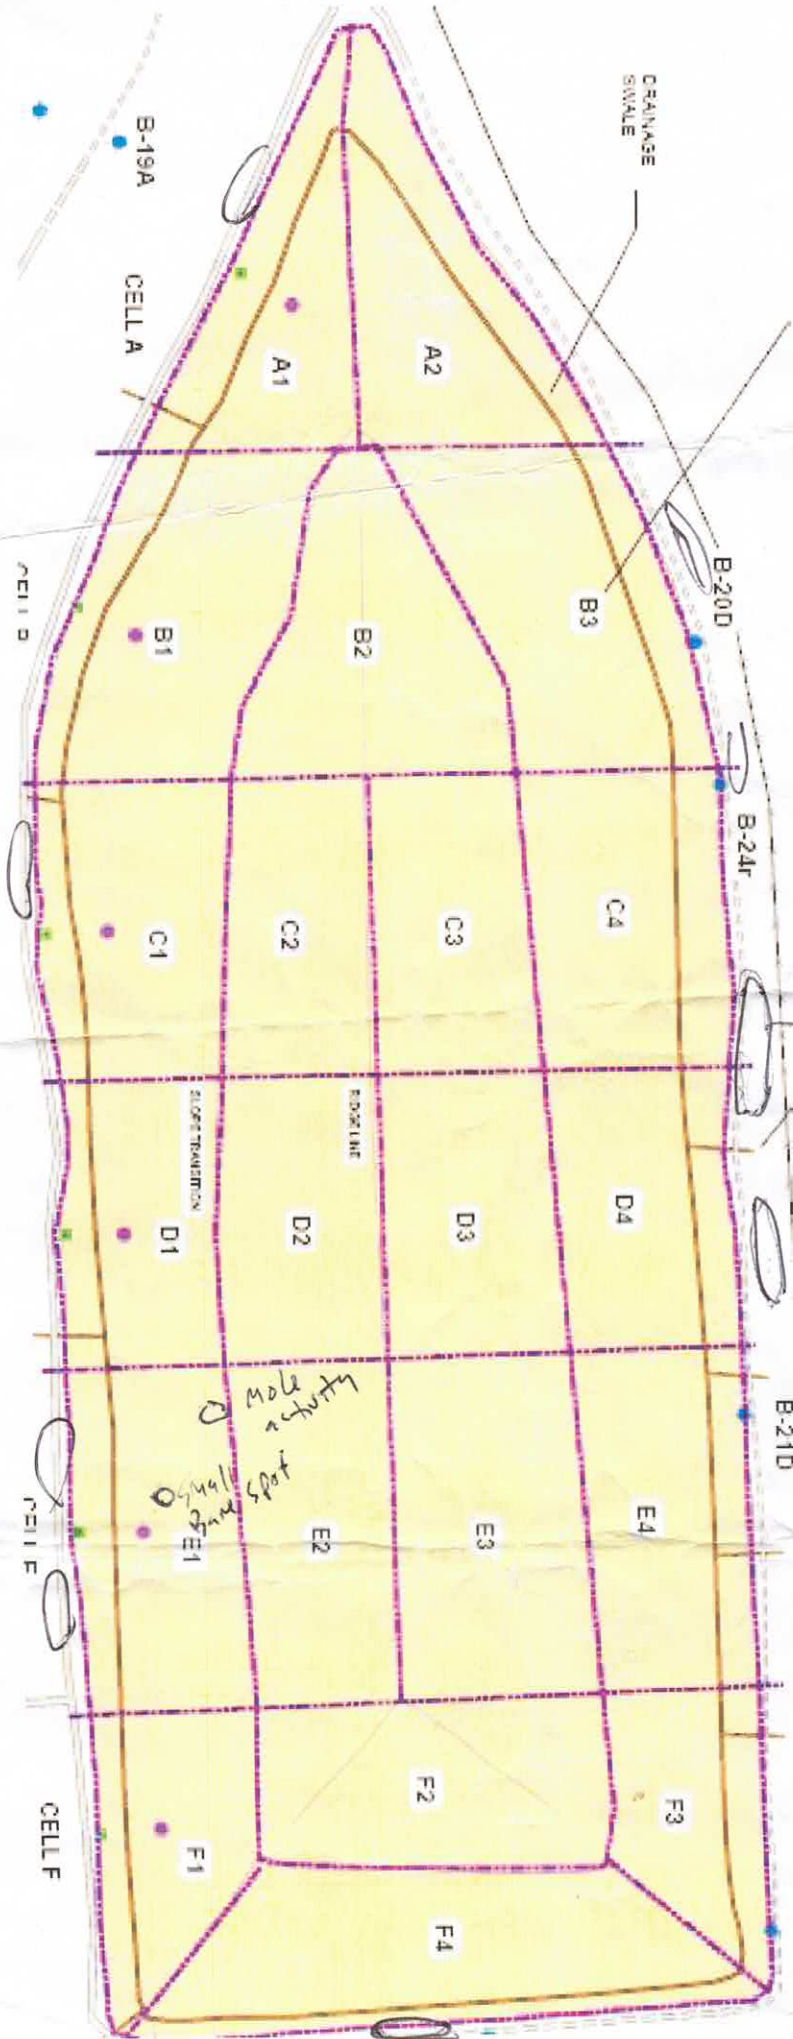
Glass on Cap moved

Shallow Ruts
