**2009 Annual  
Landfill Inspection Report  
REALM Coldwater Road  
Flint, Michigan  
MID 005 356 860**

Motors Liquidation Company  
Detroit, Michigan

February 2010

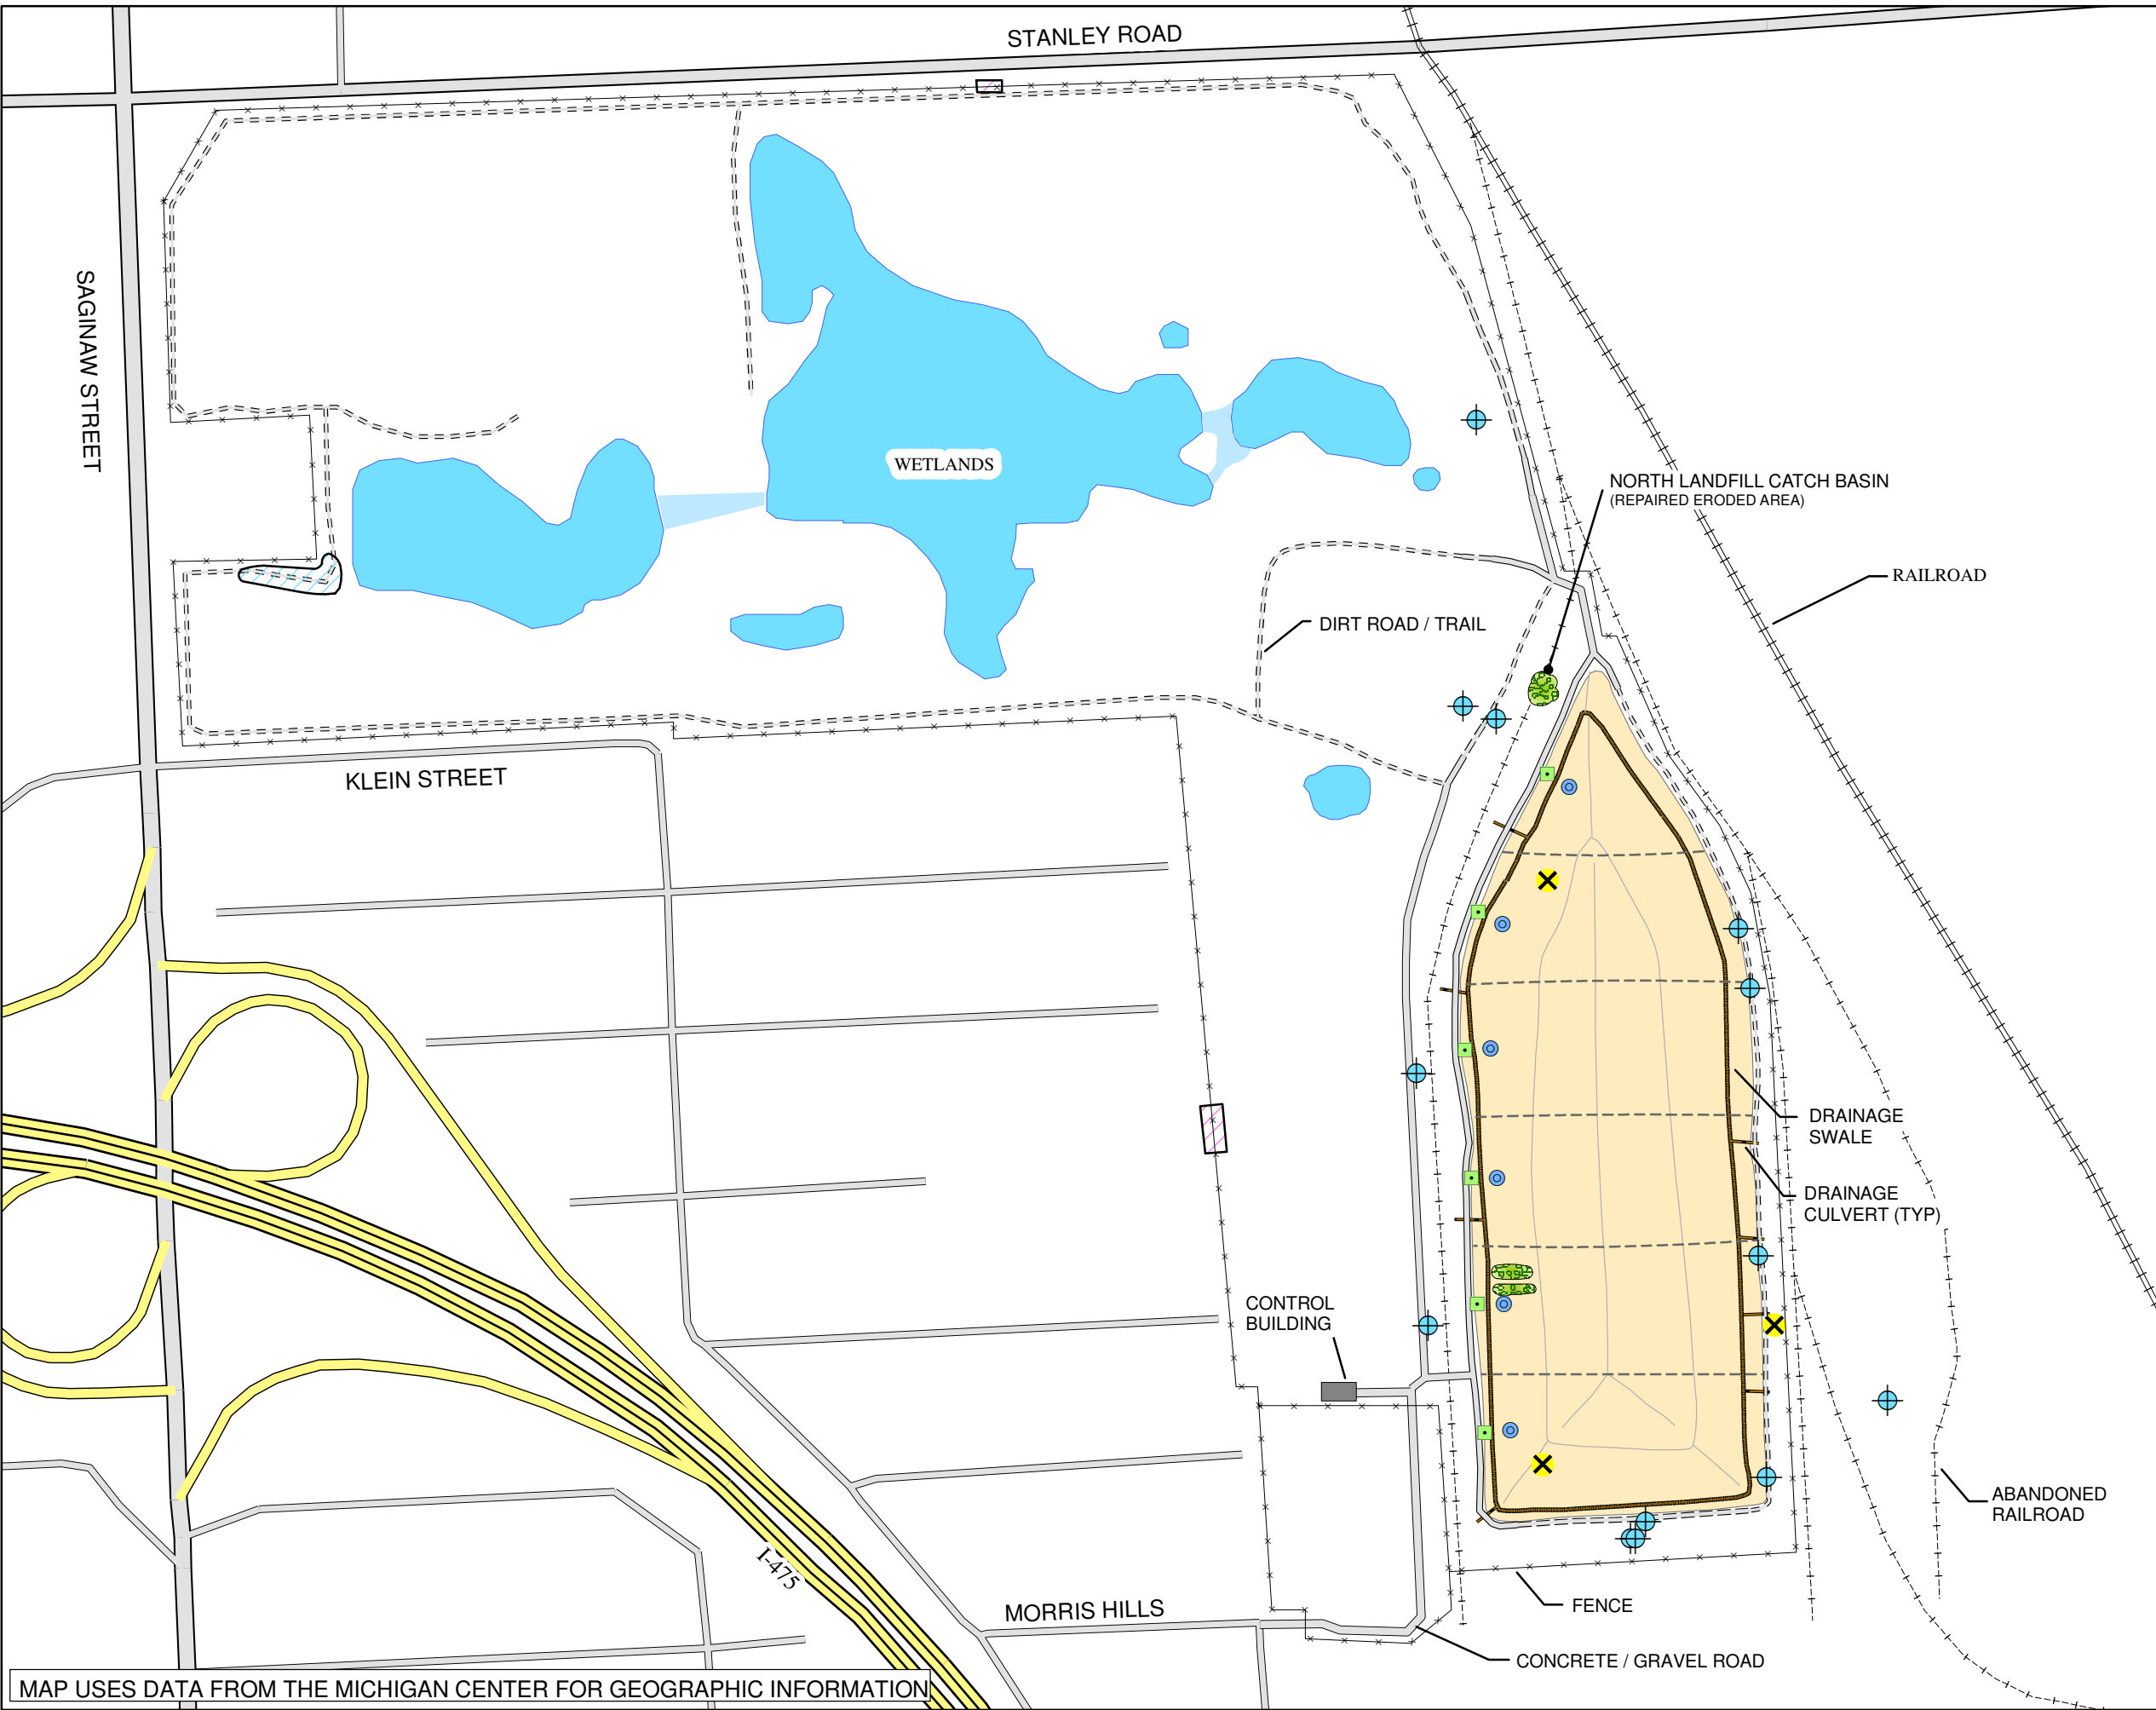
FIGURE 3

Several hundred woody-stemmed plants were removed by the root from the landfill cap between March 2009 and December 2009. During the March 26, 2009 inspection, small wash out areas at the location of the pervious wash out areas were observed. The washed out material was removed from the swale and replaced onto the cap. The washout areas were then covered with topsoil and re-seeded. Locations of the washed out areas are noted in Figure 3.

Three animal burrows were identified between March 2009 and December 2009. Traps were set at the opening of each animal burrow that appeared to be active. After five days without animal activity, the burrows were filled using methods approved by the MDEQ. Animal burrow locations are noted on Figure 3. A log of burrow activity is maintained at the landfill. The log contains information on the date that a burrow is identified, response activities, and the date the burrow is closed.

Ponded water was observed during the June 26, 2009 inspection along the access road located west of the wetlands near the northwest catch basin. No other problems to the access roads were observed during 2009.

The site perimeter fence and/or the barbwire were damaged at a number of locations during the quarterly inspections. During the March 26, 2009 inspection, an opening was observed along the north perimeter fence and the barbwire was cut along the west perimeter fence. The hole in the perimeter fence was repaired by the addition of new materials and grading the soil. On September 24, 2009 the barbwire was cut along the south and west perimeter fences.

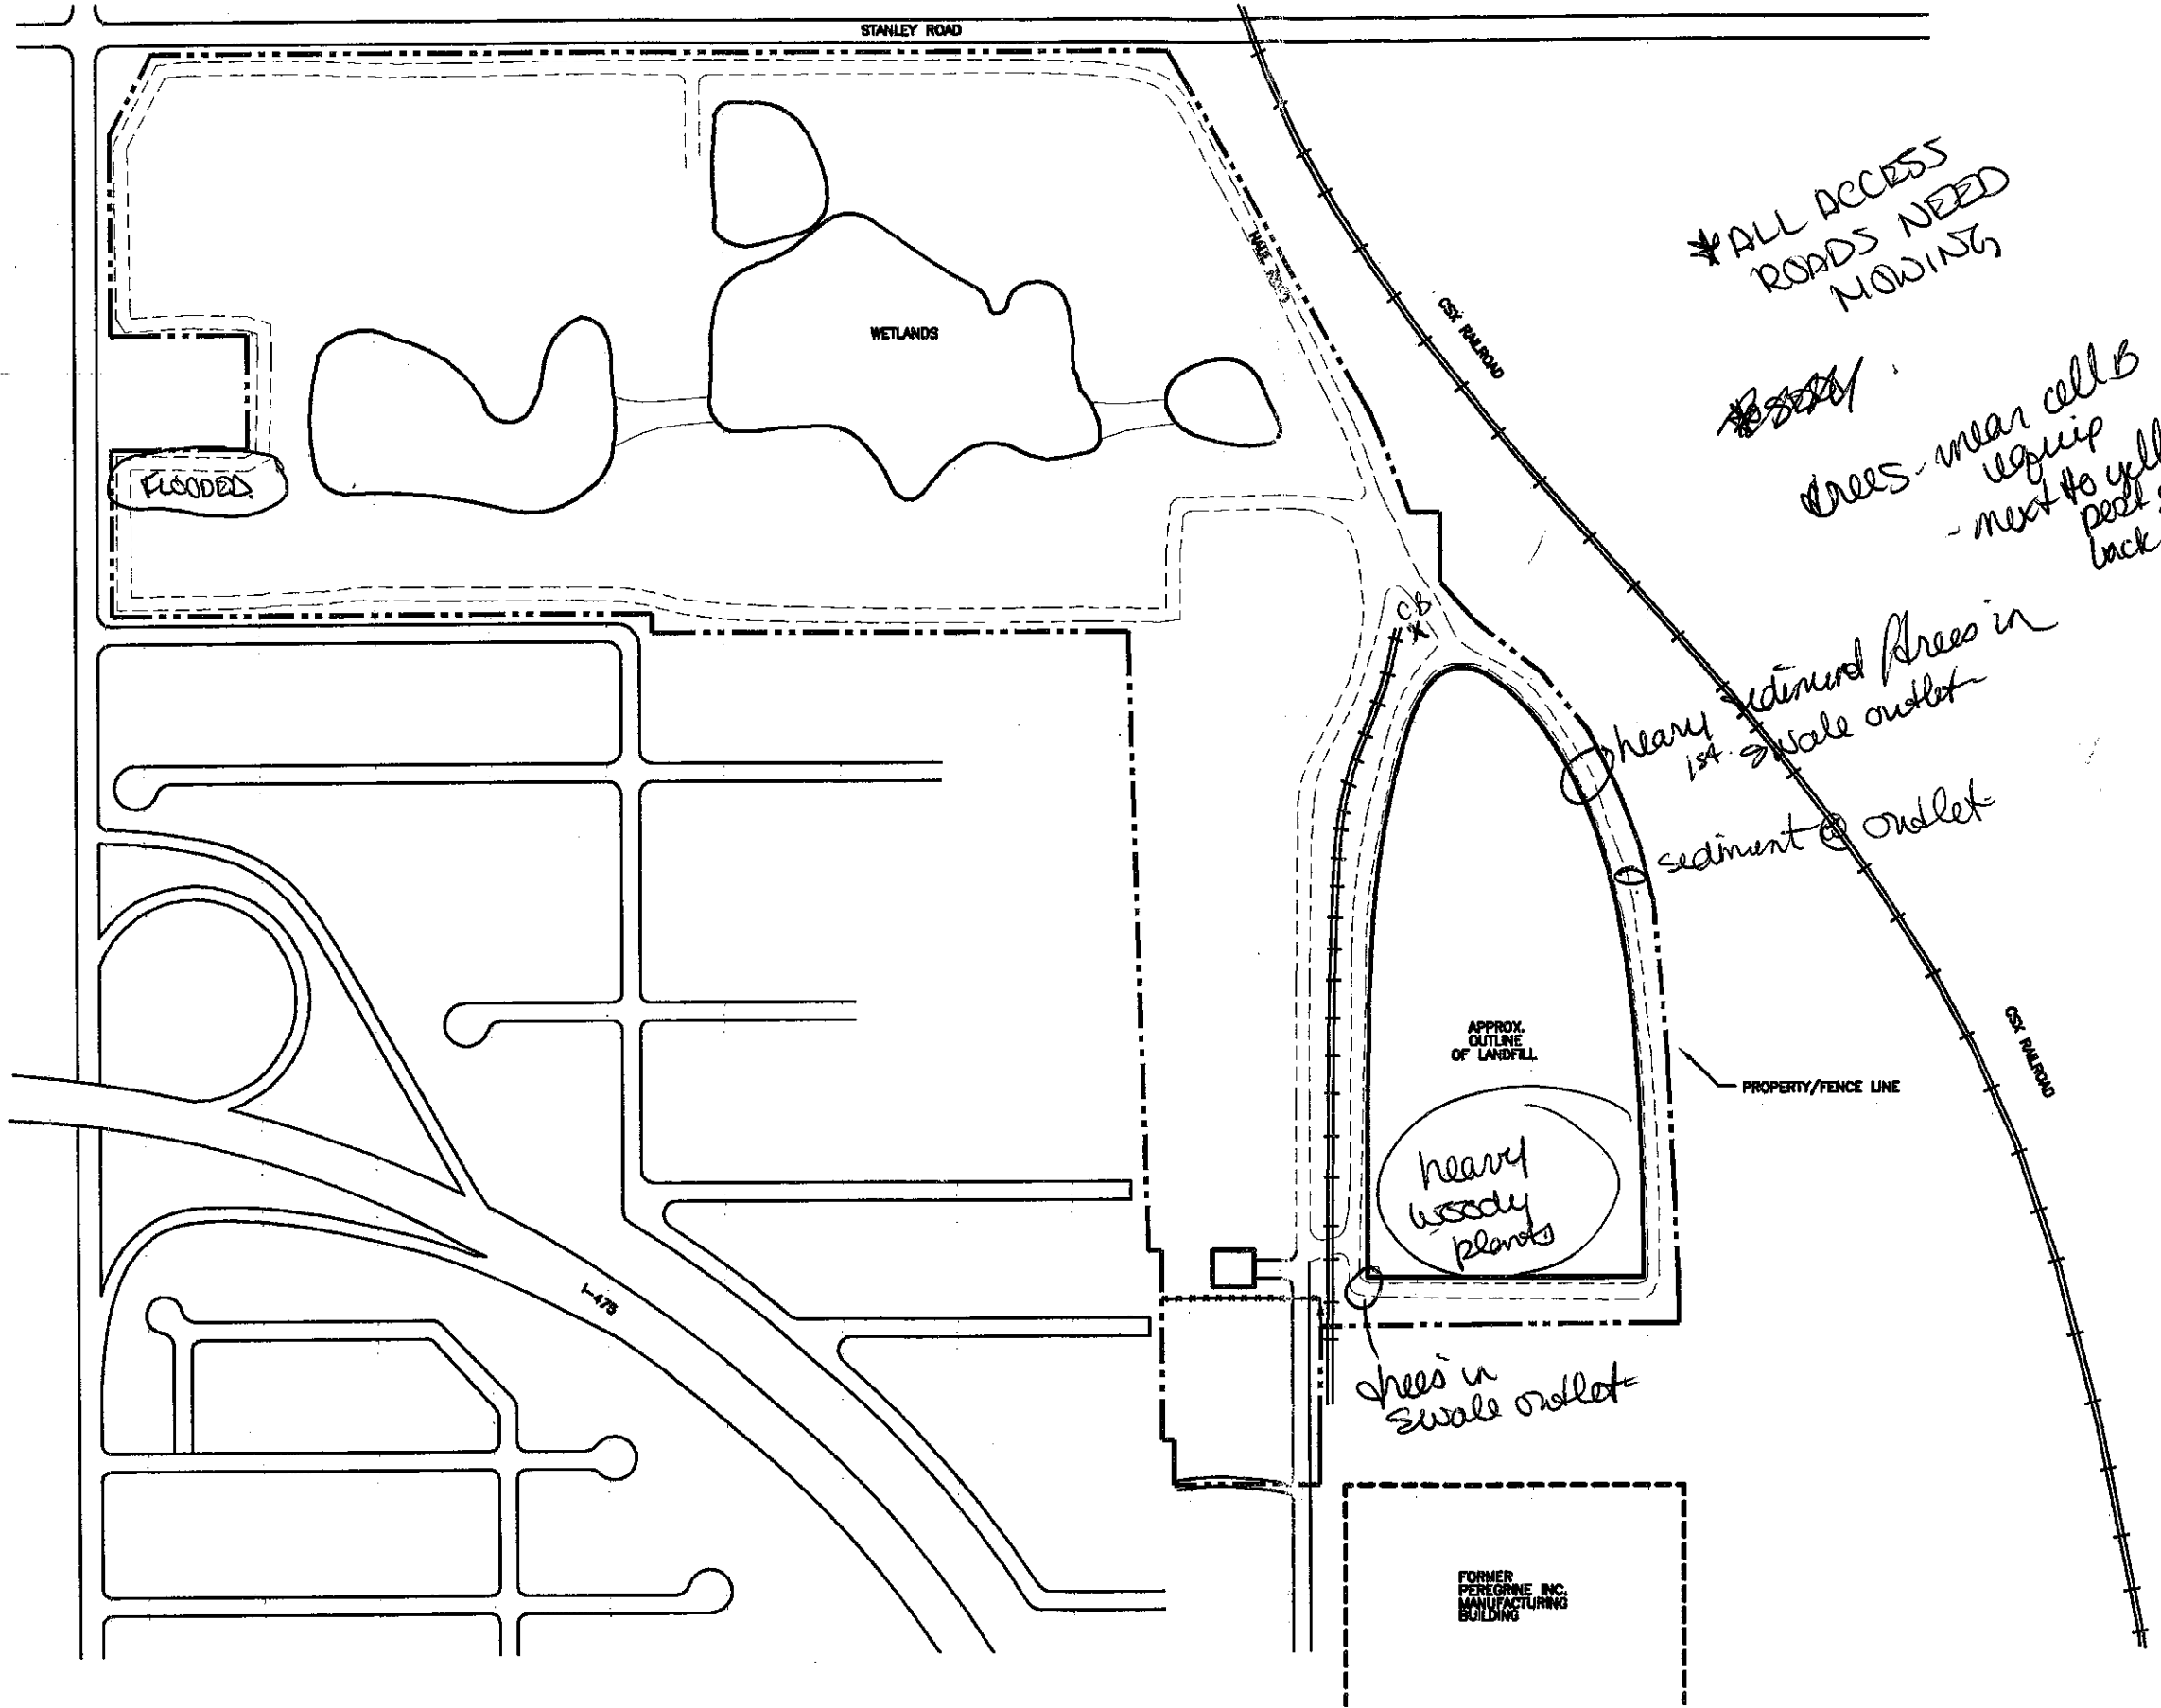
FIGURE 2

Cell	Areas with sparse vegetation present?	Deep-rooted plants present?	Areas around building and equipment mowed?	Access roads mowed and in good condition?
A	N	NO	N	N*
B	N	NO	N	N*
C	NO	NO	N	N*
D	NO	NO	N	N*
E	NO	YES*	N	N*
F	NO	YES*	N	N*
Berms	NO	3 drums mowed & removed.	N/A	N/A
		many woody plants approx 6-12"		* ACCESS ROADS NEED MOWING.

Area Inspected	Drainage problem or blockage observed?	Location (note on figure)	Description	Corrective Actions
Perimeter of landfill and berm				
Drainage trenches at base of landfill			<del>SOME TREES PRESENT AT VARIOUS AREAS</del>	
RMA				
Wetlands area	YES	NW C.B.	FLOODED AREA	PENDING CHANGE ORDER SUBMITTED GM.
Culverts around landfill				
Western drainage swale				
North landfill catch basin	Y	in railroad area,		*will place rocks around area to reduce erosion

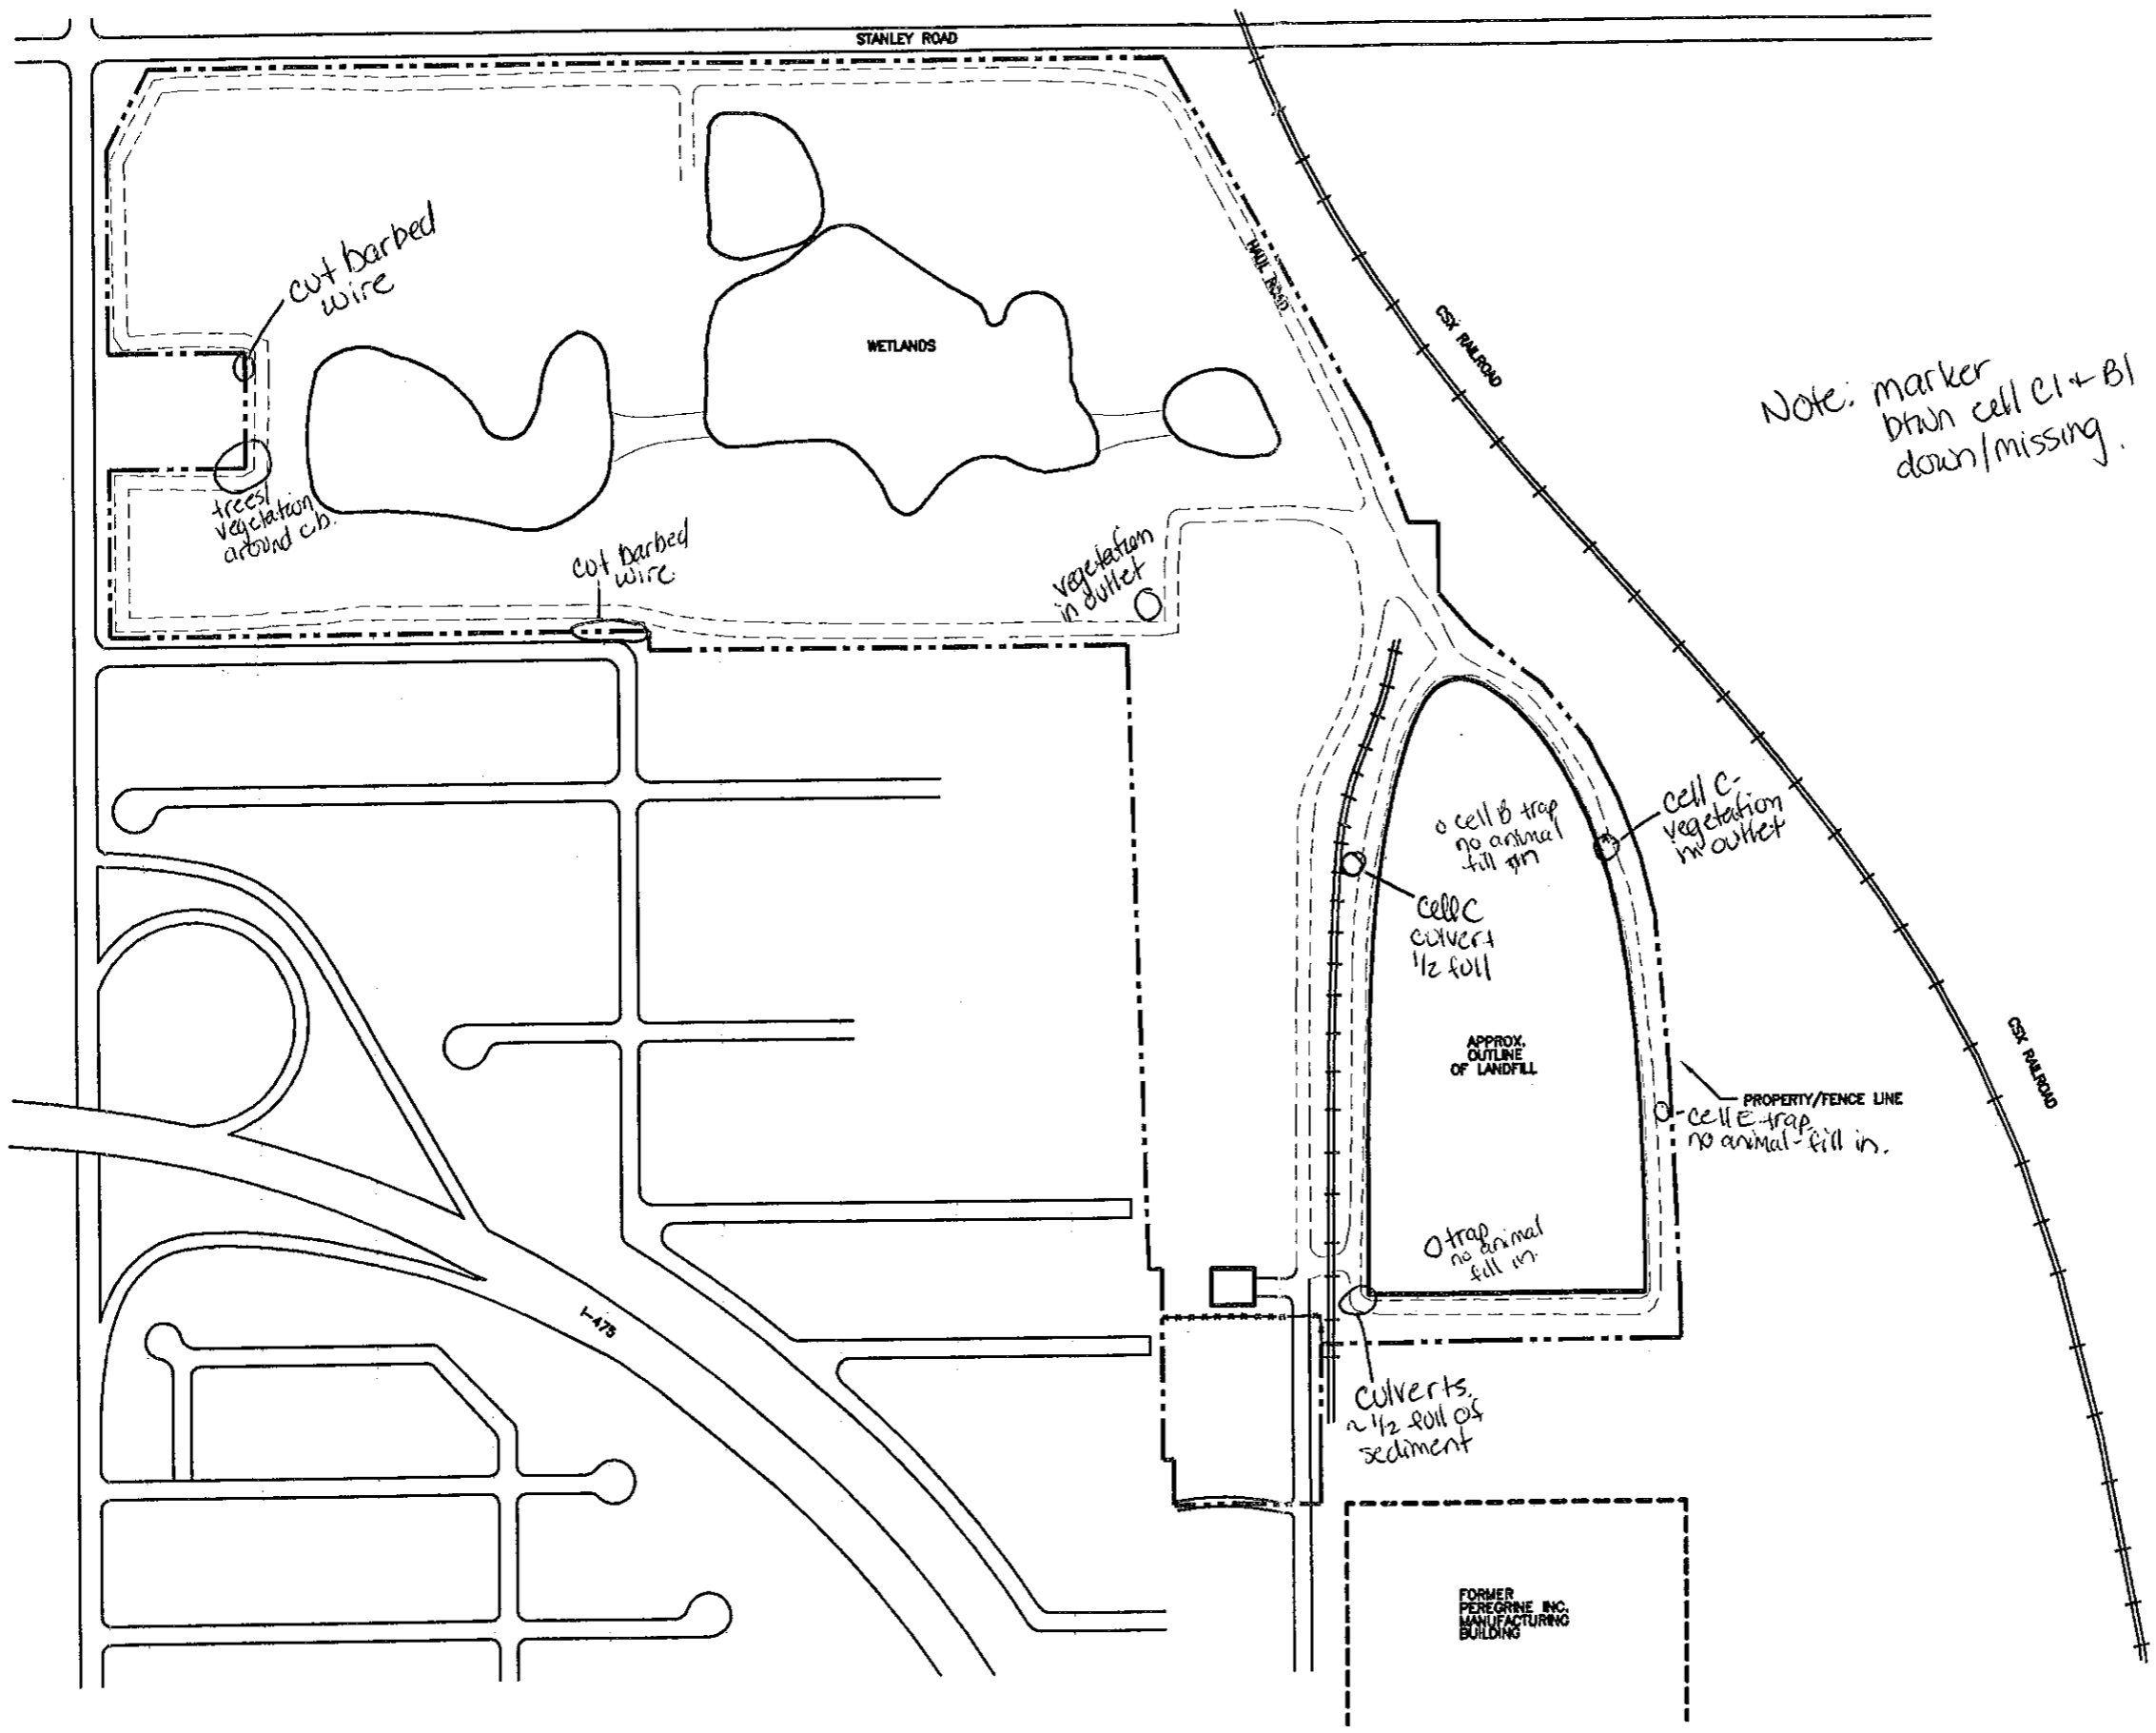
FIGURE 2

Area of Inspection	Animal Burrows?	Soil Erosion	Slope Failures?	Ponding?	Washouts?	Liner damage or exposure?	If yes to any, describe issue, location, and actions taken
Cell A	no	no	no	no	no	no	
Cell B	yes	no	no	no	no	no	trap set - no animal caught
Cell C	no	no	no	no	no	no	
Cell D	no	no	no	no	no	no	
Cell E	no	no	no	no	no	no	
Cell F	yes	no	no	no	no	no	trap set - no animal caught.
Berms	no	no	no	no	no	no

Area	Any damage present?	Signs of unauthorized entry?	Broken or damaged locks on gates?	"Tresspassing Prohibited" and "Private Property" Signs Posted?
Fences along north property line	no	no	no	yes
Fences along south property line	yes - cut barbed wire	no	no	yes
Fences along west property line	yes - cut barbed <del>wire</del> wire	no	no	yes
Fences along east property line	no	no	no	yes
Roads located approx. west of wetlands				
Roads located approx. east of wetlands

Area Inspected	Drainage problem or blockage observed?	Location (note on figure)	Description	Corrective Actions
Perimeter of landfill and berm	no			
Drainage trenches at base of landfill	<del>yes</del> <sup>ms</sup> no	<del>cells C&amp;F as noted</del> <sup>ms</sup>	<del>culverts 1/2ms full of sediment.</del>	
RMA	no			
Wetlands area	no			
Culverts around landfill	yes	cells C&F as noted	culverts 1/2 soil of sediment	
Western drainage swale	no			
North landfill catch basin	No blockage, but trees around C.B. should be cut down.	adj. to fence
