# RACER TRUST LANSING PLANTS 2, 3, & 6

4Q 2020 Quarterly Progress Report | January 15, 2021

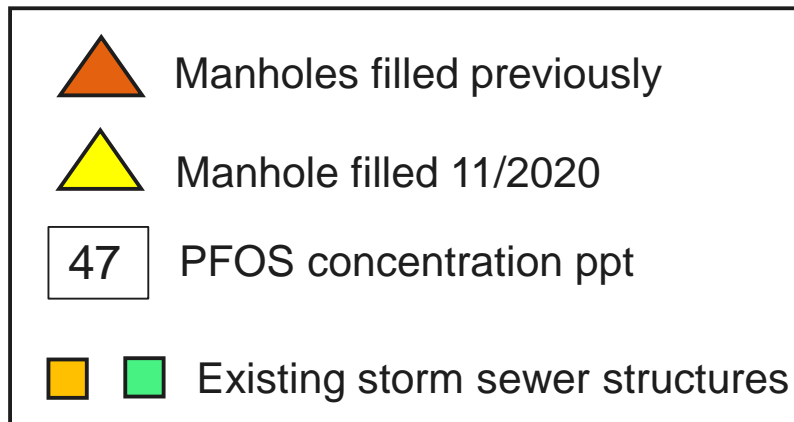
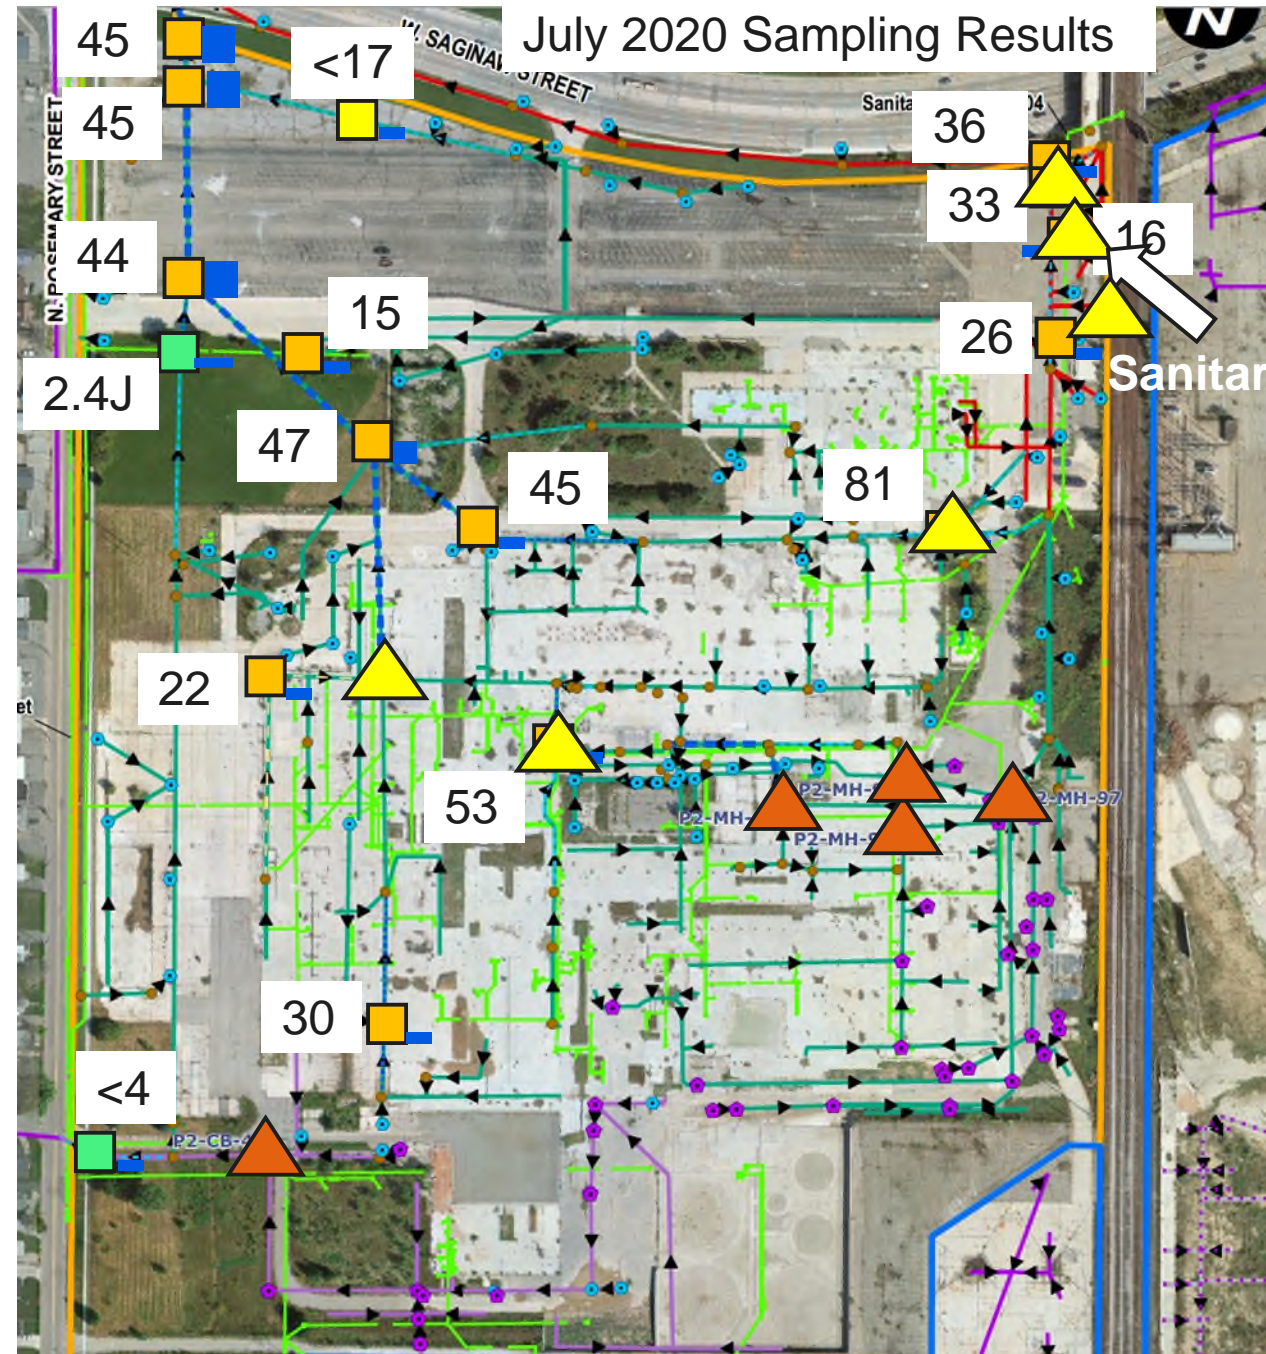
## Plant 2 Sewer Modifications

- Filled manholes with concrete to mitigate movement of PFOS impacts to discharge offsite
  - 5 storm sewer manholes filled
  - 1 sanitary sewer manhole filled
- Also capped 22 catch basins to minimize stormwater infiltration into plugged pipes
- Structures resampled in December 2020. Results will be presented in separate report during Q1 2021

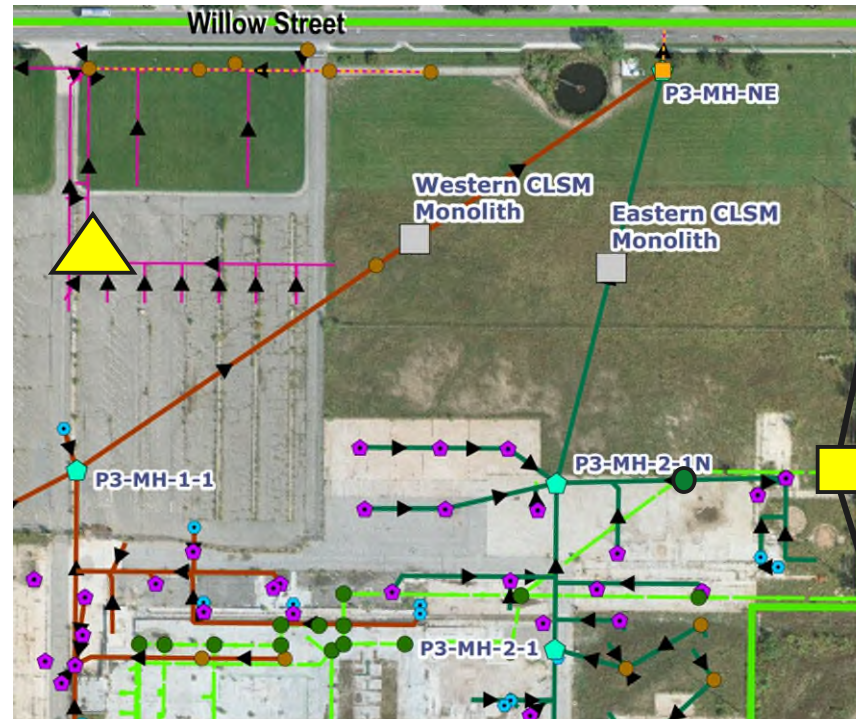
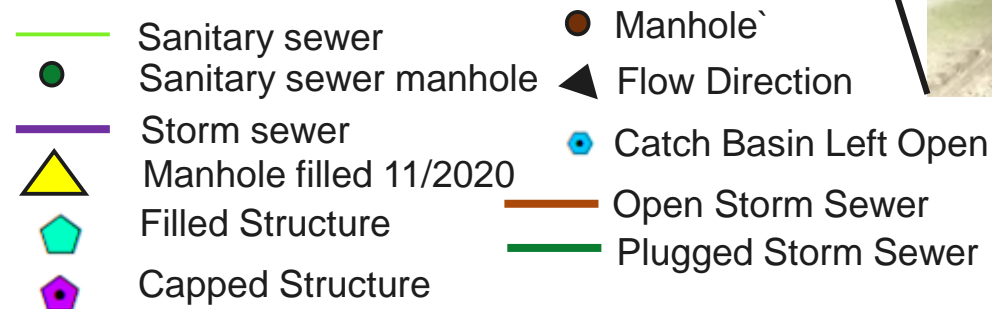
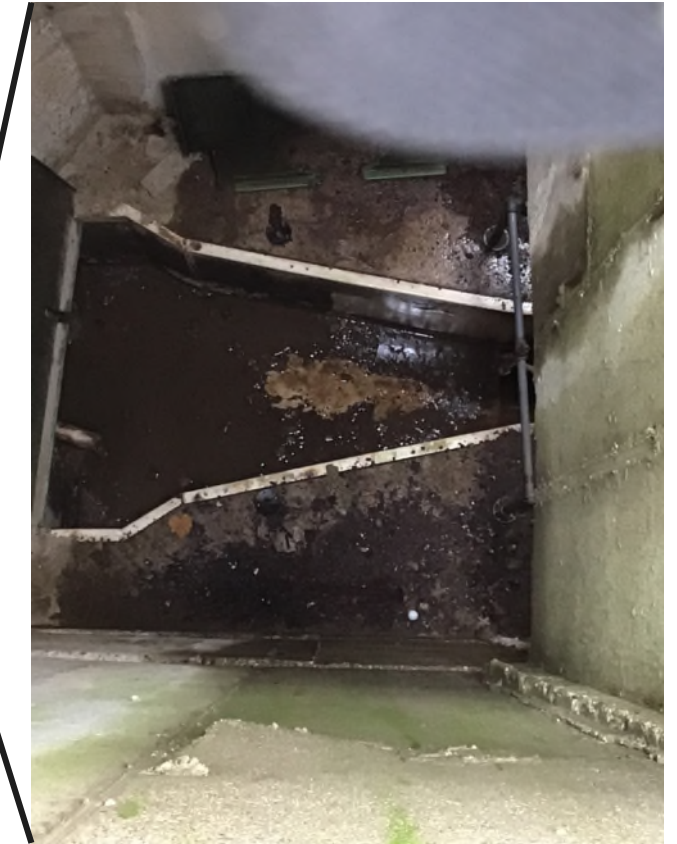
## Plant 3 Sewer Modifications

- Worked completed in November 2020.
- Filled one manhole in NW parking lot and capped associated catch basins
- Bulkheaded pipe entering sanitary vault, along east side of Plant 3, to mitigate potential for offsite discharge
- All structures resampled for PFAS in December 2020. Results will be presented in separate report during Q1 2021

Sanitary sewer outfall

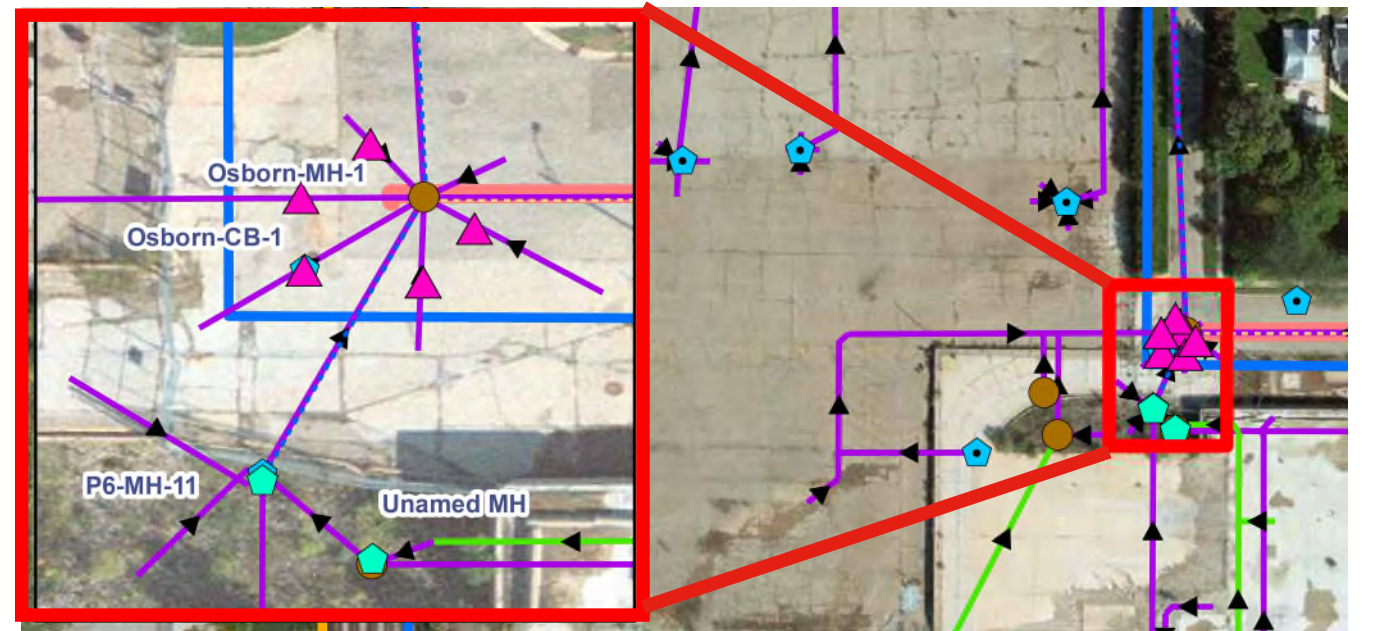
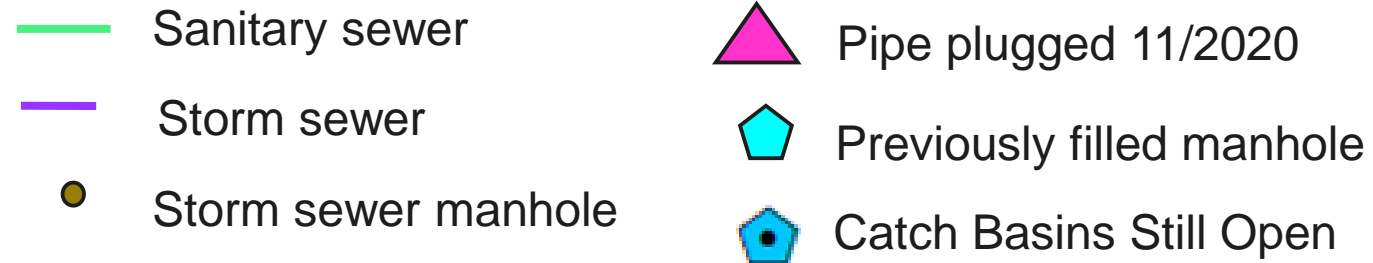
## Plant 6 Sewer Modifications

- Work completed in November 2020
- Plugged small diameter pipes entering the Osborne St. manhole from the site
- Maintained flow in sewer pipe along Stanley St. and Osborne St.

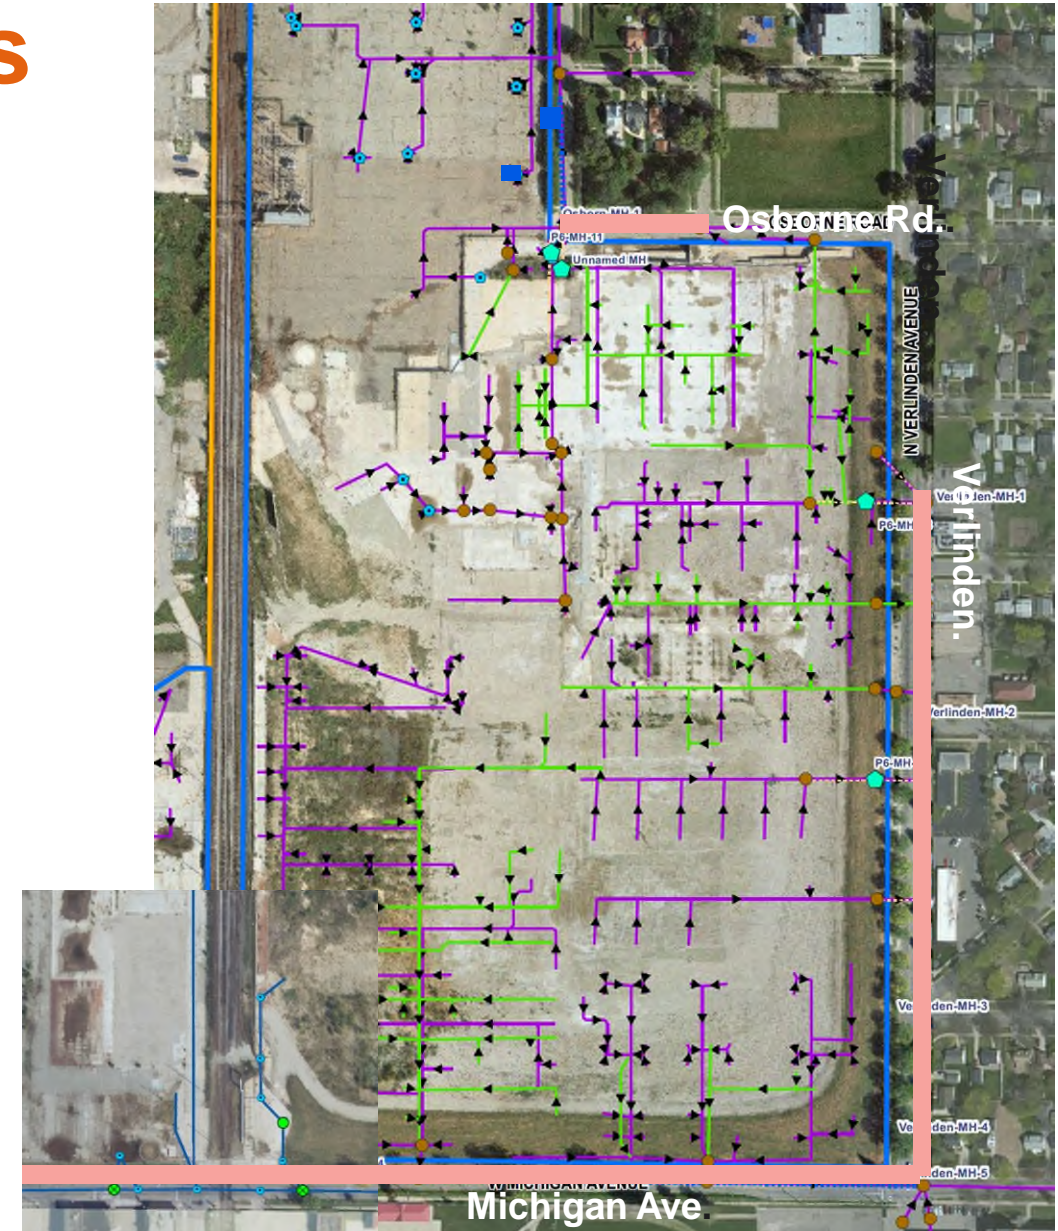
## Plant 6 Activities Cont.

- Closed Circuit Television (CCTV) inspection of sewer along Verlinden, Michigan and Osborne completed in December 2020.
- Structures resampled in December 2020. Results will be presented in separate report during Q1 2021
- Propose next steps based on CCTV results and resampling of manholes – first quarter 2021

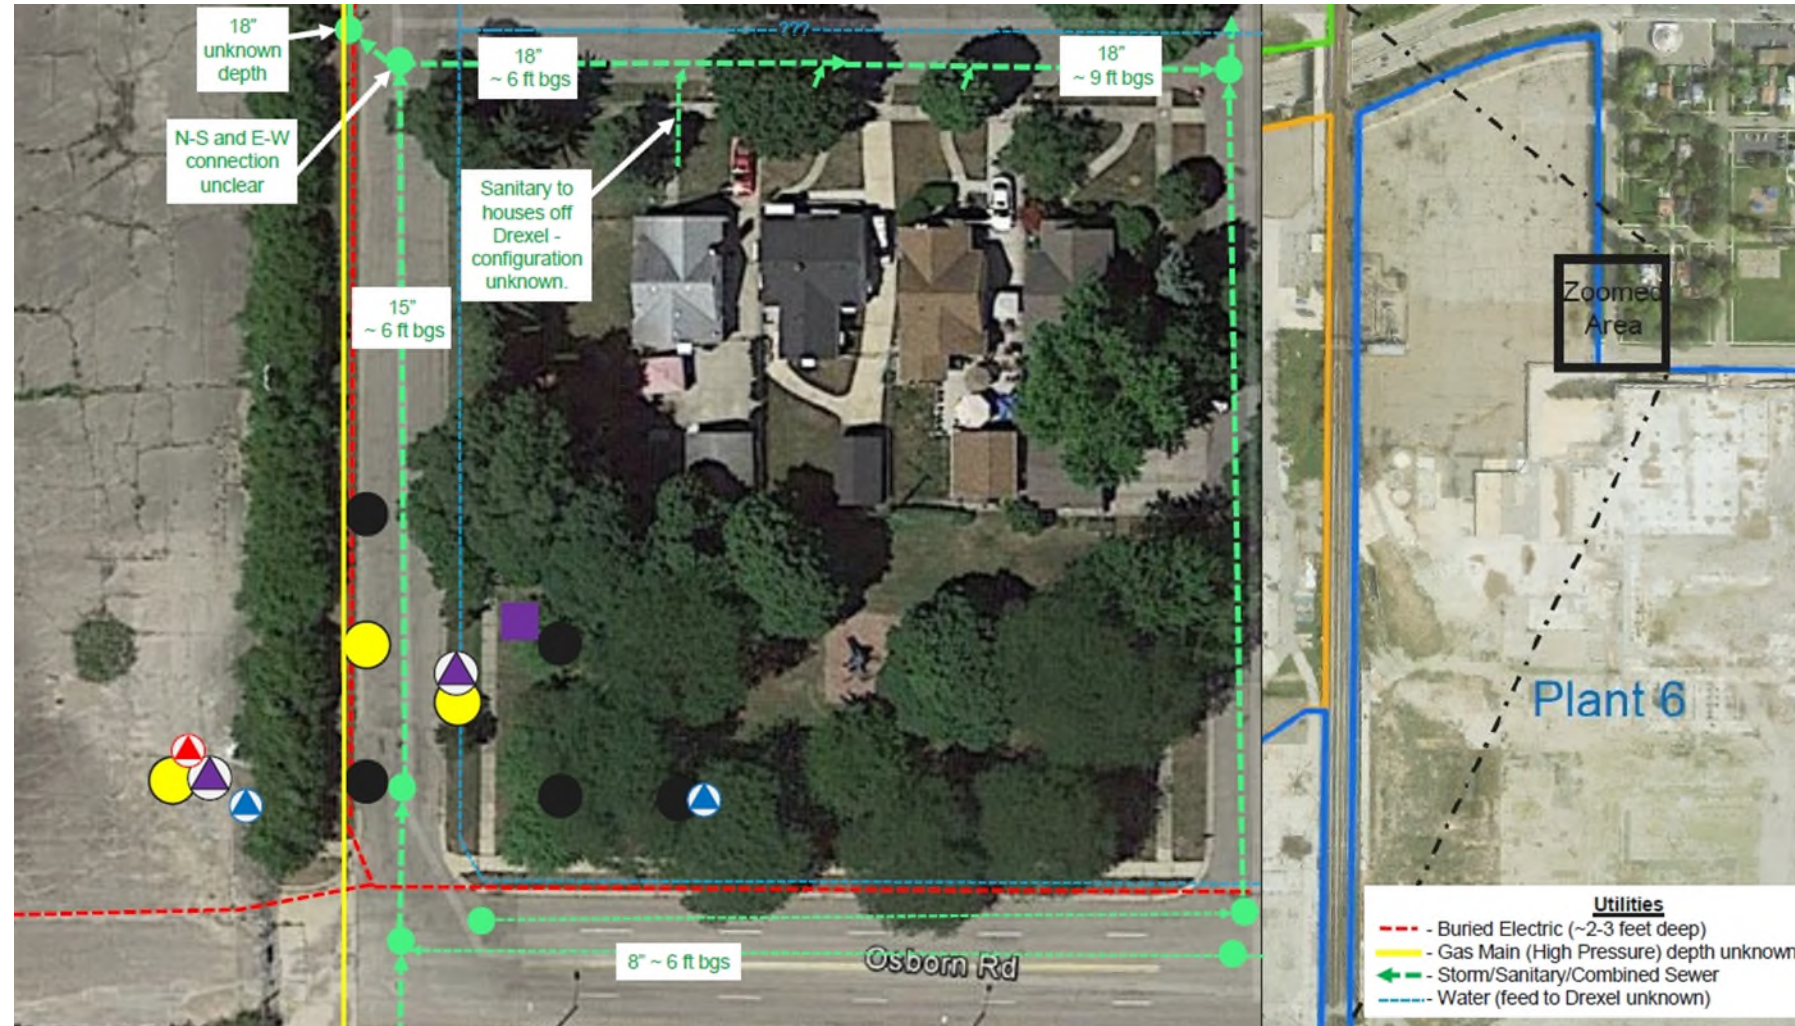
## Plant 6 VI Update

Additional monitoring wells and SVMP installed November 2020

- Saturated sand encountered at SVMP location at 7' – one SVMP installed, groundwater sample collected from sand seam
- Results will be presented in separate report during Q1 2021
