Re: Ley Creek PCB Dredgings Site
June 2007 OM&M Inspection

LEY CREEK PCB DREDGINGS SITE
SYRACUSE, NEW YORK
SITE REMEDIATION PROJECT

JUNE 2007
OM&M INSPECTION
PARTIAL SITE PLAN

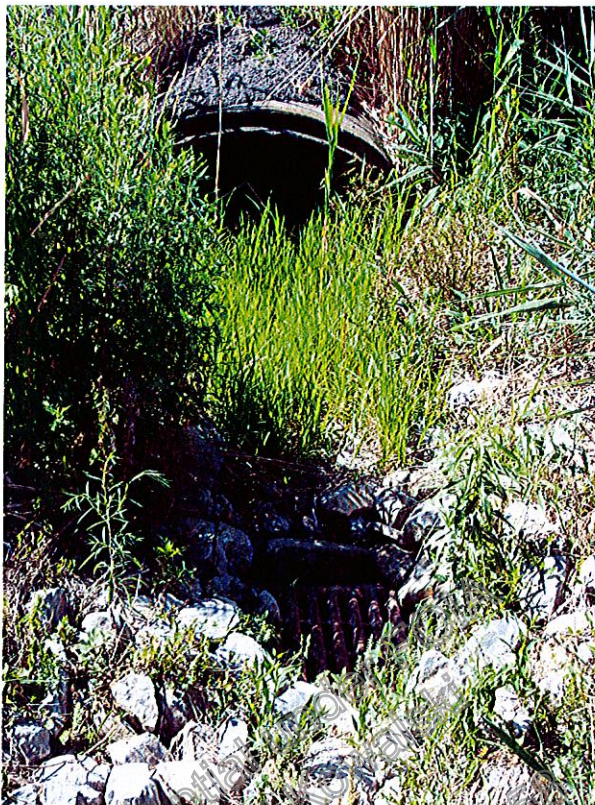
Photograph 1: View of CB-5/Outfall 004 spillway.

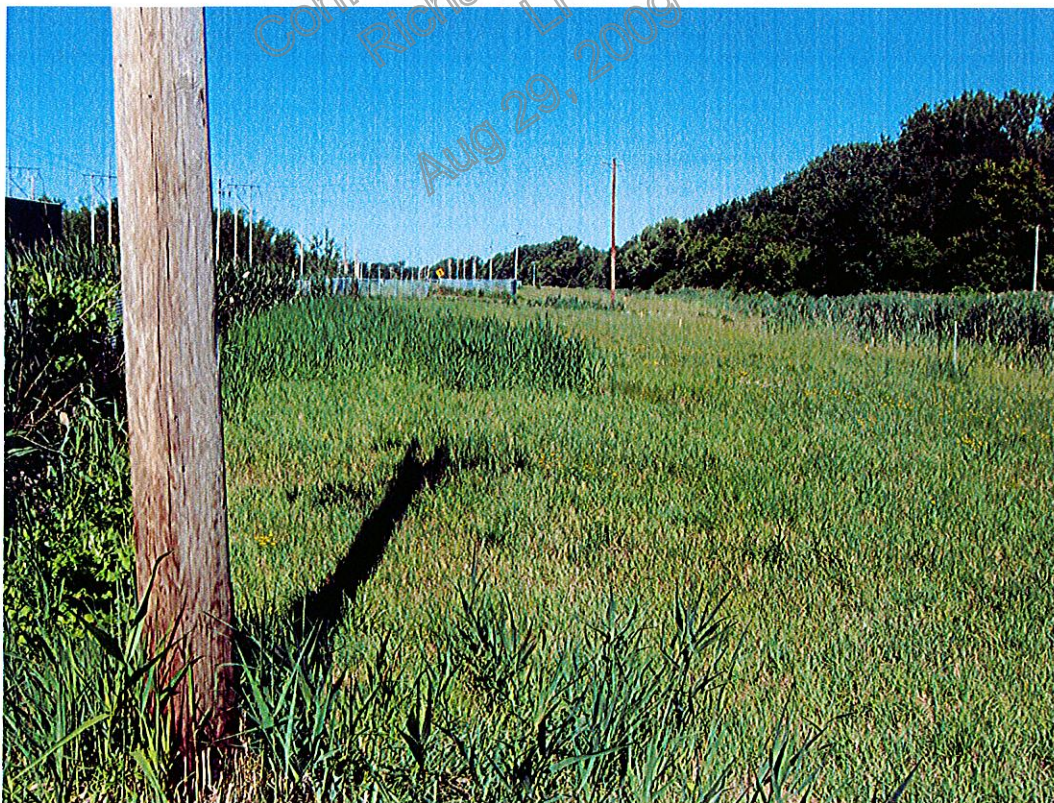
Photograph 2: View looking west from CB-5/Outfall 004 outlet.

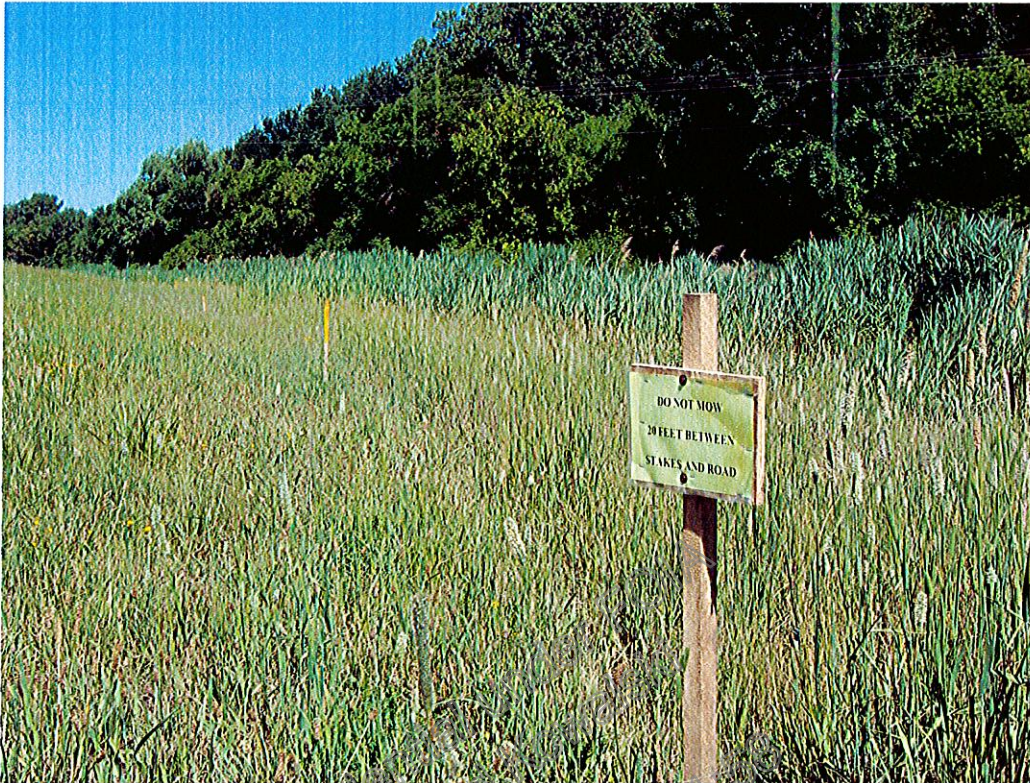
Photograph 3: View looking west from eastern stone access drive.

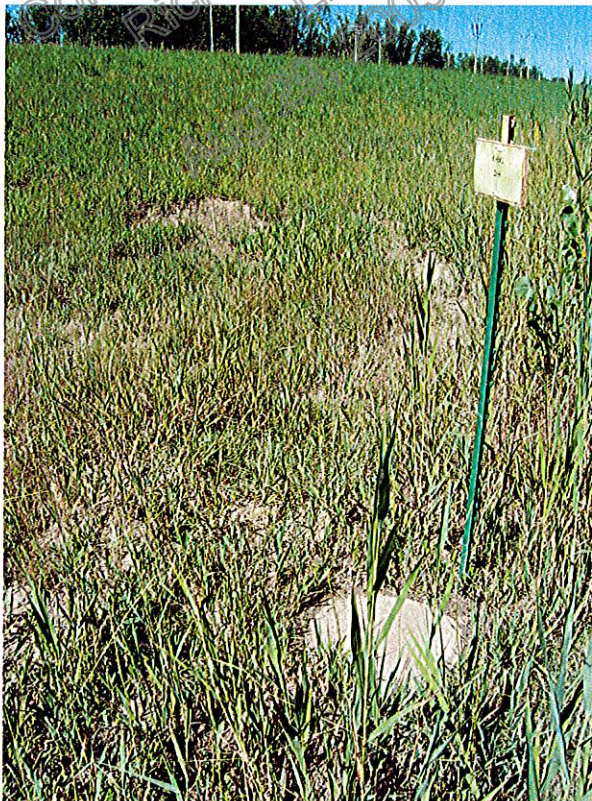
Establishment of vegetation in the areas that were repaired in the 2006 construction season to address erosion (Figures 3 and 4 and Photograph 4) has improved, but requires additional monitoring until fully established.

Photograph 4: View of area near OBG-26S, which was re-seeded in Fall of 2006.

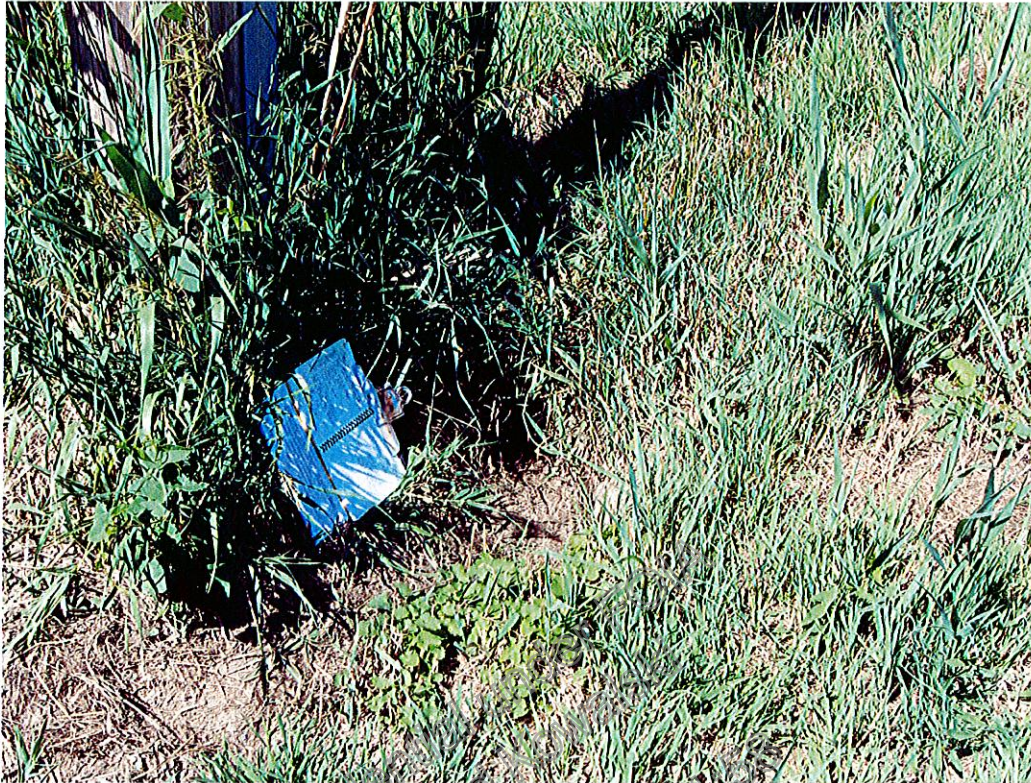
Photograph 5: Burrowing animal hole along fenceline southeast of OBG-21D.

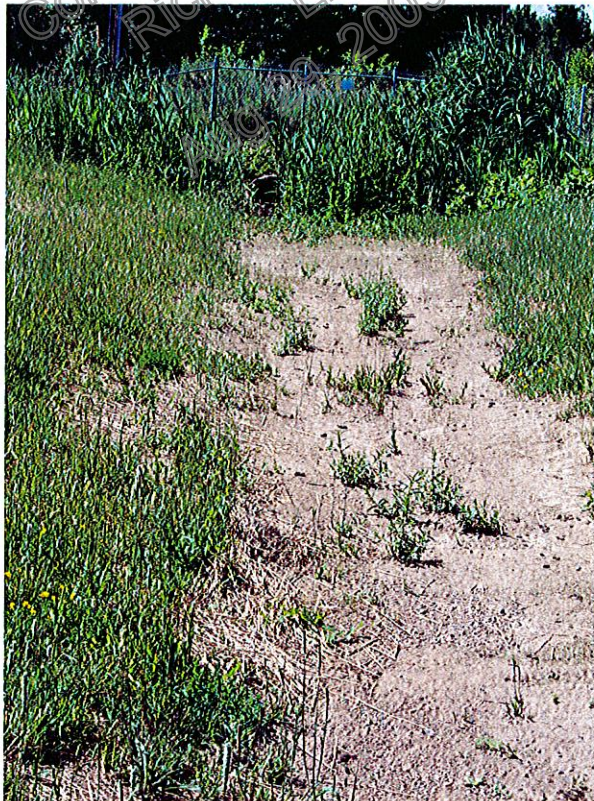
Photograph 6: Newly placed topsoil in CB-3 overflow spillway without vegetation establishment.

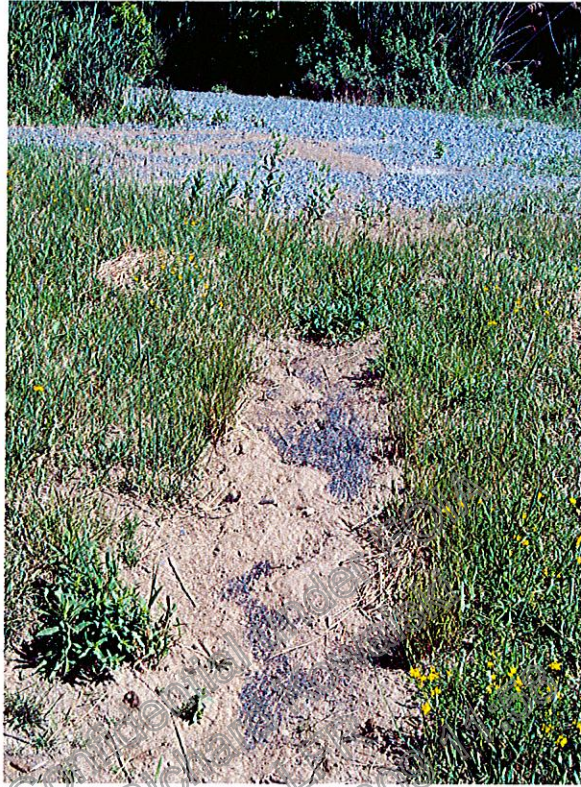
Photograph 7: View of eroded topsoil with visible erosion control fabric.

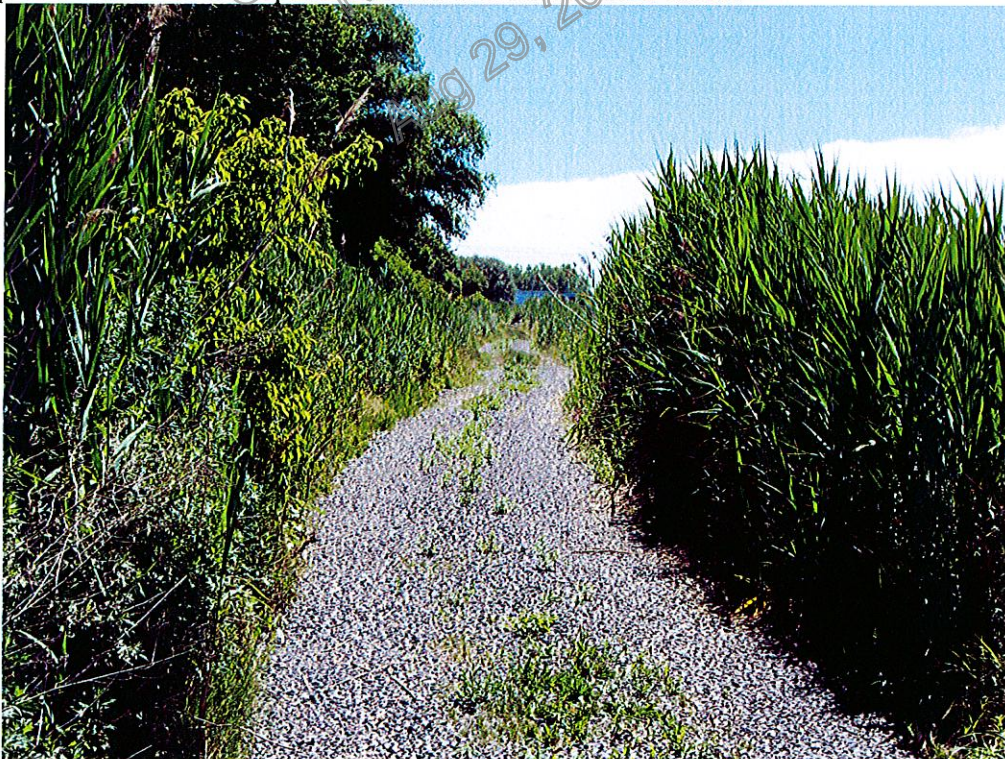
Photograph 8: View looking east from CB-3 outlet at repaired access road.

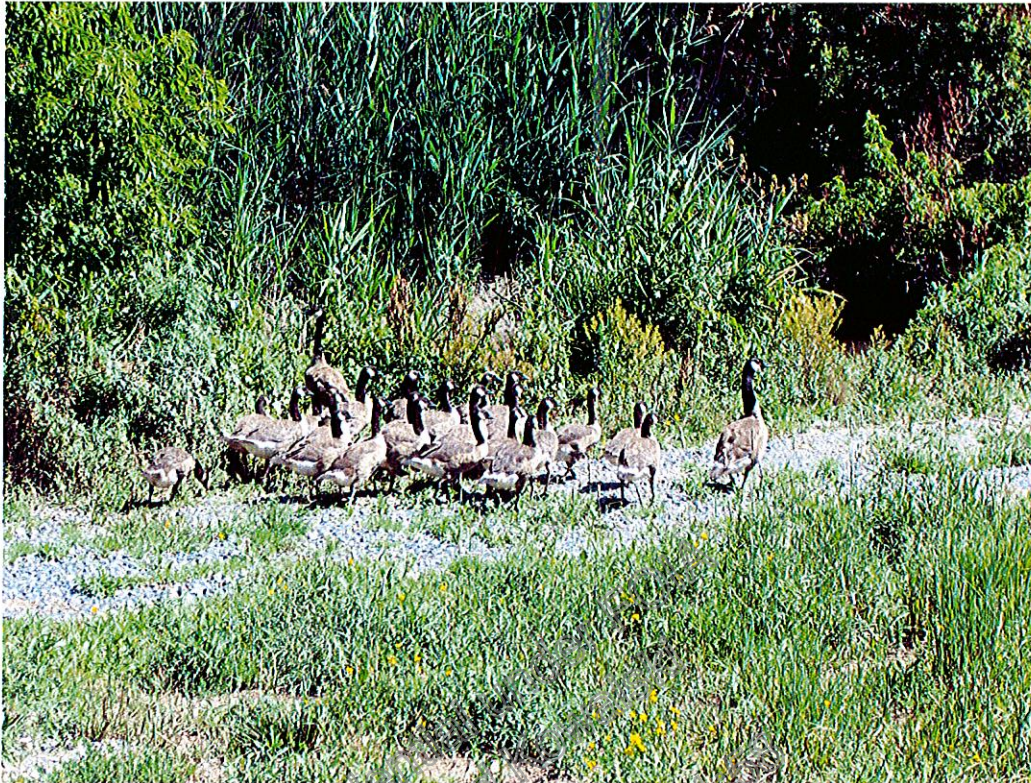
Photograph 9: View of Canada geese near CB-2 outlet.

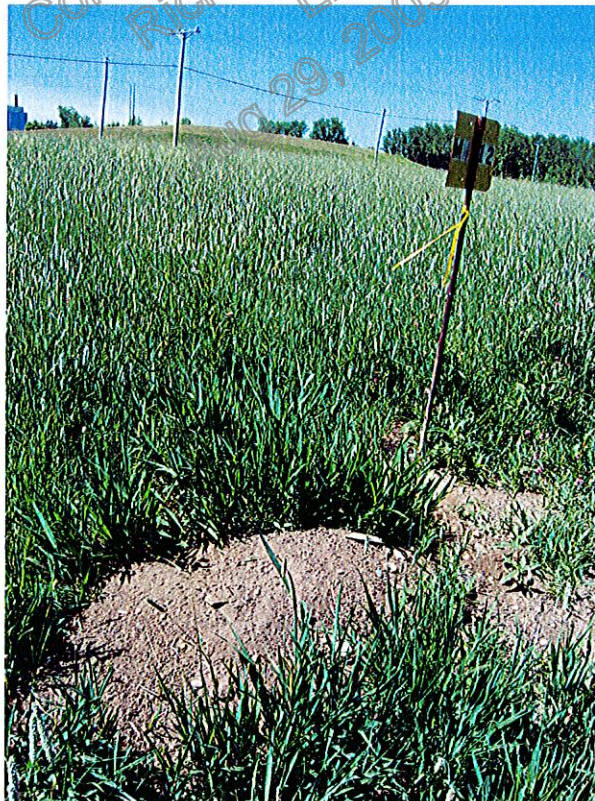
Photograph 10: View of burrowing animal hole near MW-12.

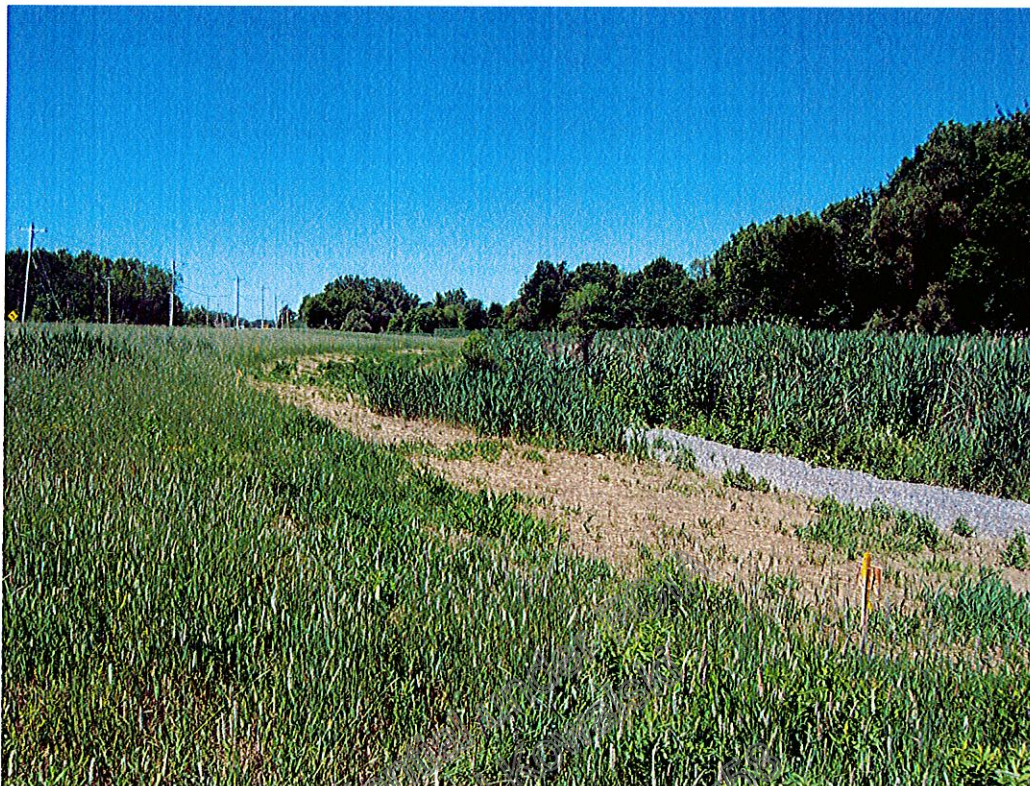
Photograph 11: View looking west from eastern extent of re-seeded wetland area.

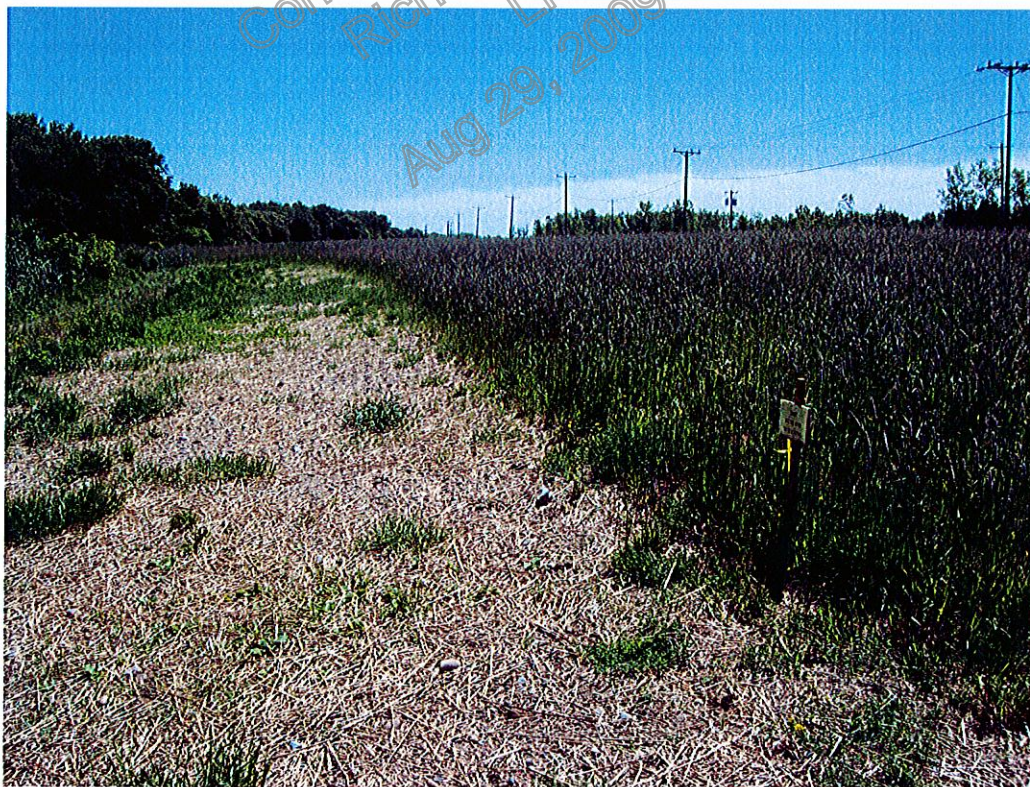
Photograph 12: View looking east from western extent of re-seeded wetland area.

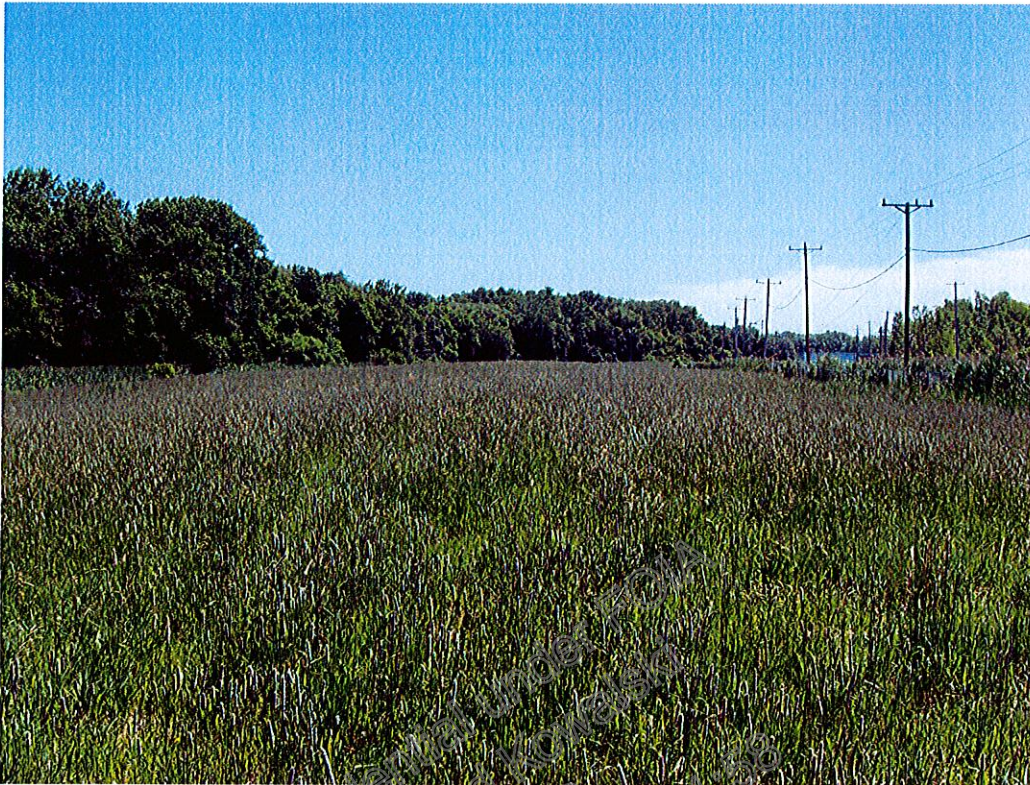
Photograph 13: View looking east from CB-1

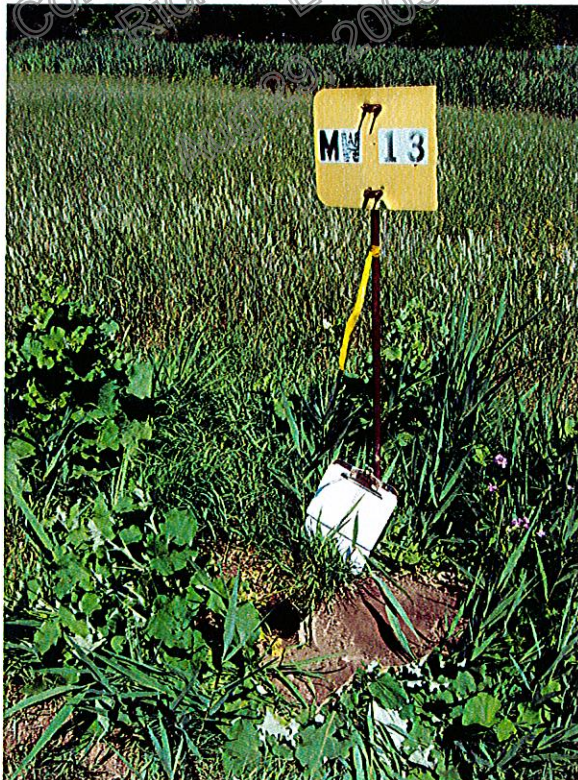
Photograph 14: View looking at burrowing animal hole at MW-13.

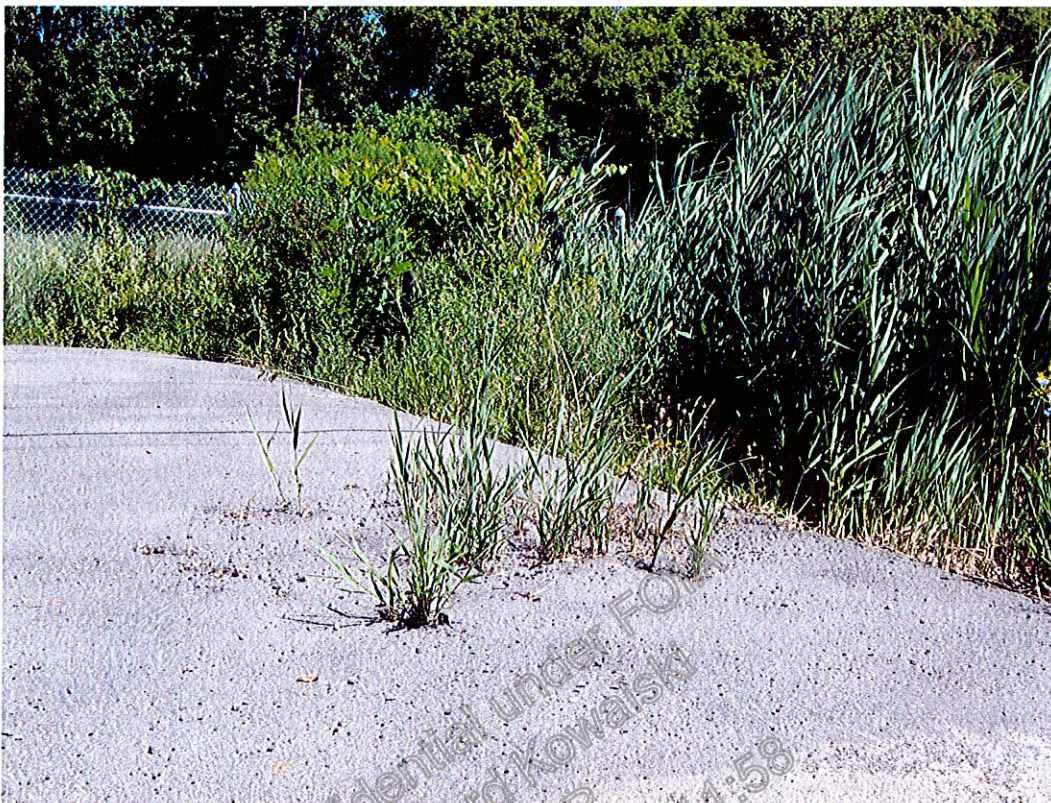
Photograph 15: View of phragmites in pavement access drive
