## MEMORANDUM

TO: Peter Ramanauskas/EPA  
FROM: Thomas Kinney/MC/ds/26/Det.  
CC: Dave Favero/RACER  
RE: **Storm Sewer Bulkhead Completion**  
**PCC-Validation**  
**Pontiac, Michigan**

REF. NO.: 017322  
DATE: September 12, 2014

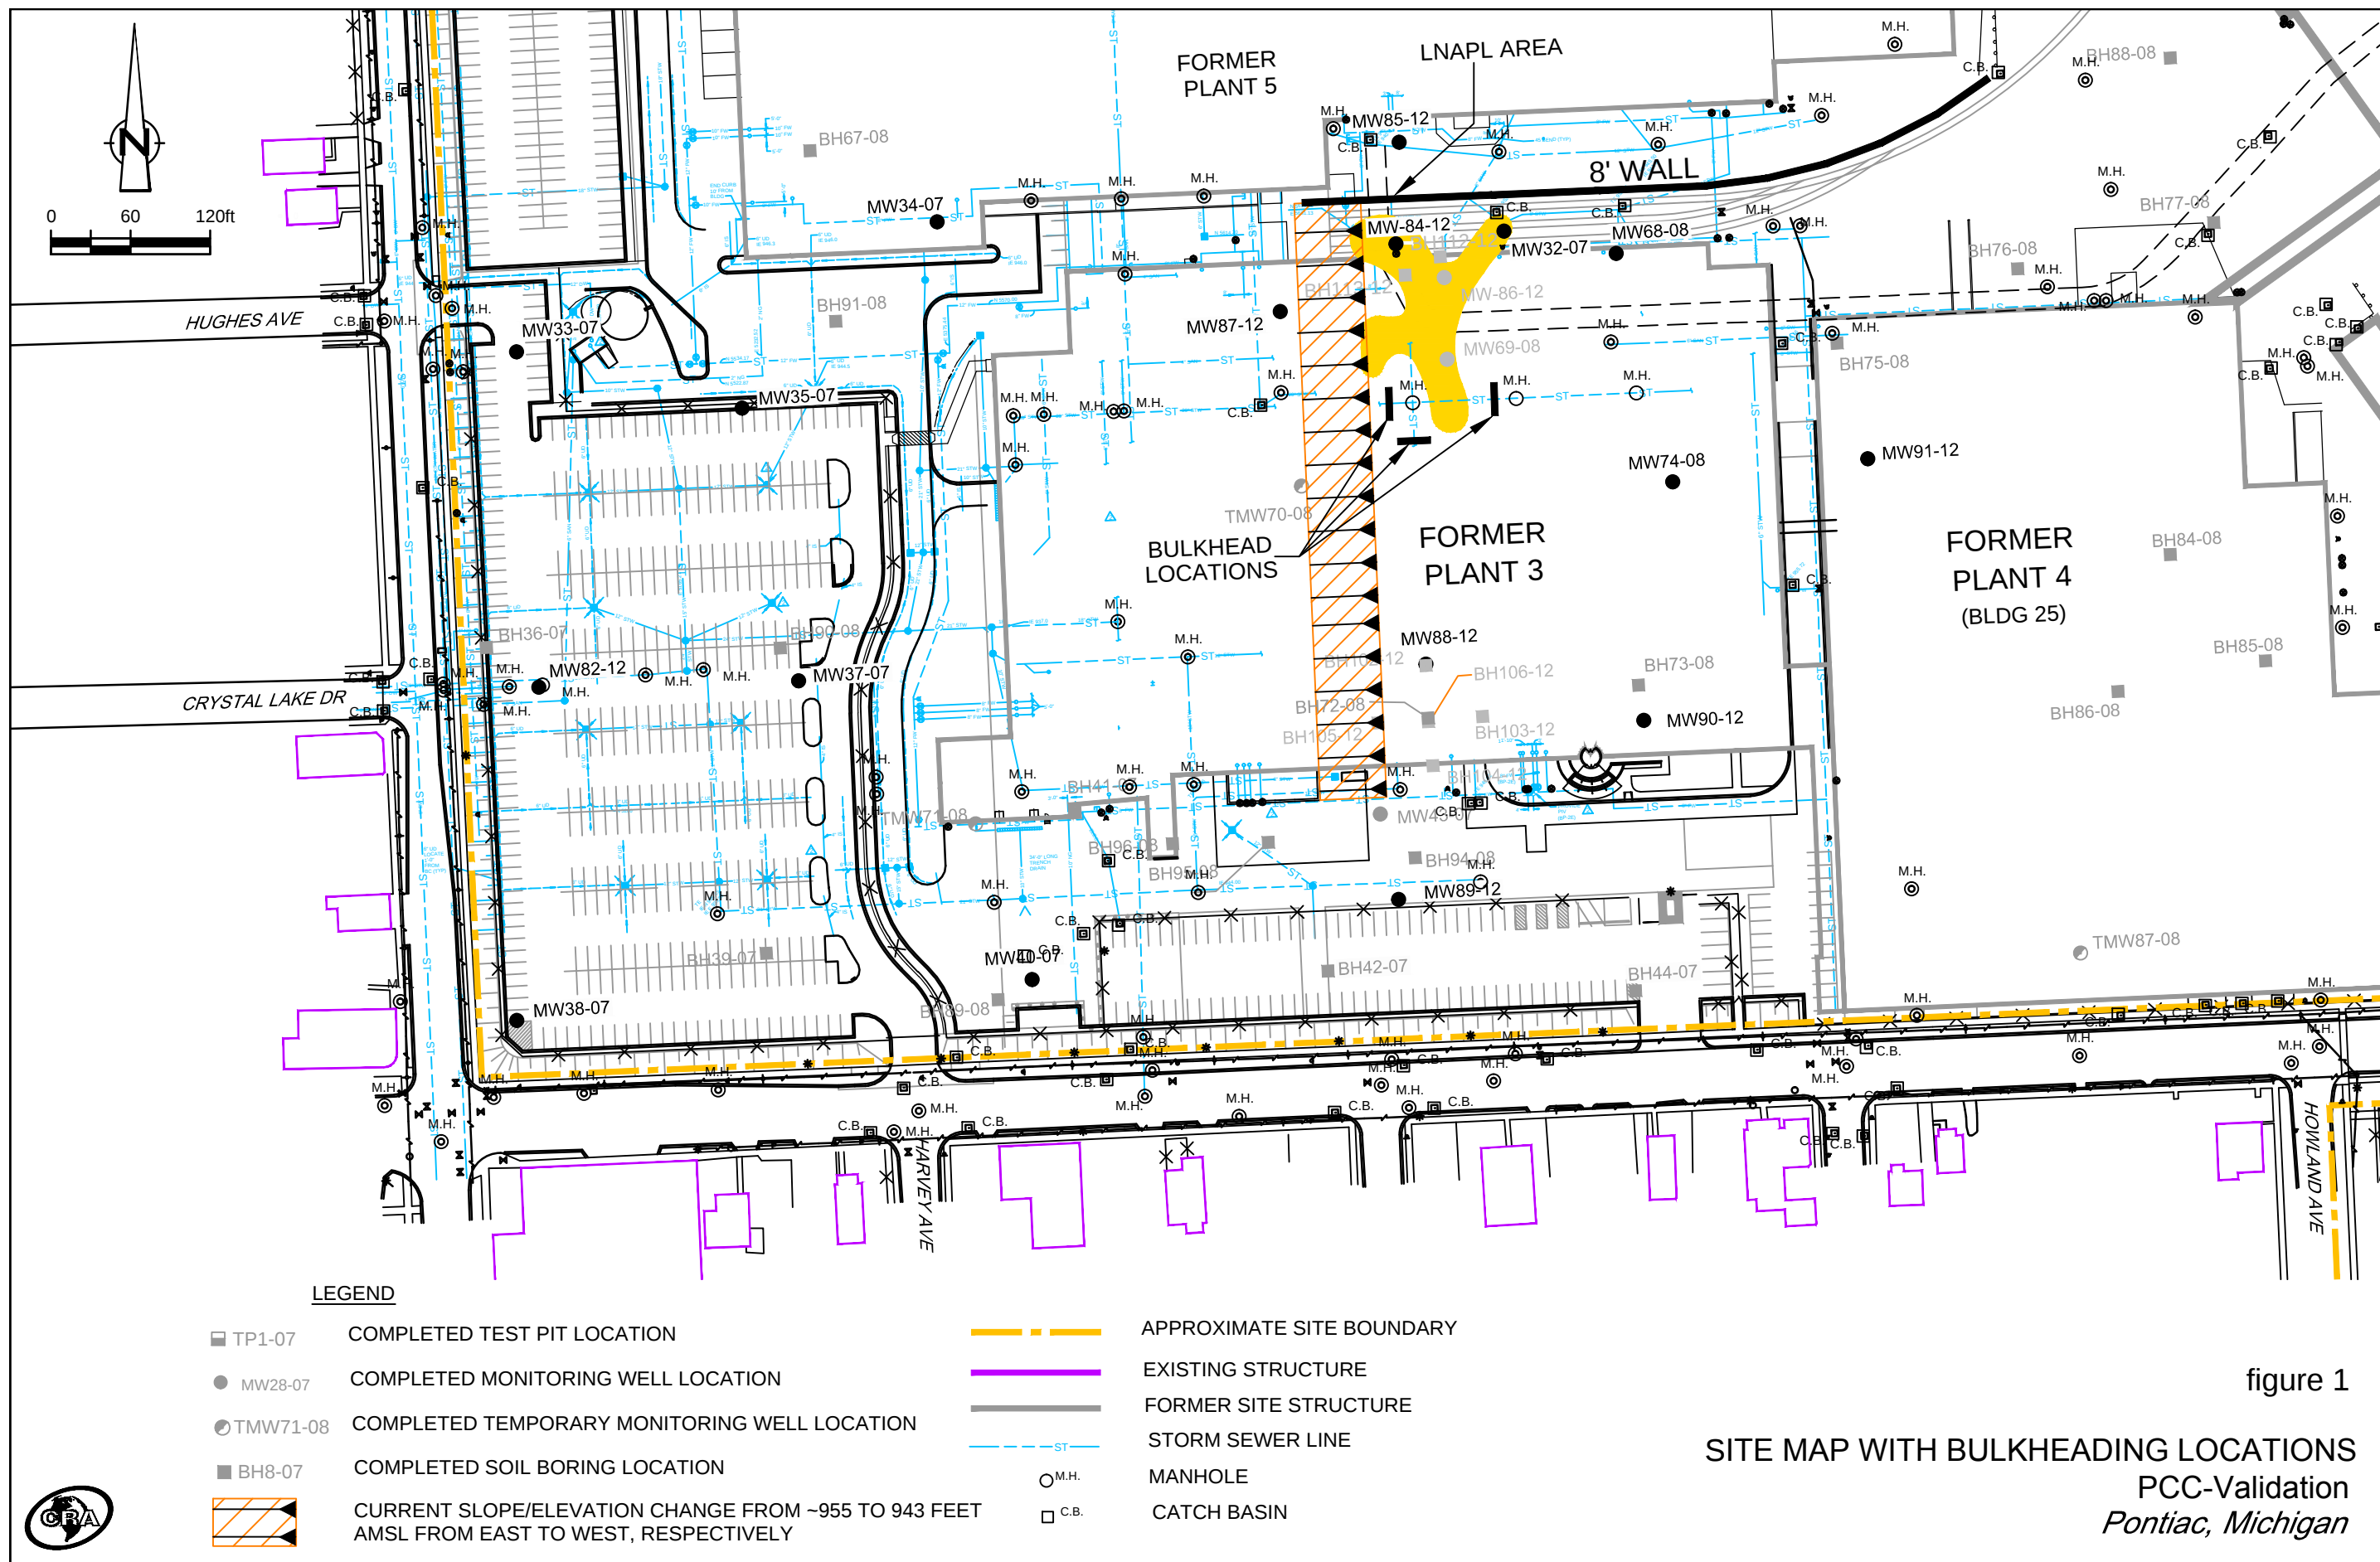
figure 1

SITE MAP WITH BULKHEADING LOCATIONS  
PCC-Validation  
Pontiac, Michigan

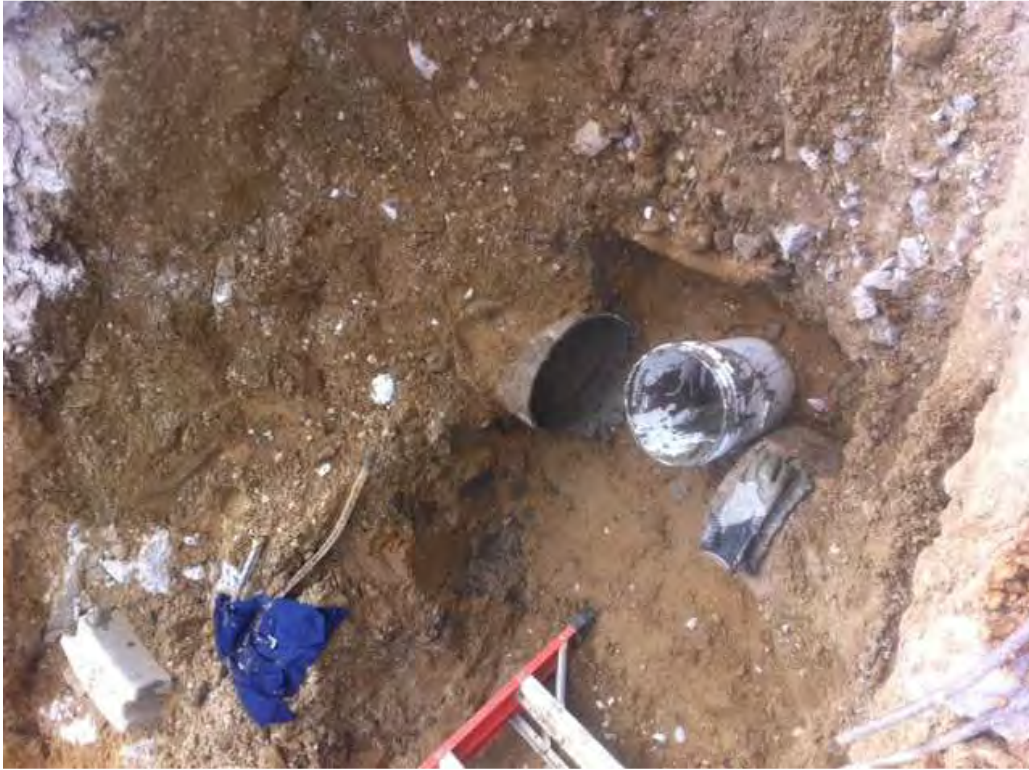
Photo 1: View of cut/separation of pipe at bulkhead location #1.

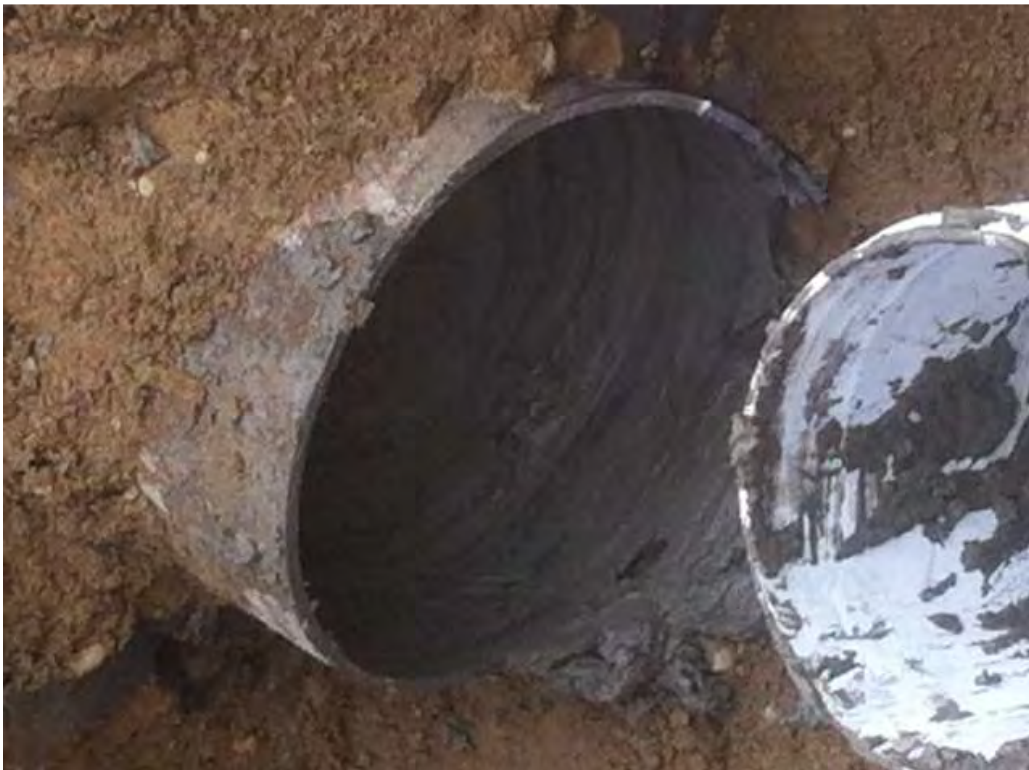
Photo 2: View cut and separated pipe and brick and cement in pipe of bulkhead location #1.

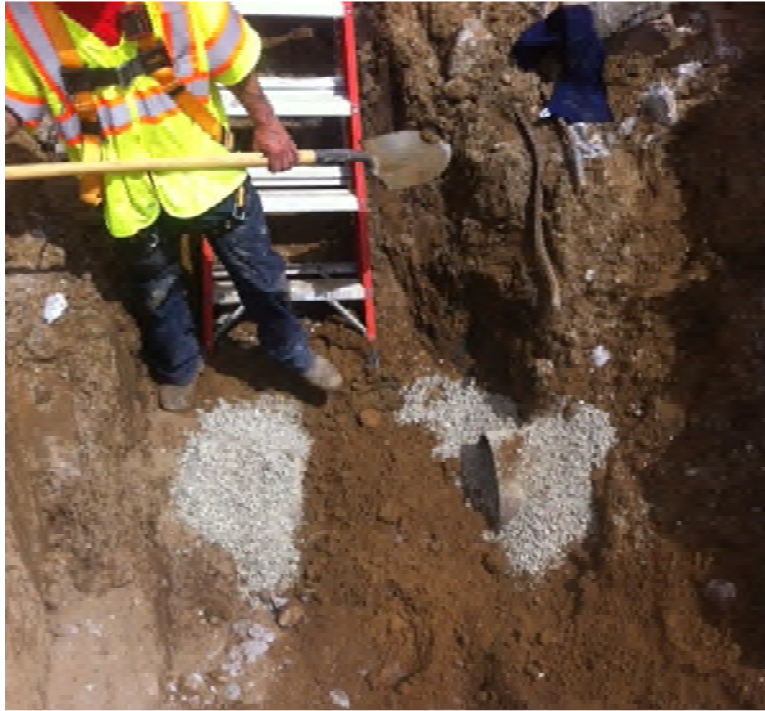
Photo 3: View of bentonite collar at bulkhead location #1.

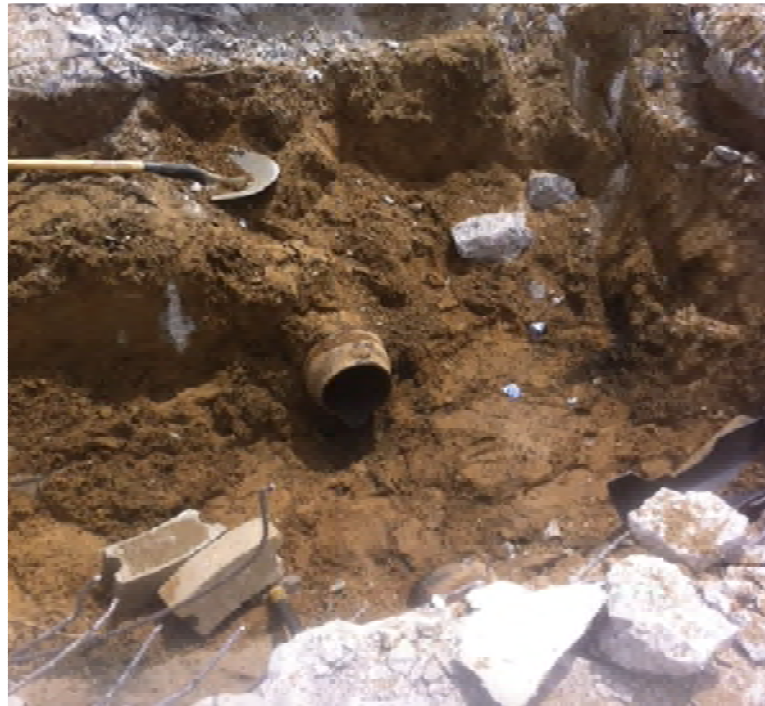
Photo 4: View of cut/separation of pipe at bulkhead location #2.

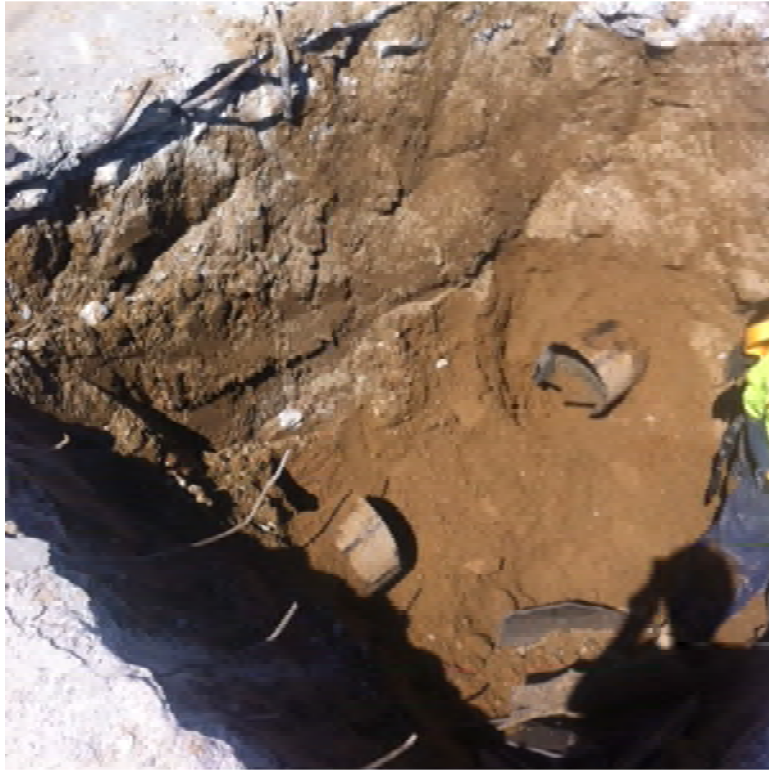
Photo 5: View of cut/separation of pipe at bulkhead location #3.

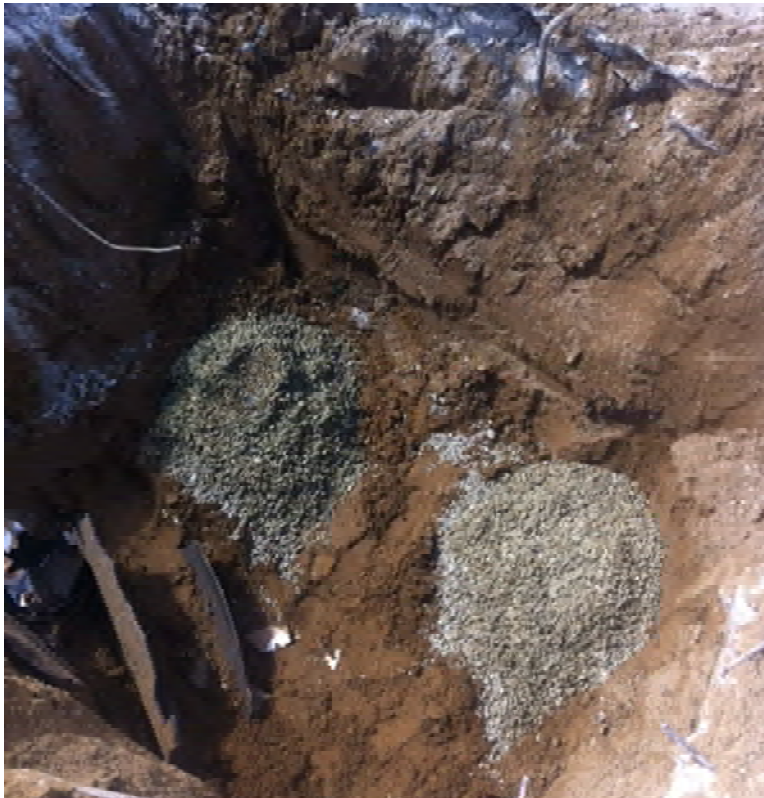
Photo 6: View of bentonite collar around lines at bulkhead location #3.

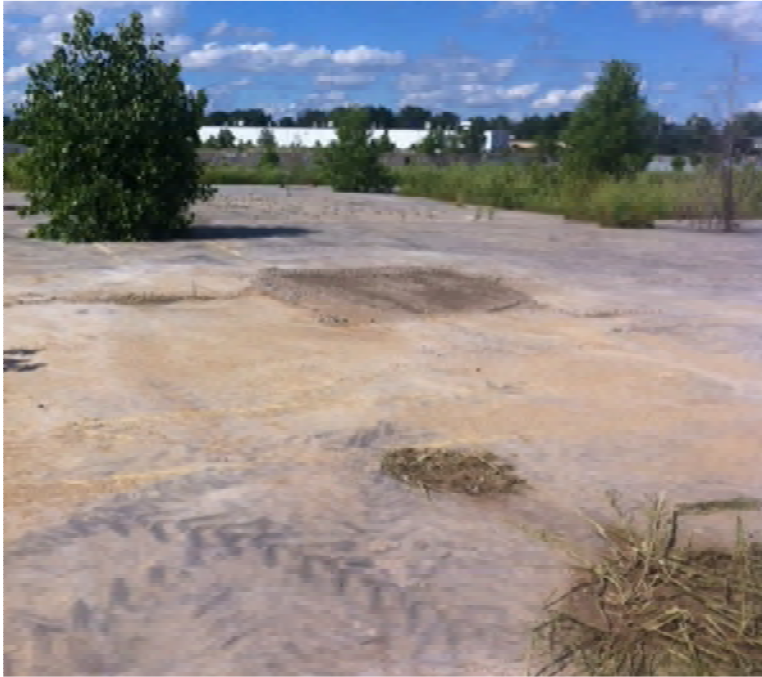
Photo 7: View of backfill at bulkhead locations.

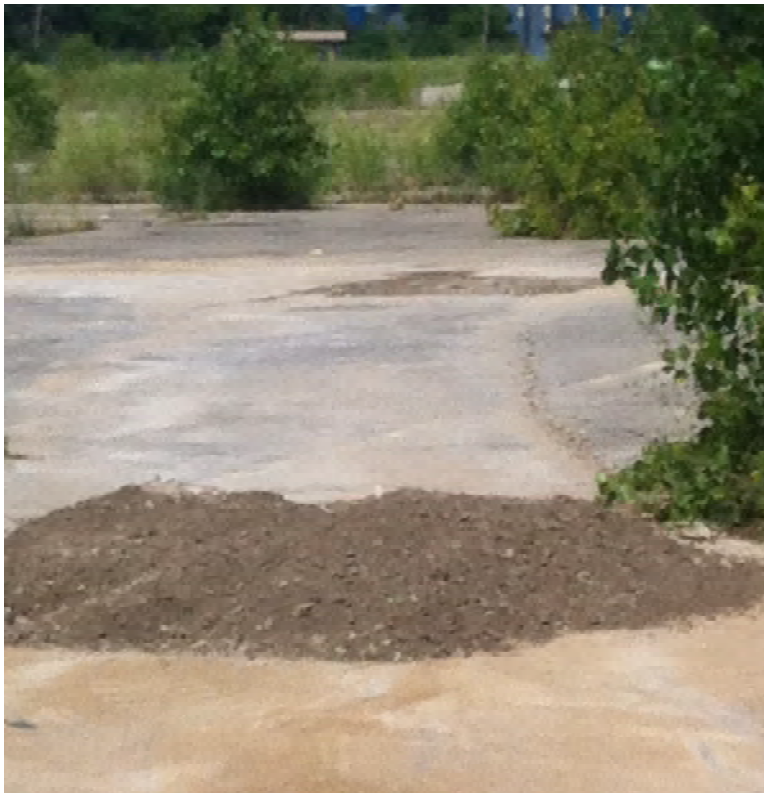
Photo 8: View of backfill at bulkhead locations.
