Re: Ley Creek PCB Dredgings Site (Registry # 7-34-044)
NYSDEC Order on Consent Index # D-7-0008-97-06
2002 Annual OM&M Inspection Report

Re: Ley Creek PCB Dredgings Site
2002 August OM&M Inspection

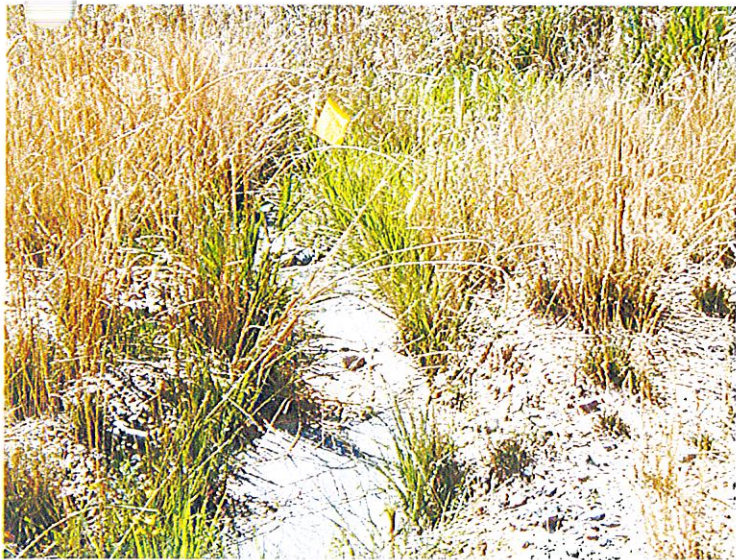
- Gully erosion: (Photograph 1, Figure 5.) One area of gully erosion identified in the 2001 OM&M site inspection leading down the slope to CB-5/004 overflow spillway was observed and requires maintenance.

Photo 1- Erosion area with geotextile in view near CB-5/004.

- Repair the damaged chain link fence
- Repair the gully erosion with topsoil, seed, and fertilizer application
- Apply seed and fertilizer to areas that received topsoil earlier this year
- Repair the stone access road by additional placement of crushed stone
- Remove the woodchuck from the Site, place topsoil in the hole, and apply seed and fertilizer
- Mow/trim the vegetation around CB-3 catch basin
- Remove the debris around CB-1 catch basin.

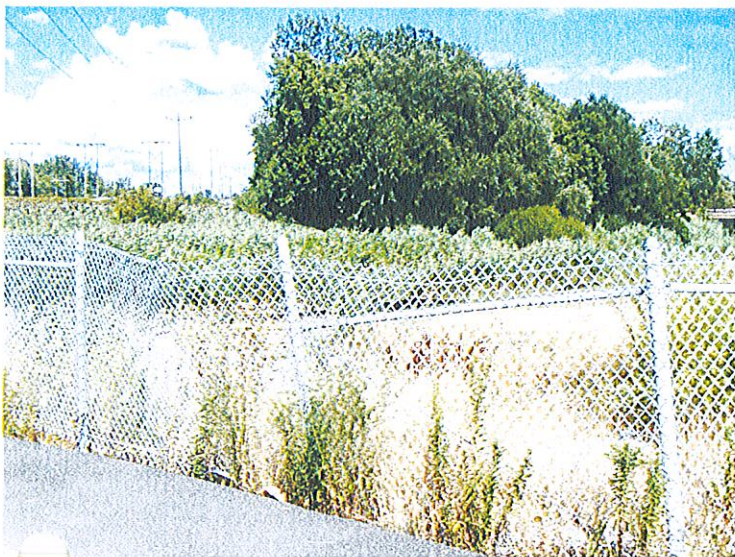
Item	Task	Response		Comments
		Yes	No	
Sanitary sewer access paths	2. Manhole covers in place?	X		
	3. Debris accumulating in access paths?		X	
Physical Site Security	Visually inspect fences and gates			
	1. Signs intact?	X		
	2. Fence breached?	X		Photos 7, and 9 - Views of breached fencing.
	3. Access gates locked?	X		
	4. Areas of damage?	X		Photos 3, 7, and 9 - Views of damaged and breached fencing.

Photo 3 - View of damaged fence near CB-4/003.

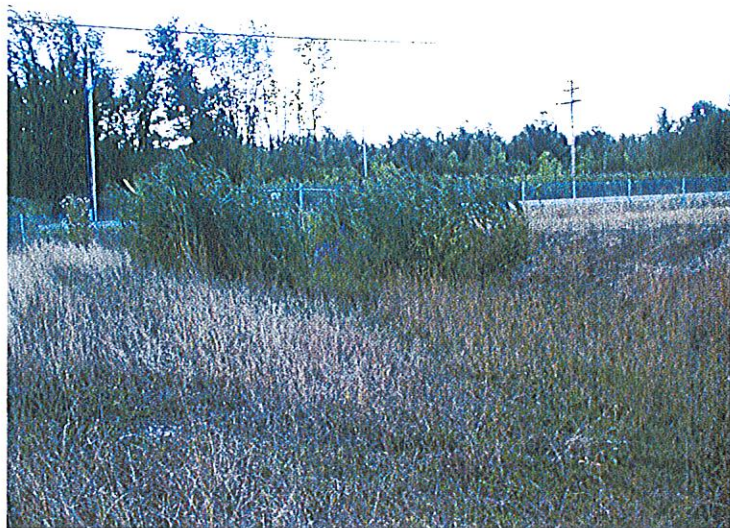
Photo 4 - Area around CB-3 that requires trimming.

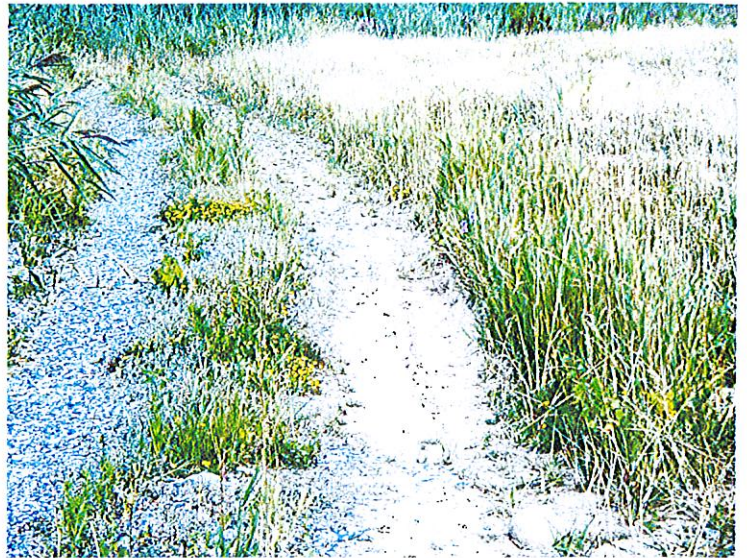
- Stone access road rutting: (Photograph 6. Figure 1.) Silt deposition on the stone access road was observed in this area during the OM&M inspection, which led to rutting.
- Burrowing animals: (Figure 3.) A woodchuck was observed in the area of CB-3 during the site inspection. A hole was observed on the western side slope of the CB-3 overflow spillway near the CB-3 catch basin.
- Area requiring mowing: (Photograph 4. Figure 3.) The vegetation around the CB-3 catch basin was quite high.
- Debris accumulation: Debris was accumulated around the catch basin CB-1.

Photo 6 - View of rut in road at western end of the Site.

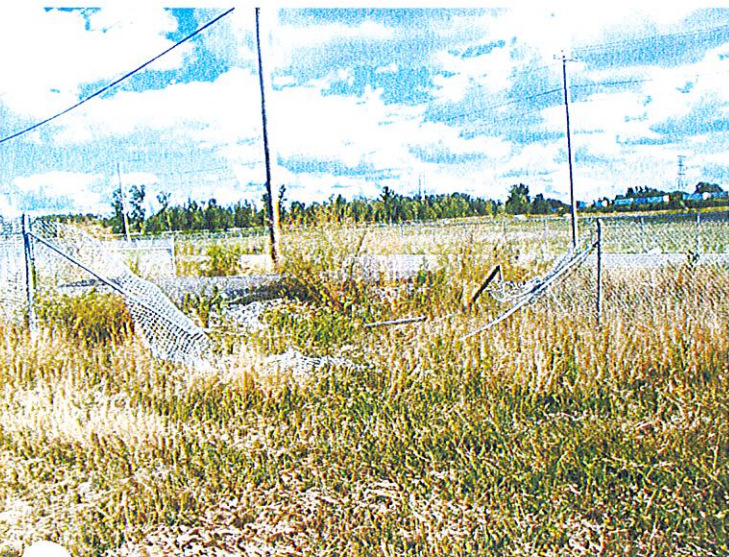
During the August 2002 site inspection, two areas of the site security fence were observed to be damaged. These areas are depicted in photographs 7 and 9. The security fence damage should be repaired as soon as practicable.

Photo 7 - View of breached fence near CB-1.

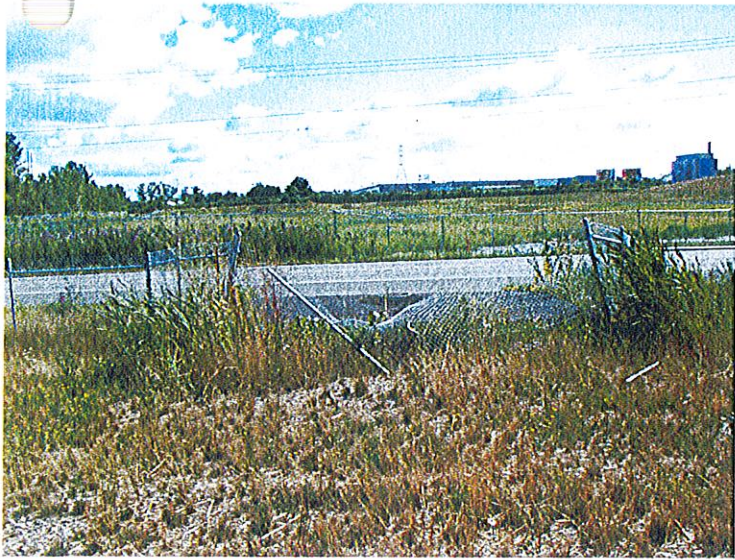
Photo 9 - View of breached fence between CB-1 and CB-2.

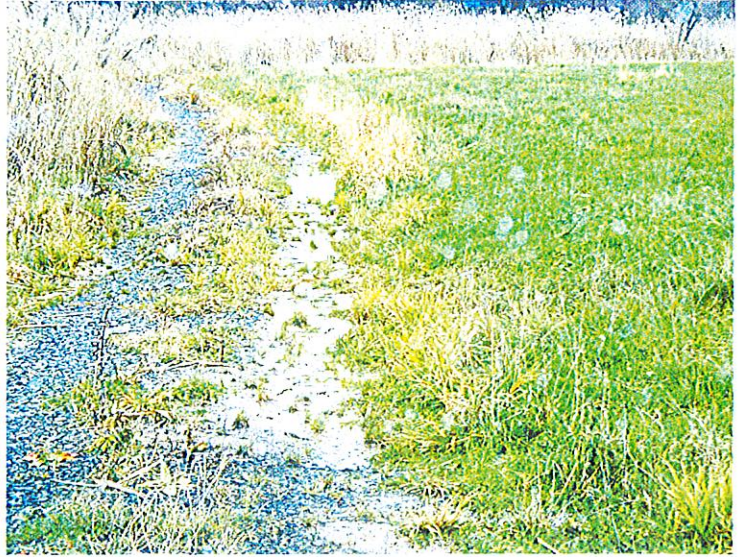
- Stone access road rutting: (Photograph 2. Figure 1.) Rutting of the stone access road was observed; the ruts were filled with sediments and water.
- Visible geotextile: (Photographs 3,4, and 9. Figures 1 and 5.) Geotextile fabric was visible due to erosion of the vegetative cover.

11/19/02
Photograph 2- View of ponded water in ruts in access road.

- Repair the areas of vegetative cover erosion with topsoil, seed, and fertilizer application
- Repair the stone access road by additional placement of crushed stone
- Remove the woodchuck from the Site, place topsoil in the hole, and apply seed and fertilizer
- Repair damage to the fence
- Remove the debris from the ditch and access pathway
- Repair sinkhole by removal of rip-rap, placement of crushed stone to meet surrounding grade, and replacement of removed rip-rap.

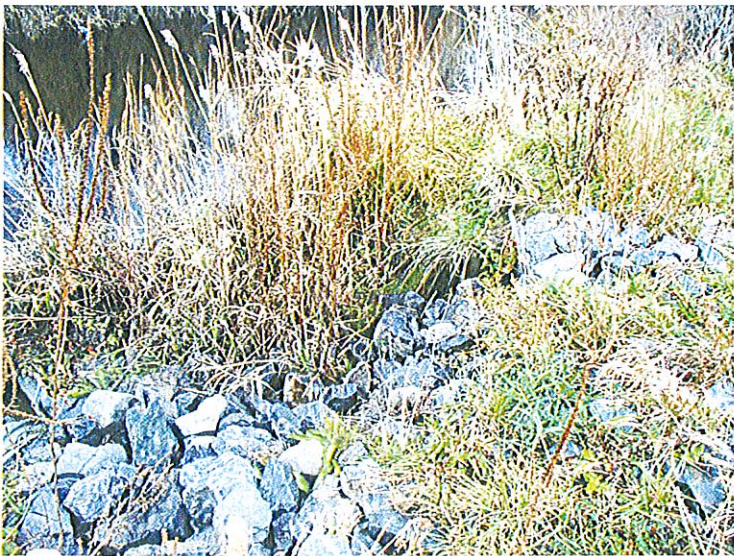
11/19/02
Photograph 3- View of geotextile near CB-1 flared end section.

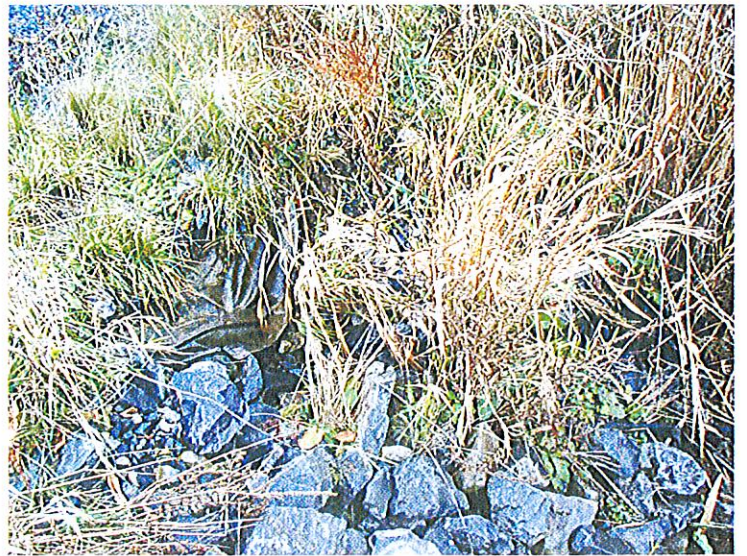
11/19/02
Photograph 4- View of geotextile near CB-1 flared end section.

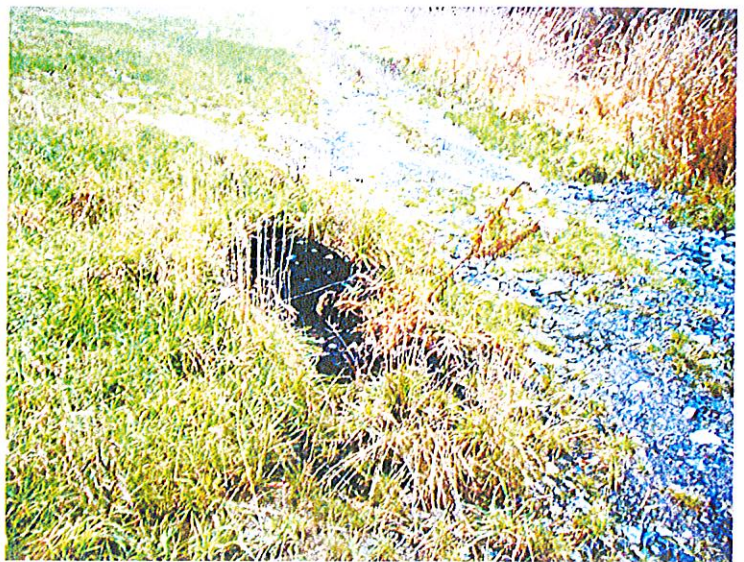
Photograph 6- View of erosion area in CB-3 overflow spillway.

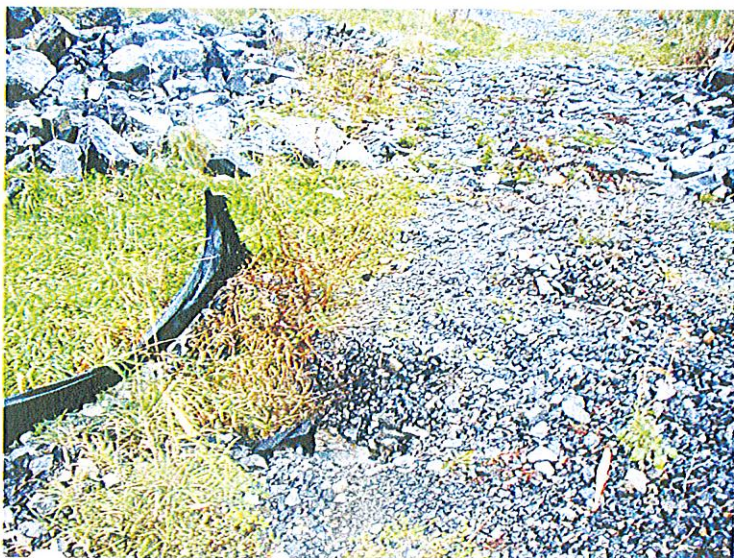
- Stone access road erosion: (Photograph 7. Figure 5.) A portion of the stone access road near the CB-4/003 overflow spillway was observed to be eroded.

Photograph 7- View of erosion in access road near CB-4/003.

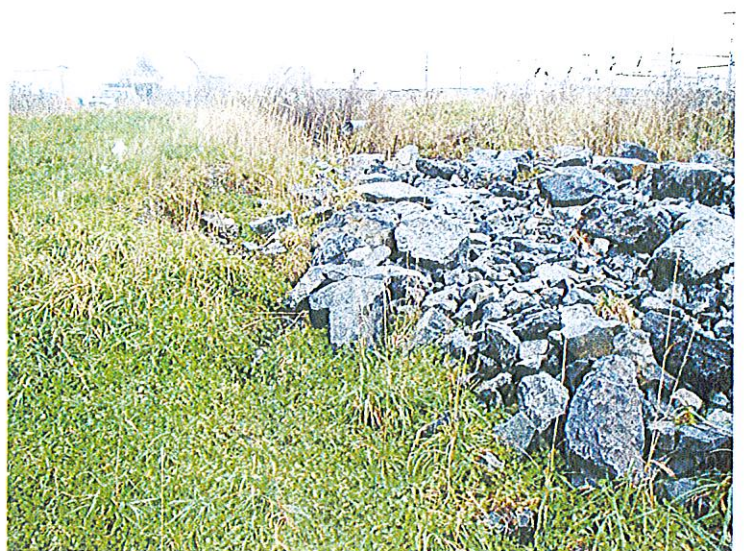
Photograph 8- View of erosion in CB-4/003 overflow spillway.

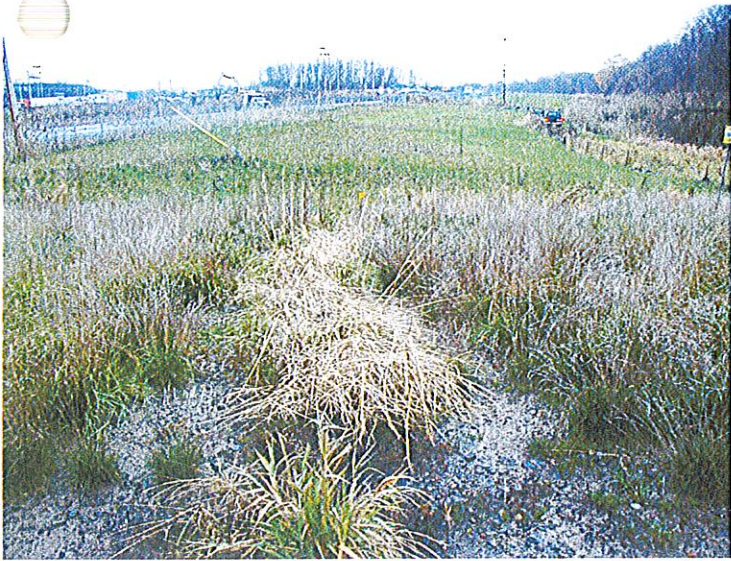
- Gully erosion: (Photograph 9. Figure 5.) One area of gully erosion identified in the August 2002 OM&M site inspection leading down the slope to CB-5/004 overflow spillway was observed and requires maintenance.
- Vegetative cover erosion: (Photographs 3,4,6,7,8, and 9. Figures 1,3 and 5.) Small areas of the vegetative cover were observed to be eroded.

11/19/02
Photograph 9- View of erosion channel near CB-5/004.

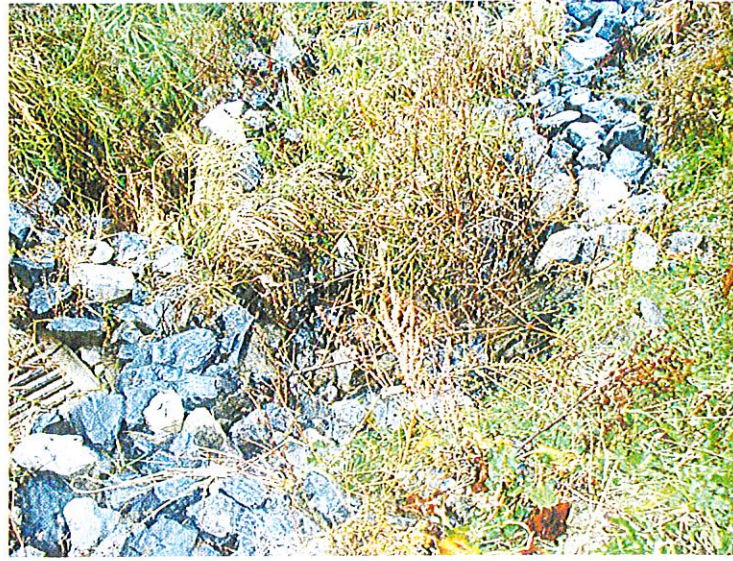
- Fence damage: (Figure 5.) A small portion of the fence near the eastern gate was observed to be damaged, but not breached.
- Sinkhole: (Photograph 10. Figure 5.) A sinkhole, located immediately south of the CB-5/004 catch basin was observed.

11/19/02
Photograph 10- View of sinkhole near CB-5/004.

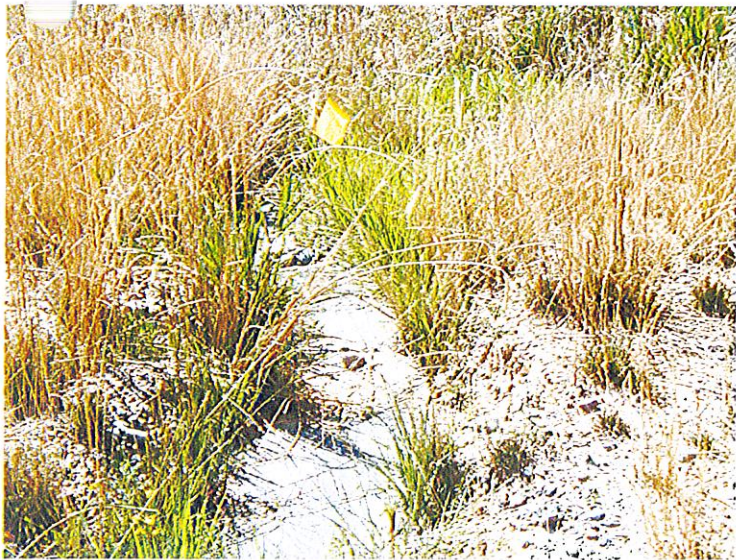
- Gully erosion: (Photograph 1, Figure 5.) One area of gully erosion identified in the 2001 OM&M site inspection leading down the slope to CB-5/004 overflow spillway was observed and requires maintenance.

Photo 1- Erosion area with geotextile in view near CB-5/004.

- Repair the damaged chain link fence
- Repair the gully erosion with topsoil, seed, and fertilizer application
- Apply seed and fertilizer to areas that received topsoil earlier this year
- Repair the stone access road by additional placement of crushed stone
- Remove the woodchuck from the Site, place topsoil in the hole, and apply seed and fertilizer
- Mow/trim the vegetation around CB-3 catch basin
- Remove the debris around CB-1 catch basin.

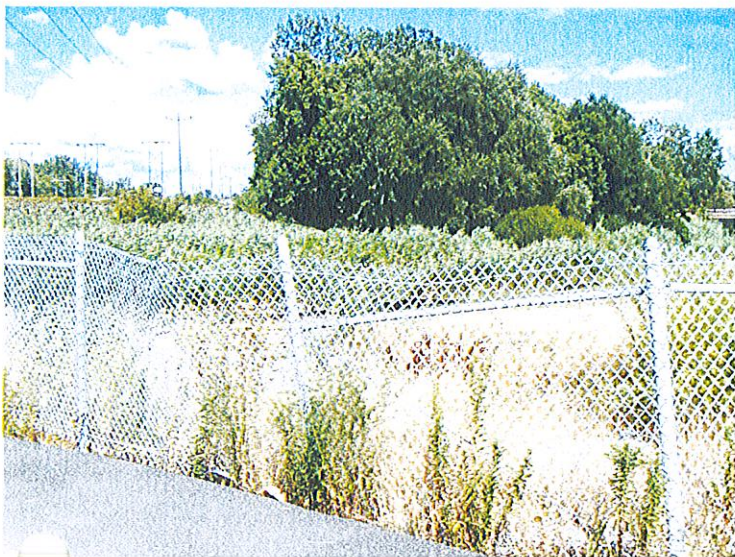
2. Fence breached?	X		Photos 7, and 9 - Views of breached fencing.
	3. Access gates locked?	X		
	4. Areas of damage?	X		Photos 3, 7, and 9 - Views of damaged and breached fencing.
Note any additional comments.				
Areas that had thinning vegetation have had topsoil placed in the area. These areas will be fertilized and seeded when the weather is favorable for growth and establishment of vegetation. Overall the vegetative cover system is in good condition with increasingly denser growth and coverage.

Photo 3 - View of damaged fence near CB-4/003.

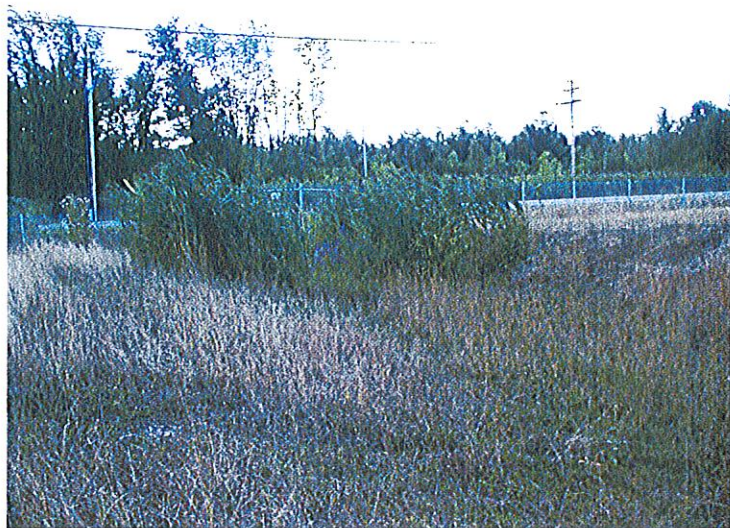
Photo 4 - Area around CB-3 that requires trimming.

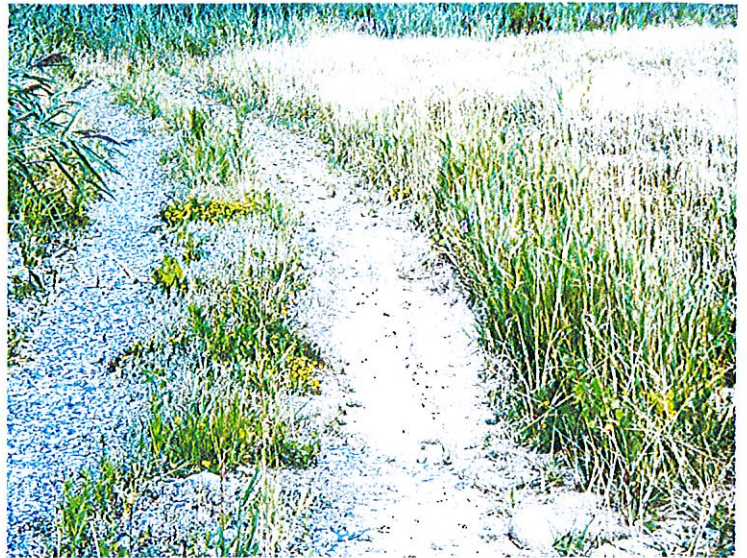
- Stone access road rutting: (Photograph 6. Figure 1.) Silt deposition on the stone access road was observed in this area during the OM&M inspection, which led to rutting.
- Burrowing animals: (Figure 3.) A woodchuck was observed in the area of CB-3 during the site inspection. A hole was observed on the western side slope of the CB-3 overflow spillway near the CB-3 catch basin.
- Area requiring mowing: (Photograph 4. Figure 3.) The vegetation around the CB-3 catch basin was quite high.
- Debris accumulation: Debris was accumulated around the catch basin CB-1.

Photo 6 - View of rut in road at western end of the Site.

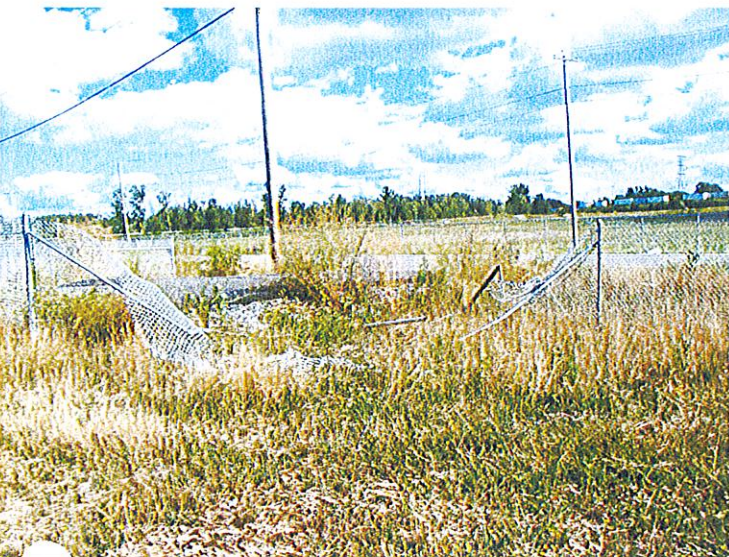
During the August 2002 site inspection, two areas of the site security fence were observed to be damaged. These areas are depicted in photographs 7 and 9. The security fence damage should be repaired as soon as practicable.

Photo 7 - View of breached fence near CB-1.

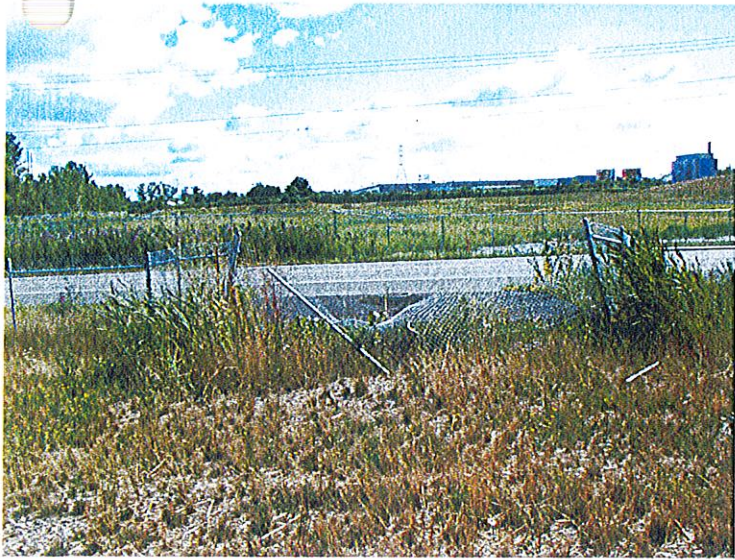
Photo 9 - View of breached fence between CB-1 and CB-2.
