RACER TRUST LANSING PLANTS 2, 3, & 6

3Q 2020 Quarterly Progress Report | October 15, 2020

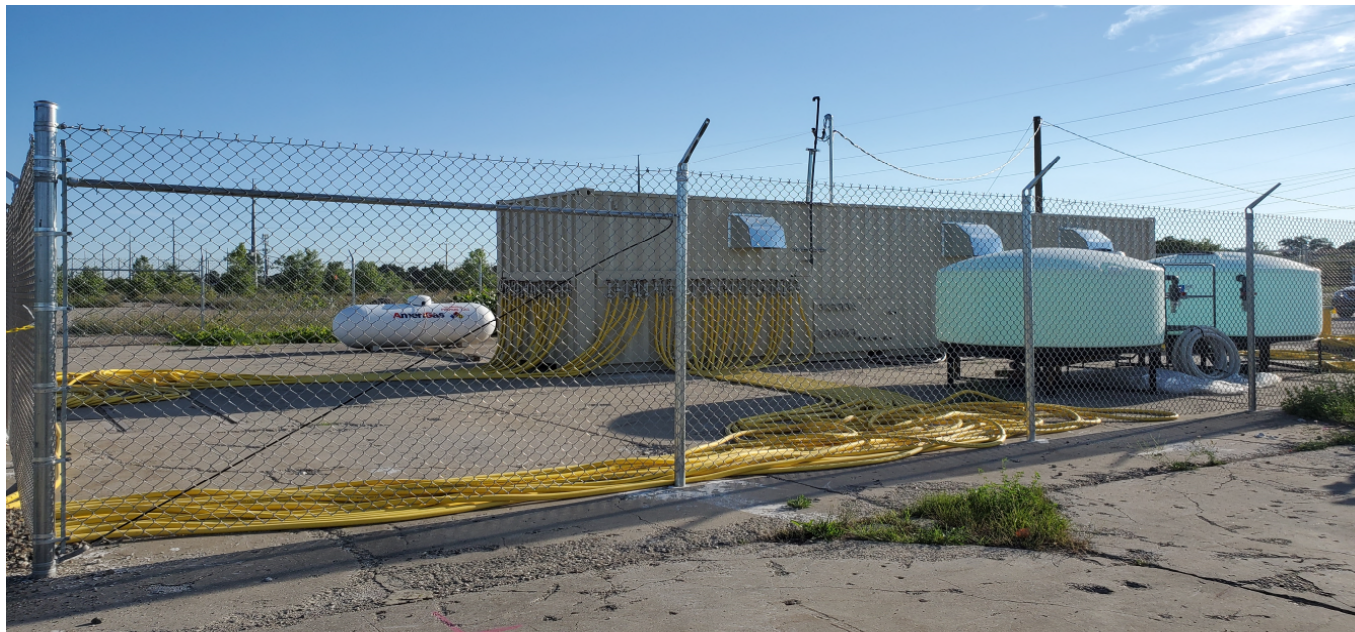
System Building and Nutrient Injection Tanks

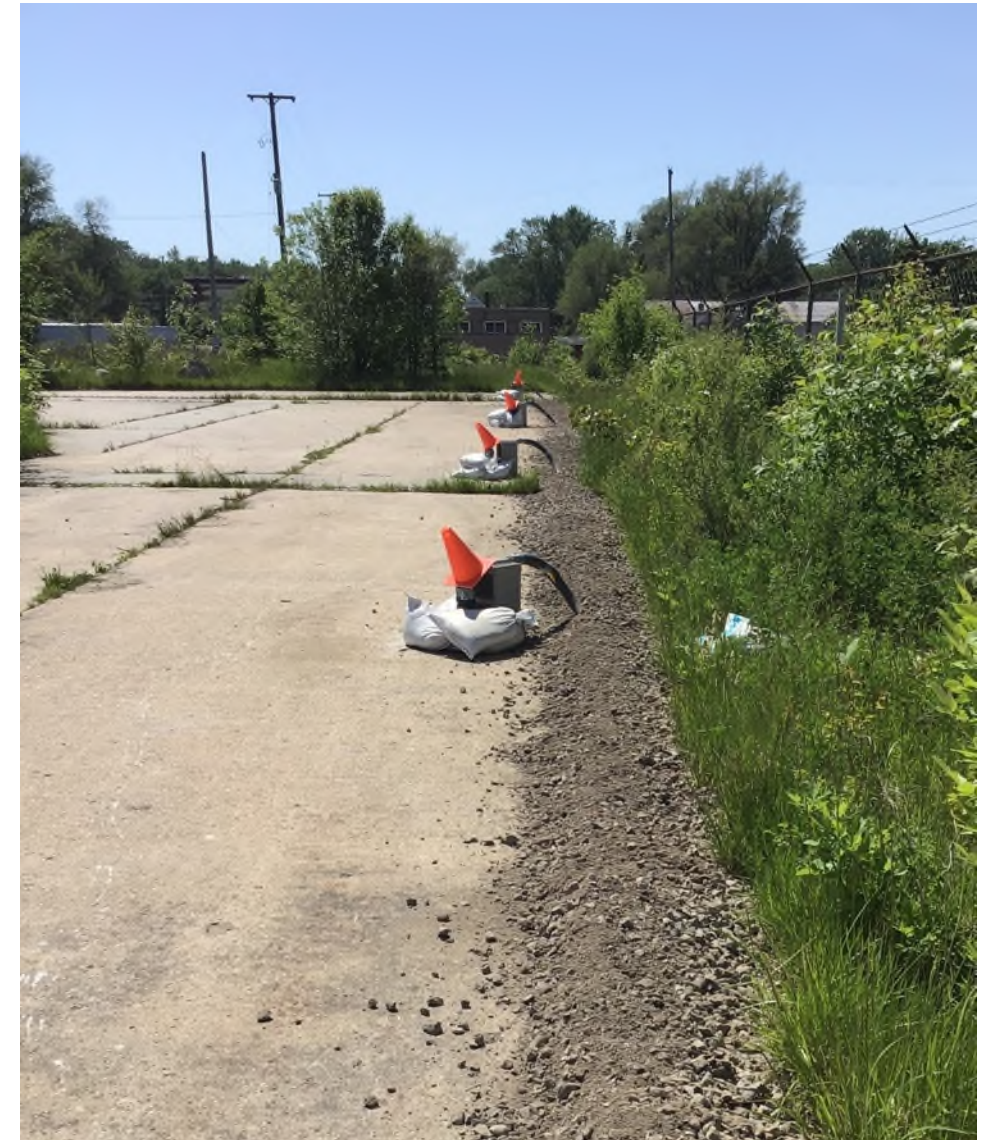
Biosparge Transect With Hoses Covered in Gravel

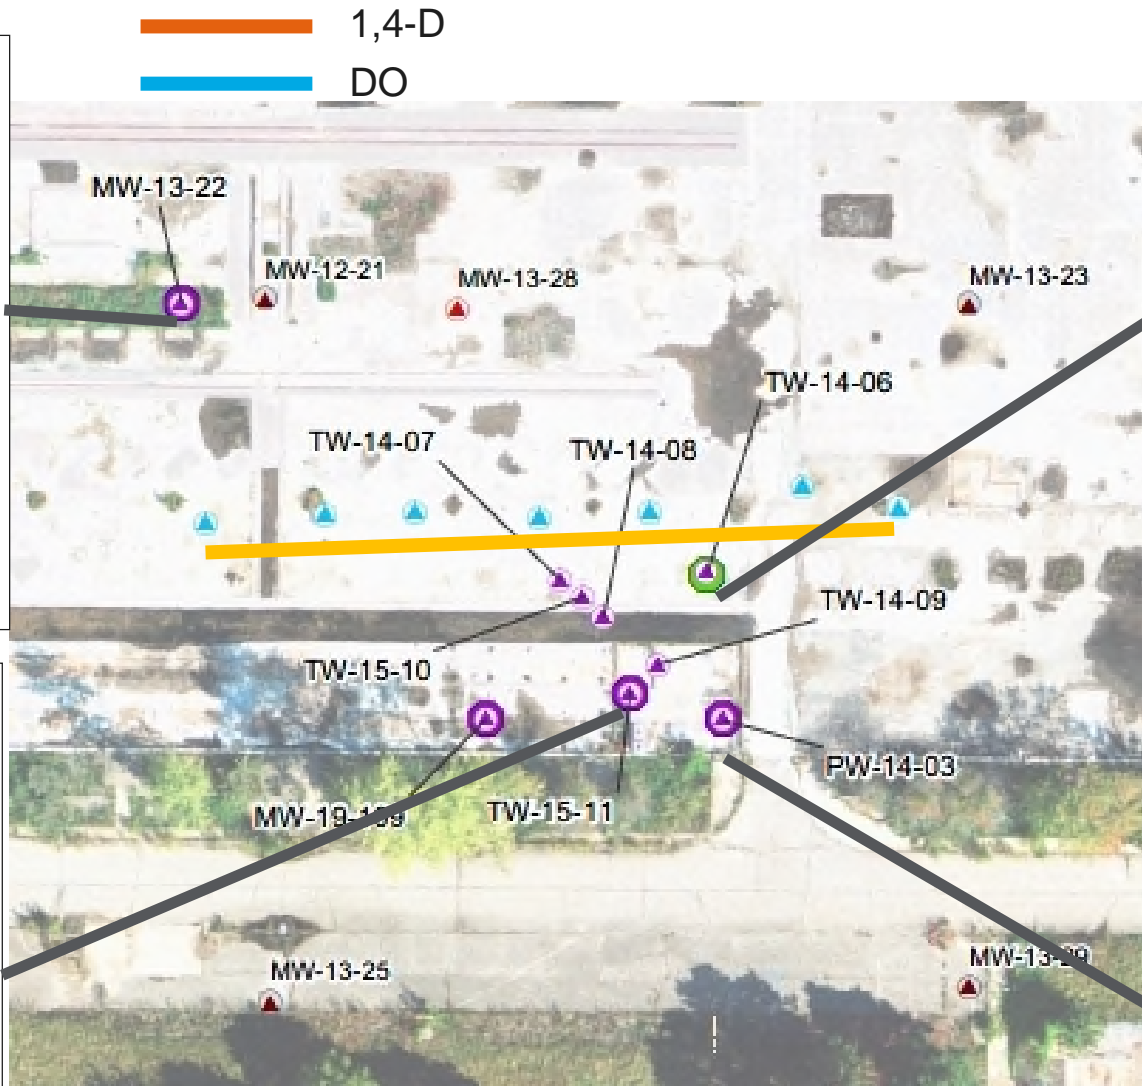
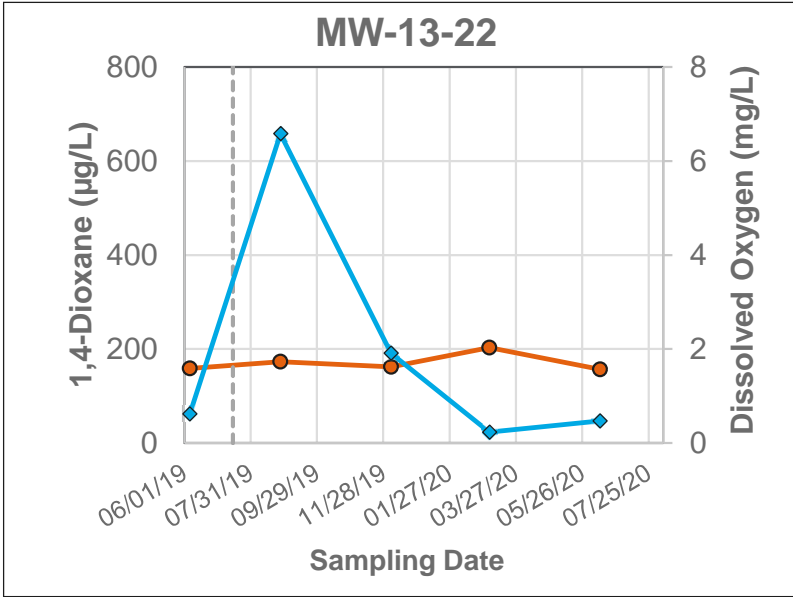
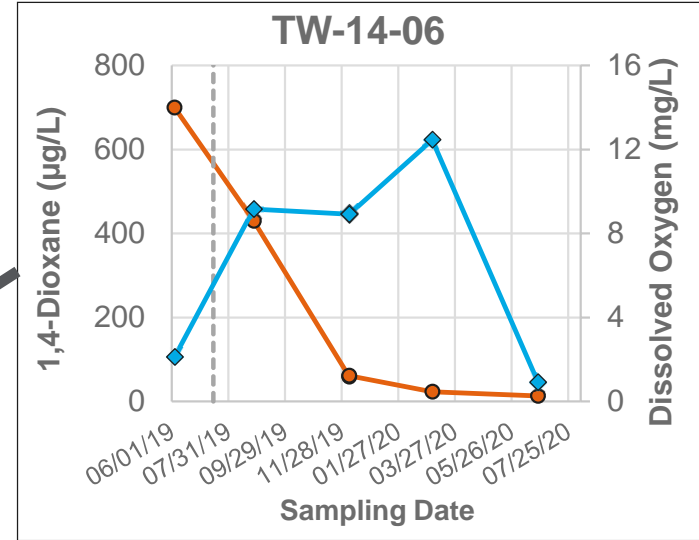
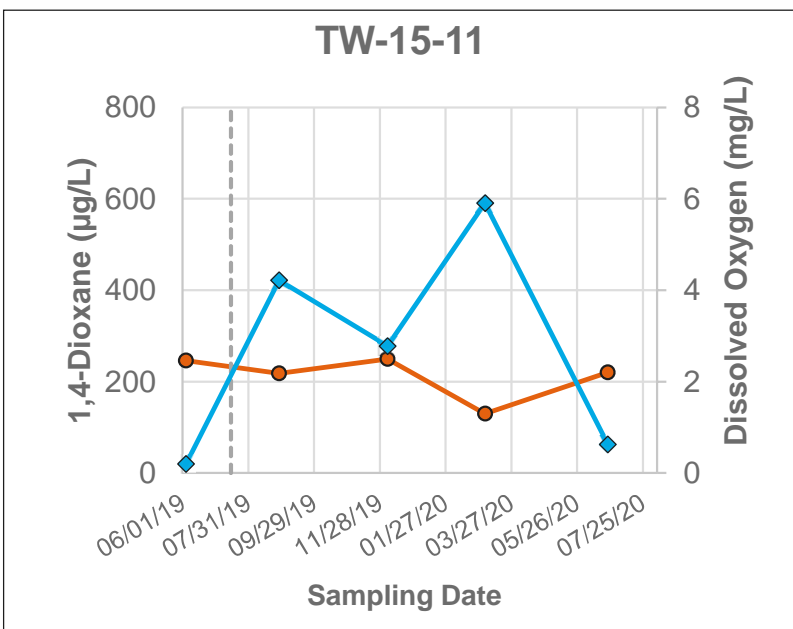
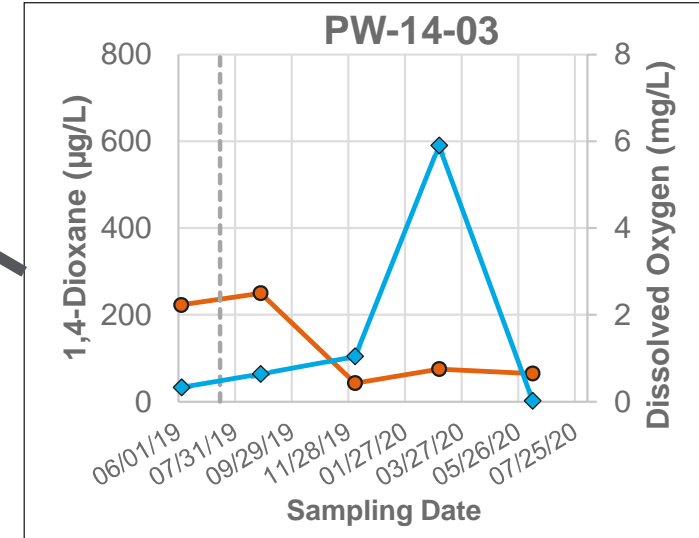
Plant 3 Performance Results

- Graphs generally show an increase in DO and a decrease in 1,4-dioxane which demonstrates the biosparge system is working to remediate the 1,4-dioxane.
- Last sample was collected in July while system down for 2 months due to a broken compressor

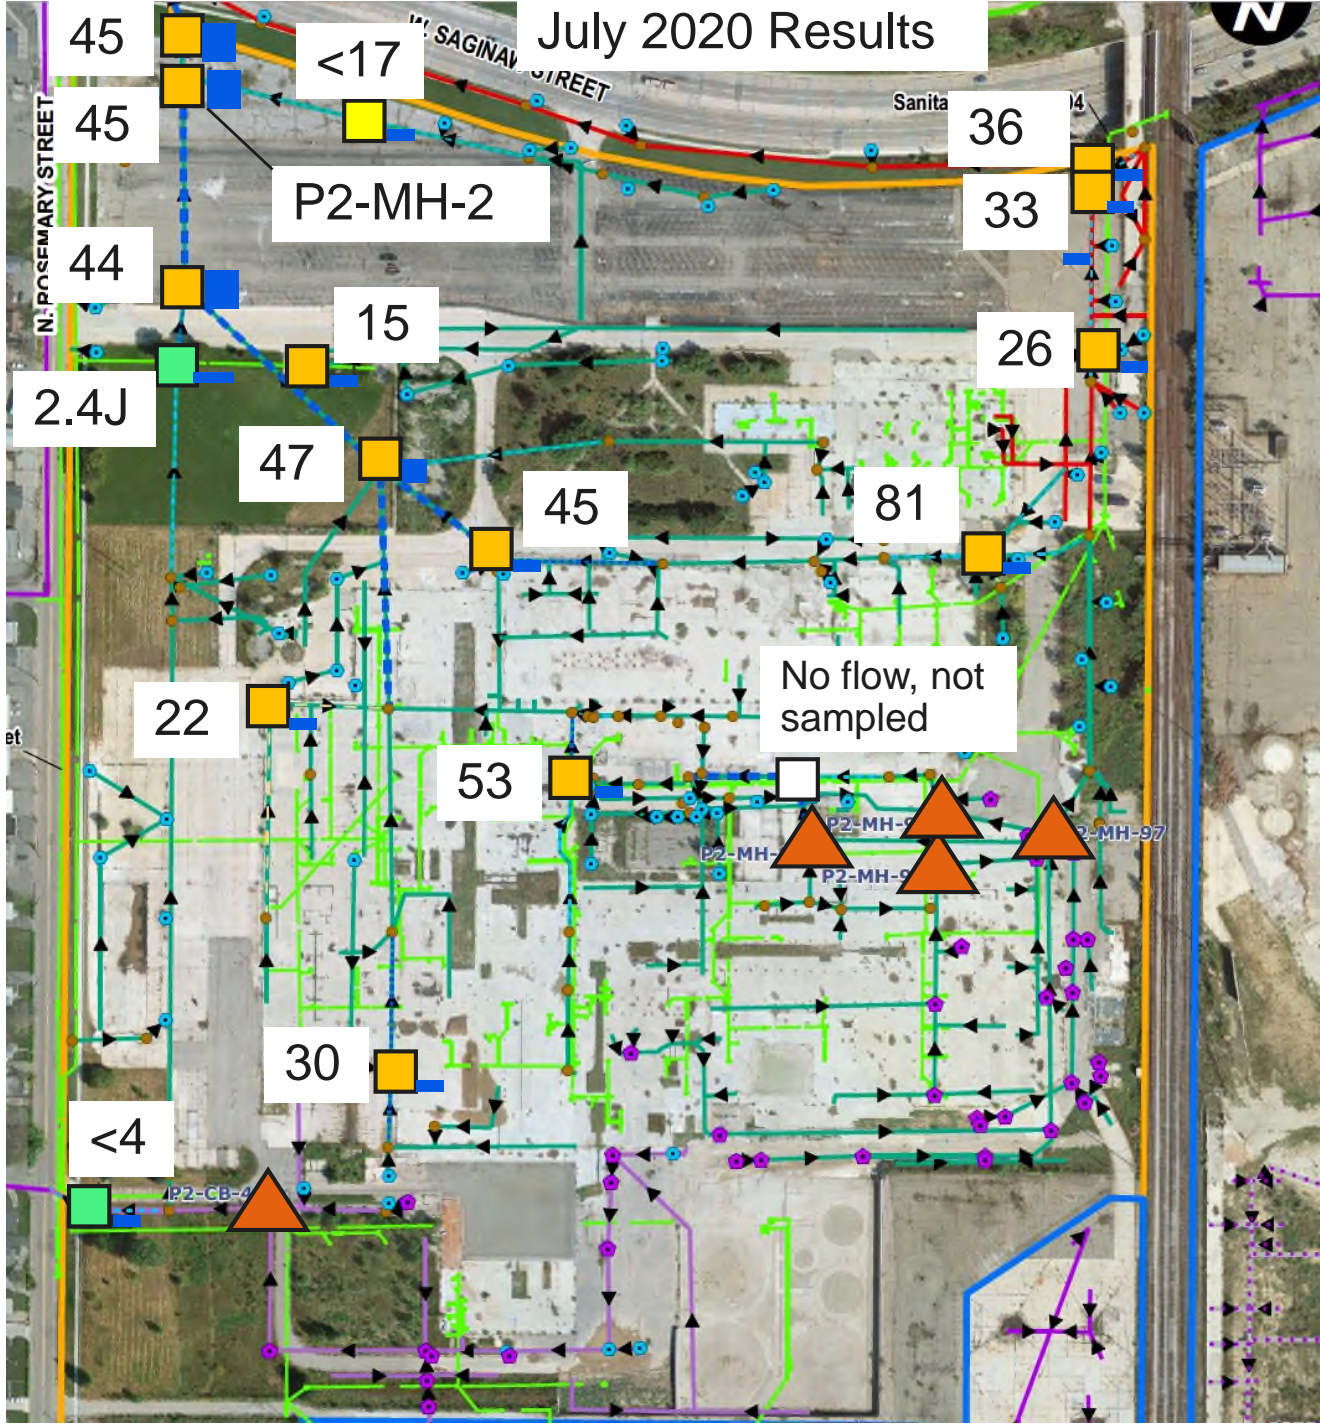
Plant 2 PFOS Storm Sewer Results (July)

- Filled 2 additional manholes with concrete in May 2020 to isolate areas with concentrations of PFAS above criteria in sewers
- Sampling completed in July and was preceded by a particularly dry period with no rainfall
- Northwest Outfall manhole P2-MH-2 results

Date	PFOS (ng/L)
Jan 2019	161
Feb 2020	31.3
July 2020	45

Concentrations decreasing (improving) over time

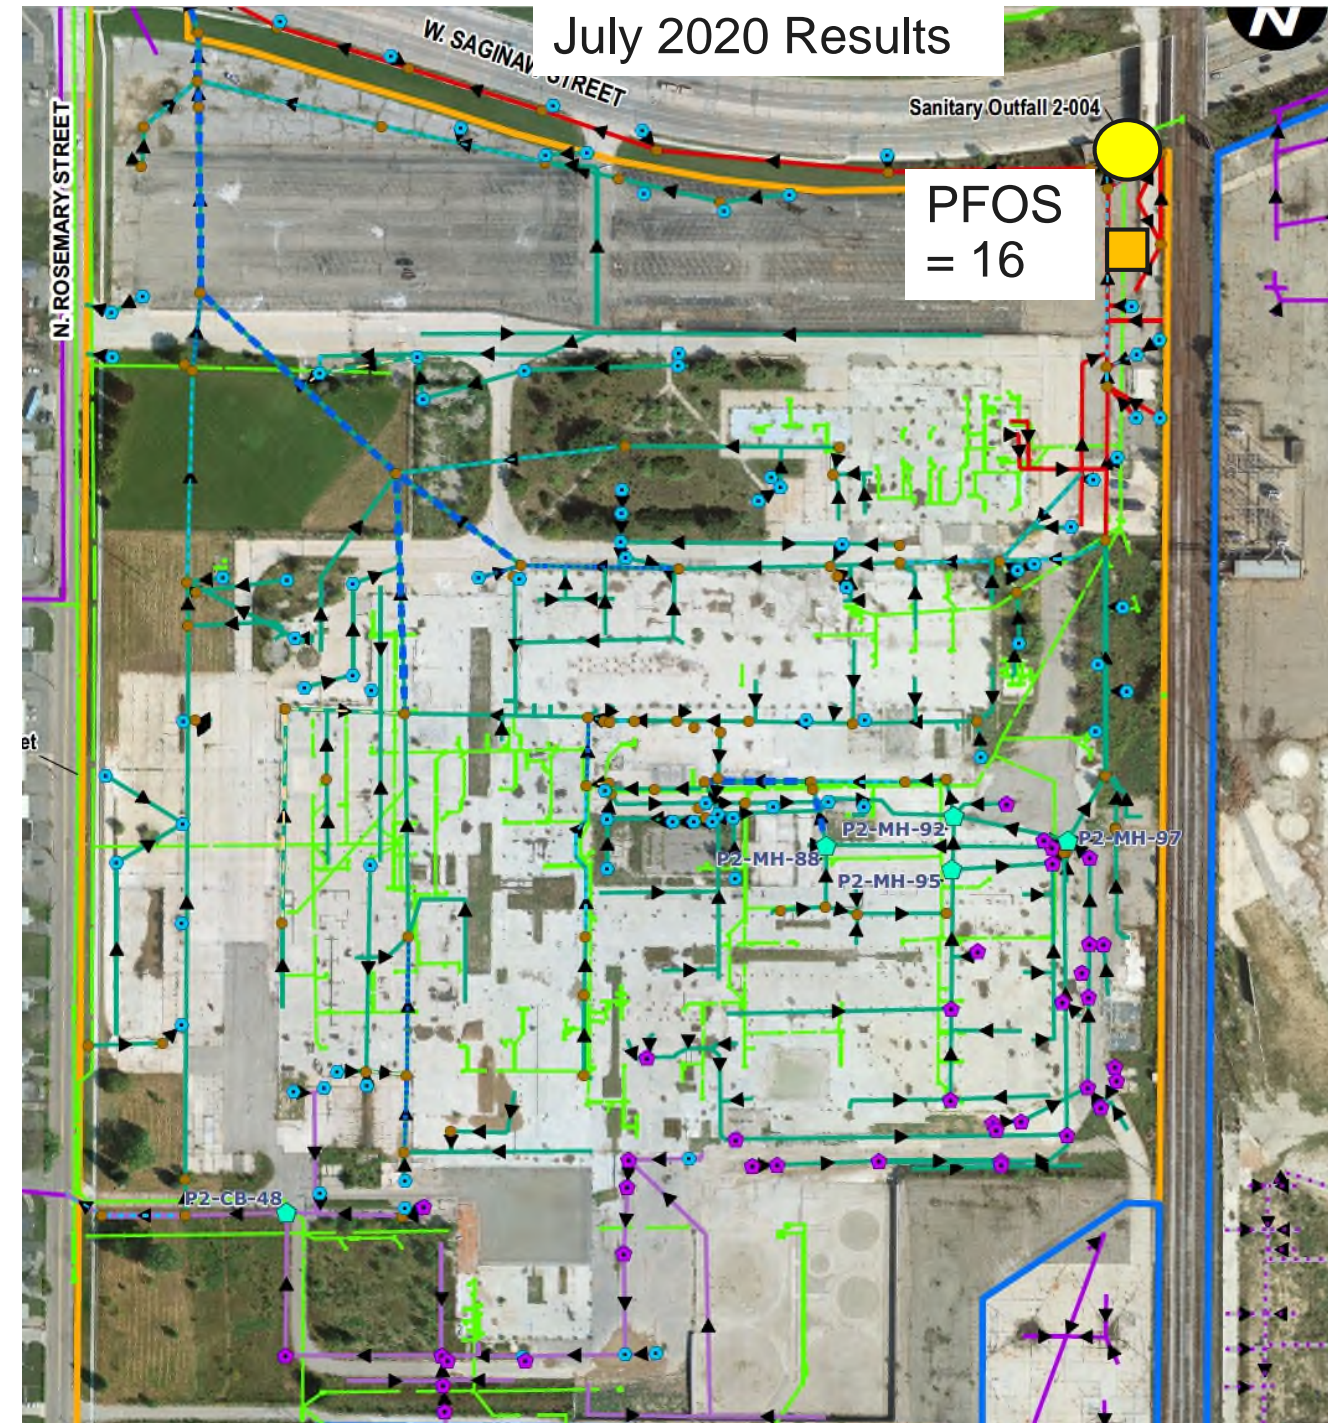
Plant 2 Sanitary Sewer Sampling Results (July)

- A trickle of water was observed in sanitary sewer line near northeast outfall
 - Flow within inactive sanitary sewer indicates potential GW infiltration
 - Sample collected from sanitary outfall above GSI for PFOS
- No outfall could be identified along western property boundary – RACER sanitary line appears separate from Rosemary Street sanitary line
- Recommend filling northeast sanitary manhole with concrete

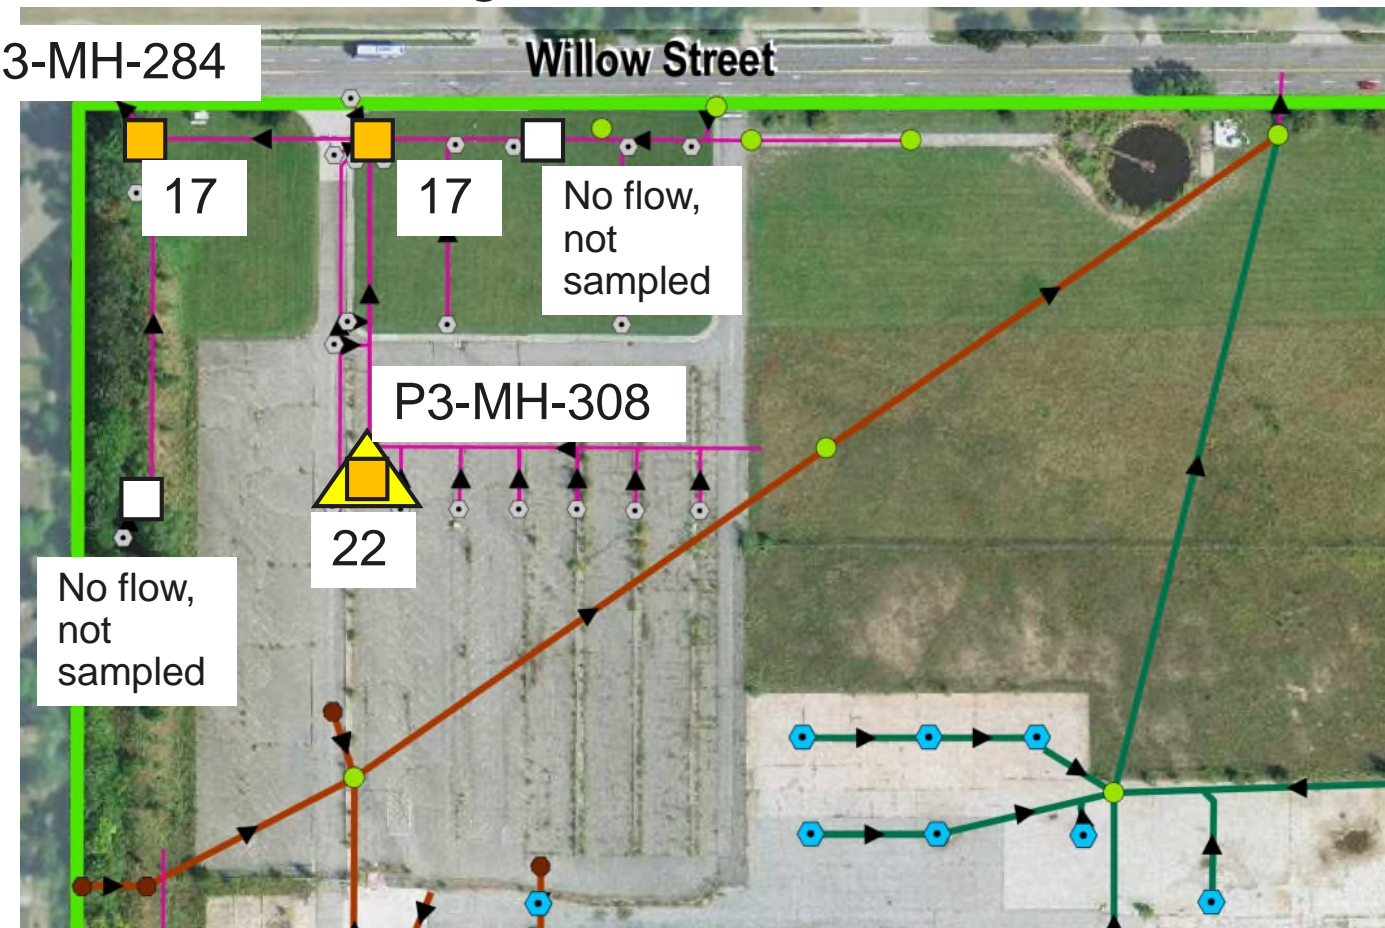
Plant 3 Storm Sewer Northwest Parking Lot

- Plant 3 Northwest Outfall P3-MH-284.

Date1	PFOS (ng/L)
February 2020	5.1
July 2020	33
August 2020	17

Manhole to fill

- Also conducted expanded sampling in August to identify locations of PFAS impacts in sewer
- Recommend filling P3-MH-308
- Recommend continued monitoring of Outfall

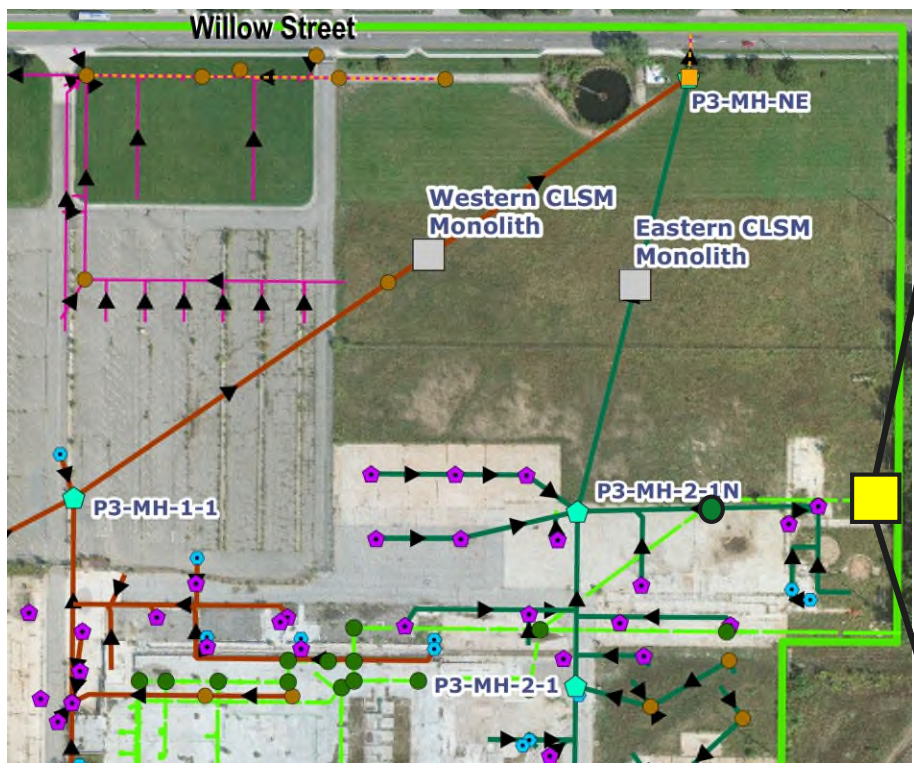
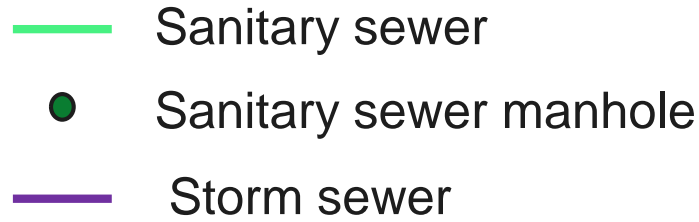
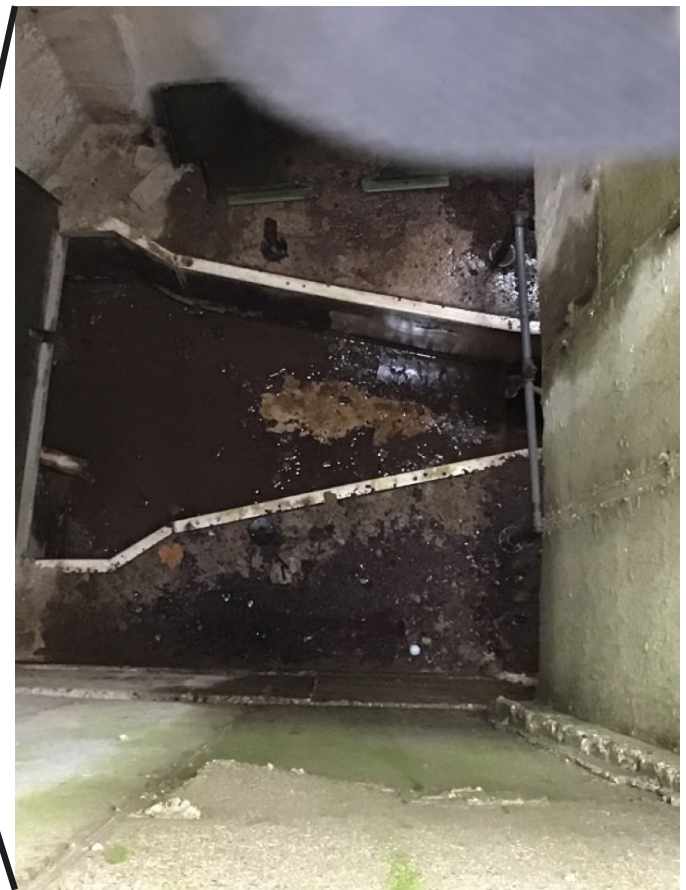
Plant 3 Northeast Sanitary Outfall

- Sanitary sewer vault and flume structure located at NE property outfall
- Trickle flow observed discharging after rain events, no discharge in dry weather
- Flow may be groundwater infiltration based on upstream observations
- Recommend bulkheading pipe entering sanitary vault to mitigate potential for discharge

Trickle flow observed in sanitary sewer outfall

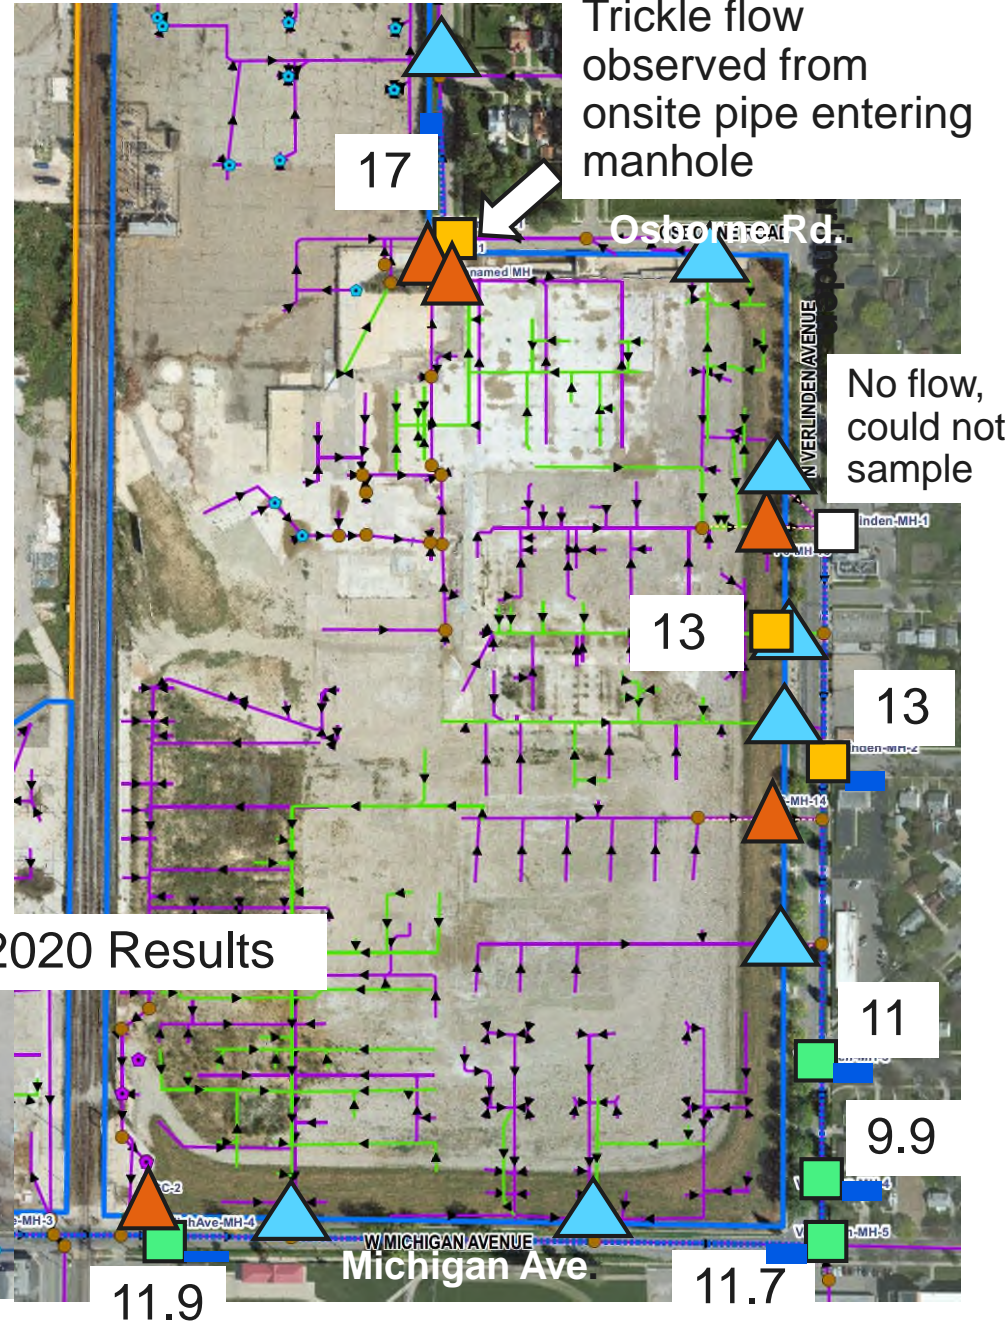
Plant 6 Storm Sewer PFOS Results Summary

- Majority of outfalls have now been plugged or cut and capped at the curb
- Trickle flow observed from 3" pipe coming from the direction of the Site and entering Osborne Street manhole
- Recommend plugging 3" pipe
- Recommend performing video inspection of offsite sewers to look for groundwater infiltration

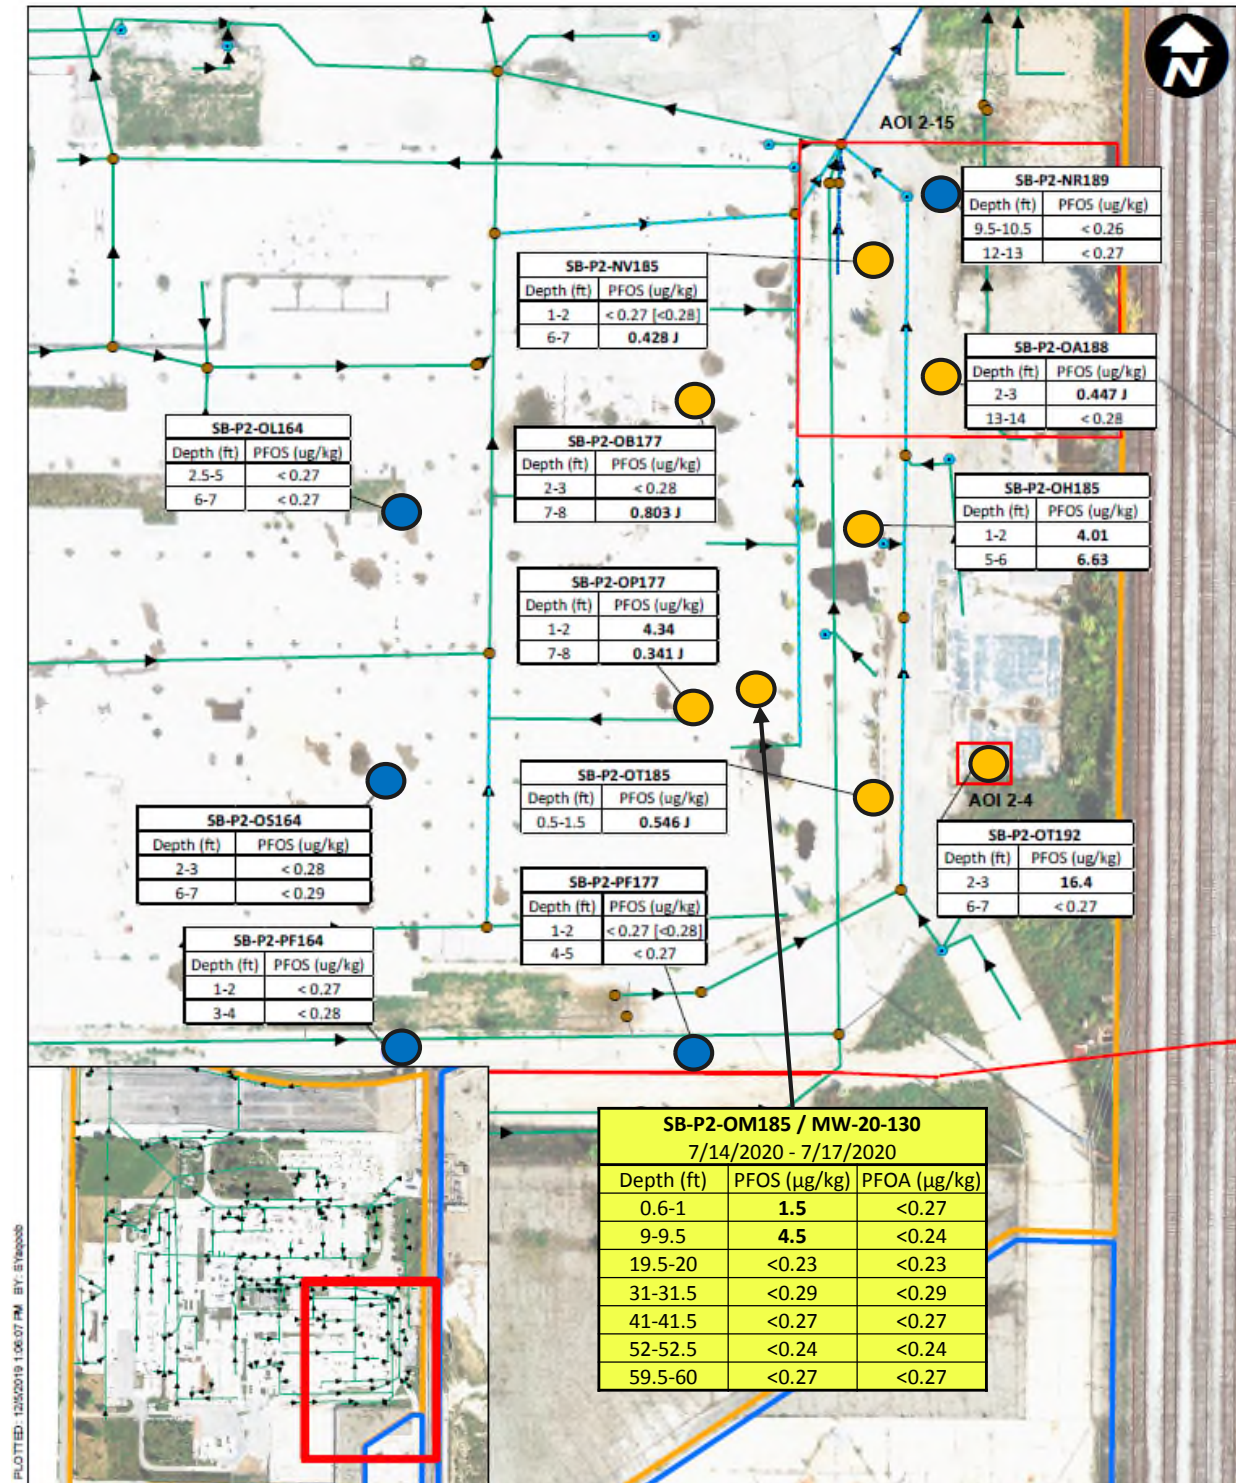
Plant 2 PFAS Investigation – GW Analytical Results

- Results of July 2020 PFAS investigation highlighted
 - 5 vertical aquifer profile (VAP) borings completed to ~40' bgs
 - 2 samples collected where multiple permeable zones were encountered
 - 2 existing monitoring wells sampled
 - New weathered bedrock monitoring well MW-20-130 sampled
- Non-detects in MW-20-130 indicate no vertical migration

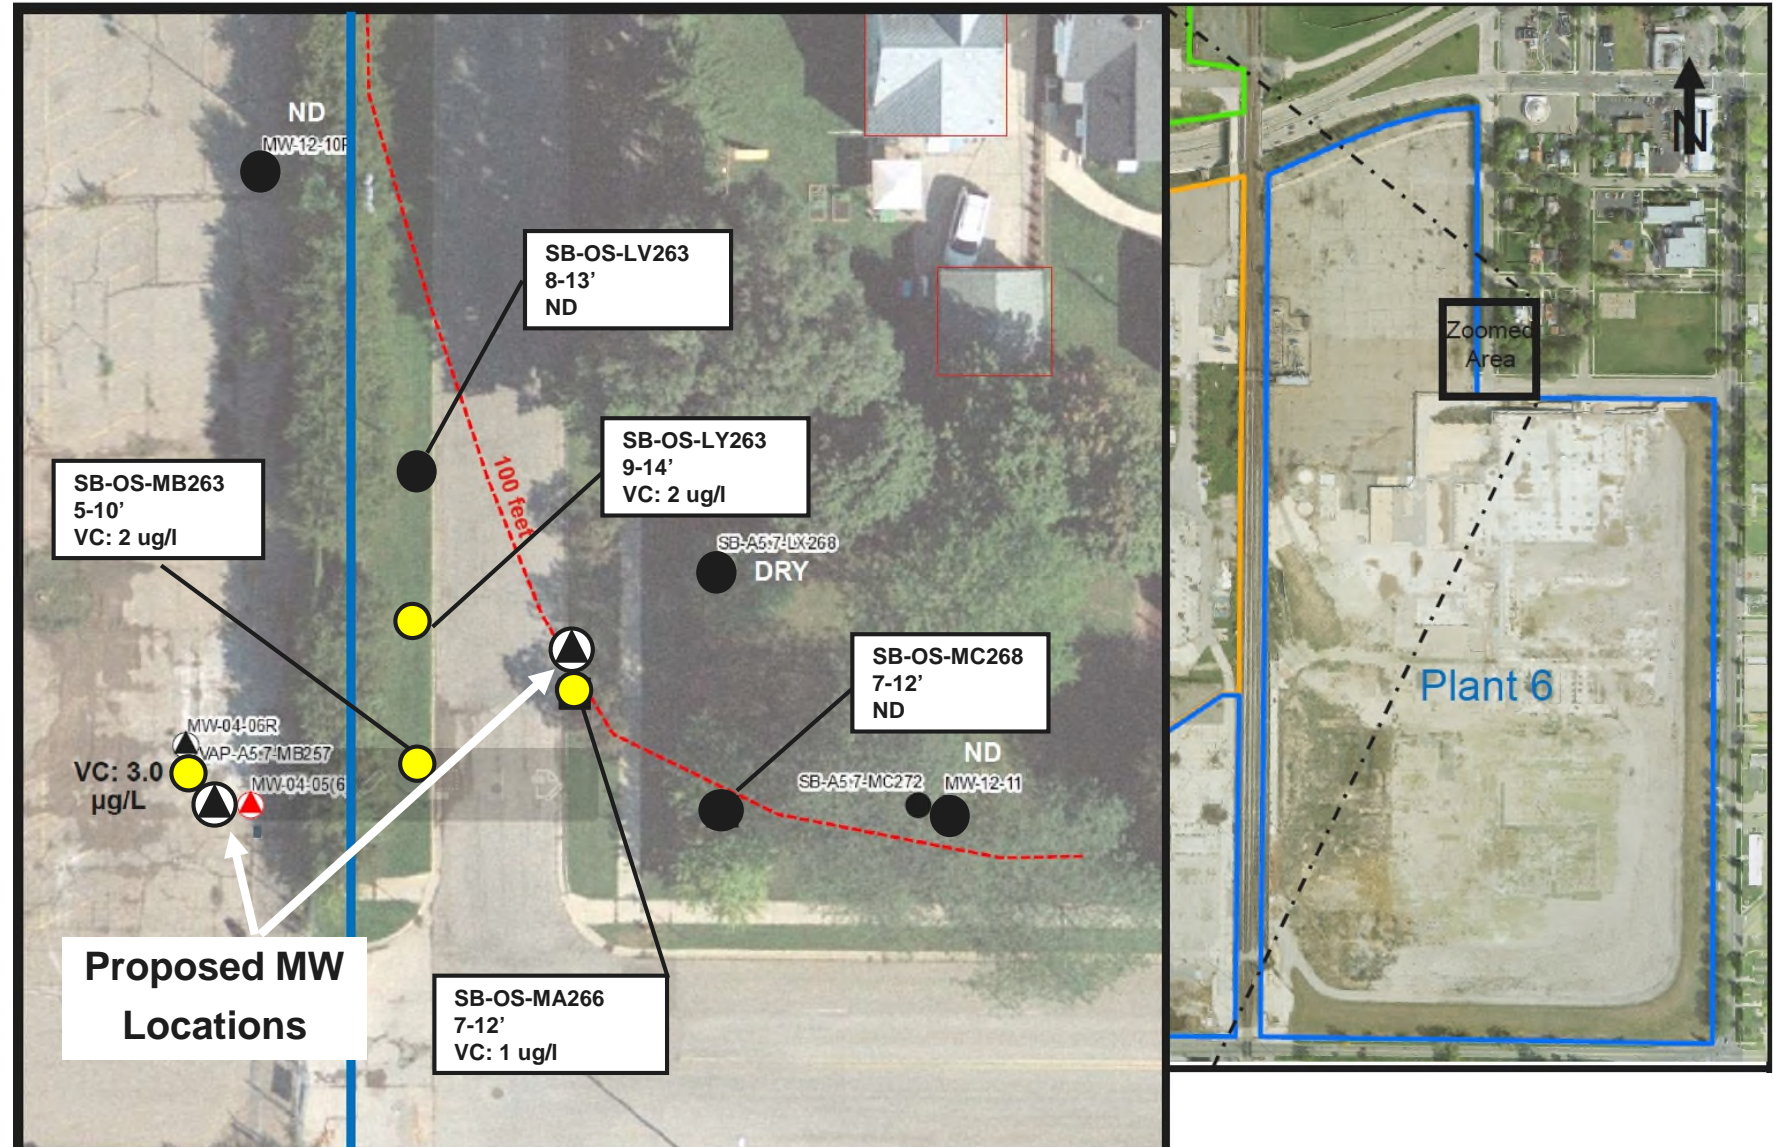
Plant 6 Additional VI Investigation

- Completed 5 VAP borings in July to delineate vinyl chloride detected in shallow GW at VAP-A5.7-MB257
- Detections of vinyl chloride in 3 of the 5 borings at 1-2 µg/L
- The results of the sampling suggest no vapor intrusion to indoor air to off-site residences
- Recommend installation of two monitoring wells to monitor vinyl chloride in the shallow zone
