RE: Windiate Park/Dixieland Subdivision Landfill, Genesee County, Michigan (Site ID No. 25000689)  
FILE: 15388/64738 - Soil Cover Inspection Report

## WINDIATE PARK SOIL COVER MAINTENANCE CHECKLIST

Inspection Date: November 2, 2017

# INSPECTION MAP

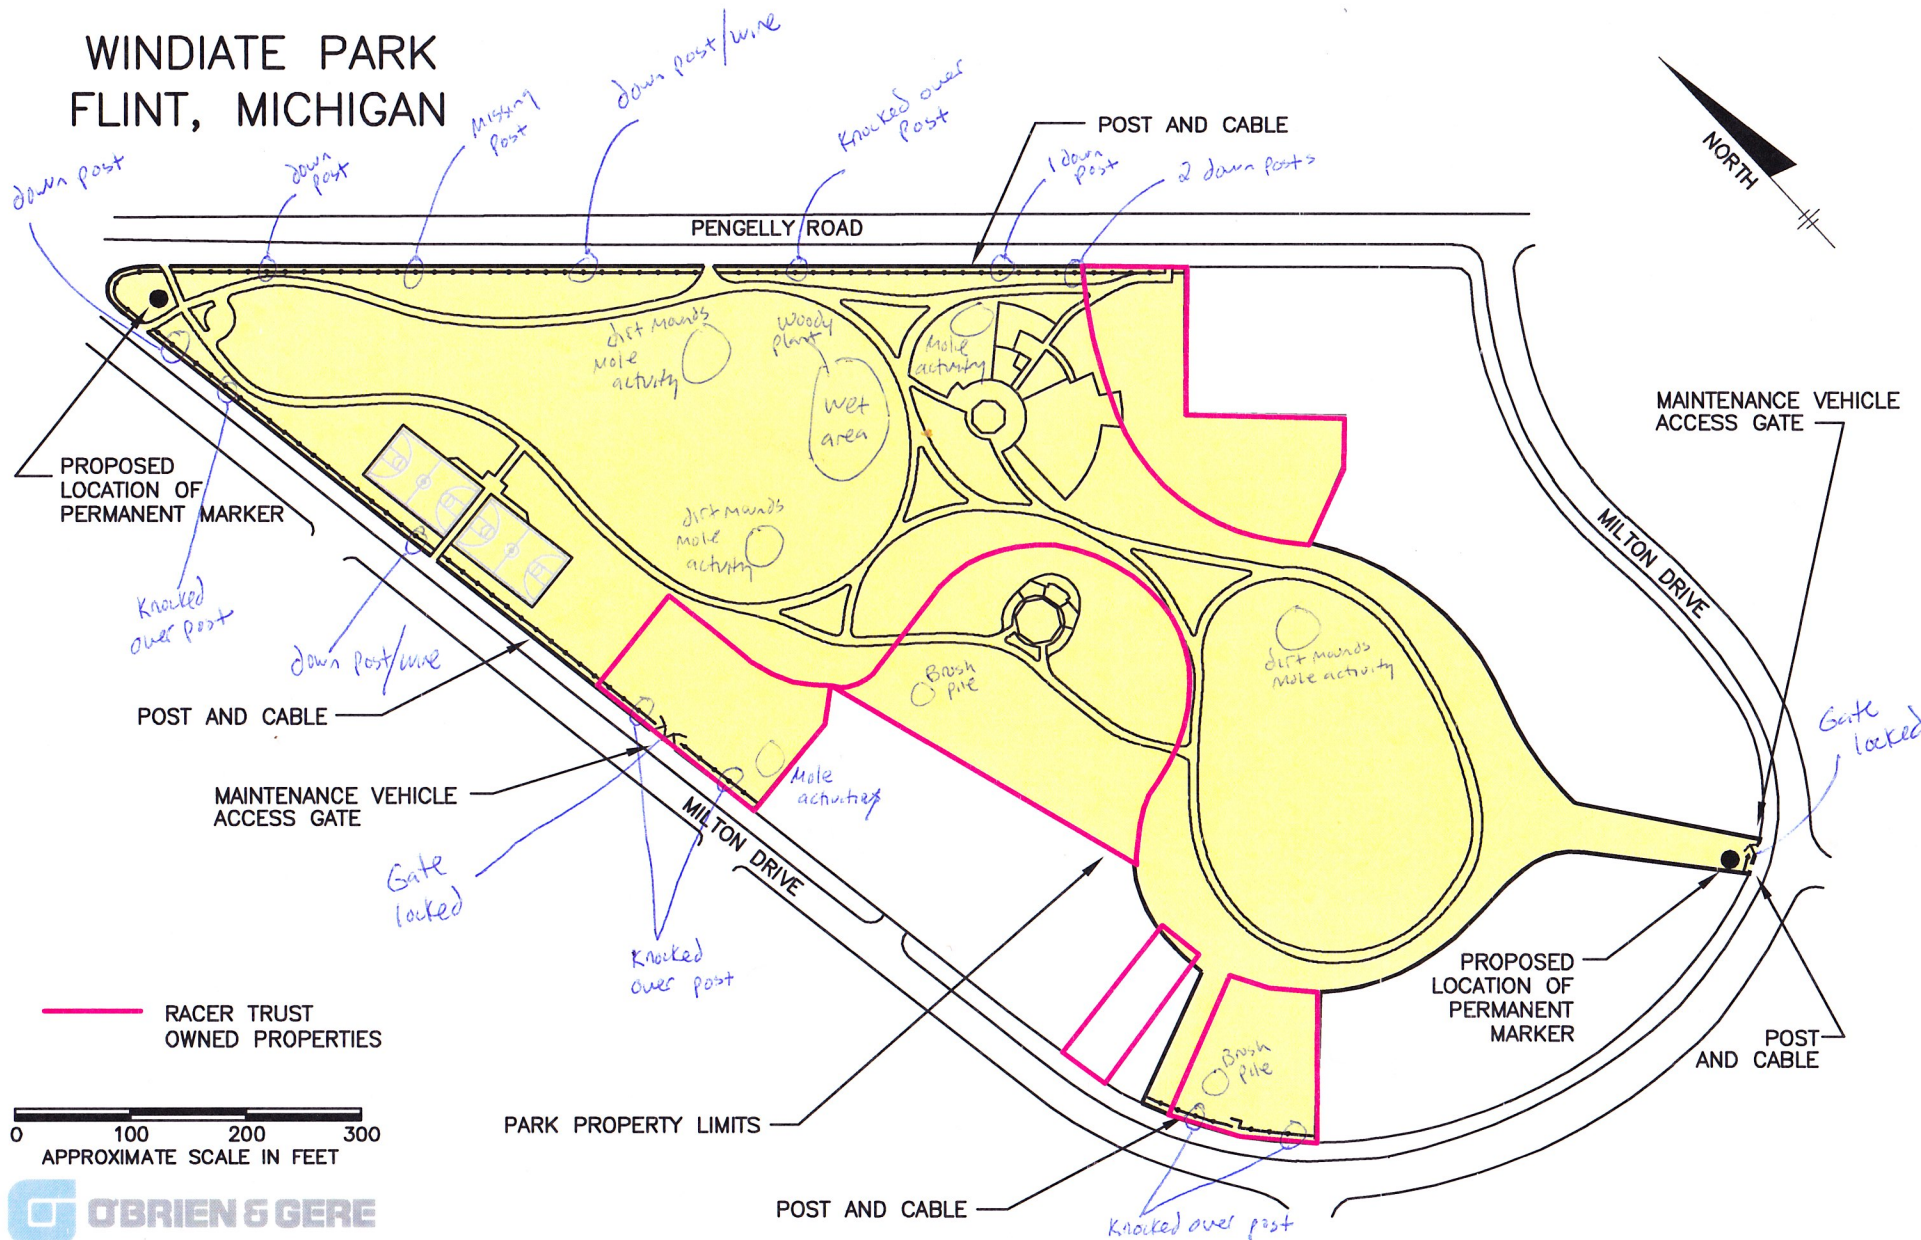
| Inspected Item: | Comments: |
|---|---|
| <i>GRASS/VEGETATIVE LAYER</i> | Acceptable. No maintenance required at this time. One area was observed where water had previously ponded after rain events. Located east of the basketball court. |
| <i>POST &amp; CABLE / VEHICLE GATES</i> | Acceptable. Fourteen damaged posts were observed during the site inspection (either partially down or completely down). Two sections of down cable were observed. The south and west maintenance vehicle access gates were locked. |
| <i>OTHER OBSERVATIONS</i> | A number of mole mounds were observed. Fewer disturbances were observed compared to previous inspections. |

Add additional soil to area where water has ponded.
