**Landfill Inspection Report  
Coldwater Road Landfill  
Flint, Michigan  
MID 005 356 860**

**RACER Trust  
Detroit, Michigan**

February 2015

RE: 2014 Annual Landfill Inspection Report  
Coldwater Road Landfill  
Flint, Michigan  
FILE: 15388/51440/rep

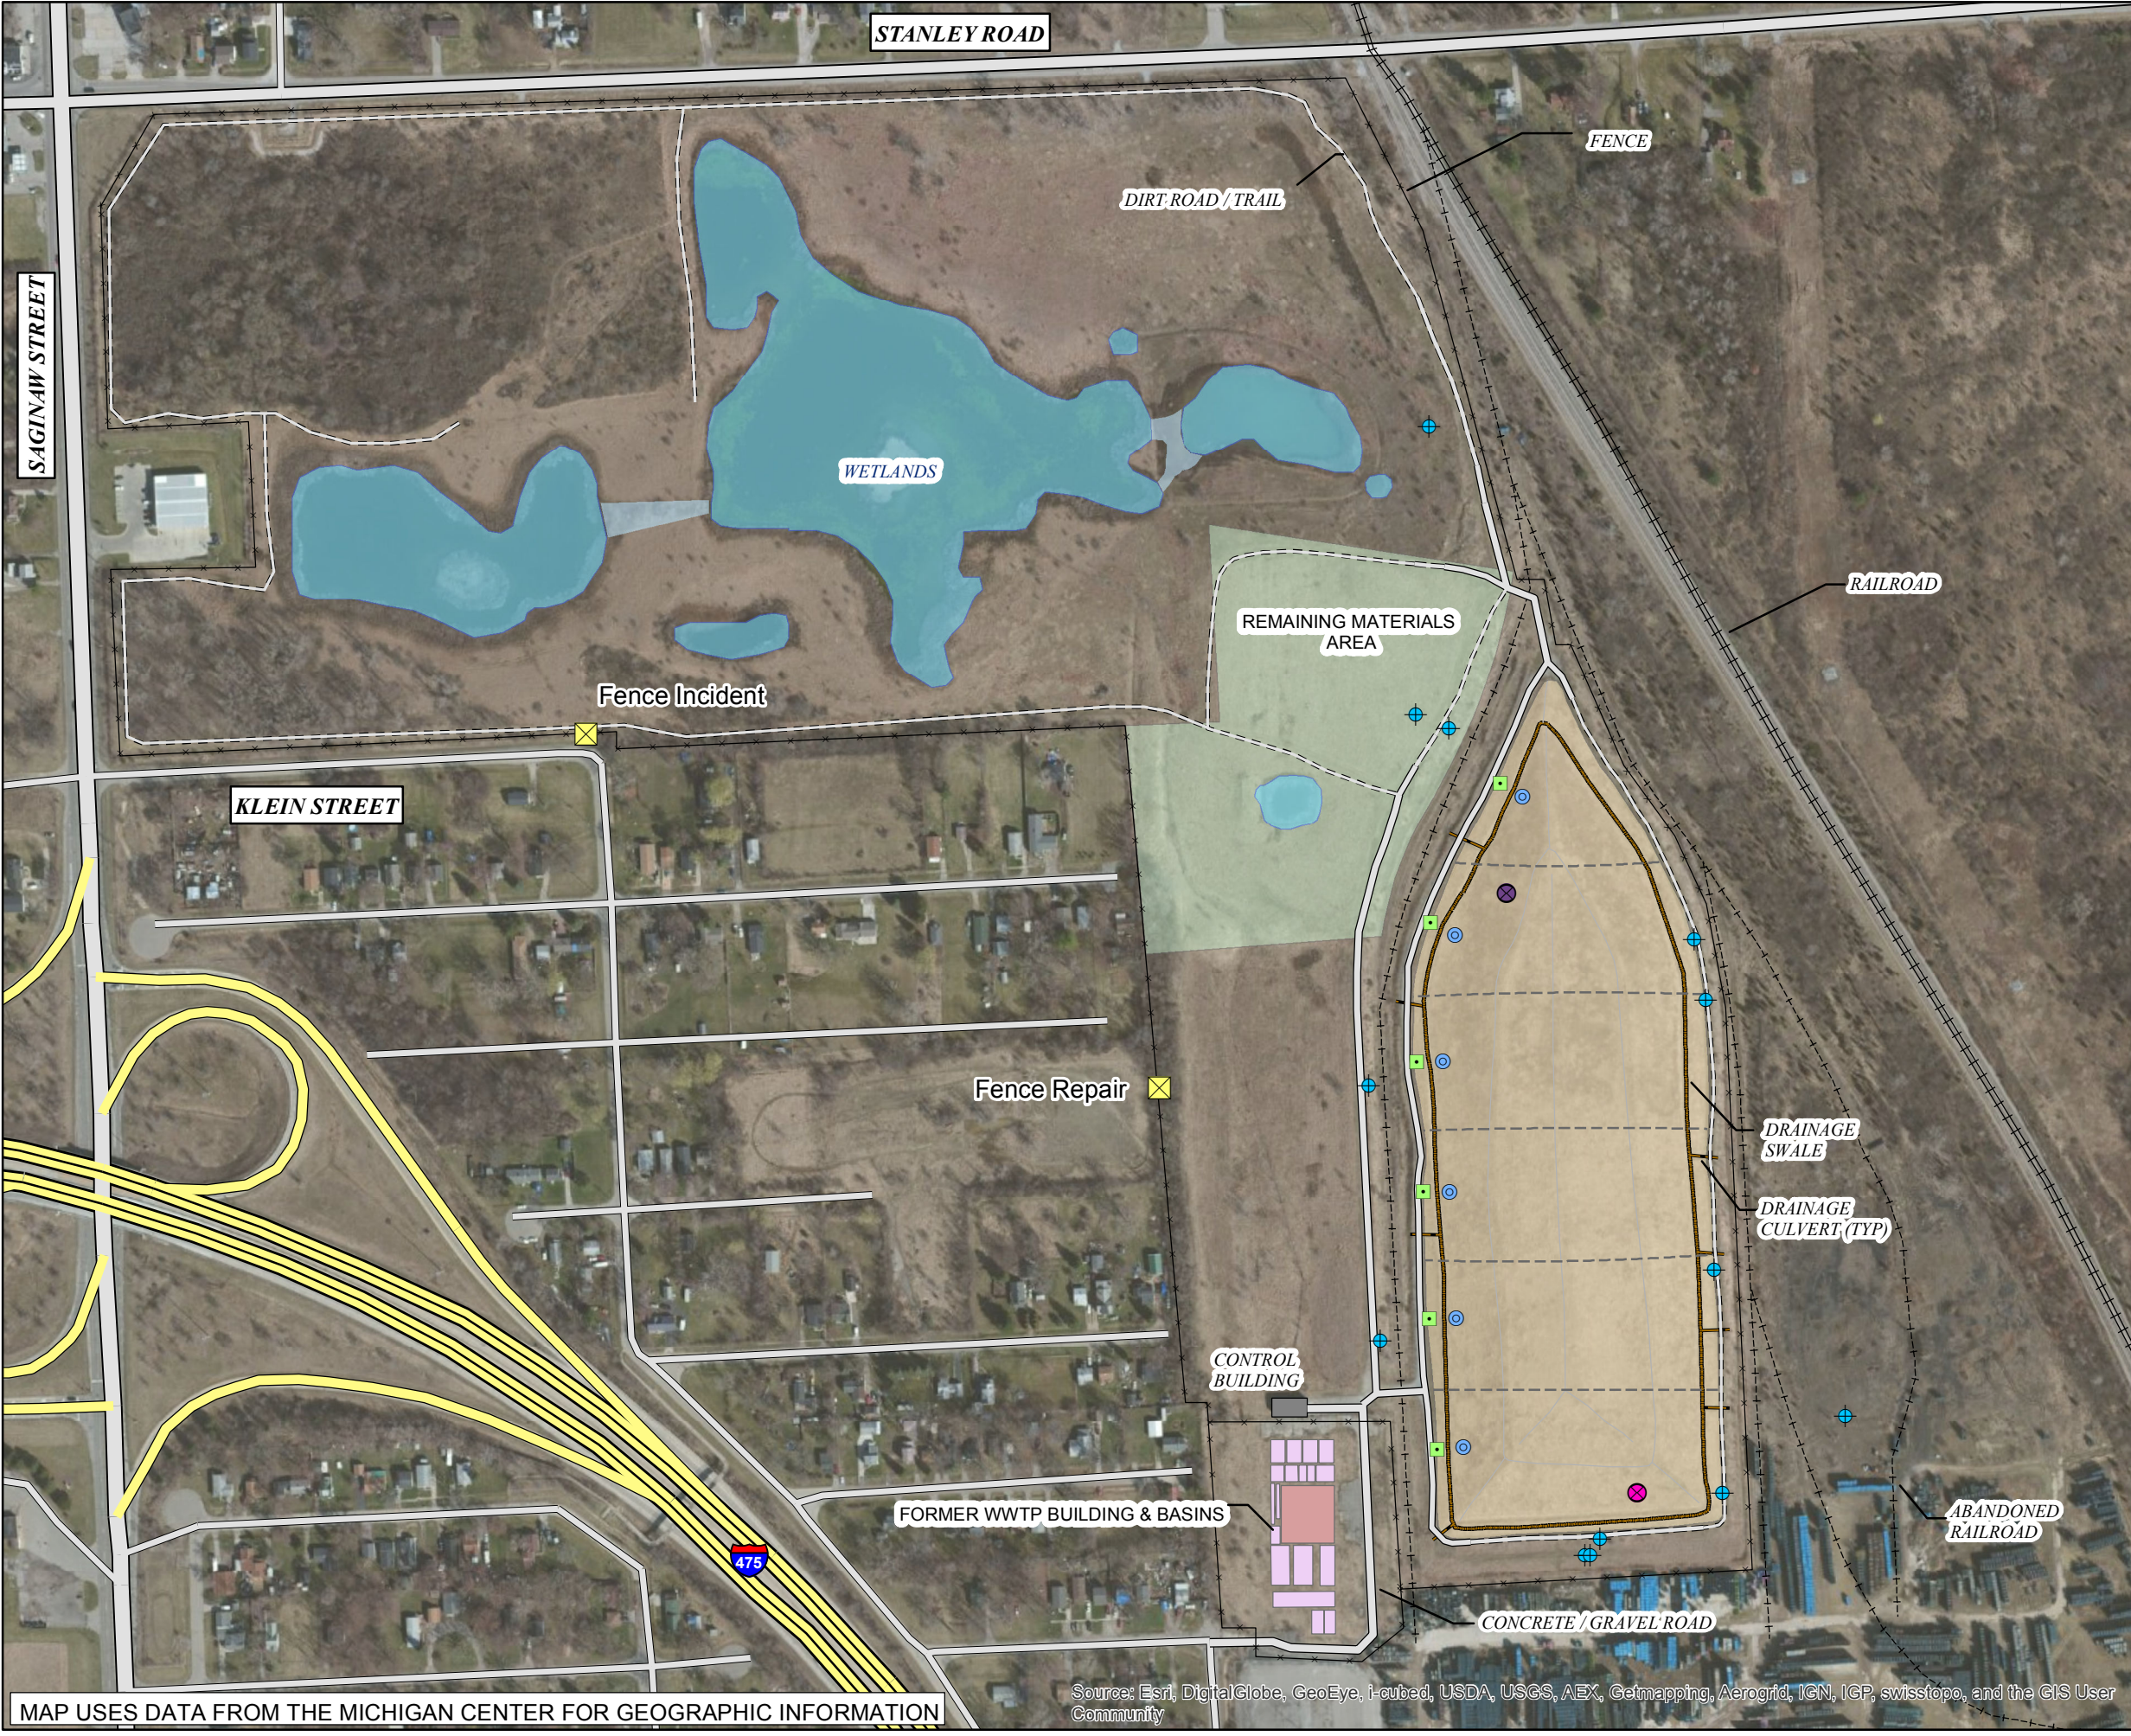
FIGURE 3

Two animal burrows were identified and closed throughout the year. Animal burrows were photographically documented (before and after repair), and the approximate size and configuration of the burrows were documented and included in the Quarterly Status Reports.

Damage to the site perimeter fence was noted at two locations during the quarterly inspections. During the 1<sup>st</sup> quarter inspection, one previously repaired hole was reopened along the west perimeter fence. During the 3<sup>rd</sup> quarter inspection, the southwest perimeter fence along Klein Street appeared to have been hit by a vehicle. The fence was pushed in with one pole being partially bent. The integrity of the fence is intact and still standing, providing adequate protection.

Traps were set at the opening of each of the animal burrows. Animals were trapped at each burrow after a several weeks of being set up. The burrows were filled using methods approved by the Michigan Department of Environmental Quality (MDEQ). Animal burrows located during the quarterly inspections are noted on Figure 3. A log of burrow activity throughout the year is maintained at the landfill. The log contains information on the date that a burrow was identified, response activities, and the date the burrow was filled and seeded.

The hole in the perimeter fence was repaired during the 1<sup>st</sup> quarterly inspection on March 20, 2014.

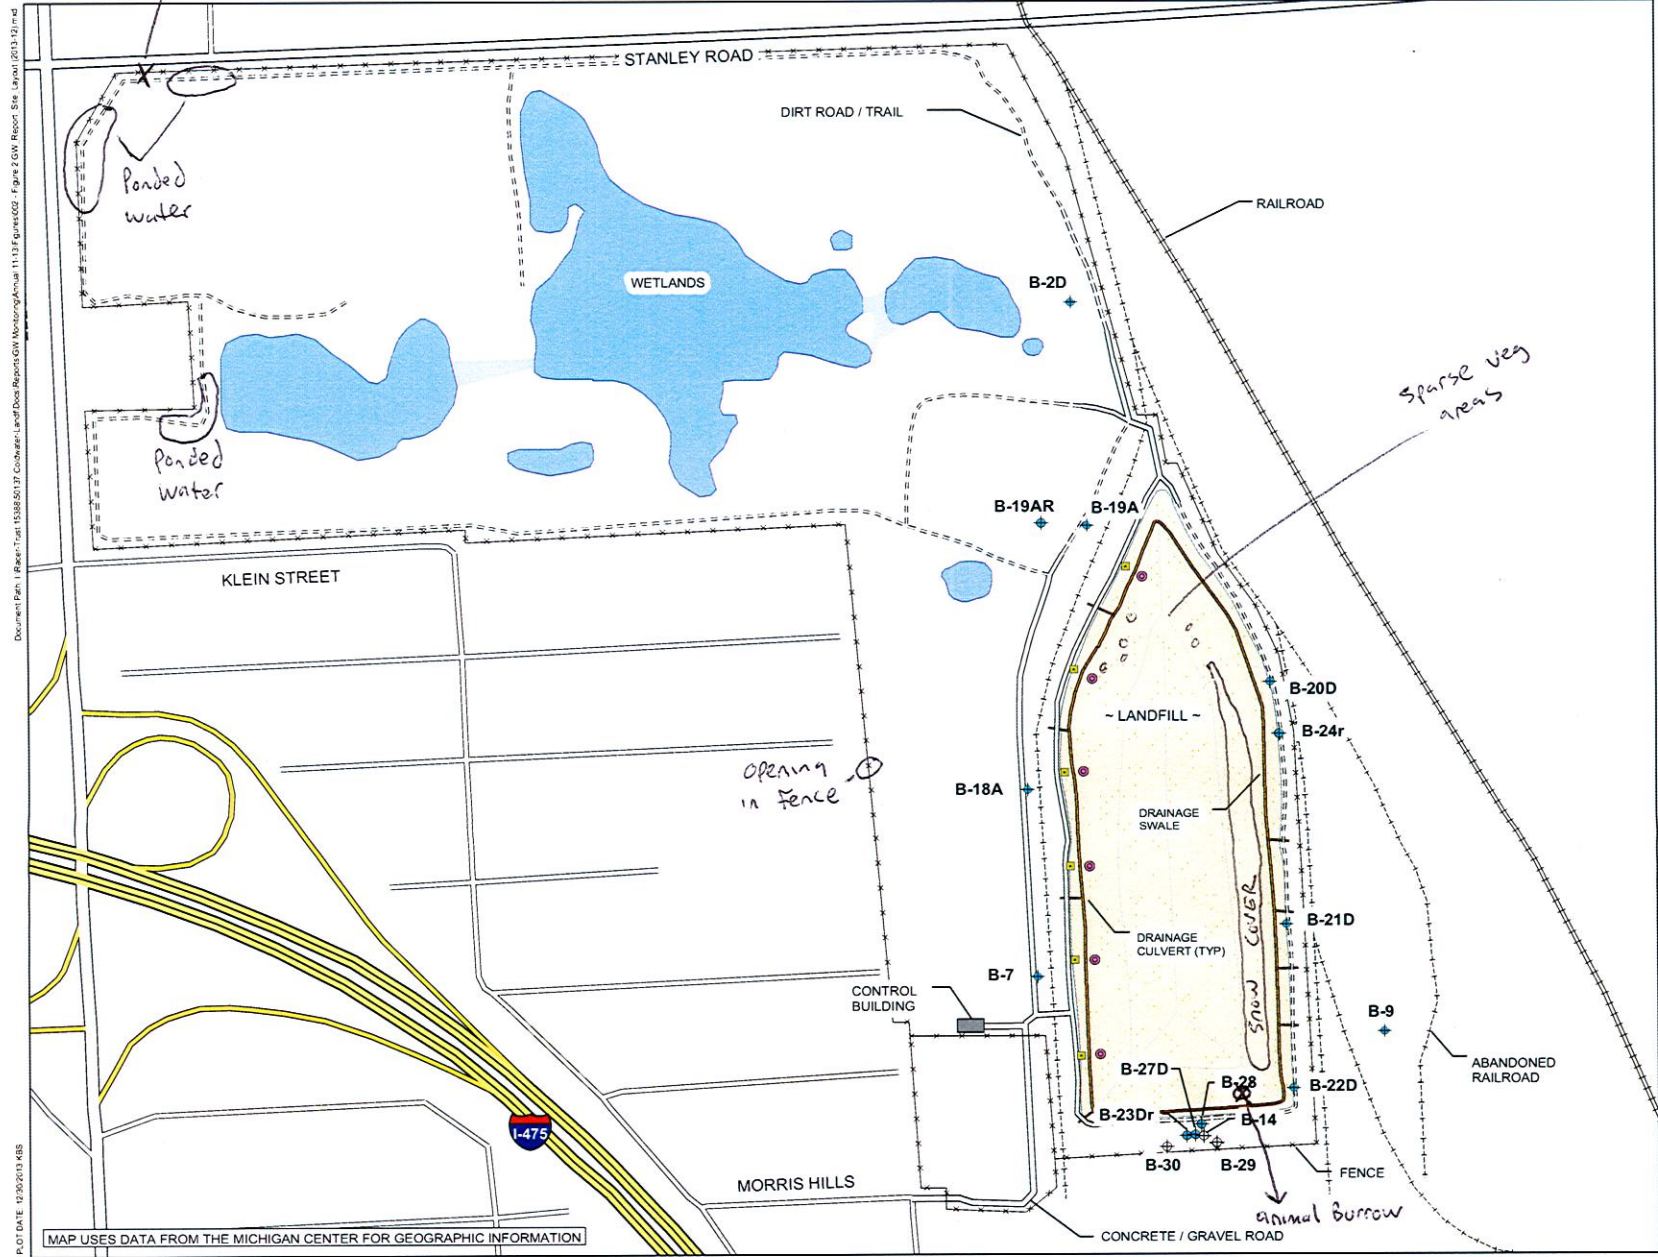
FIGURE 2

Area of Inspection	Animal Burrows?	Soil Erosion	Slope Failures?	Ponding?	Washouts?	Liner damage or exposure?	If yes to any, describe issue, location, and actions taken	Date Corrected
Cell A	No	No	No	No	No	No		
Cell B	No	↓	↓	↓	↓	↓		
Cell C	No							
Cell D	No							
Cell E	No							
Cell F	Yes							
Berms	No	↓	↓	↓	↓	↓

Area	Any damage present?	Signs of unauthorized entry?	Broken or damaged locks on gates?	"Trespassing Prohibited" and "Private Property" Signs Posted?	If yes to any, describe issue, and actions taken	Date Corrected			
Fences along north property line	No	No	No	Yes					
Fences along south property line	↓	↓	↓	↓					
Fences along west property line							No	One opening @ previous repair	3/20/14
Fences along east property line

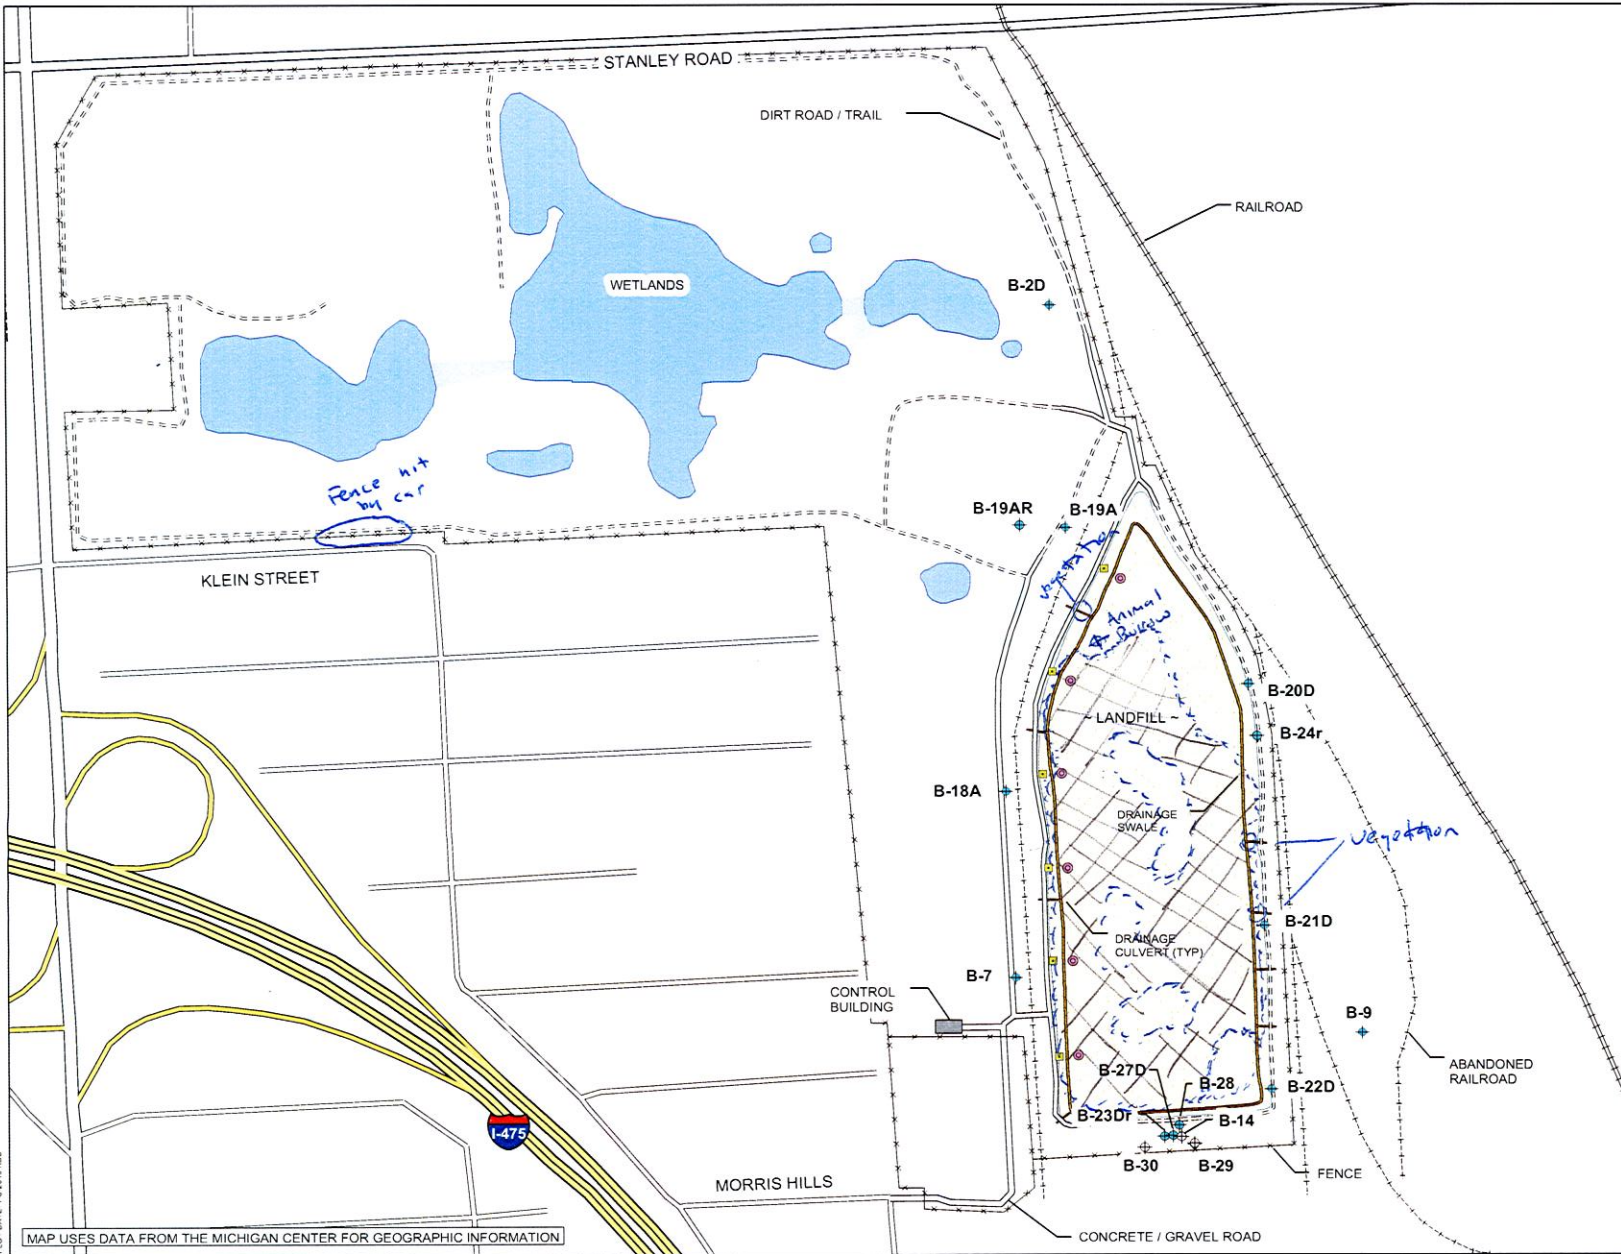
FIGURE 2

Area of Inspection	Animal Burrows?	Soil Erosion	Slope Failures?	Ponding?	Washouts?	Liner damage or exposure?	If yes to any, describe issue, location, and actions taken	Date Corrected
Cell A	No	No	No	No	No	No		
Cell B	Yes (animal burrow appears around)						set trap at animal burrow	10/22/14
Cell C	No							
Cell D	No							
Cell E	No							
Cell F	No							
Berms

Area	Any damage present?	Signs of unauthorized entry?	Broken or damaged locks on gates?	"Trespassing Prohibited" and "Private Property" Signs Posted?	If yes to any, describe issue, and actions taken	Date Corrected
Fences along north property line	No	No	No	Yes		
Fences along south property line	No	No	No	Yes		
Fences along west property line	Yes SW fence along Klein St was hit by car	No	No	Yes	fence is pushed in but still standing	
Fences along east property line	No	No	No	Yes
