RE: *Quarterly Status Report –October 2013 – December 2013*
Coldwater Road Landfill
1245 East Coldwater Road, Flint, MI
MID 005 356 860
FILE: 15388/50137/Docs

**4TH QUARTER 2013
BURROW LOCATION
MAP**

COLDWATER RD LANDFILL – ANIMAL BURROW PHOTO LOG

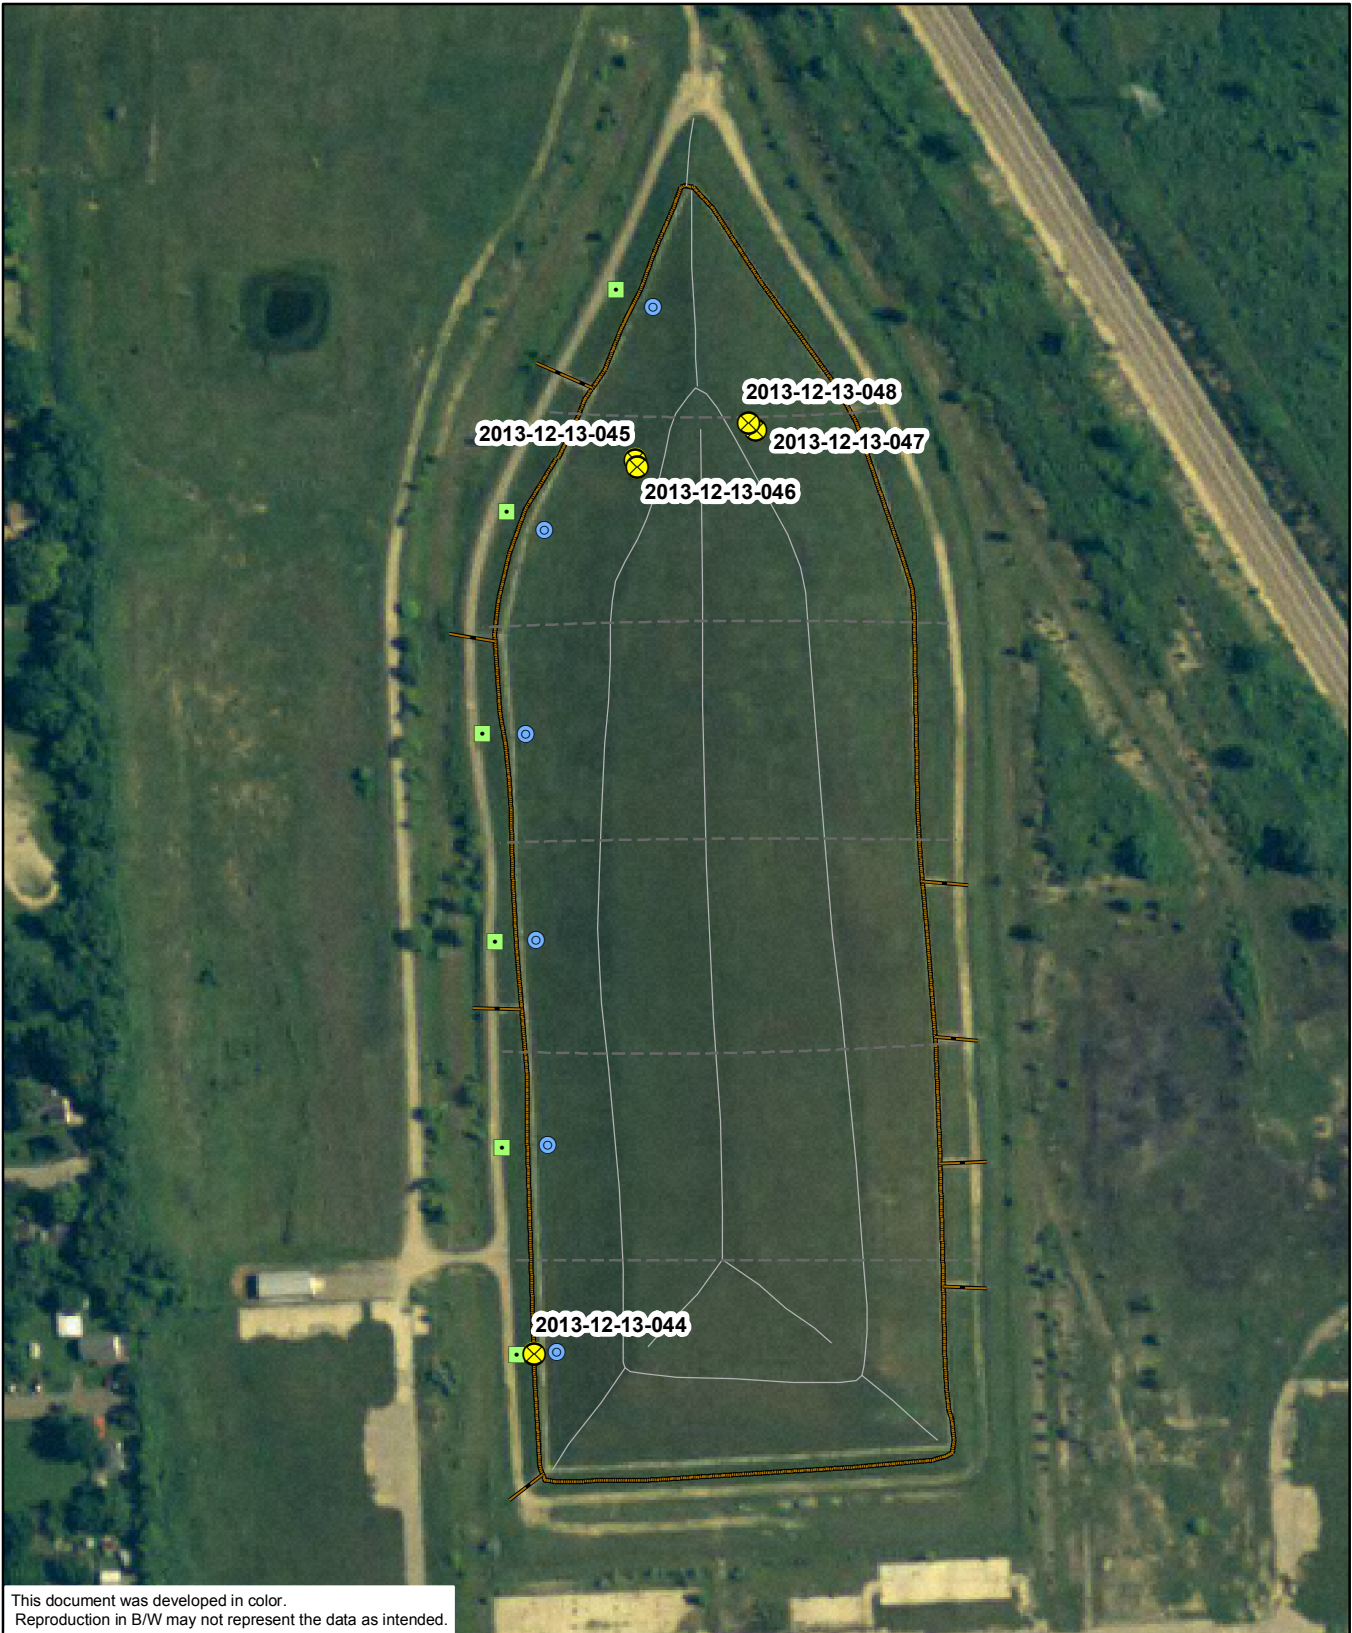
- » Observed 3 potentially active animal burrows on October 17, 2013 and set traps. See attached figure for animal burrow locations and photo log for detailed information concerning animal burrow activities for this quarter. The entrances to the burrows were temporarily blocked (filled) with rip rap because the available soils on site were frozen and could not be used for backfilling the burrows. Sand will be purchased and used to backfill the burrows prior to the next site visit to complete the backfilling efforts until spring, when topsoil will be placed over the backfilled burrows and grass seed will be spread over the backfilled areas.

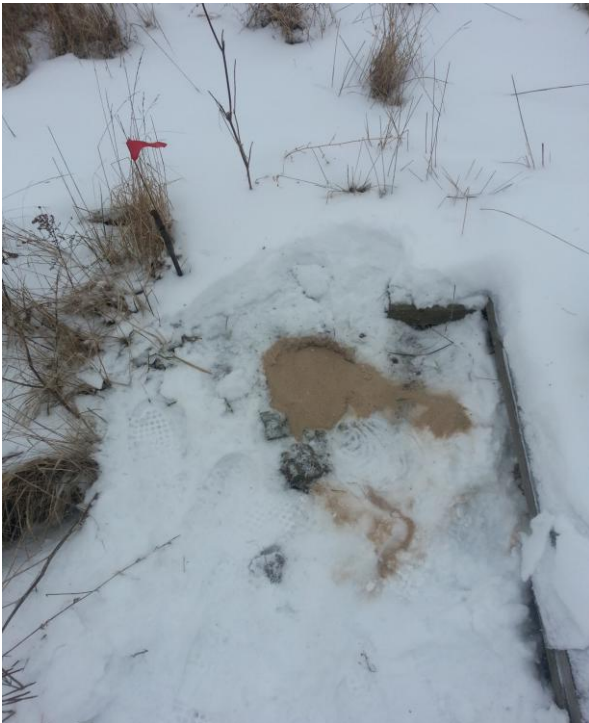
LOCATION:		APPROX. LENGTH:	APPROX. DEPTH:	APPROX. DIAMETER:
F1 – Bottom of Slope		5+ ft	1 ft	7 inch
DATE FOUND: 10/17/13	DATE CLOSED: 12/13/13	 		
NOTES: ID: 2013-12-13-044 PRE repair photo. Trap set up for eight weeks. Trap was moved by animal three times and reset. No activity after four weeks. No animal trapped. No signs of liner damage.				
LOCATION:		APPROX. LENGTH:	APPROX. DEPTH:	APPROX. DIAMETER:
F1 – Bottom of Slope		5+ ft	1 ft	7 inch
DATE FOUND: 10/17/13	DATE CLOSED: 12/13/13

NOTES: POST repair photo. Filled in burrow. Will spread grass seed in spring.

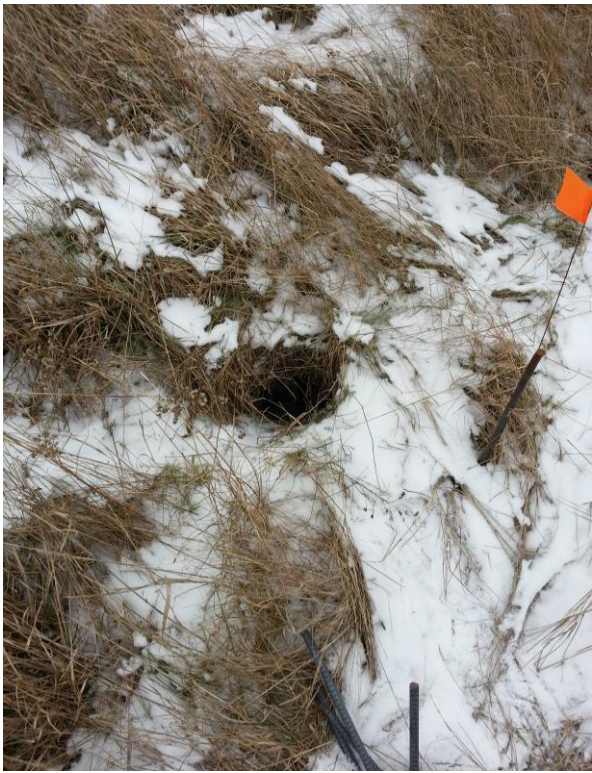
NOTES: ID: 2013-12-13-045 PRE repair photo of burrow entry. Trap set up for eight weeks. Trapped animal at exit burrow. The distance between the entry (045) and exit (046) was approximately eight feet. No signs of liner damage.				
LOCATION: B1 – Middle of Slope		APPROX. LENGTH: 5+ ft	APPROX. DEPTH: 1.5 ft	APPROX. DIAMETER: 8 inch
DATE FOUND: 10/17/13	DATE CLOSED: 12/13/13
