Date: December 20, 2024

Subject: 2024 Exposure Barrier Inspection Report for Plant 2, Areas 2, 5-2, 5-3, and Tank 225 Area; Plant 3, Areas 14, 18, and 19; and Plant 6, Area 5-6  
RACER Lansing Plants, Lansing, Michigan

**MAINTENANCE OF EXPOSURE BARRIERS**  
**INSPECTION LOG SHEET**  
 RACER Trust Plants 2 and 3 – Lansing, Michigan

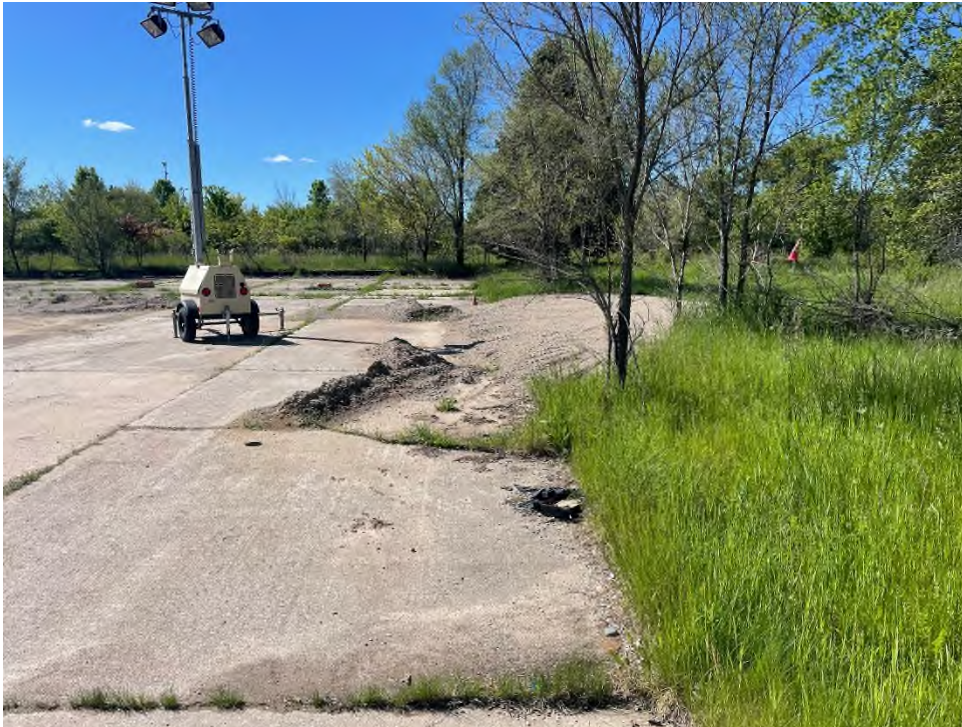
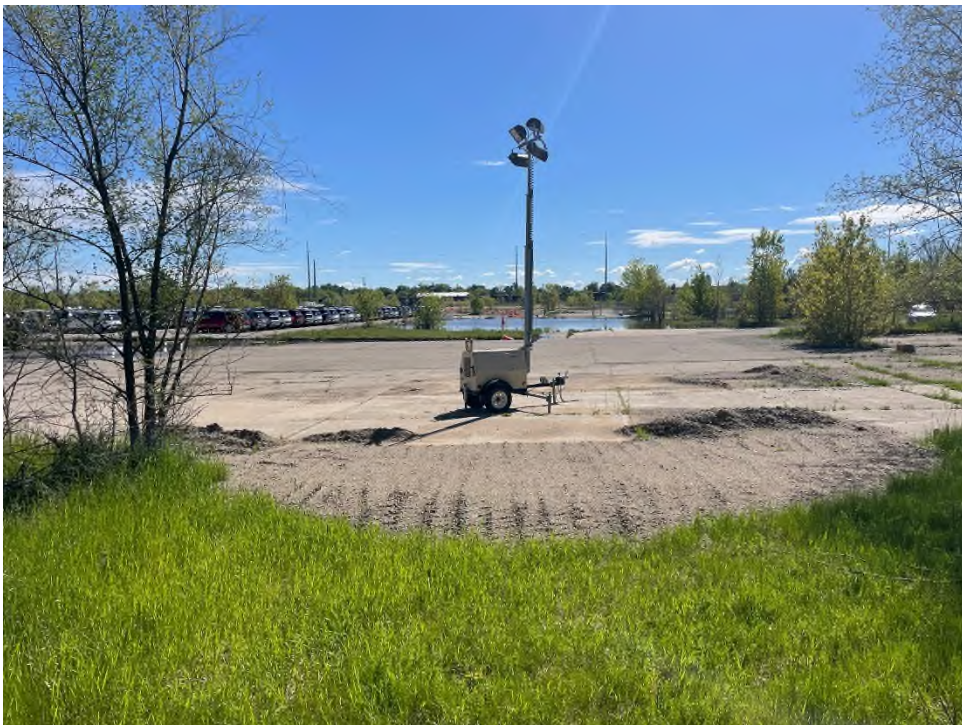
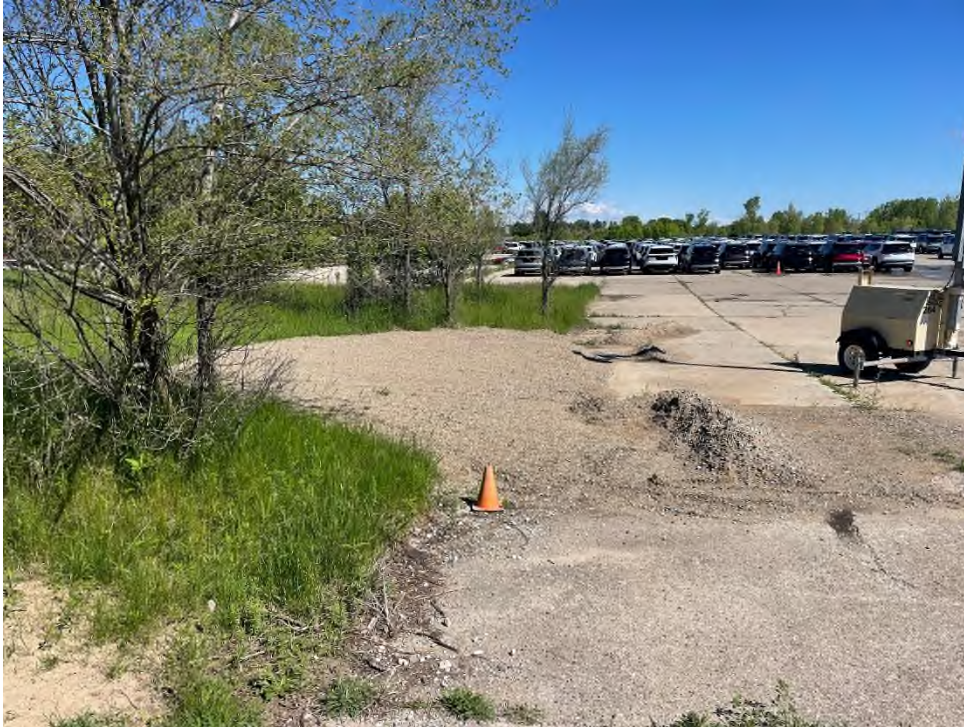
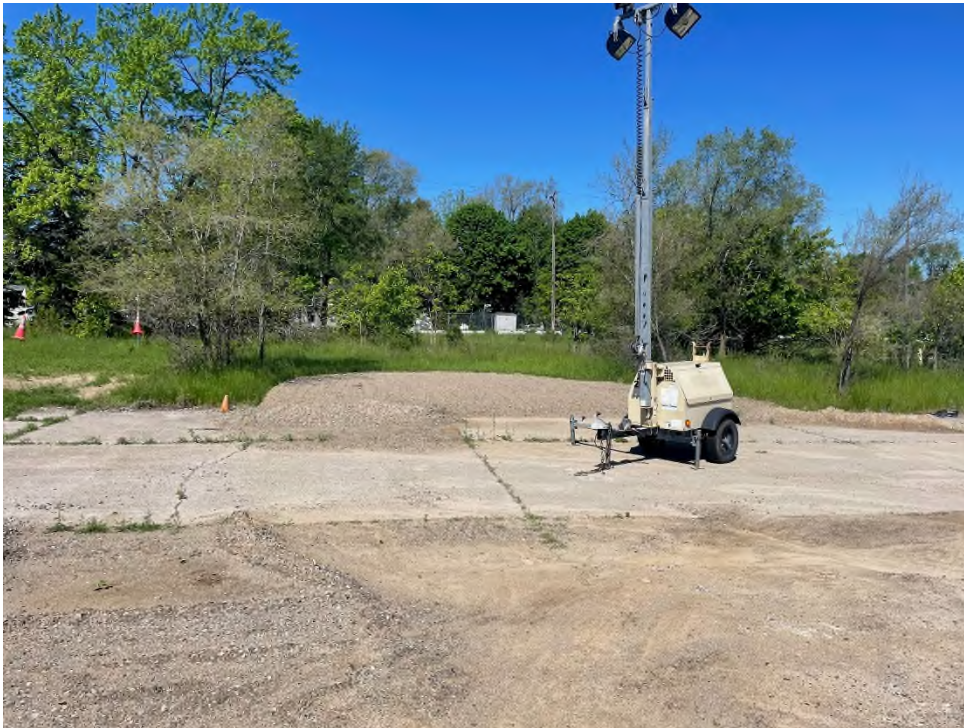
- Plant 2 Area 2 Exposure Barrier – condition was noted as satisfactory. The exposure barrier area consists of existing concrete pavement. The concrete shows some signs of weathering and cracking, with some areas also containing short grass growth. At the time of the inspection the exposure barrier appears to be functioning adequately to prevent exposure to the underlying soil containing concentrations of arsenic that exceed Michigan Environment, Great Lakes, and Energy (EGLE) Part 201 generic Nonresidential Direct Contact Criteria (December 30, 2013). Accordingly, no corrective actions are recommended. The soils above Direct Contact Criteria for arsenic were located between existing concrete and a grassy area onsite. Therefore, in December 2023, an excavation was completed to remove impacted soils in the grassy area onsite. The existing concrete remains over the soils that were not removed during excavation and constitutes the exposure barrier area that will be visually inspected on an annual basis. The excavation activities

<b>Exposure Barrier</b>	<b>Groundcover Condition</b> (Describe weathering, erosion, settling, water ponding, vegetation growth, etc.)	<b>Overall Condition</b> (Good / Fair / Poor)	<b>Photo Notes</b> (Attach labelled photographs)
Plant 2 Area 2 Exposure Barrier	The Eastern half of exposure barrier consists of a concrete cap. The concrete shows little cracking with short grassy growth in a few areas. The Western half of the exposure barrier consists of a gravel and dirt cap. No signs of settling, weathering, and erosion. No vegetation growing in western half.	Good	1. See attached photo log for pictures of the area. 2. 3. 4.
Plant 2 Area 5-2 Exposure Barrier	Most of the exposure barrier ground cover consists of a gravel and dirt cap. No signs of settling, weathering, and erosion. No vegetation growing in the gravel and dirt at this time.	Good	1. See attached photo log for pictures of the area. 2. 3. 4.

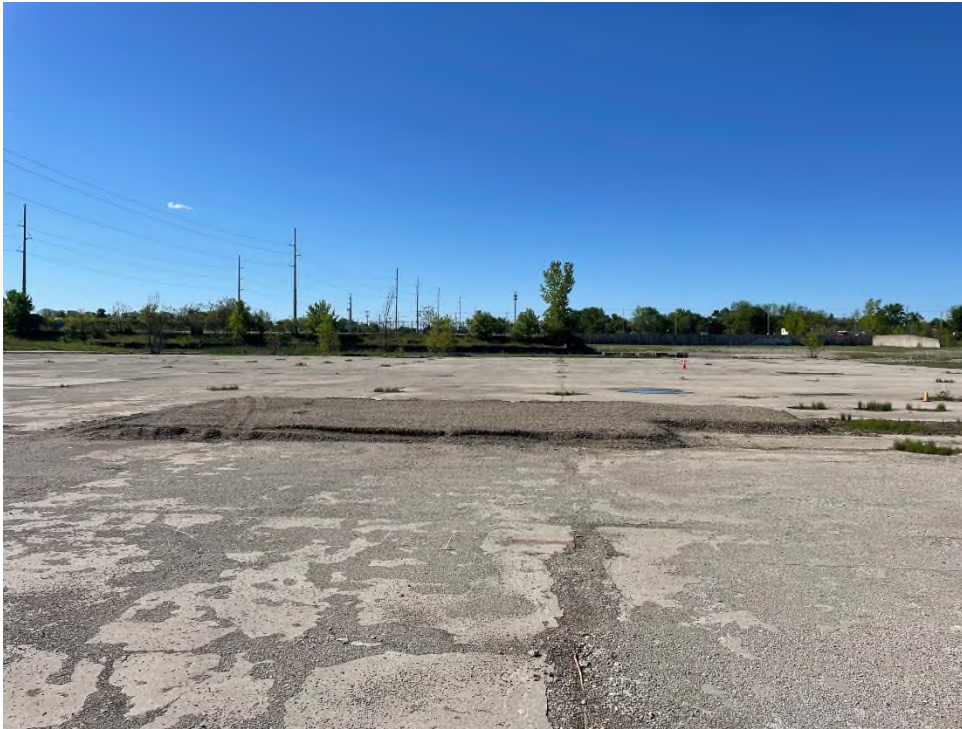
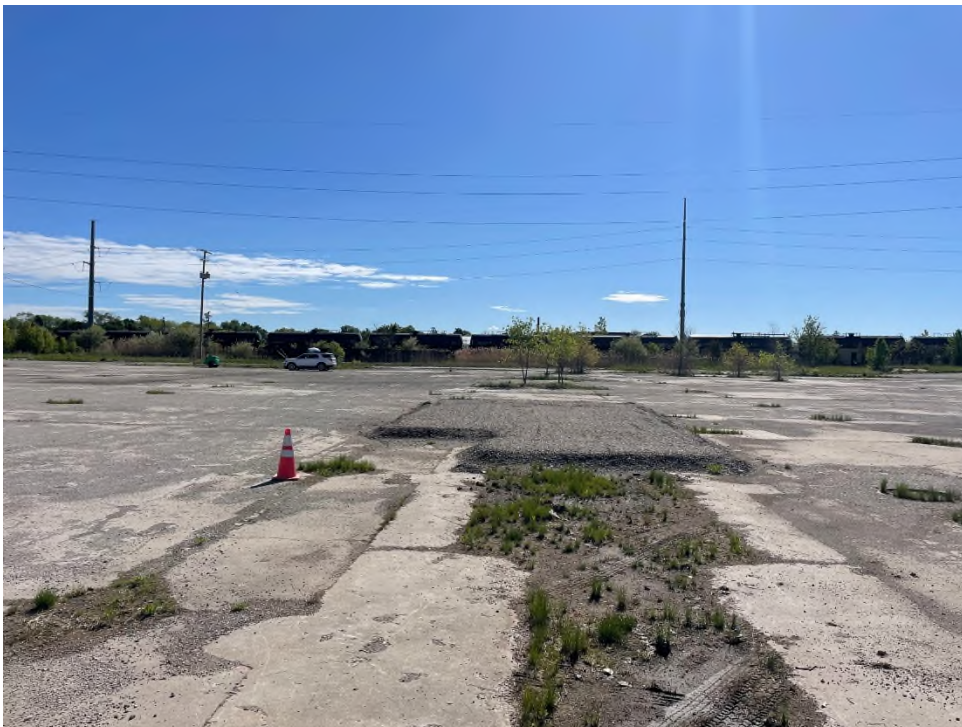
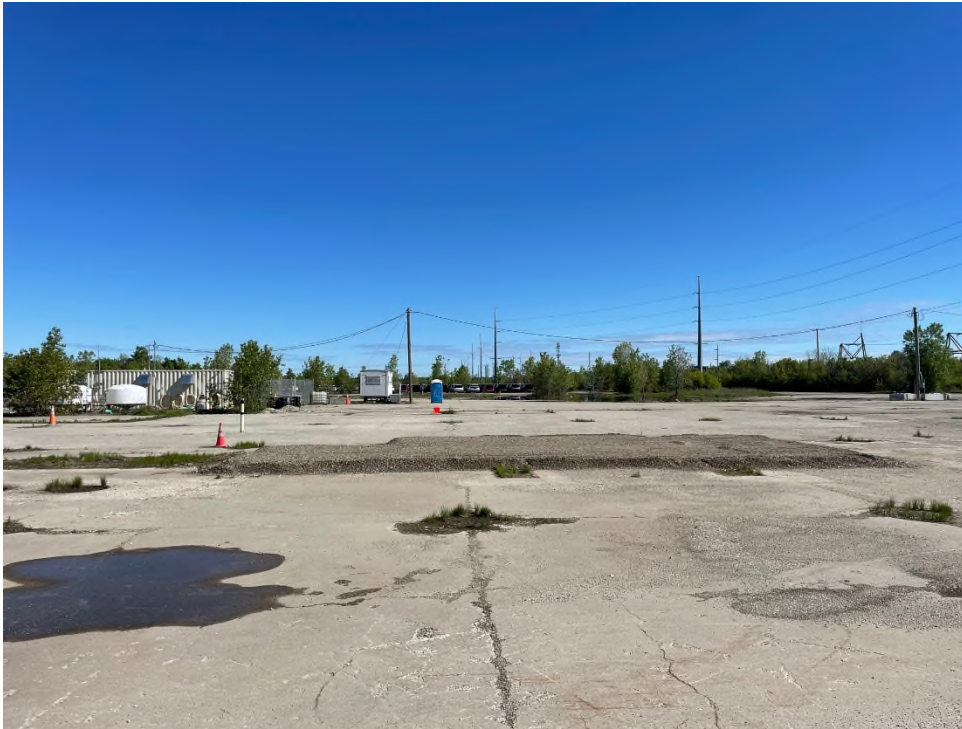
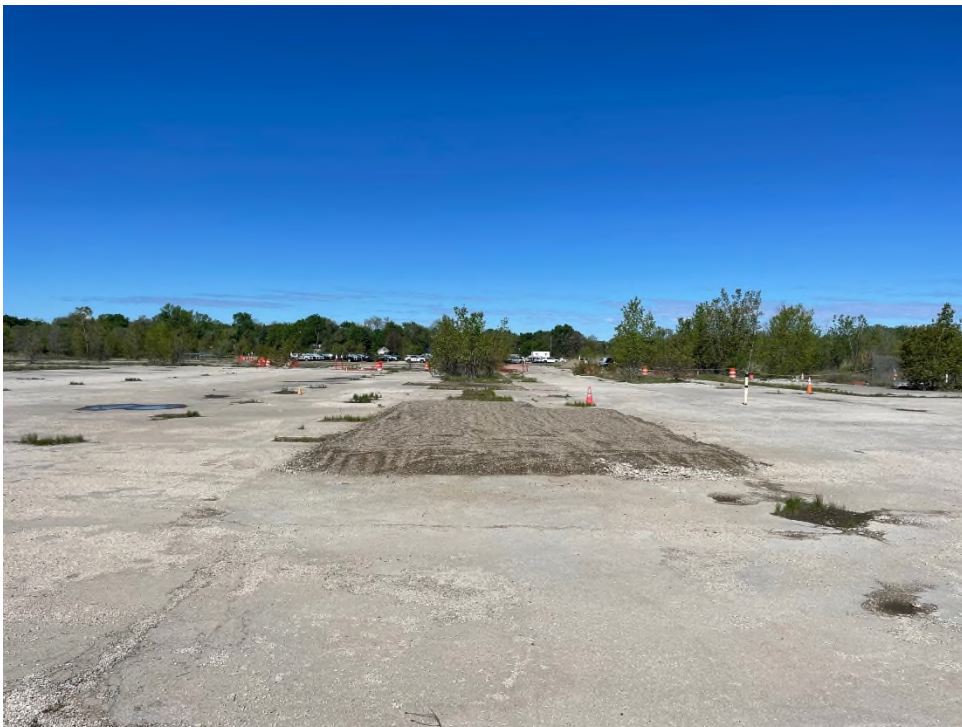
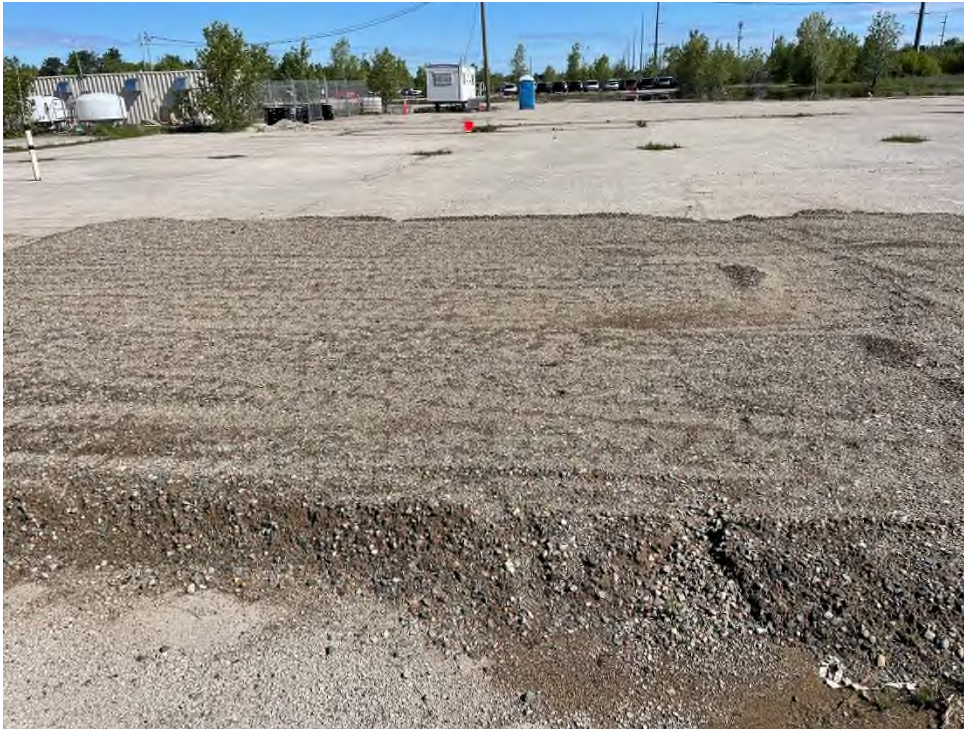
- Plant 2 Area 5-2 and Area 5-3 Exposure Barriers – condition was noted as satisfactory. The exposure barriers in these areas were placed in December 2023 and consist of demarcation fabric underlying an approximate 6-inch to 1-foot layer of 22A road gravel. During inspection no vegetation was observed to be growing in the exposure barrier areas. At the time of the inspection the exposure barriers appeared to be functioning adequately to prevent exposure to the underlying soil containing concentrations of benzo(a)pyrene that exceed EGLE Part 201 generic Nonresidential Direct Contact Criteria (December 30, 2013). Accordingly, no corrective actions are recommended. The exposure barrier placement activities are summarized in the *Plant 2 Area 2 Excavation and Plants 2 and 3 Exposure Barrier Placement Completion Report*, dated August 1, 2024 that has been submitted to EGLE. Due to the new exposure barrier placement at Areas 5-2 and 5-3, and current new vehicle parking activity occurring at the Site, it was suggested that traffic barrels with yellow plastic chain link be placed around the exposure barrier areas to identify these areas and prevent vehicles from driving over the barriers. This was completed in July 2024.

Suggest putting new orange traffic barrels and yellow plastic chain around Plant 2 Areas 5-2 and 5-3 to protect the gravel caps from vehicle traffic.

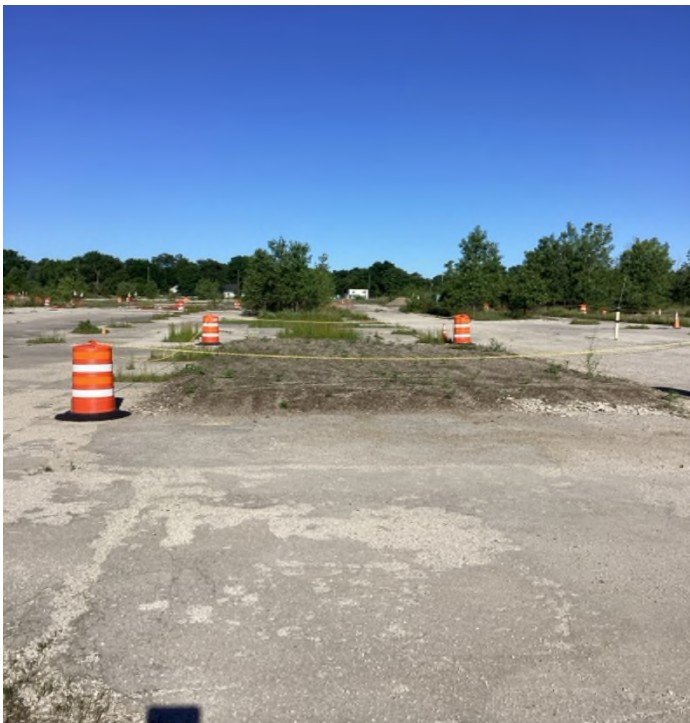
**Photograph: 6**

**Description:** Plant 2  
Area 5-2 Barrells and  
Chain Set Up

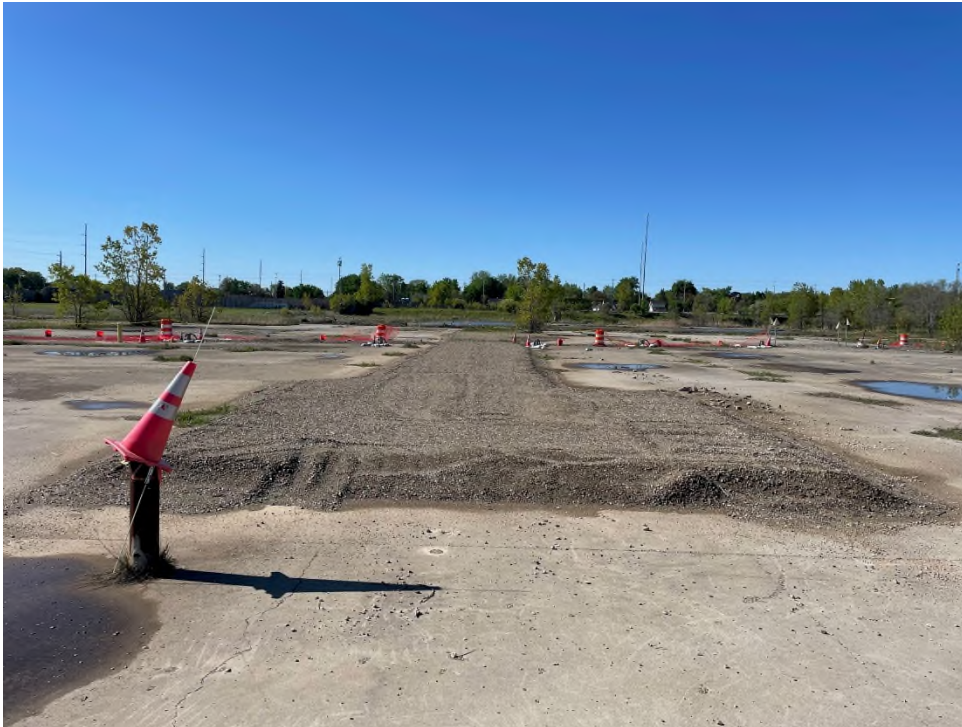
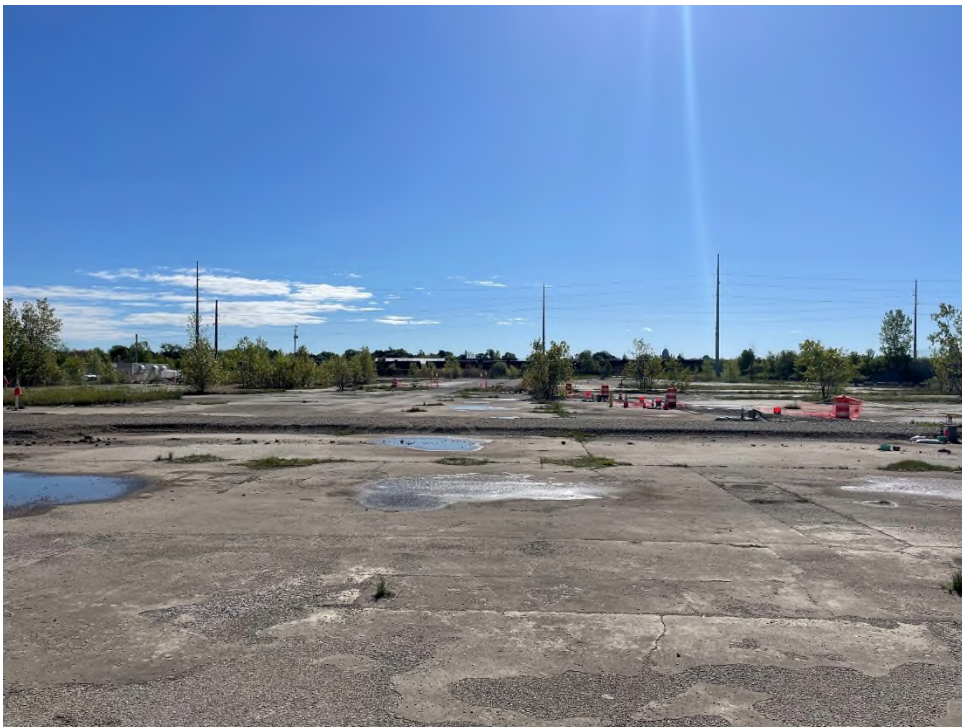
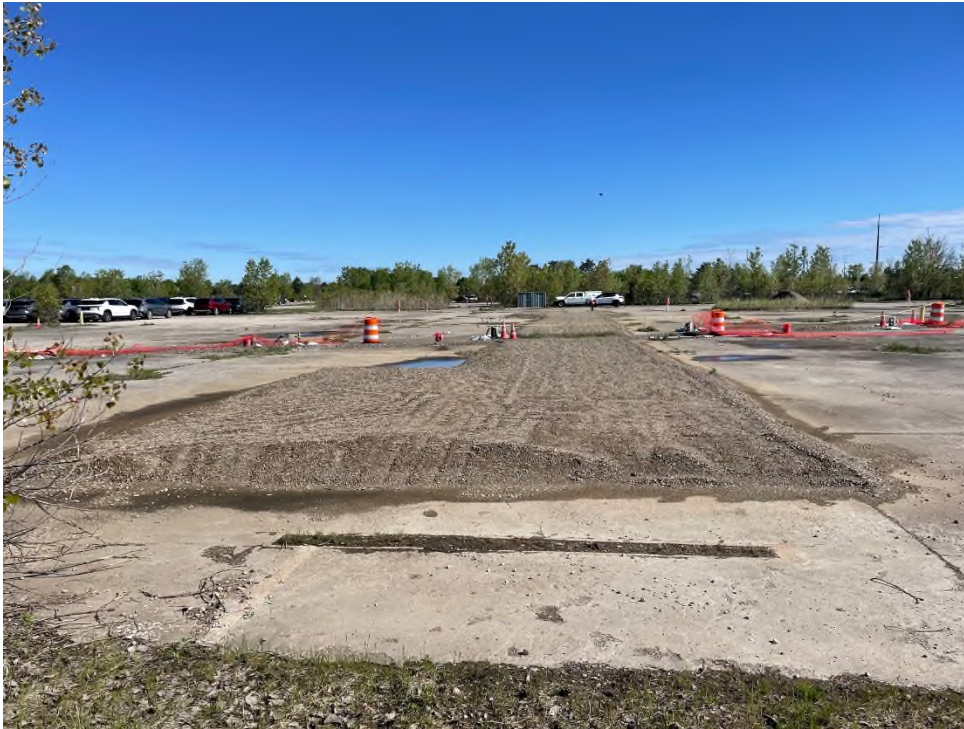
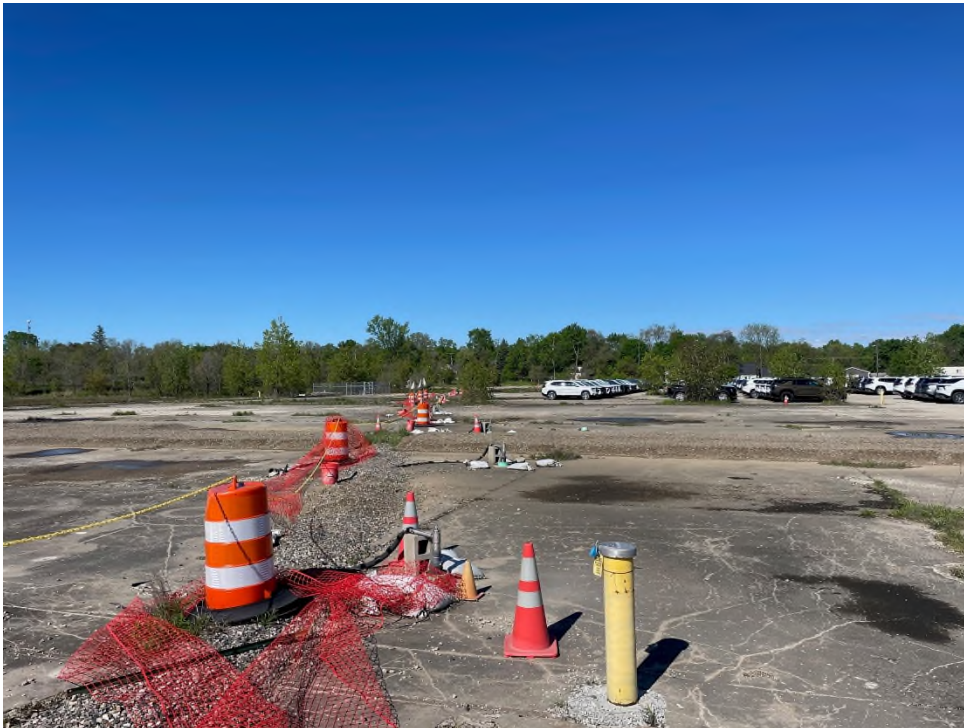
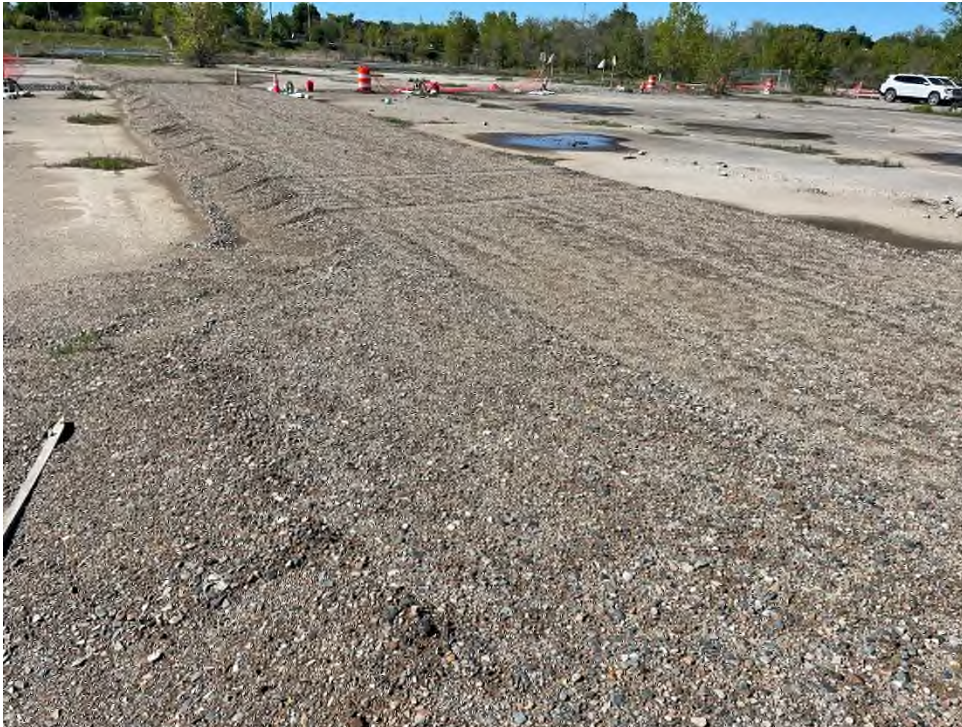
Plant 2 Area 5-3 Exposure Barrier	Most of the exposure barrier ground cover consists of a gravel and dirt cap. No signs of settling, weathering, and erosion. No vegetation growing	Good	1. See attached photo log for pictures of the area. 2. 3. 4.

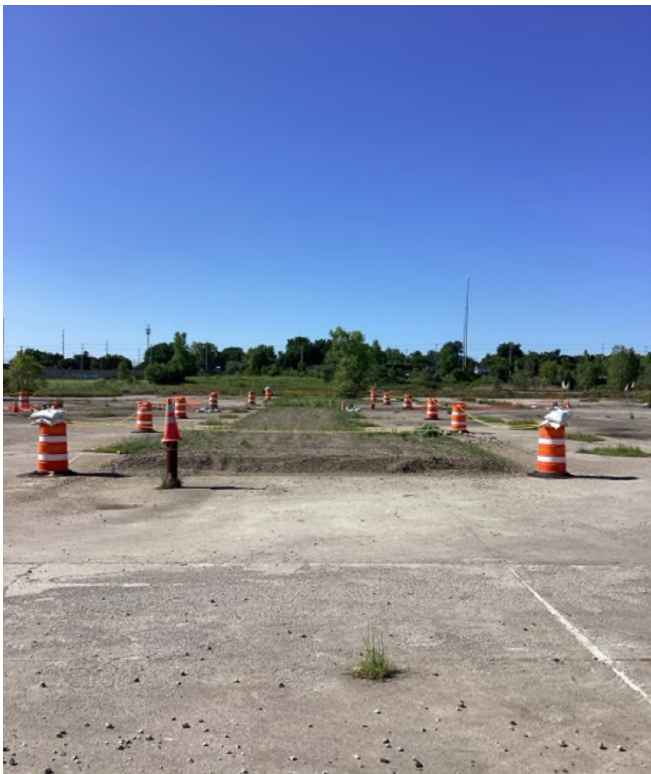
**Photograph: 6**

**Description:** Plant 2  
Area 5-3 Barrels and  
Chain Set Up

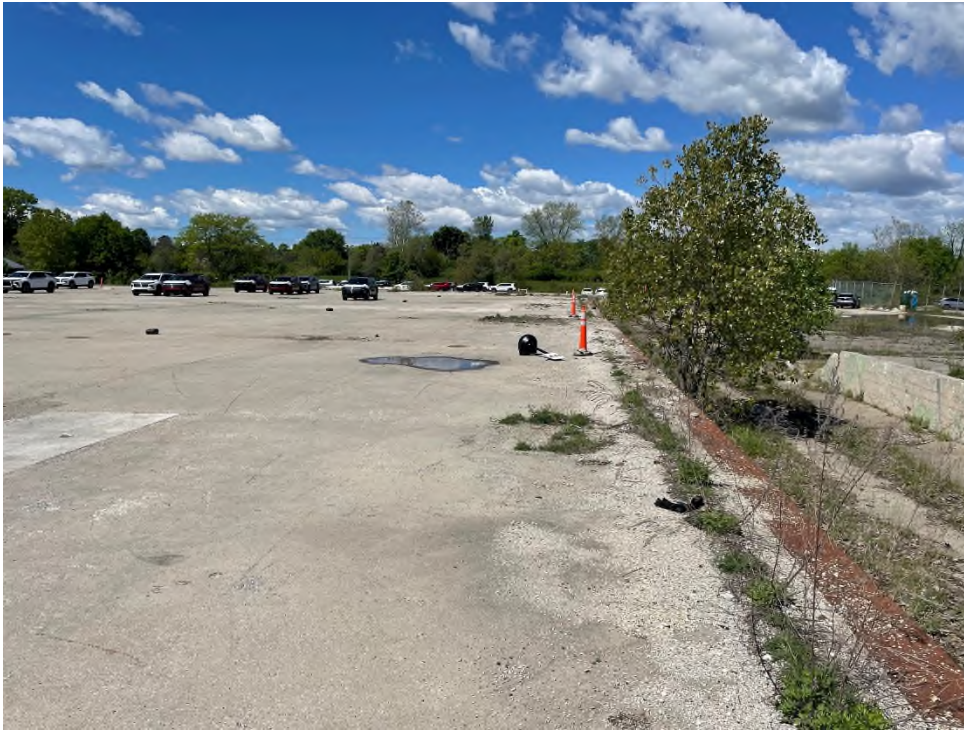
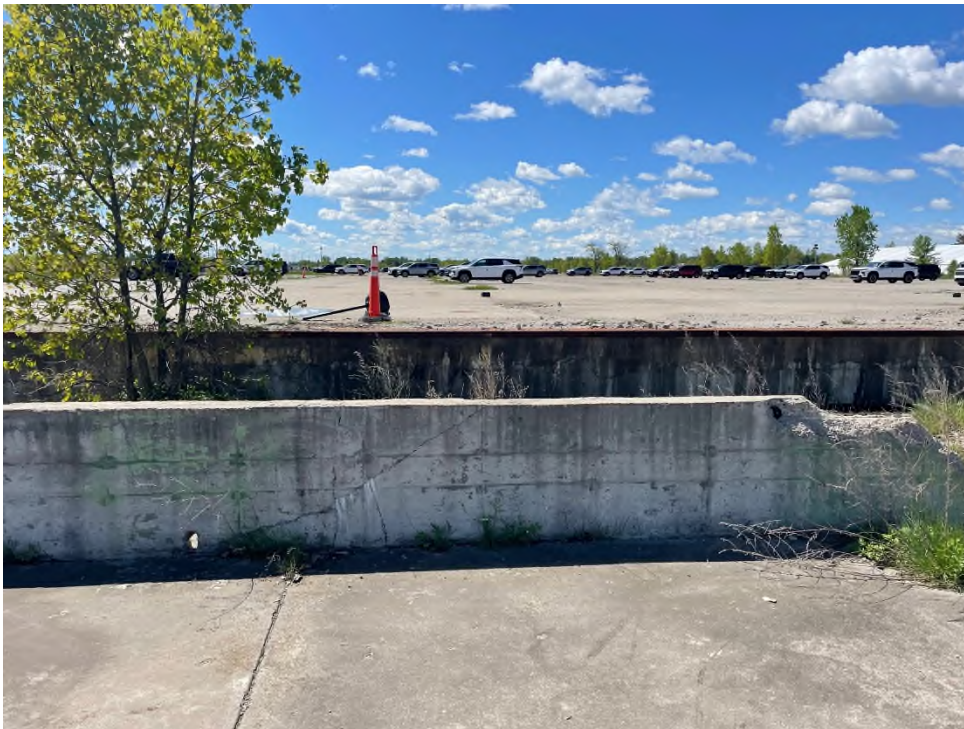
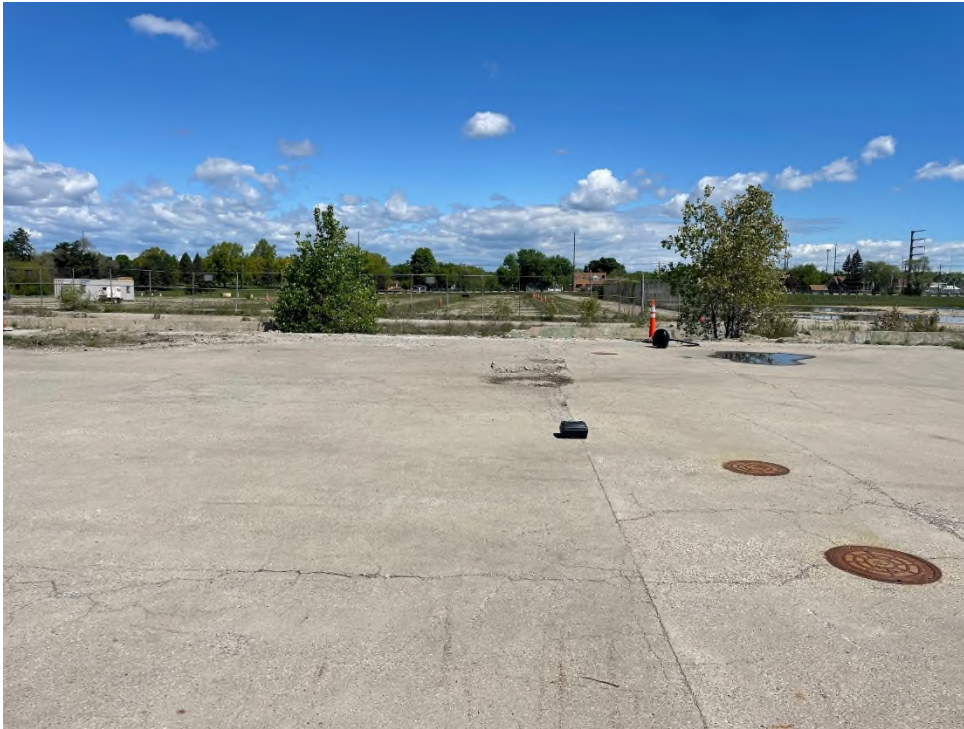
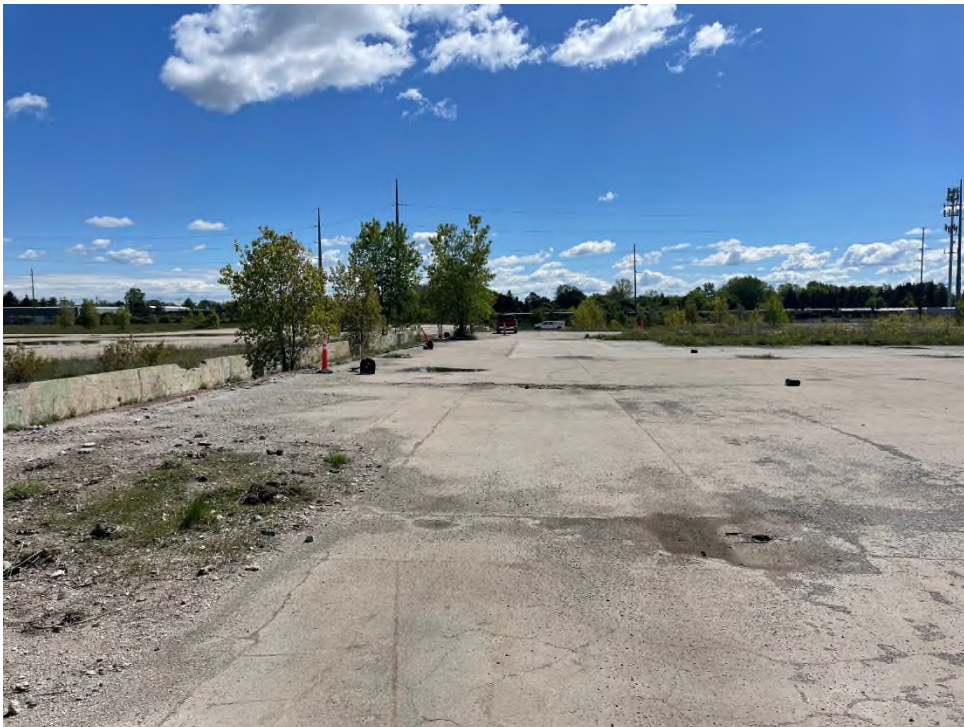
- Plant 3 Area 14 Exposure Barrier – condition was noted as satisfactory and in fair condition. The exposure barrier in this area consists of existing concrete pavement. The concrete shows some signs of weathering and cracking, with some areas also containing vegetation growth. At the time of the inspection the exposure barrier appears to be functioning adequately to prevent exposure to the underlying soil containing concentrations of cyanide that exceed EGLE Part 201 generic Nonresidential Direct Contact Criteria (December 30, 2013). Accordingly, no corrective actions are recommended.

<b>Exposure Barrier</b>	<b>Groundcover Condition</b> (Describe weathering, erosion, settling, water ponding, vegetation growth, etc.)	<b>Overall Condition</b> (Good / Fair / Poor)	<b>Photo Notes</b> (Attach labelled photographs)
Plant 3 Area 14 Exposure Barrier	Most of the exposure barrier ground cover consists of concrete pavement. The area shows some signs of weathering and cracking. There are a couple poplar trees and some weeds growing up through the cracks	Fair	<ol style="list-style-type: none"> <li>1. See attached photo log for pictures of the area</li> <li>2.</li> <li>3.</li> <li>4.</li> </ol>
Plant 3 Area 18 Exposure Barrier	Most of the exposure barrier ground cover consists of a gravel and dirt cap. No signs of settling, weathering, and erosion. No vegetation growing in the gravel and dirt at this time. Few poplar shrubs growing near the perimeter	Good	<ol style="list-style-type: none"> <li>1. See attached photo log for pictures of the area</li> <li>2.</li> <li>3.</li> <li>4.</li> </ol>

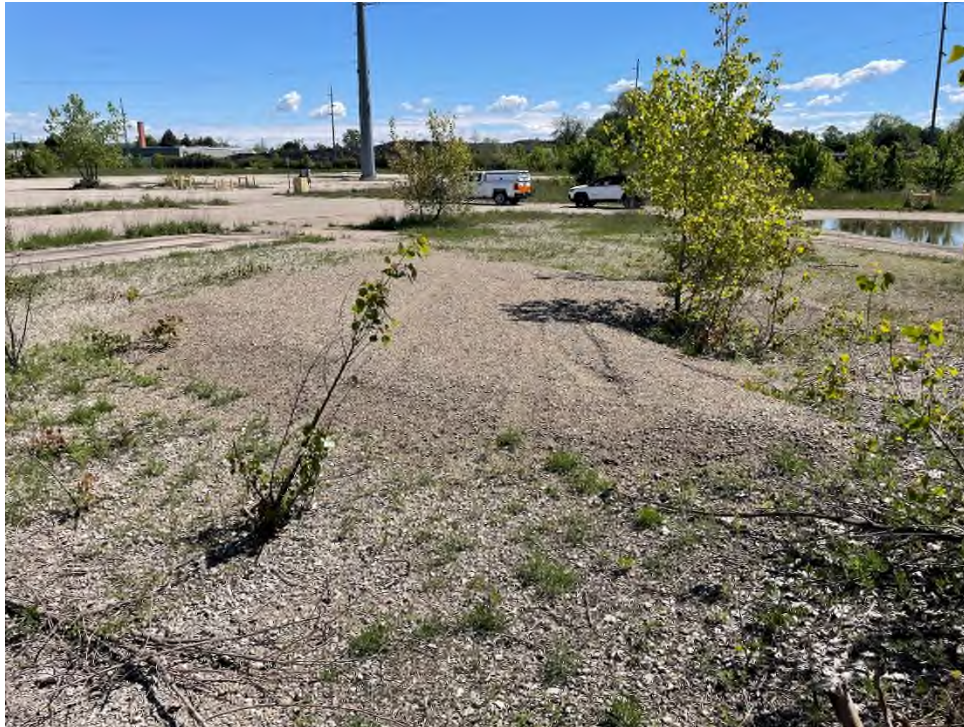
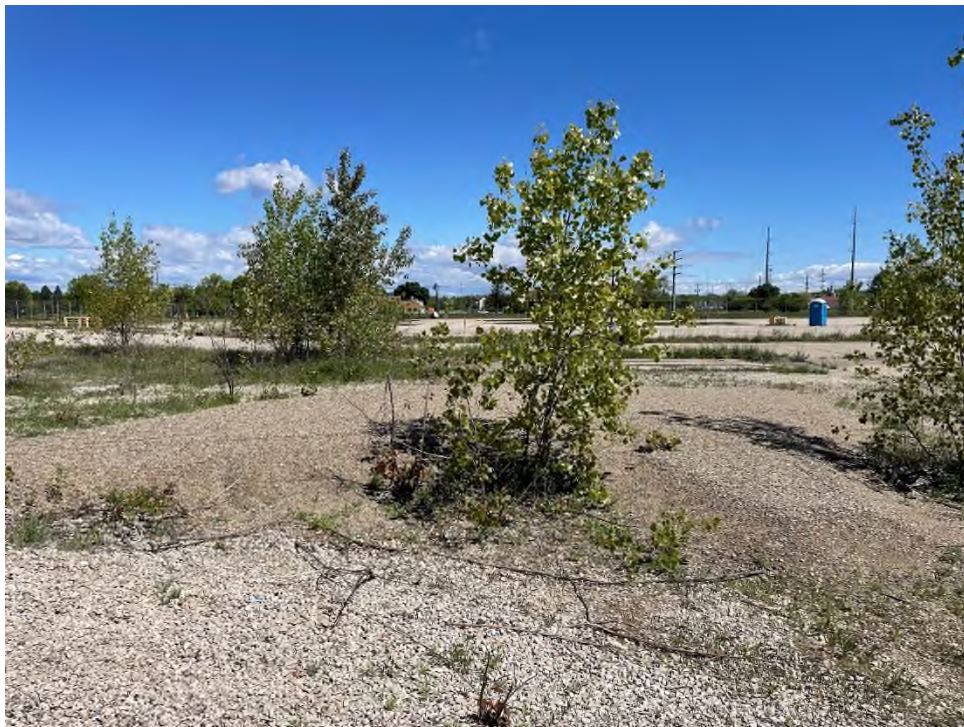
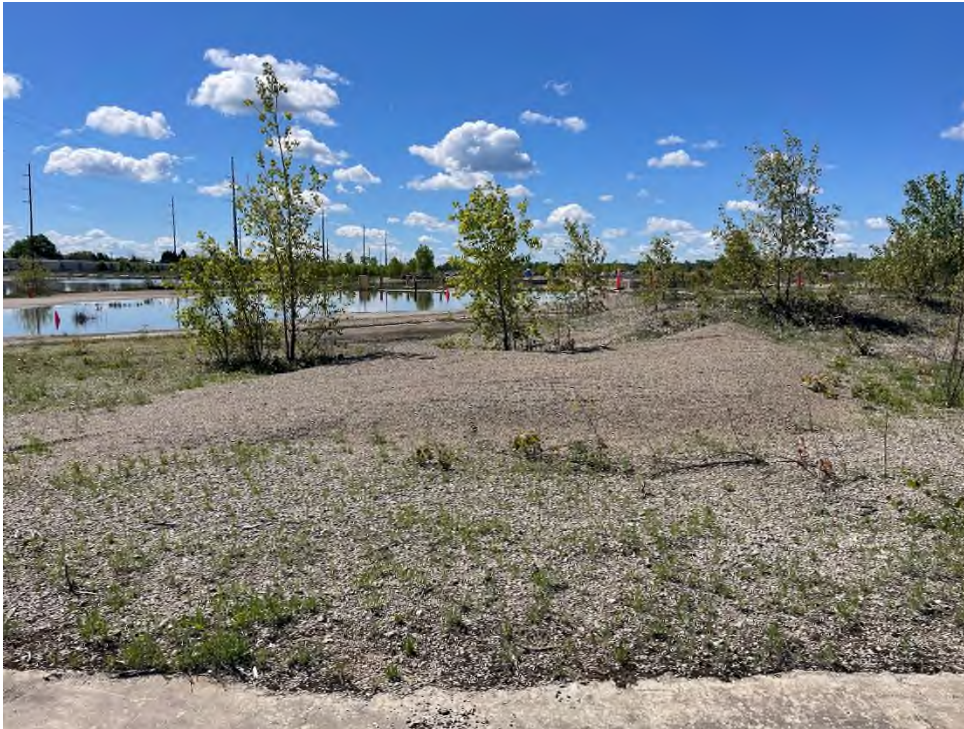
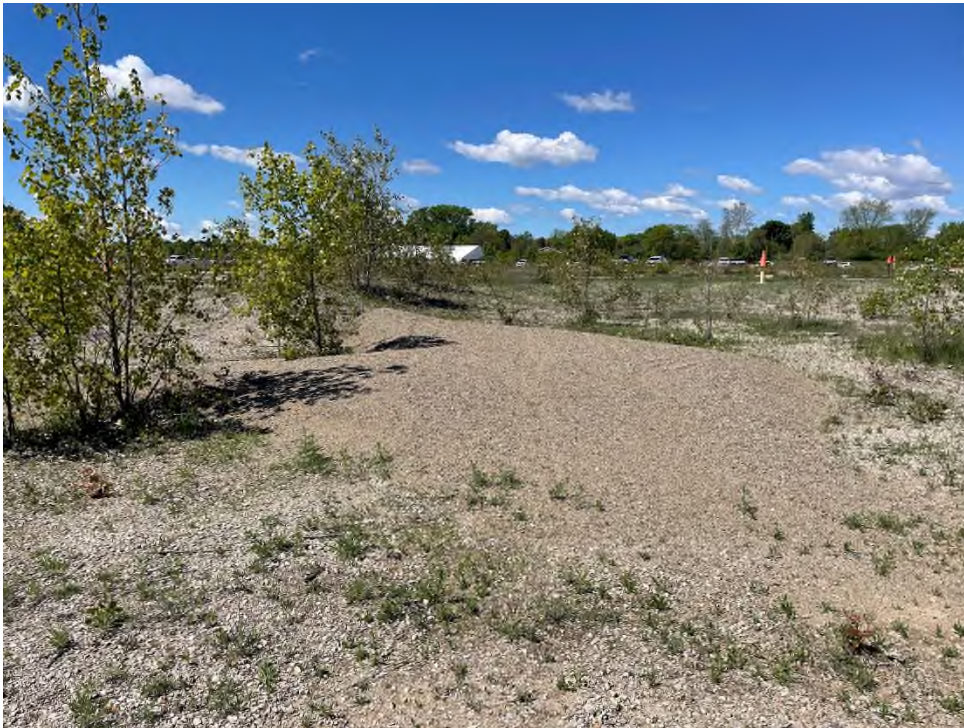
- Plant 3 Area 18 Exposure Barrier – condition was noted as satisfactory and in good condition. The exposure barrier in this area was placed in December 2023 and consists of demarcation fabric underlying a layer of 22A road gravel. During inspection no vegetation was observed to be growing in the exposure barrier areas. A few small shrubs were observed to be growing near the perimeter of the barrier. At the time of the inspection the exposure barrier appeared to be functioning adequately to prevent exposure to the underlying soil containing concentrations of benzo(a)pyrene

that exceed EGLE Part 201 generic Nonresidential Direct Contact Criteria (December 30, 2013). Accordingly, no corrective actions are recommended. The exposure barrier placement activities are summarized in the *Plant 2 Area 2 Excavation and Plants 2 and 3 Exposure Barrier Placement Completion Report*, dated August 1, 2024 that has been submitted to EGLE.

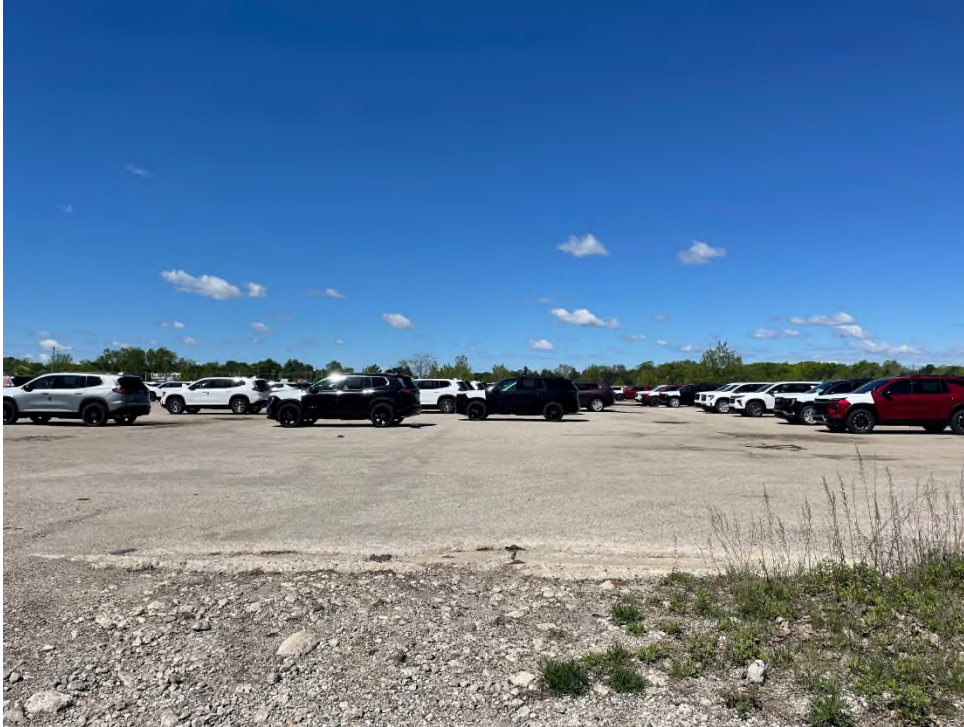
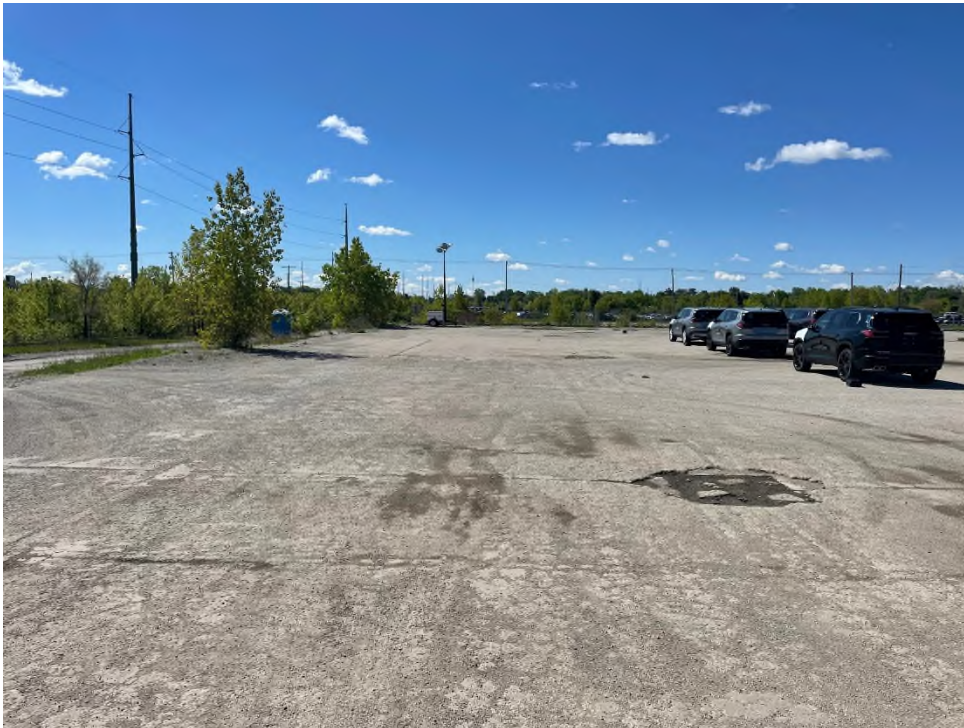
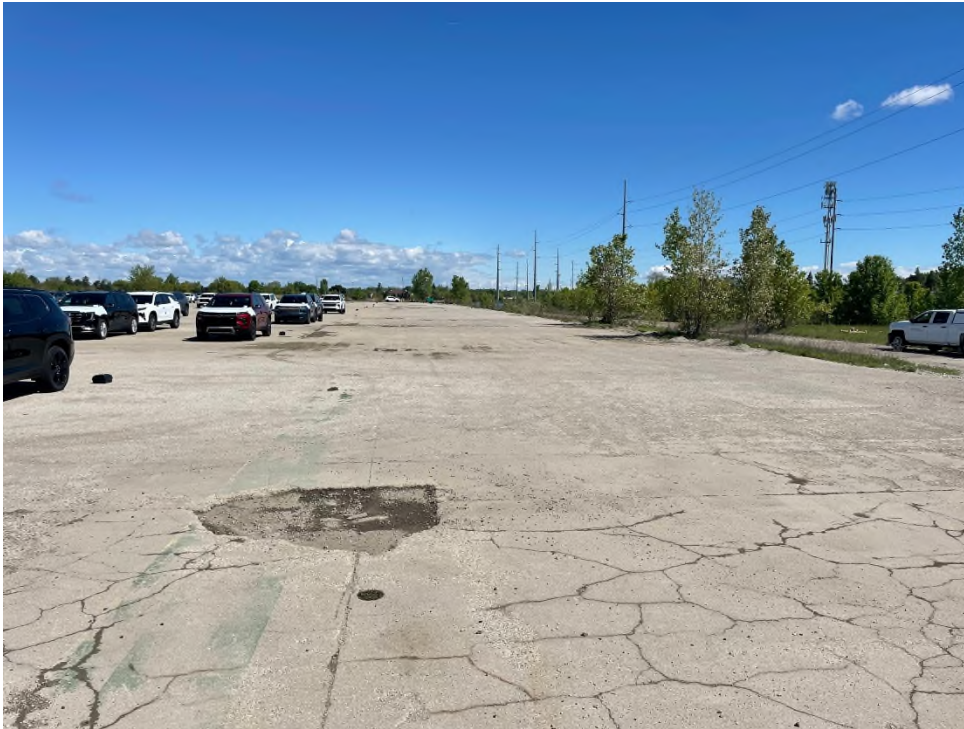
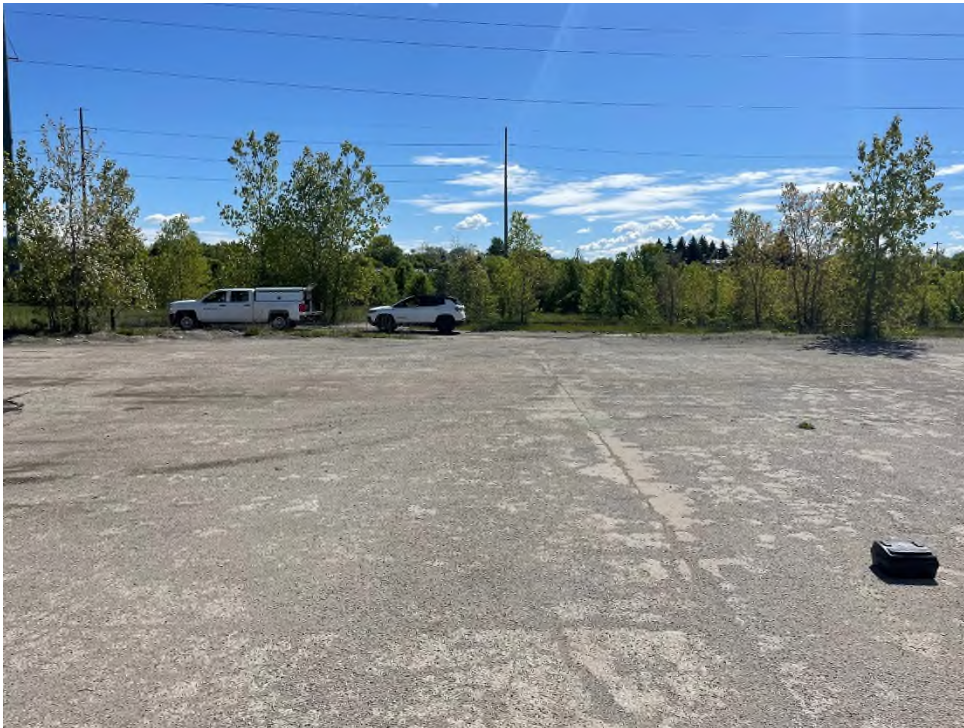
- Plant 3 Area 19 Exposure Barrier – condition was noted as satisfactory and fair condition. The exposure barrier area consists of existing concrete pavement. The concrete shows some signs of weathering and cracking. At the time of the inspection the exposure barrier appeared to be functioning adequately to prevent exposure to the underlying soil containing concentrations of arsenic that exceed EGLE Part 201 generic Nonresidential Direct Contact Criteria (December 30, 2013). Accordingly, no corrective actions are recommended.

Plant 3 Area 19 Exposure Barrier	Most of the exposure barrier ground cover consists of concrete pavement. The area shows some signs of weathering and cracking	Fair	<ol style="list-style-type: none"> <li>1. See attached photo log for pictures of the area</li> <li>2.</li> <li>3.</li> <li>4.</li> </ol>
