Date: December 20, 2024

Subject: 2024 Exposure Barrier Inspection Report for Plant 2, Areas 2, 5-2, 5-3, and Tank 225 Area; Plant 3, Areas 14, 18, and 19; and Plant 6, Area 5-6  
RACER Lansing Plants, Lansing, Michigan

**MAINTENANCE OF EXPOSURE BARRIERS**  
**INSPECTION LOG SHEET**  
 RACER Trust Plants 2 and 3 – Lansing, Michigan

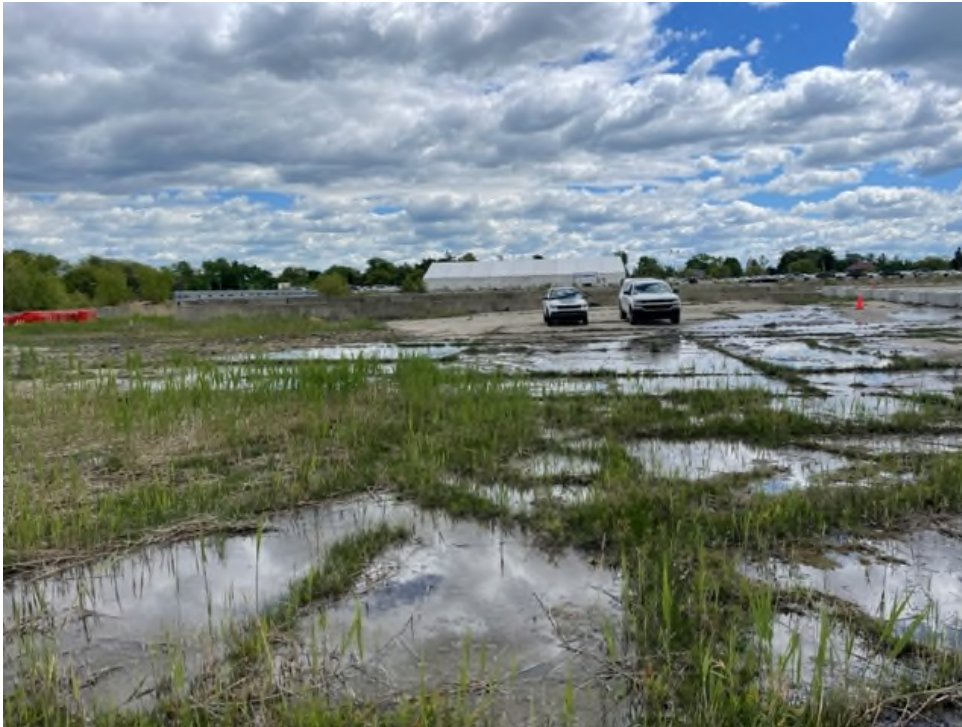
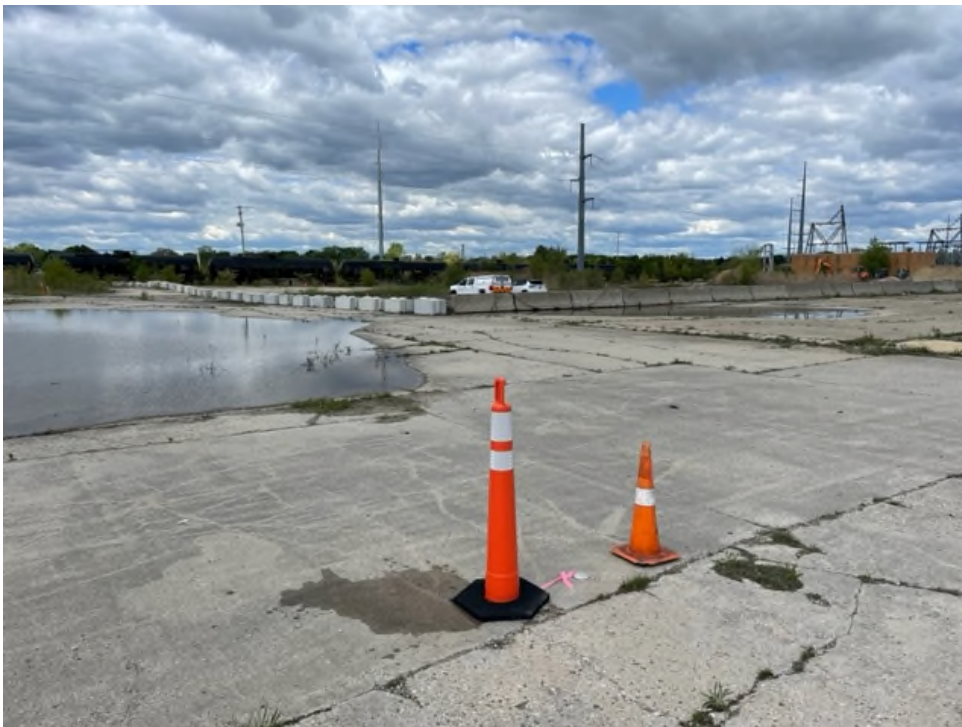
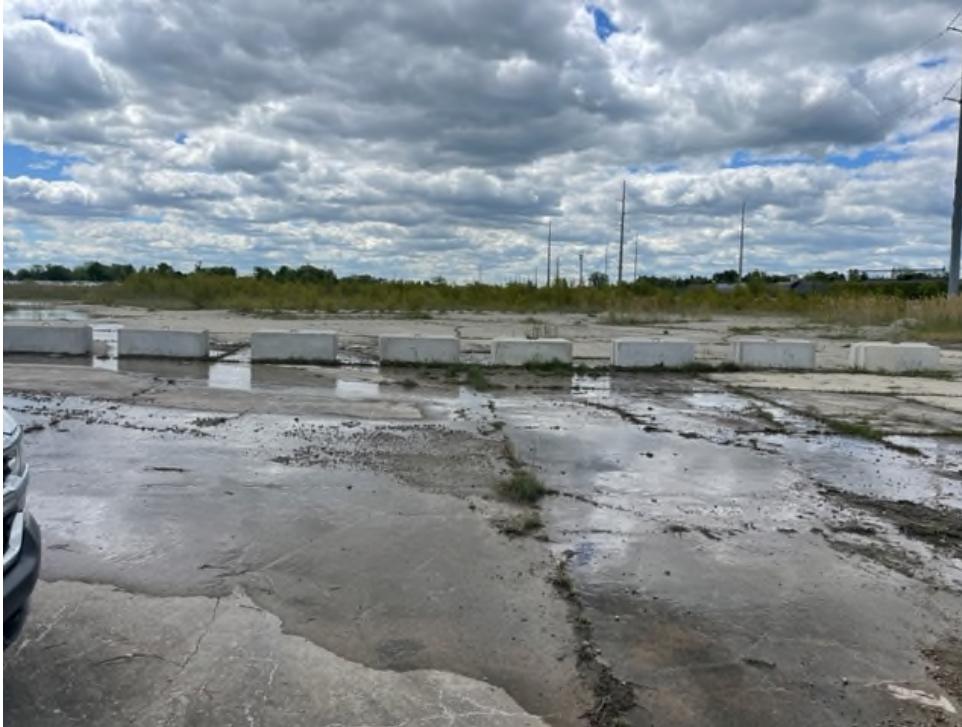
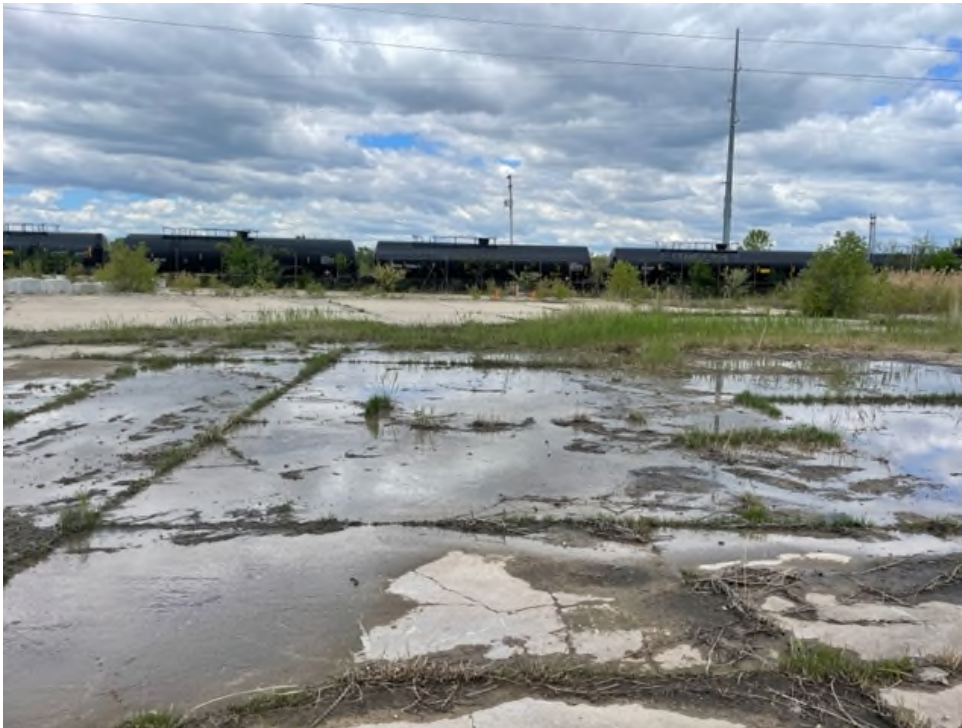
- Plant 6 Area 5-6 Exposure Barrier – condition was noted as satisfactory and fair condition. The exposure barrier area consists of portions of concrete pavement as well as some areas of crushed concrete. The concrete shows some signs of weathering and cracking, with some areas also containing vegetation growth and some standing water. At the time of the inspection the exposure barrier appeared to be functioning adequately to prevent exposure to the underlying soil containing concentrations of lead that exceed EGLE Part 201 generic Nonresidential Direct Contact Criteria (December 30, 2013). Accordingly, no corrective actions are recommended. The steel markers placed in September 2023 were still present, in good condition, with the stamping on the markers legible.

Most of the exposure barrier ground cover consists of a concrete pavement with some sections containing crushed concrete. The concrete shows some signs of weathering and cracking, with some areas containing poplar trees and phragmite growth. A few areas have some ponding water.

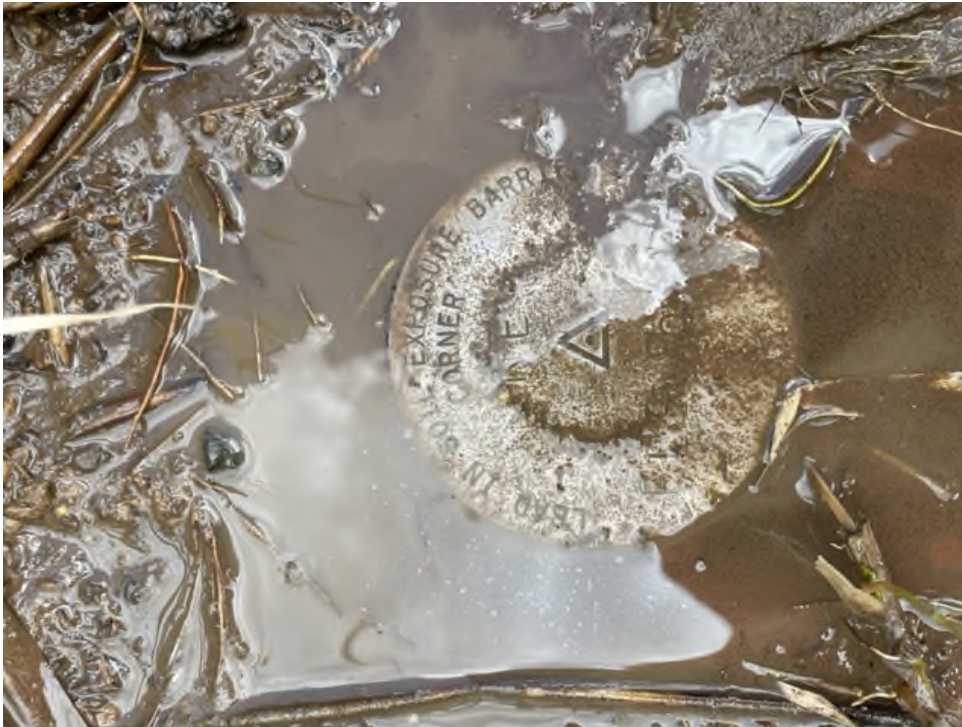
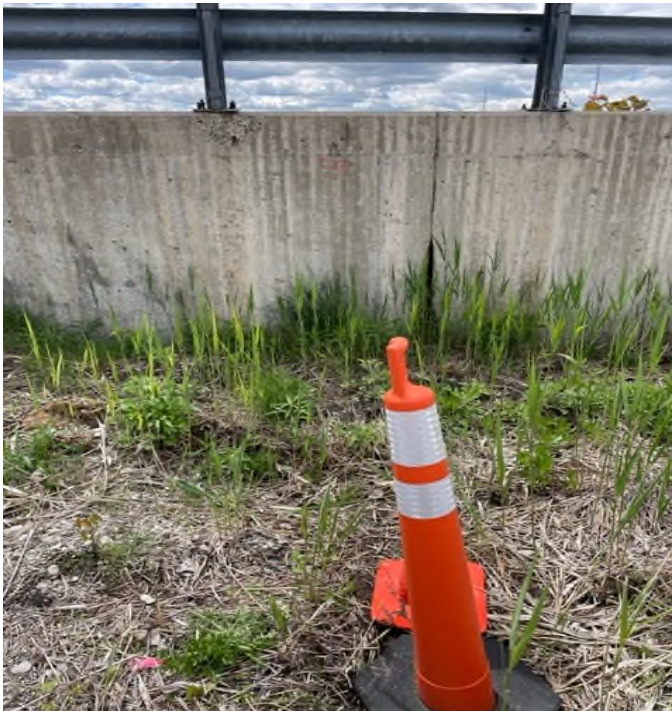
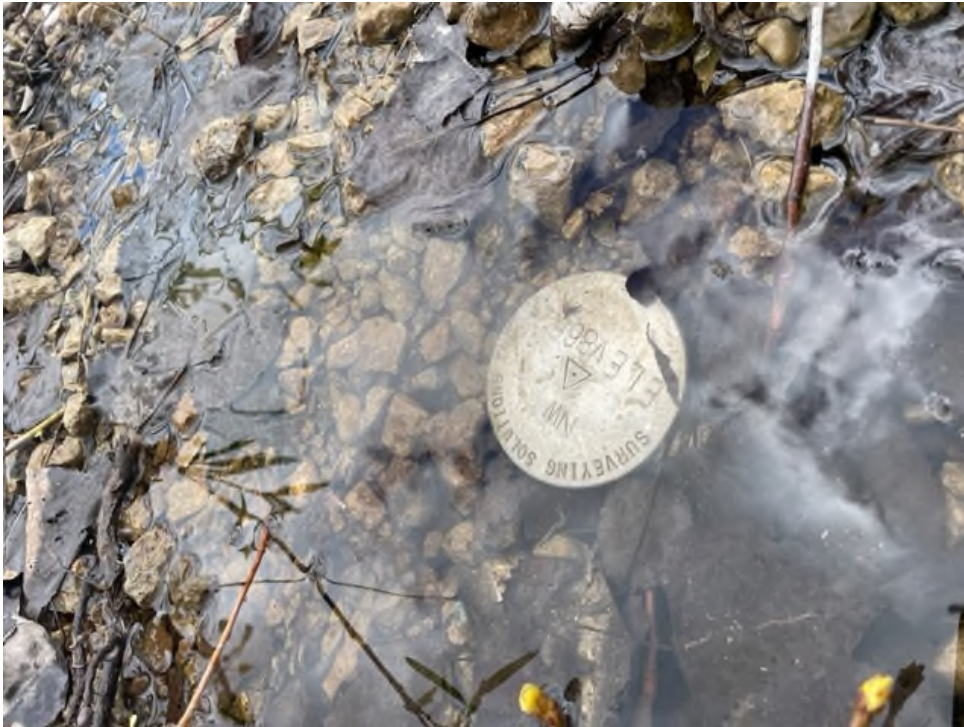
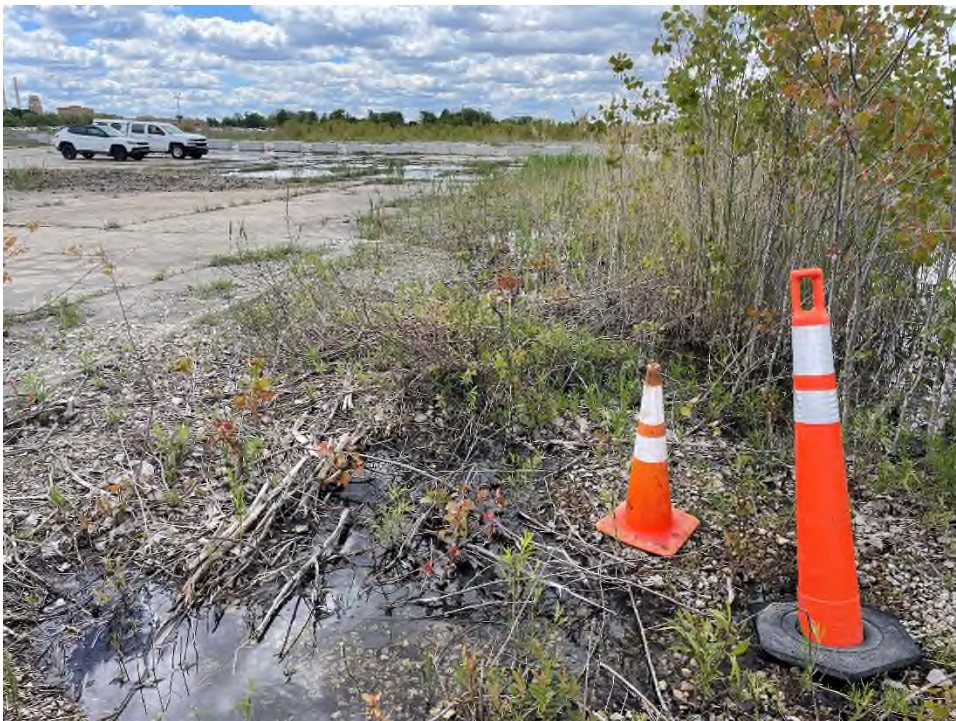
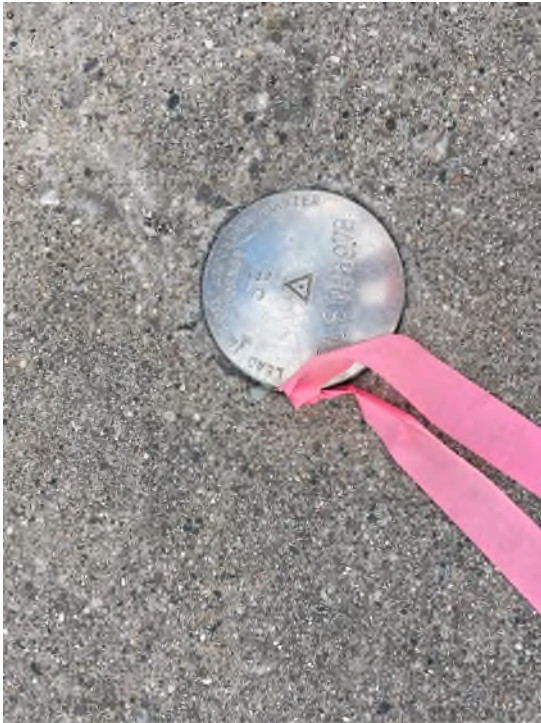
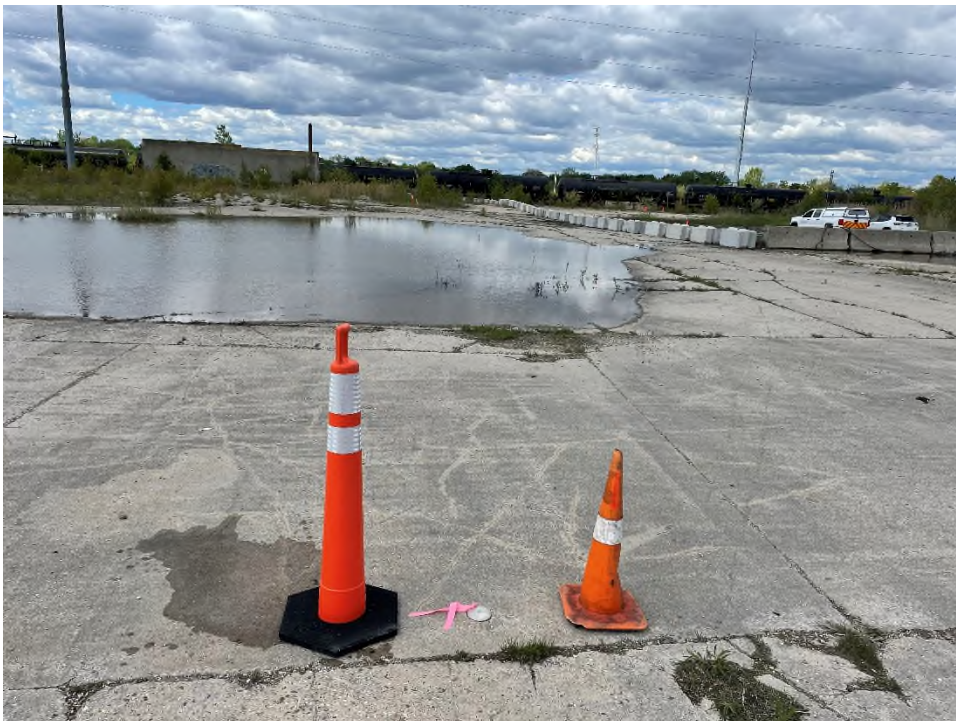
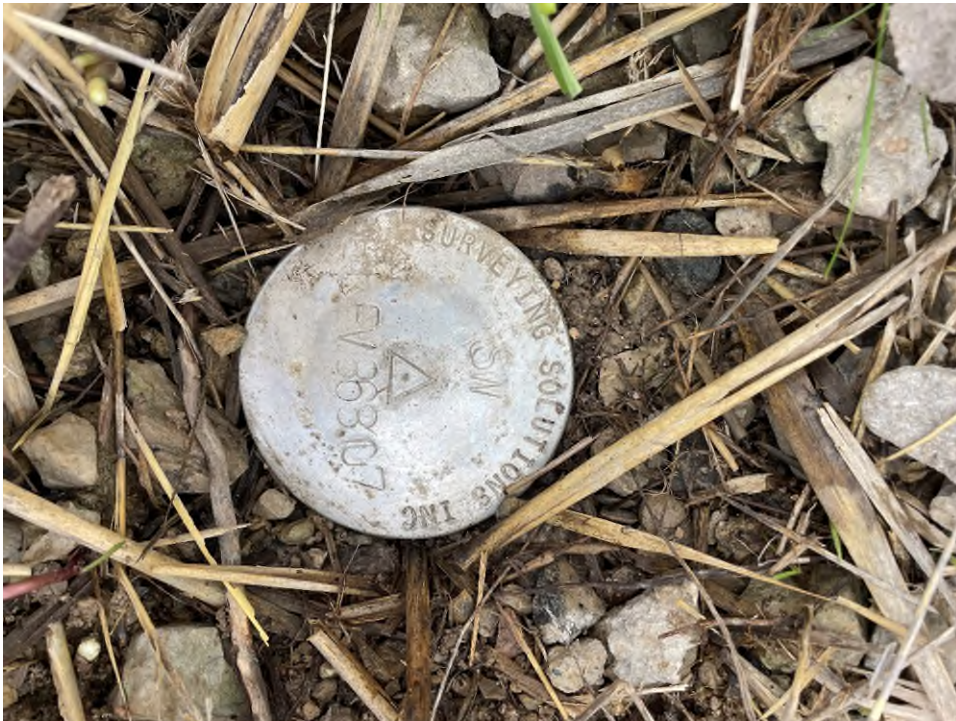
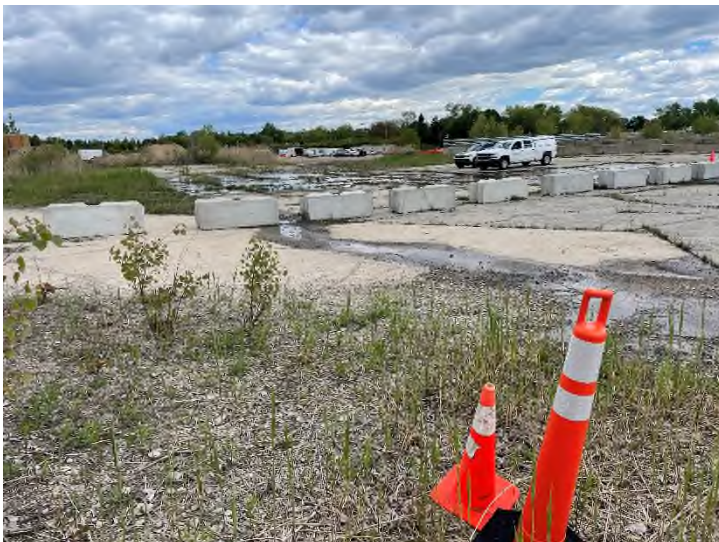
Area 5-6 Exposure Barrier corner markers are in good condition and the stamping is legible.

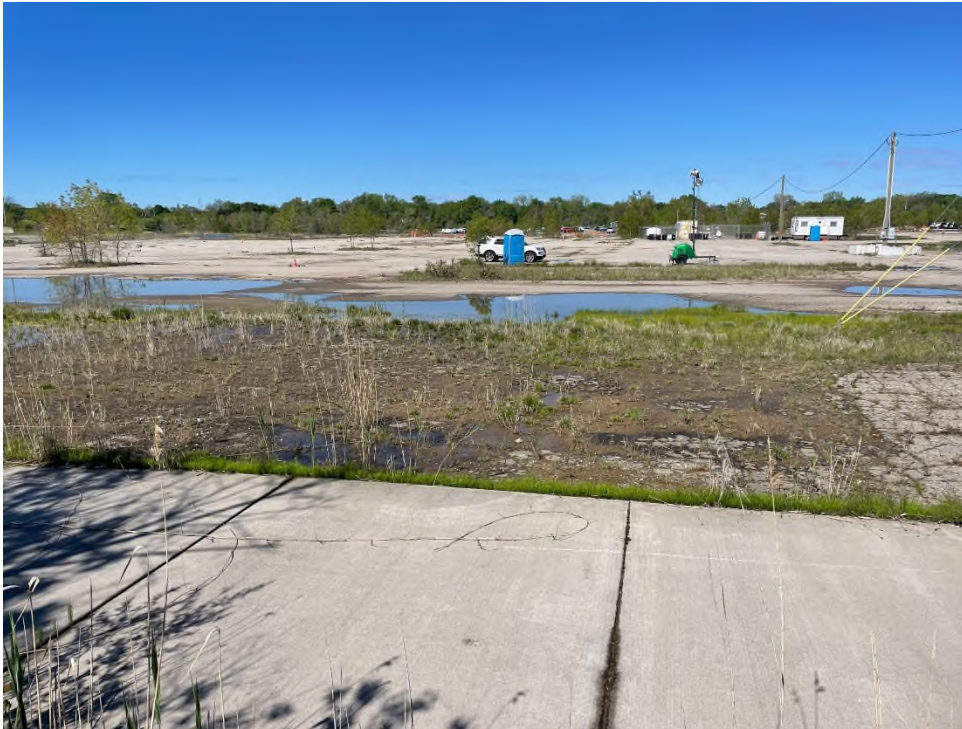
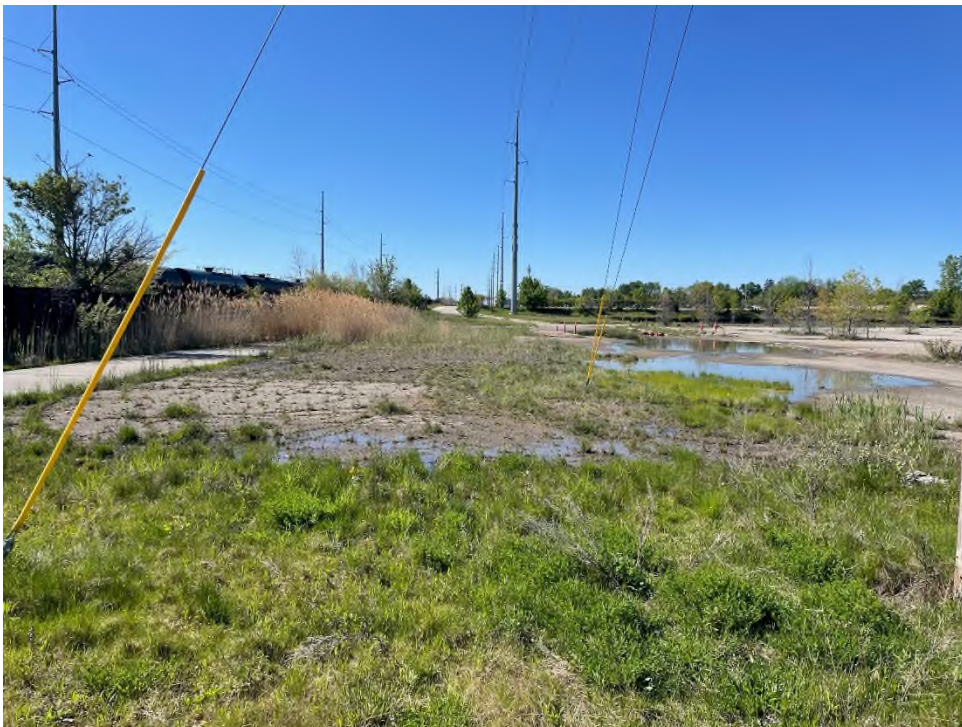
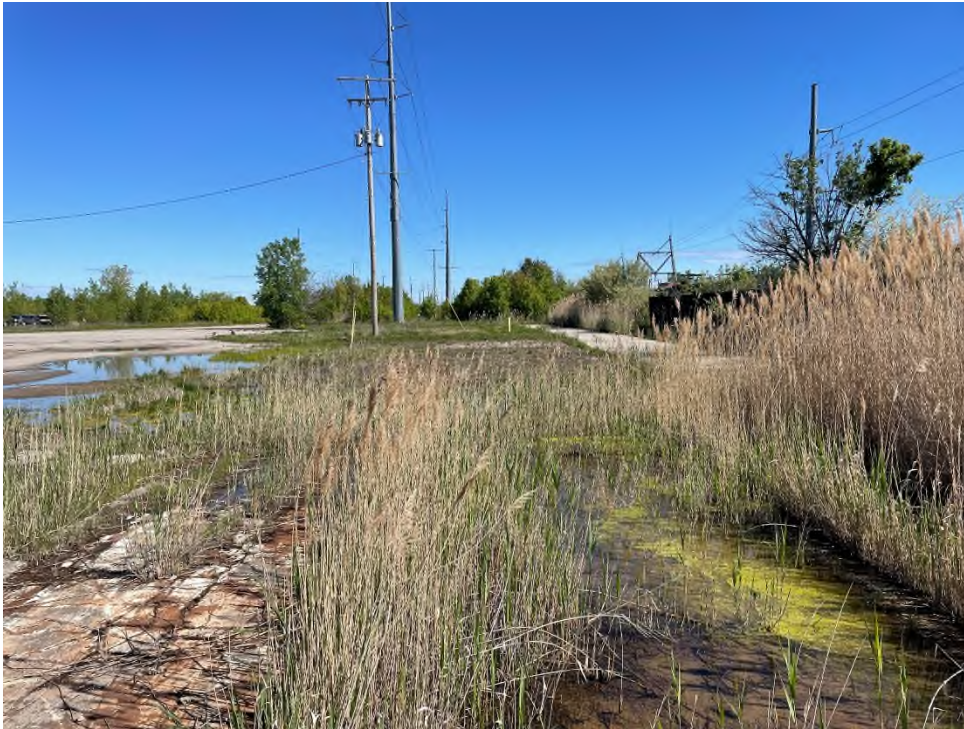
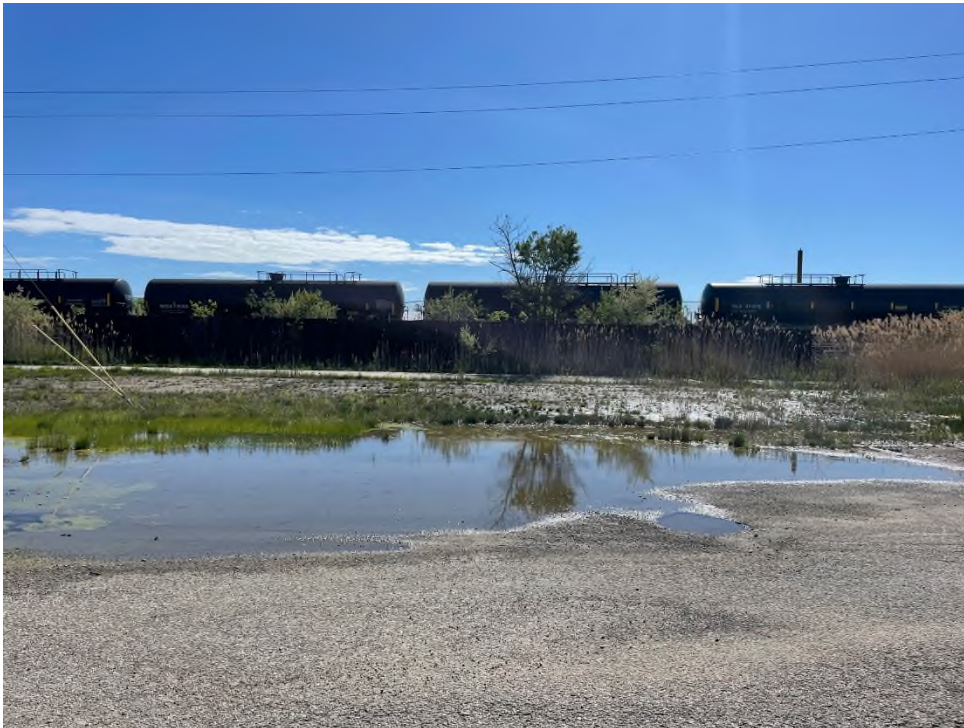
- Most of the groundcover consisted of asphalt pavement that showed visual signs of weathering and is heavily cracked. South end of the area contains some grasses and phragmite and is also partially covered with standing water from recent rain events. The condition of the cover was noted as fair and at this time no corrective actions were deemed necessary.

- Groundcover Condition: Most of the Tank 225 Area groundcover consists of asphalt pavement. There is a new strip of concrete pavement on the east side marking a buried gas utility. The asphalt shows signs of weathering and is heavily cracked. Some grasses and phragmites are growing up through the pavement. Much of the south end is under water.
- Overall Condition:  
Fair
- Photo notes:  
See attached photo log for pictures of the area.
