REPORT ON INSPECTION TO DETERMINE COMPLIANCE
WITH THE PCB DISPOSAL AND MARKING REGULATION

Textile Road Drum Site
PEAS 479-83
NW $\frac{1}{4}$, Section 25, Ypsilanti Township
Washtenaw County, Michigan

PCB INSPECTION #81012

June 29, 1983

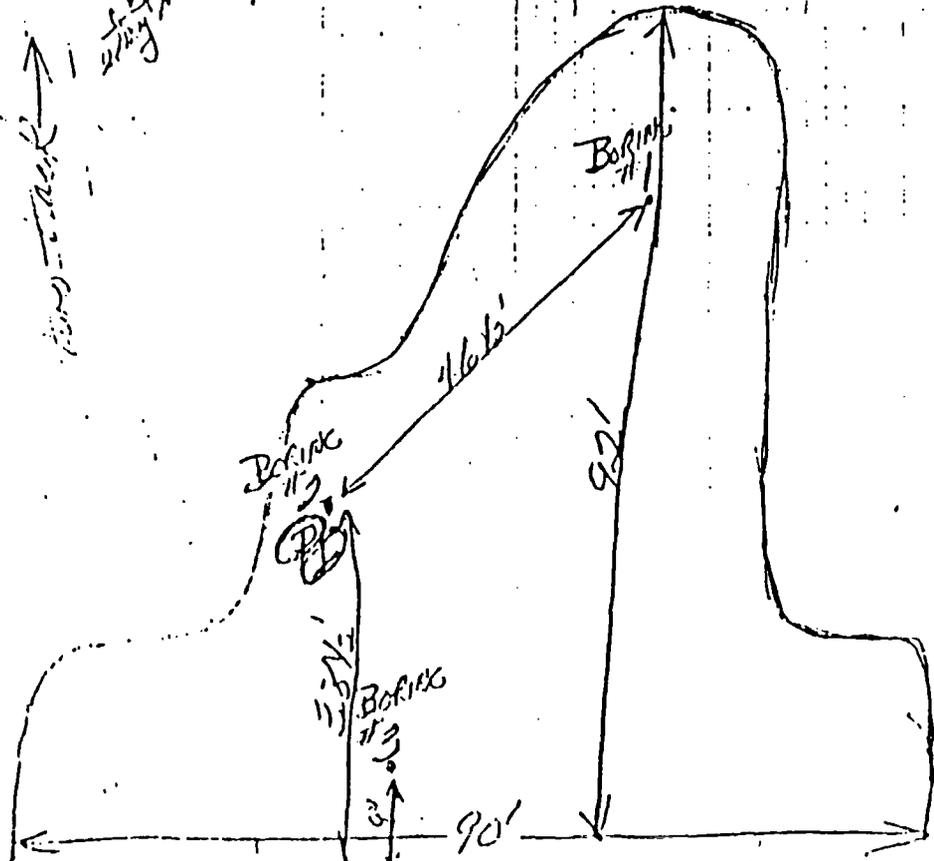
On June 29, 1983, Gene Hall and the author took photographs and sampled various areas of the site for PCBs. The parties involved were given duplicates of each. Each of the sample locations is identified on the attached diagram.

A-J - taken by M Field's
"1" - "1" at various depths (5 ft)
taken by G. Hall
