RE: Windiate Park/Dixieland Subdivision Landfill, Genesee County, Michigan (Site ID No. 25000689)  
FILE: 15388/64738 - Soil Cover Inspection Report

## WINDIATE PARK SOIL COVER MAINTENANCE CHECKLIST

# INSPECTION MAP

WINDIATE PARK  
FLINT, MICHIGAN

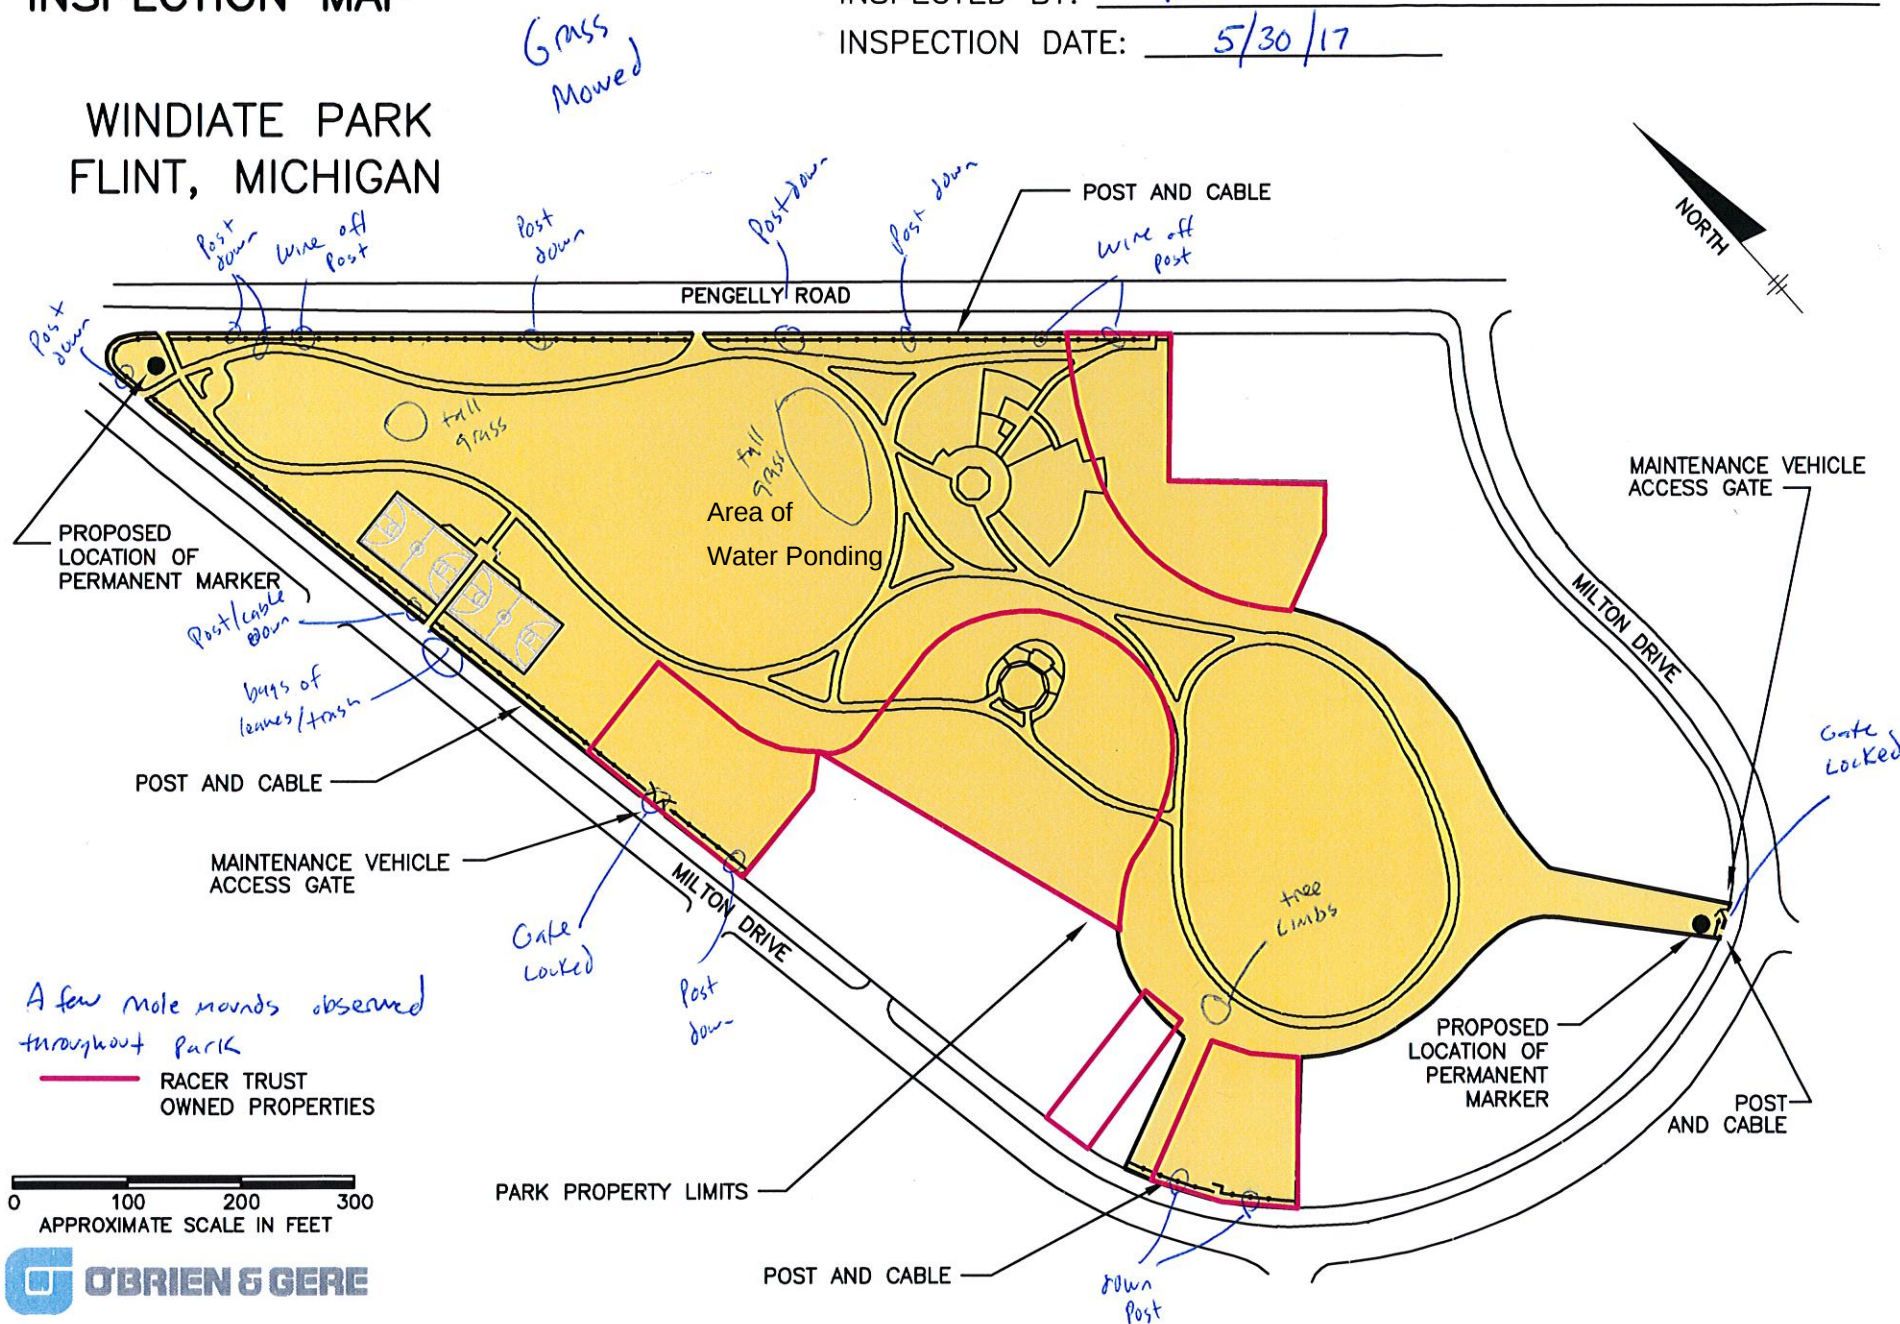
| Inspected Item: | Comments: |
|---|---|
| <i>GRASS/VEGETATIVE LAYER</i> | Acceptable. No maintenance required at this time. One area was observed where water had previously ponded after rain events. Located east of the basketball court. |
| <i>POST &amp; CABLE / VEHICLE GATES</i> | Acceptable. Ten damaged posts were observed during the site inspection (either partially down or completely down). Three sections of down cable were observed. The south and west maintenance vehicle access gates were locked. |
| <i>OTHER OBSERVATIONS</i> | A number of mole mounds were observed. Fewer disturbances were observed compared to previous inspections. |

Add additional soil to area where water has ponded.
