Re: Ley Creek PCB Dredgings Site (Registry # 7-34-044)  
NYSDEC Order on Consent Index # D-7-0008-97-06  
2001 Annual OM&M Inspection Report

Re: Ley Creek PCB Dredgings Site  
2001 OM&M Wetland Evaluation

Re: Ley Creek PCB Dredgings Site  
2001 OM&M Inspection

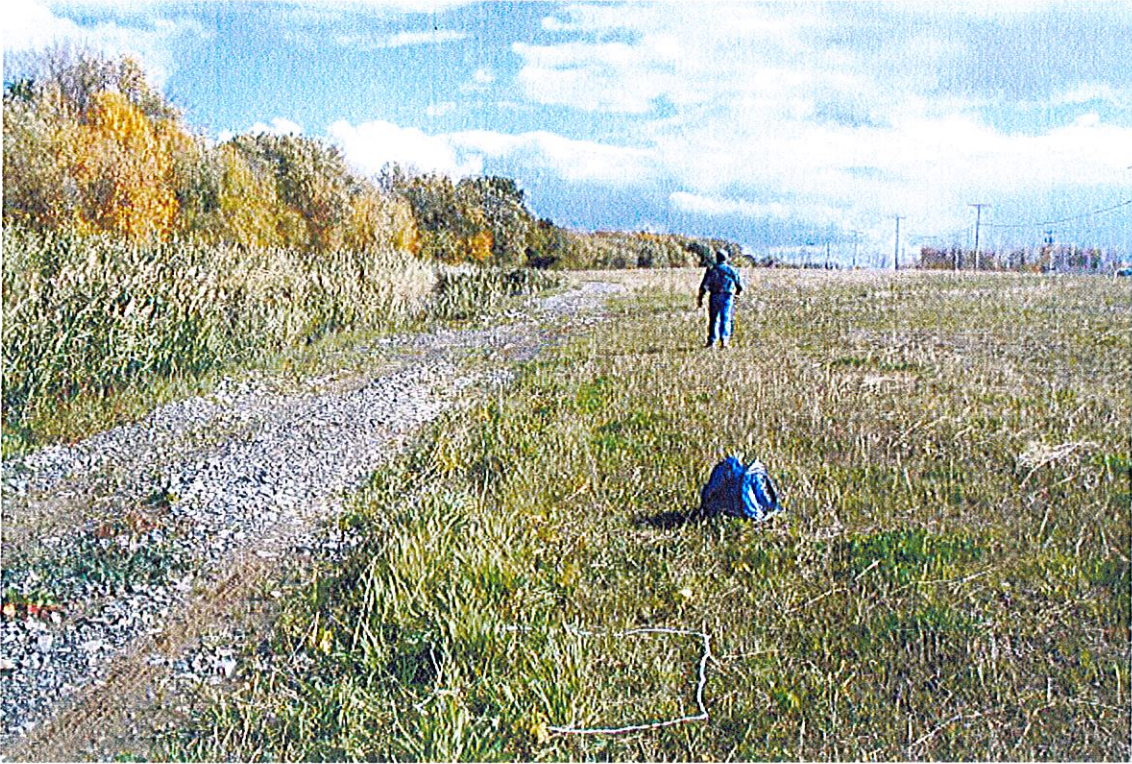
Photo 1: Looking east at area of restored wetland evaluation Plot 1.  
Date photo taken: 10/15/2001

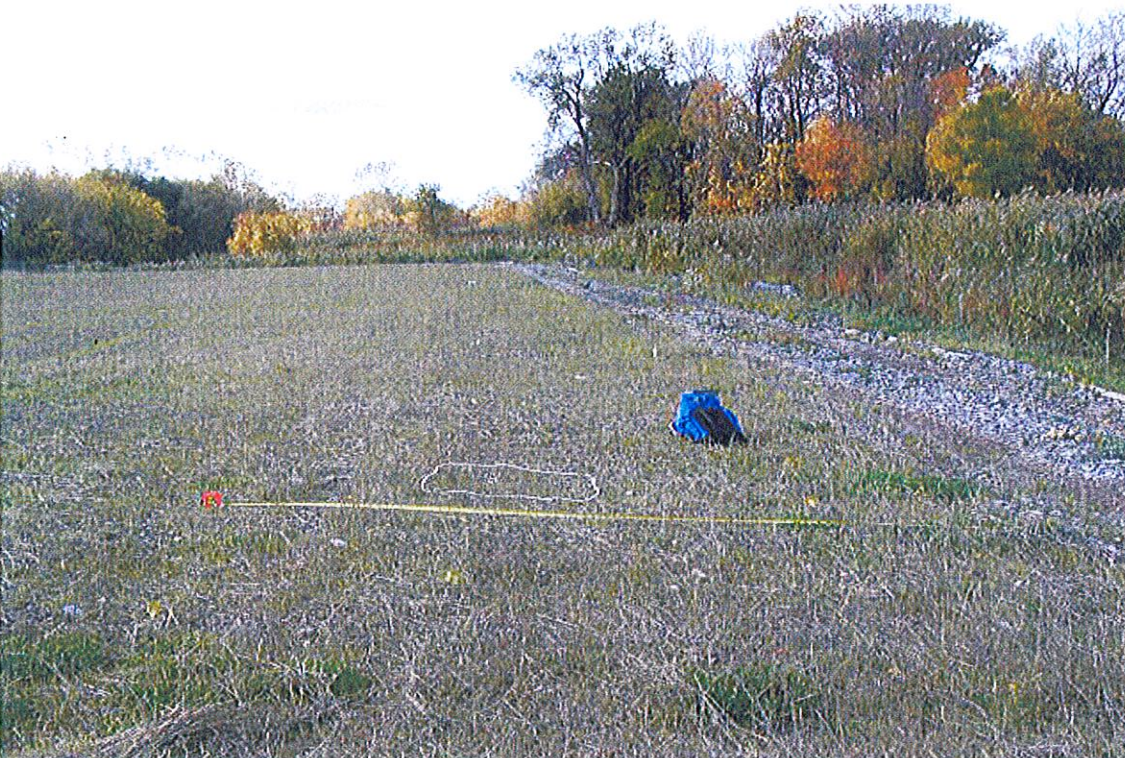
Photo 2: Looking west at area of restore wetland evaluation plot 2.  
Date photo taken: 10/15/2001

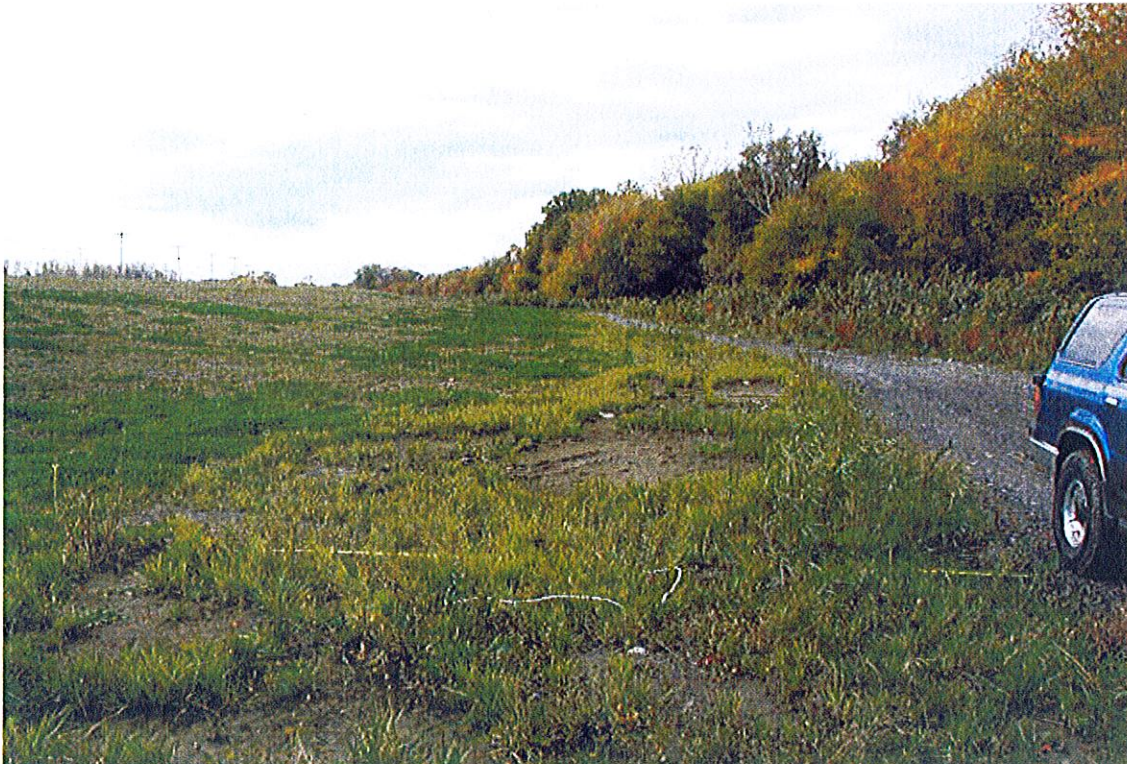
Photo 3: Looking west at area of restored wetland evaluation Plot 3.  
Date photo taken: 10/15/2001

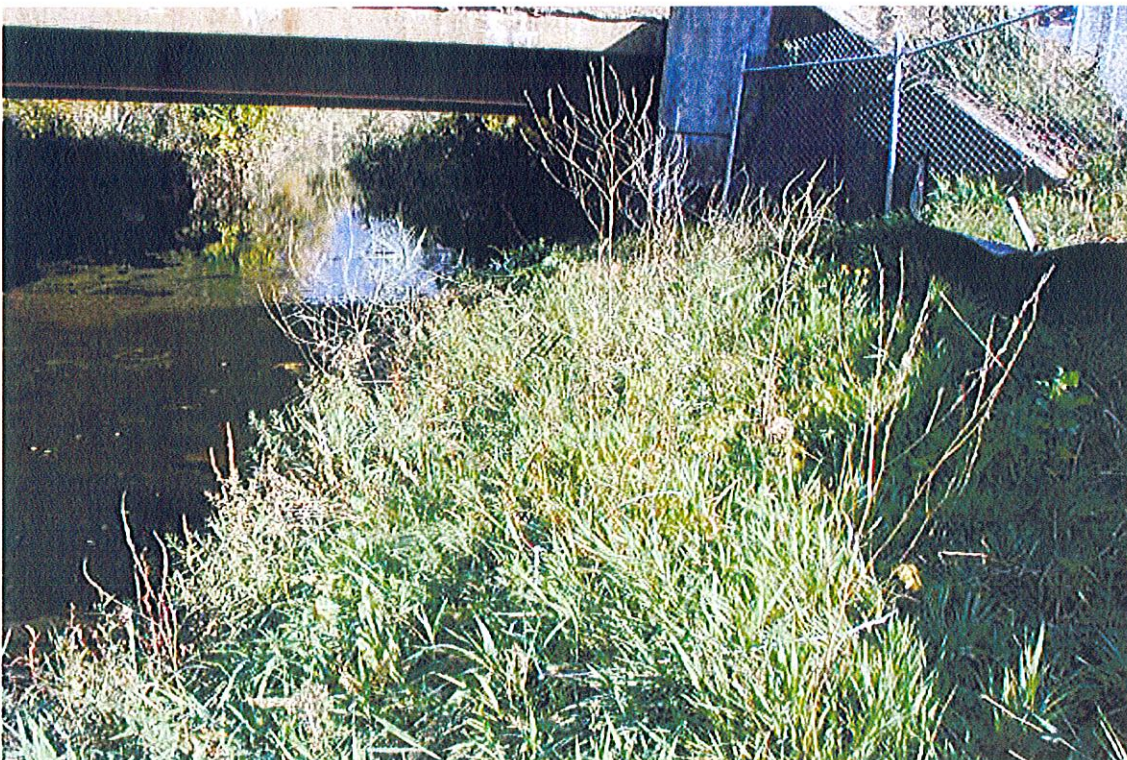
Photo 4: Looking east at area of restored wetland evaluation Plot 4.  
Date photo taken: 10/15/2001

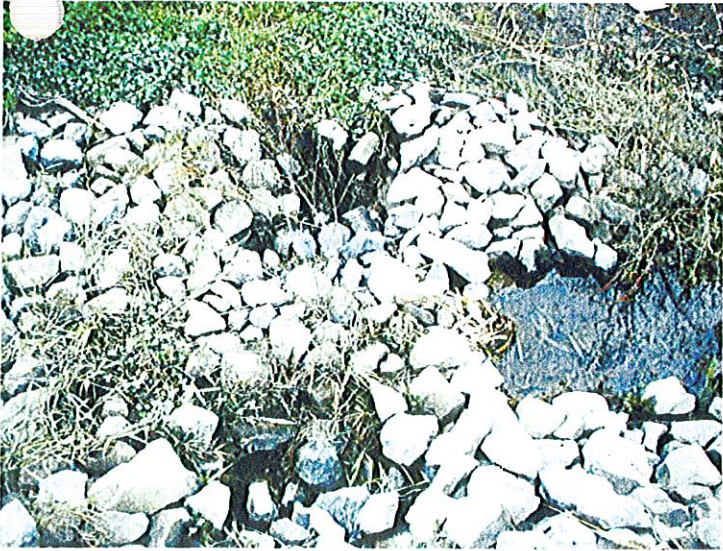
12/14/01

- DEBRIS ACCUMULATION: (Photographs 1 and 16. Figures 5 and 1.) Debris was observed to be accumulated on the grate for CB-5/004 and around the grate of CB-1.

- WASHED OUT MATERIALS: (Photograph 9. Figure 3.) Materials from erosion of ditch washed into the flowpath leading to CB-3.
- SINK HOLE: (Photograph 1. Figure 5.) An area immediately south of CB-5/004 was observed to have settlement (sinkhole) of the vegetative cover.

Photo 1 - View of CB-5/004. Debris accumulated on grate.

- Remove debris accumulated around CB-1 and CB-5/004

- Remove washed out materials from CB-3 flow path leading to catch basin
- Repair "sink hole" behind CB-5/004
- Repair areas of erosion on slopes and around overflow spillways
- Repair areas of damaged cover
- Repair rutting in stone access road

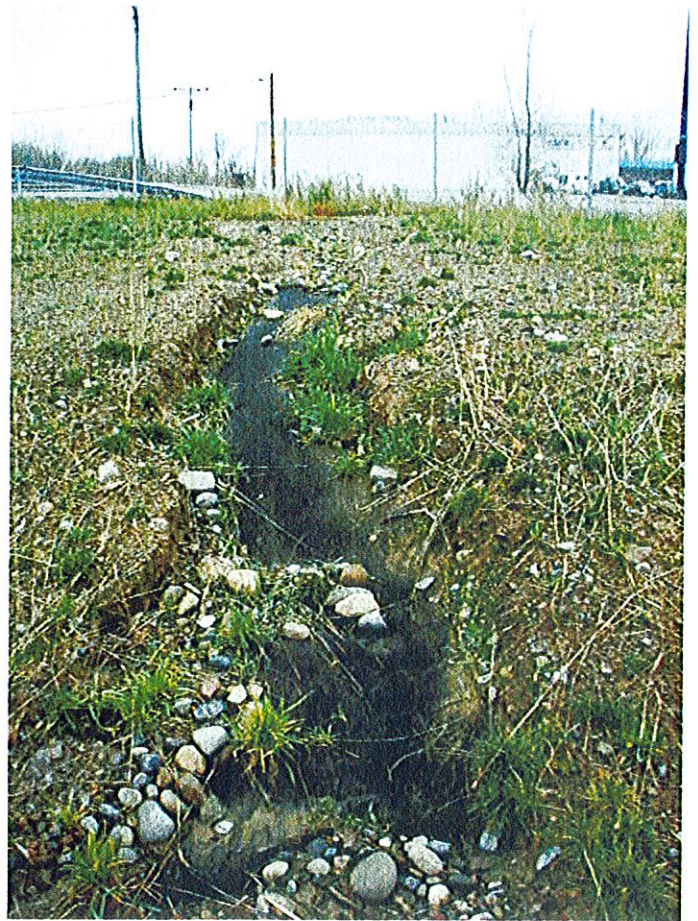
12/14/01

- GULLY EROSION: (Photograph 2 and 8. Figures 5 and 8.) Two areas of gully erosion were observed at the Site during the OM&M inspection. The first leading down to the CB-5/004 overflow spillway and the second leading down to the CB-3 flowpath.

Photo 2 - Erosion area with Mirafi indicator fabric in view.

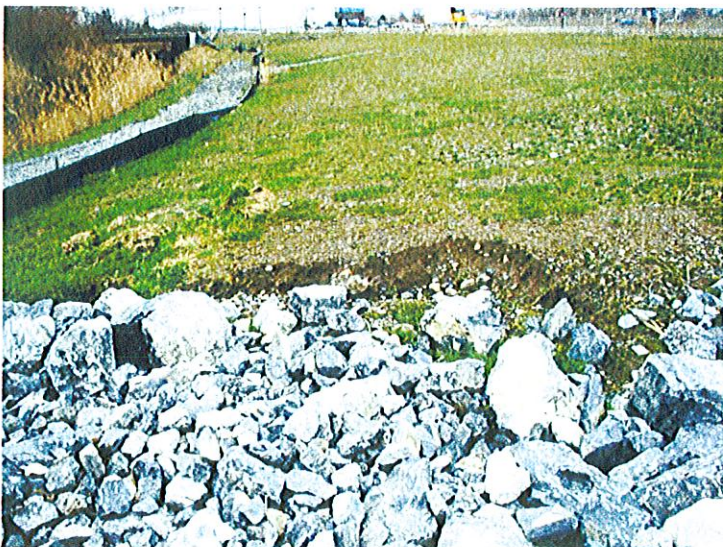
12/14/01

- CB-4/003 OVERFLOW SPILLWAY EROSION: (Photograph 3. Figure 5.) Erosion of the interface between the rip-rap and the vegetative cover material has occurred in the CB-4/003 overflow spillway.

Photo 3 - View of erosion in CB-4/003 overflow spillway.

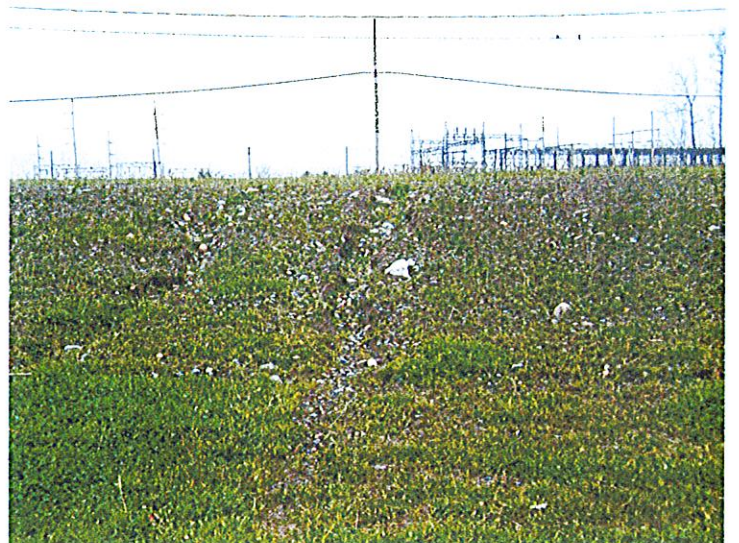
12/14/01

- RILL EROSION: (Photographs 4 and 7. Figure 4.) There were two main areas of rill erosion observed at the Site and are depicted on the two referenced photographs. The rill erosion was on the slope leading to the stone access road.

Photo 4 - View of rill erosion of slope leading down to stone access road.

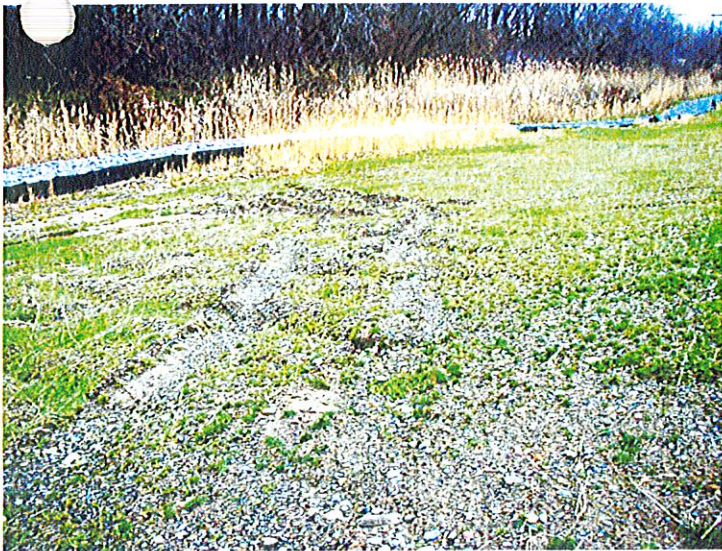
12/14/01

- VEGETATIVE COVER DAMAGE: (Photographs 5, 6 13, and 20. Figures 1 and 4.) The majority of the vegetative cover damage is from vehicles leaving ruts in the vegetative cover. The damage has resulted in poor vegetation establishment.

Photo 5 - View of damaged vegetative cover area east of MW-21D.

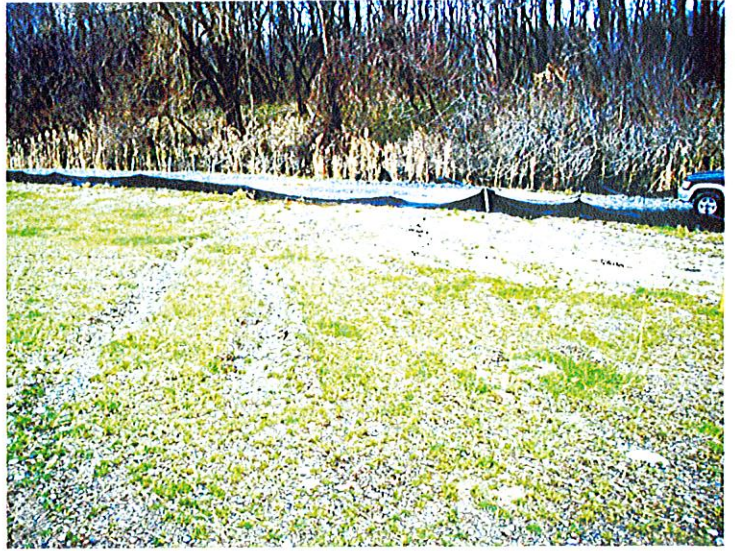
12/14/01

Photo 6 - View of damage vegetative cover area west of MW-21D.

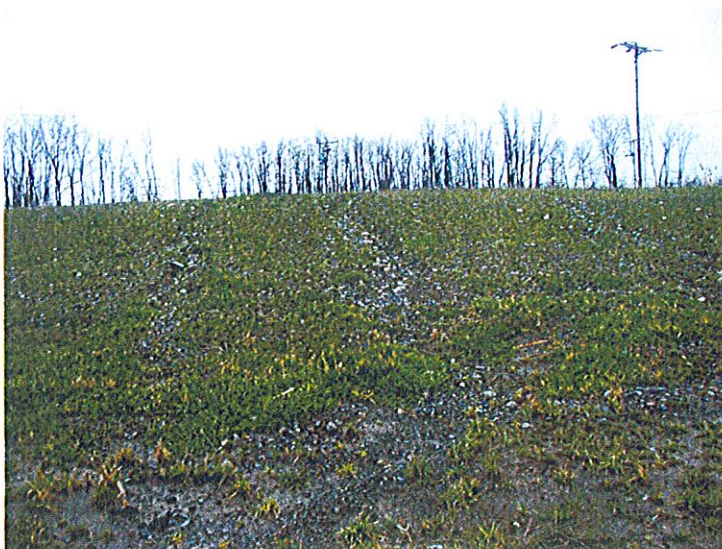
12/14/01

Photo 7 - View of rill erosion of slope leading down to stone access road.

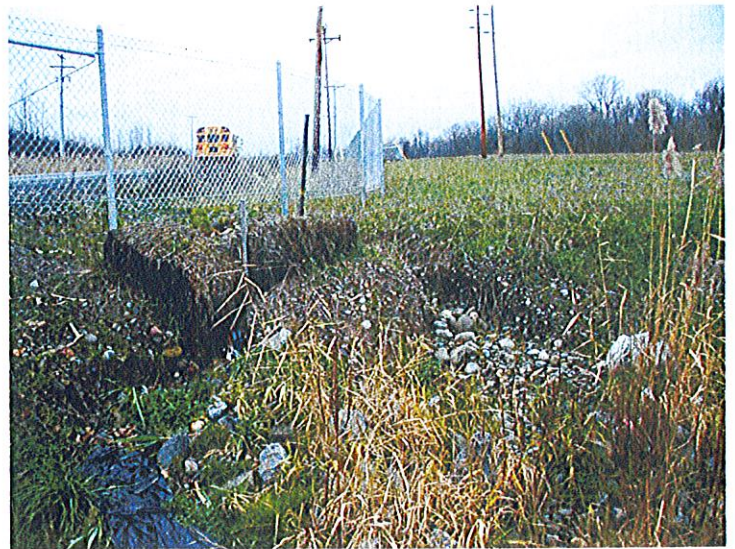
12/14/01

Photo 8 - View of gully erosion in ditch leading to CB-3.

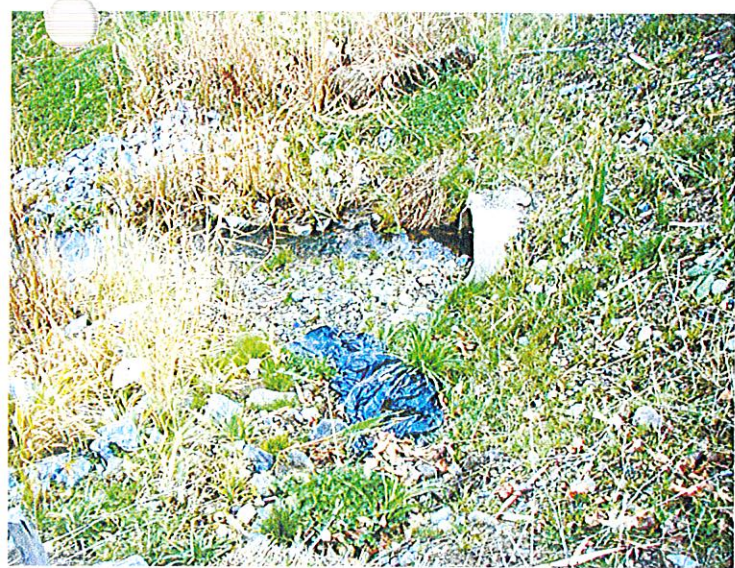
12/14/01  
Photo 9 - View of area leading to CB-3.

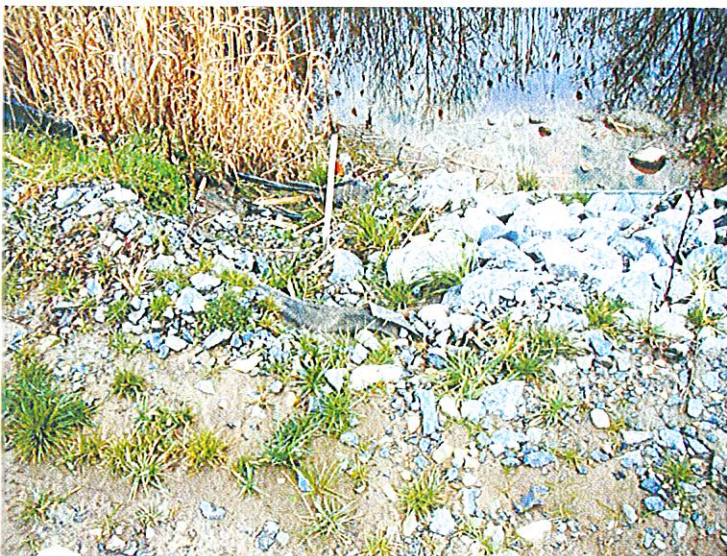
- CB-1 OVERFLOW SPILLWAY: (Photographs 11-15. Figure 1.) There are three areas of erosion associated with the CB-1 overflow spillway. The first area identified in the photographs is erosion that has occurred near the outlet structure of CB-1. The second area is erosion of the vegetative cover in the overflow spillway and the third is an area of gully erosion leading down to the catch basin.

12/14/01  
Photo 11 - View of erosion area around CB-1 outlet structure.

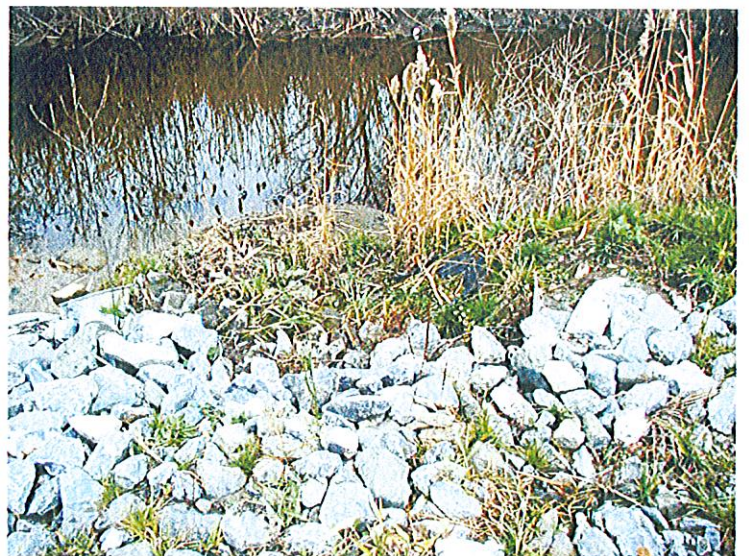
12/14/01  
Photo 12 - View of erosion area around CB-1 outlet structure.

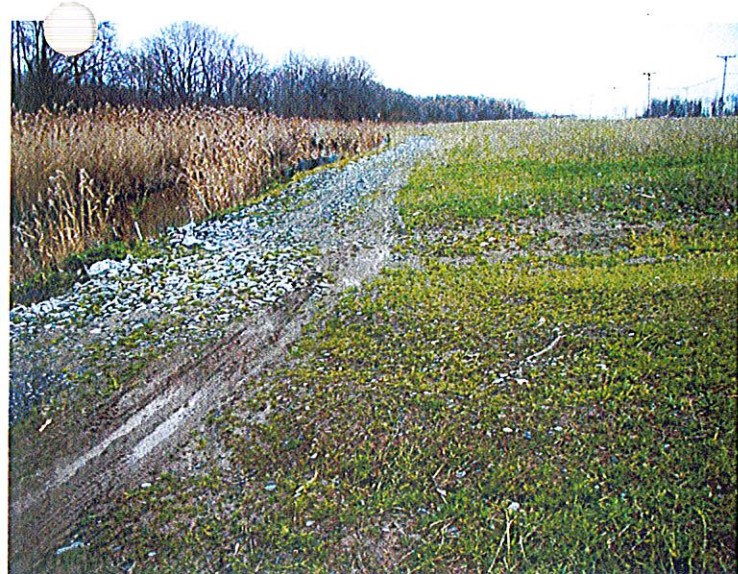
12/14/01

- STONE ACCESS ROAD DAMAGE: (Photographs 13 and 19. Figure 1.) Rutting of the stone access road was observed at the western end of the Site in the area around CB-1. Silt deposition on the stone access road was also noted during the OM&M inspection.

Photo 13 - View of damaged area around CB-1 outlet structure.

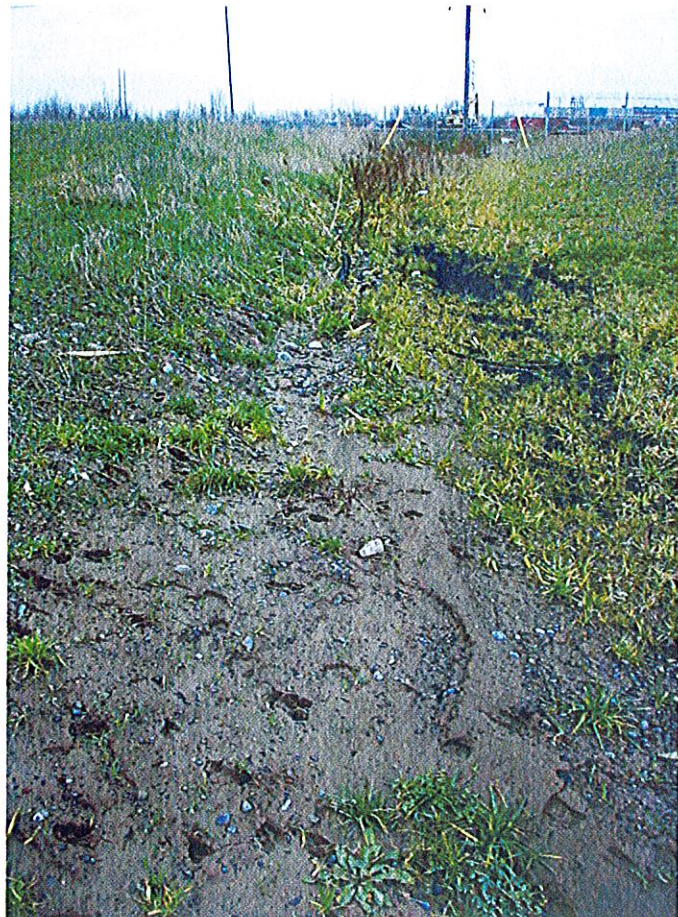
12/14/01

Photo 14 - View or erosion in CB-1 overflow spillway.

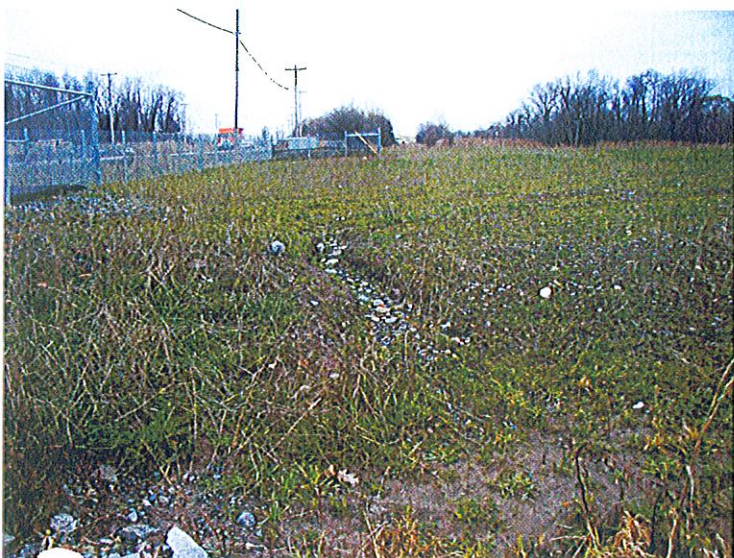
12/14/01

Photo 15 - View of gully erosion leading CB-1 off the vegetative cover.

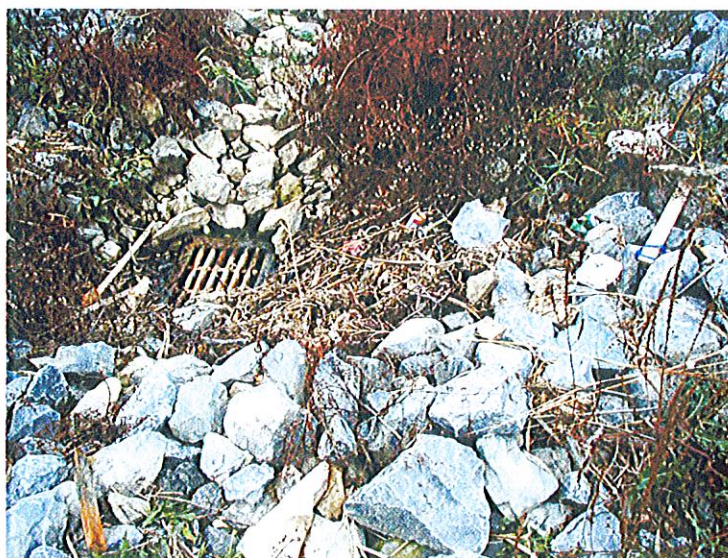
12/14/01

Photo 16 - View of CB-1 with debris accumulated around grate.

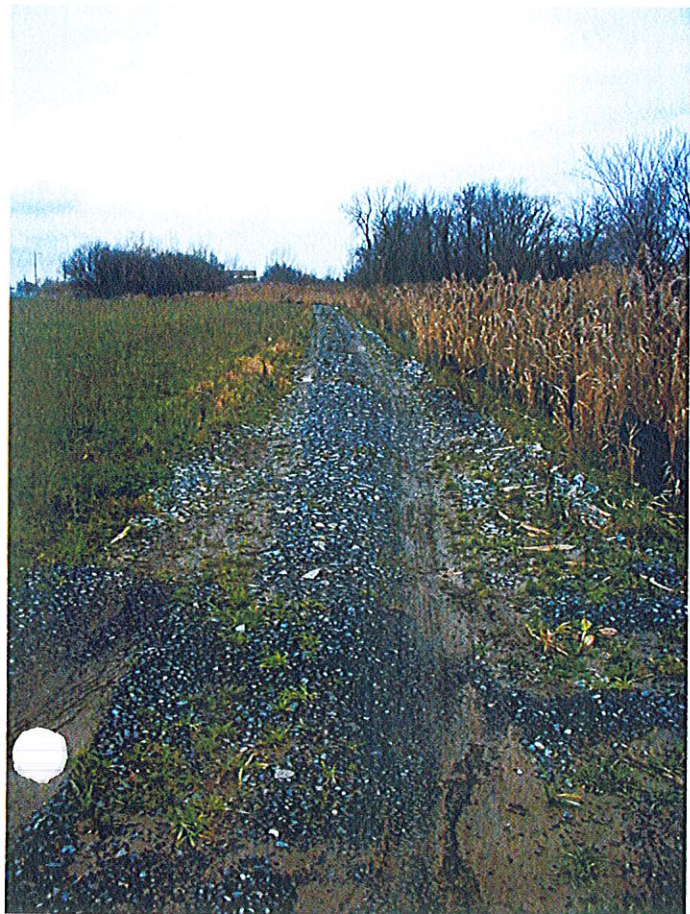
12/14/01  
Photo 19 - View of ruts in access road heading west from CB-1.

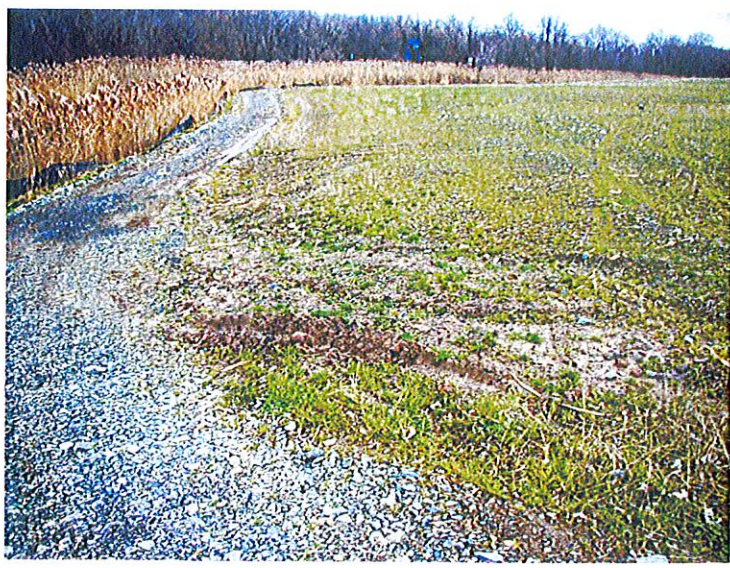
12/14/01  
Photo 20 - View of damaged vegetative cover.
